Mis Amigos Estancia SED Battery 1

CLOSURE REPORT

NMOCD Case #: 1R-4234

November 10, 2016

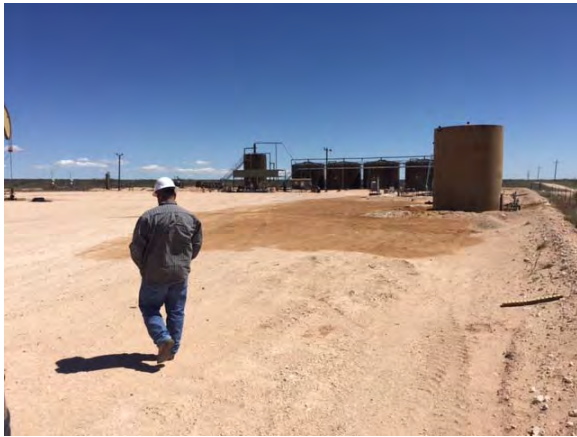
Site prior

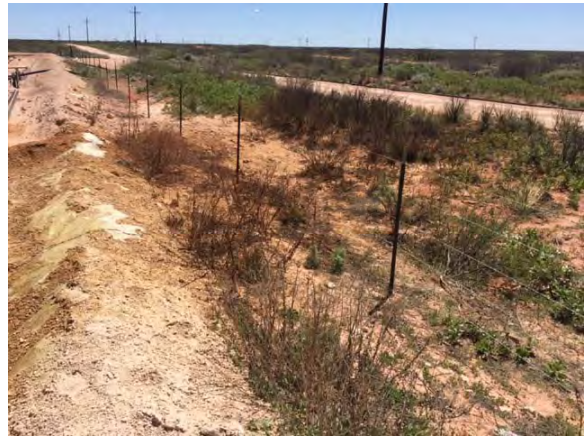
Site prior

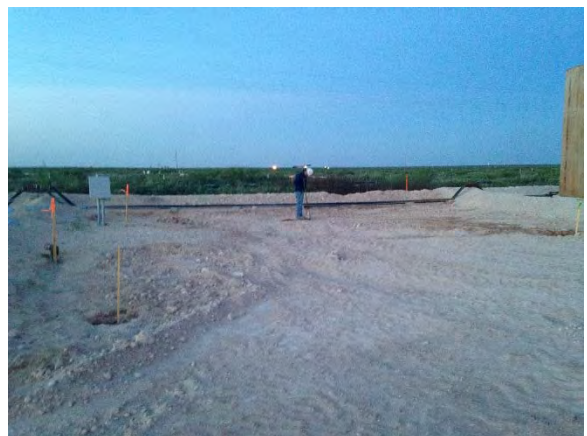
Collecting samples

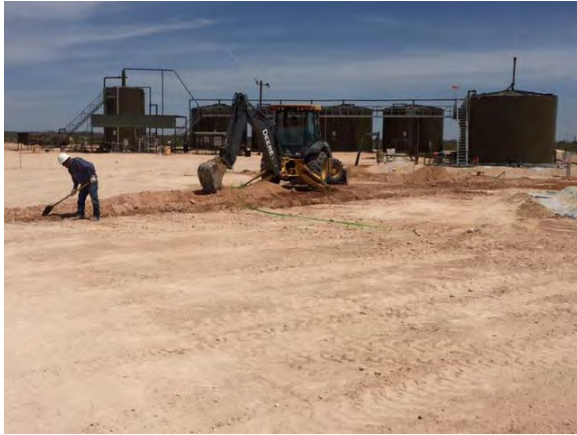
Scraping site

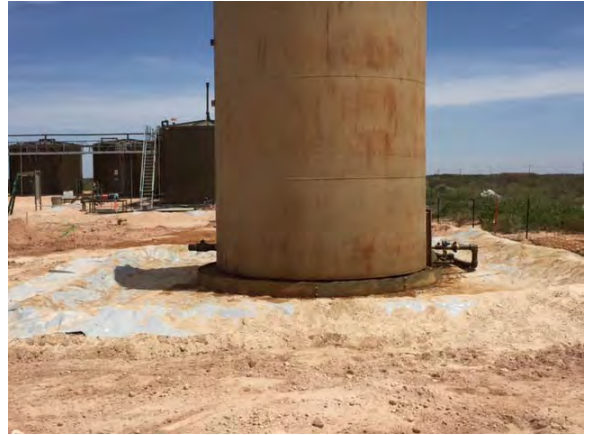
Removed caliche

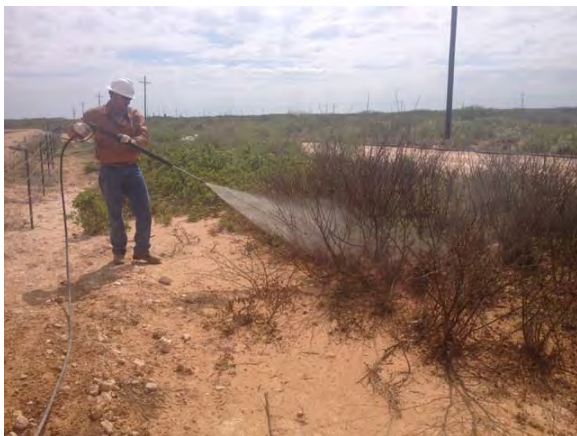
Pressuring washing vegetation

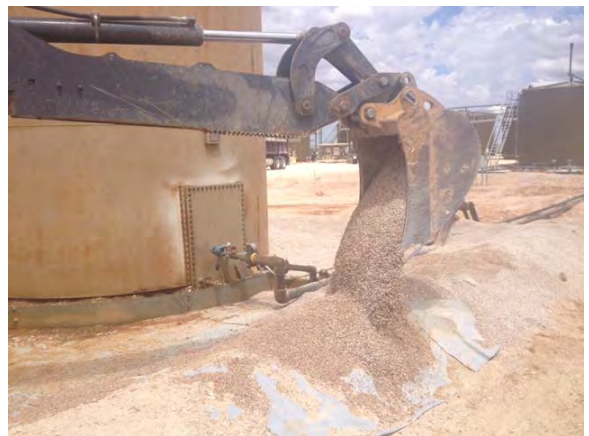
Backfilling site with caliche

A backfill request was submitted to NMOCD on April 27, 2016 and approved on May 2, 2016. The site was backfilled with clean, imported caliche to ground surface and contoured to the surrounding area (Appendix III). Seeding of the site is not warranted.

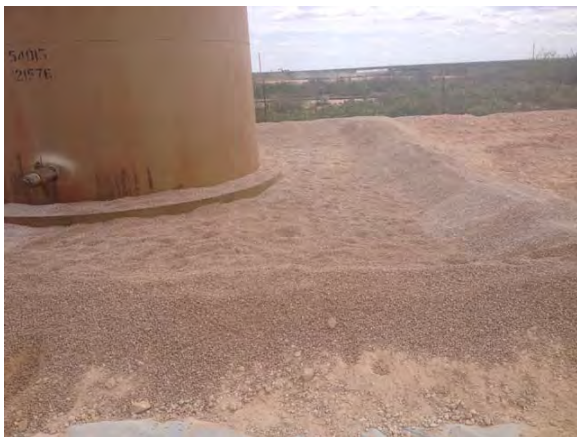
Site completed

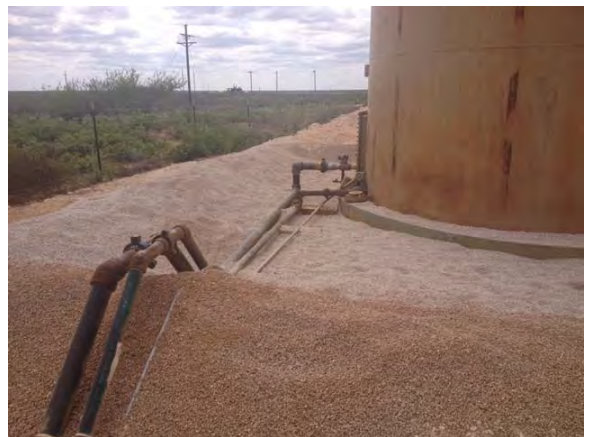
Site completed
