Re: Work Plan for Site Characterization
Bell No. 1 Facility Flowline Release
Bagley North Oil Field, Lea County, New Mexico
NE1/4 NE1/4, Sec. 21, T11S, R33E
NMOCD Case No. 1R-4702

On behalf of Jay Management, LLC (Jay Management), Timberwolf Environmental, LLC (Timberwolf) prepared this work plan for site characterization at the Bell No. 1 Facility (Site) to assess impacts related to a recent flowline release. The Site is located in the Bagley North Oil Field approximately 6.2 miles southeast of Caprock, Lea County, New Mexico (Figures 1 through 3). The release response actions, initial site assessment, and the site characterization work plan are discussed below.

Project No.:	ISR-170050	Client:	Jay Management
Project Name:	Bell No. 1 Facility Release	Site Location:	Lea County, New Mexico
Task Description:	Initial Site Assessment	Date:	05/22/17
Photo No.: 1

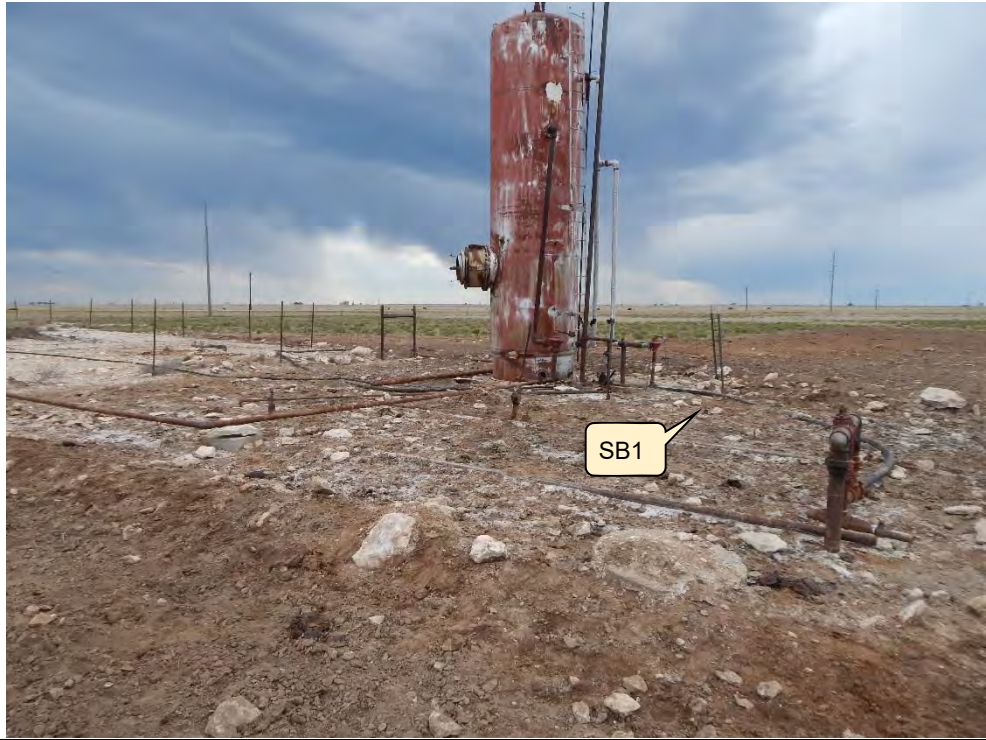
Direction: SW			
Comments: View of most heavily impacted area around at the Bell No. 1 heater treater and polyline. Note SB1 sample location.			
Photo No.: 2

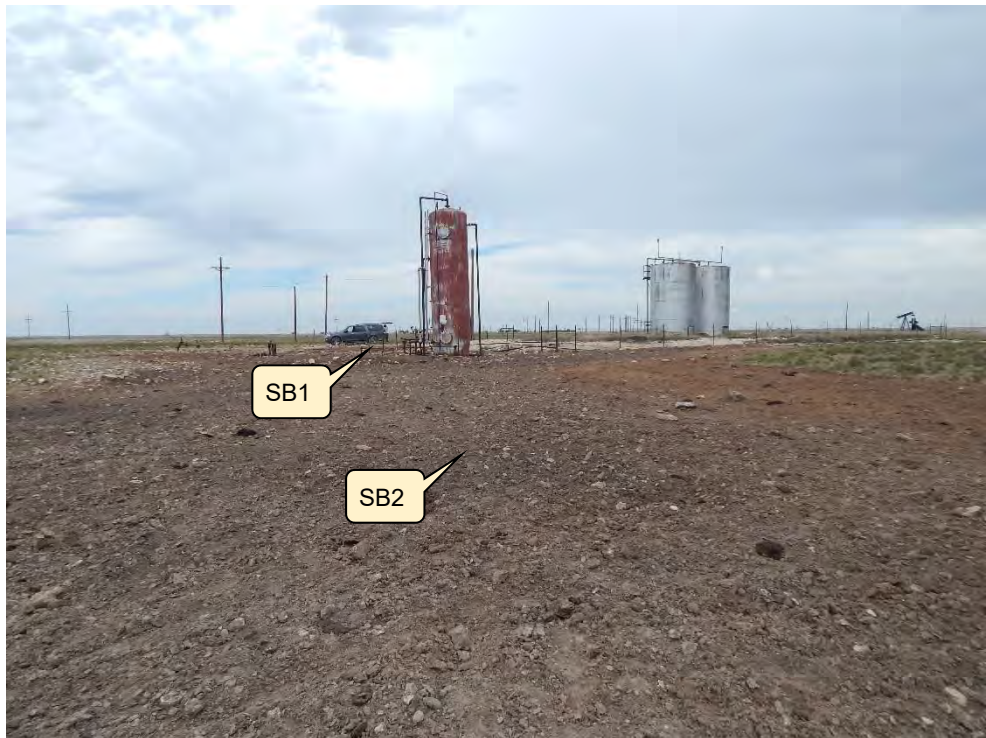
Direction: SE			
Comments: View of tilled impacted soils within the spill area. Note SB1 and SB2 sample locations.

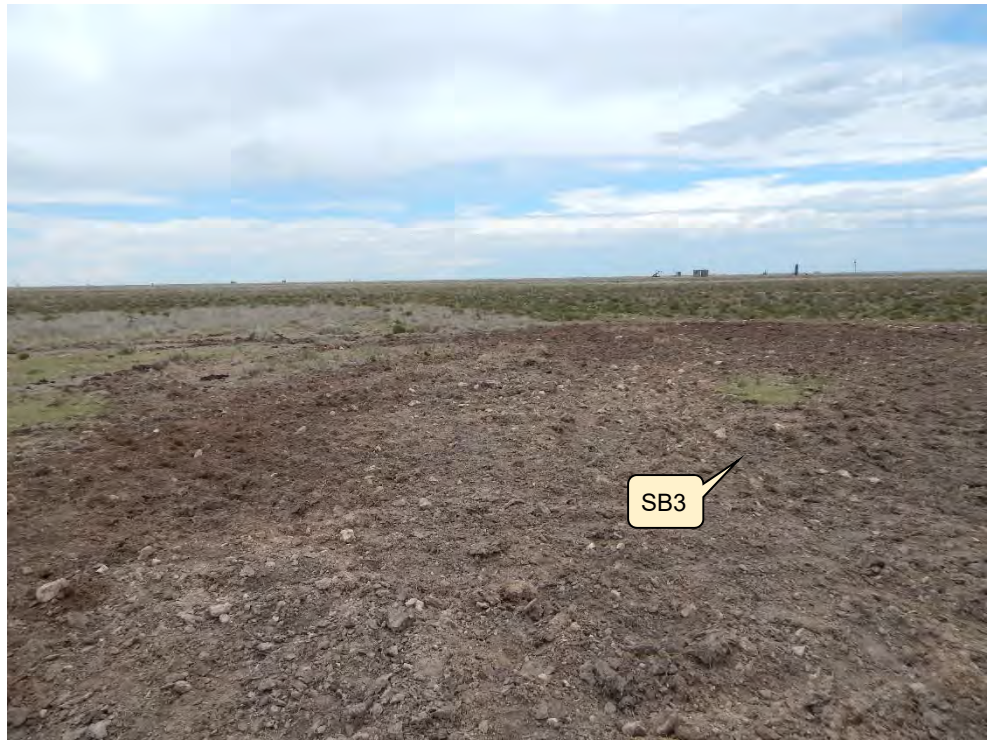
Project No.:	ISR-170050	Client:	Jay Management
Project Name:	Bell No. 1 Facility Release	Site Location:	Lea County, New Mexico
Task Description:	Initial Site Assessment	Date:	05/22/17
Photo No.: 3

Direction: NW			
Comments: View of the edge of tilled impacted soils within the spill area. Note SB3 sample location.			
Photo No.: 4

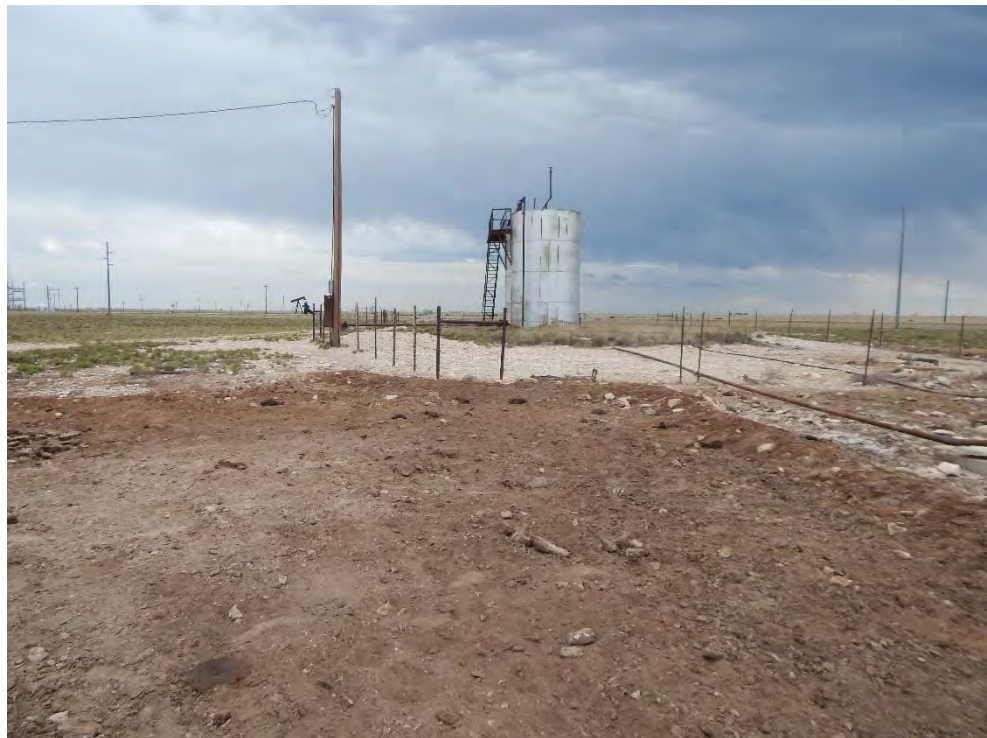
Direction: S			
Comments: View of tank battery and the edge of tilled impacted soils within the spill area.
