# Bobbi St. WFU Tank Battery

## REVISED WORK PLAN

RE: **Sundown Energy St. WFU Tank Battery – Revised Work Plan**  
UL/N, Section 20, T18S, R36E  
API No. 30-025-26954  
NMOCD Score: 20

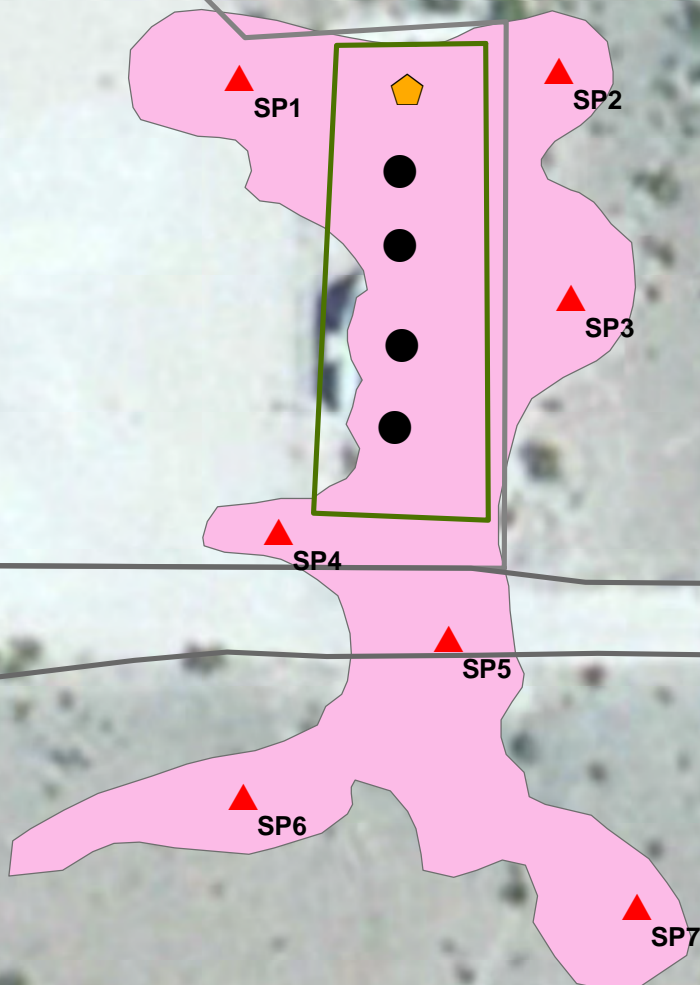
**Figure 1**

On November 9, 2016, DFSI personnel were on site to obtain samples within the leak area. Seven samples were obtained and field sampled for chloride levels, as well as BTEX (Figure 1). The BTEX samples were performed using a Mini Rae Photoionization Detector (PID). Field samples were submitted for analysis at Cardinal Laboratories of Hobbs, NM to obtain confirmation (Appendix III).

Figure 1 – Soil Delineation

SP1										SP2										SP3										
Depth	CI-	PID	Lab CI-	GRO	DRO	B	T	E	X	Depth	CI-	PID	Lab CI-	GRO	DRO	B	T	E	X	Depth	CI-	PID	Lab CI-	GRO	DRO	B	T	E	X	
SS	1425	14.3								SS	749	1.2								SS	1324	0								
1'	6472	2.4								1'	500	1.6	256	<10	<10	<0.05	<0.05	<0.05	<0.15	1'	5248	1.3								
2'	4123	0.9								2'	500	1.3	496	<10	<10	<0.05	<0.05	<0.05	<0.15	2'	1999	2.2								
3'	3024	12.3																		3'	1249	2.5								
4'	4123	7.5																		4'	749	0	768	<10	<10	<0.05	<0.05	<0.05	<0.15	
5'	4498	0																		5'	500	0	448	<10	<10	<0.05	<0.05	<0.05	<0.15	
6'	2499	1.1																												
7'	2399	1																												
8'	500	1.6	336	<10	<10	<0.05	<0.05	<0.05	<0.15																					
9'	250	1.2	176	<10	<10	<0.05	<0.05	<0.05	<0.15																					
SP4										SP5										SP6										
Depth	CI-	PID	Lab CI-	GRO	DRO	B	T	E	X	Depth	CI-	PID	Lab CI-	GRO	DRO	B	T	E	X	Depth	CI-	PID	Lab CI-	GRO	DRO	B	T	E	X

SS	145	0								SS	1749	0.1								SS	2074	0.3								
1'	4998	1.9								1'	4498	0								1'	3934	0.1								
2'	3498	2.7								2'	749	0								2'	1499	6.7								
3'	2499	3.4								3'	874	2	640	<10	<10	<0.05	<0.05	<0.05	<0.15	3'	699	2.6	448	<10	<10	<0.05	<0.05	<0.05	<0.15	
4'	749	1.4	496	<10	<10	<0.05	<0.05	<0.05	<0.15	4'	749	0	848	<10	<10	<0.05	<0.05	<0.05	<0.15	4'	375	0	128	<10	<10	<0.05	<0.05	<0.05	<0.15	
5'	624	2.8	320	<10	<10	<0.05	<0.05	<0.05	<0.15

SP4										SP5										SP6									
Depth	CI-	PID	Lab CI-	GRO	DRO	B	T	E	X	Depth	CI-	PID	Lab CI-	GRO	DRO	B	T	E	X	Depth	CI-	PID	Lab CI-	GRO	DRO	B	T	E	X
SS	145	0								SS	1749	0.1								SS	2074	0.3							
1'	4998	1.9								1'	4498	0								1'	3934	0.1							
2'	3498	2.7								2'	749	0								2'	1499	6.7							
3'	2499	3.4								3'	874	2	640	<10	<10	<0.05	<0.05	<0.05	<0.15	3'	699	2.6	448	<10	<10	<0.05	<0.05	<0.05	<0.15
4'	749	1.4	496	<10	<10	<0.05	<0.05	<0.05	<0.15	4'	749	0	848	<10	<10	<0.05	<0.05	<0.05	<0.15	4'	375	0	128	<10	<10	<0.05	<0.05	<0.05	<0.15
5'	624	2.8	320	<10	<10	<0.05	<0.05	<0.05	<0.15

SP7									
Depth	CI-	PID	Lab CI-	GRO	DRO	B	T	E	X
SS	499	0.1							
1'	1674	0							
2'	1249	0							
3'	774	0							
4'	2499	0							
5'	4248	0							
6'	3498	0							
7'	1199	0							
8'	874	2.7							
9'	524	0	352	<10	<10	<0.05	<0.05	<0.05	<0.15
10'	499	0.3	336	<10	<10	<0.05	<0.05	<0.05	<0.15

As per NMOCD request, SP1 through SP7 will be fully delineated vertically under chlorides result in concentrations at or below 250 mg/kg, plus an additional 10 ft of soil with concentrations at or below 250 mg/kg.

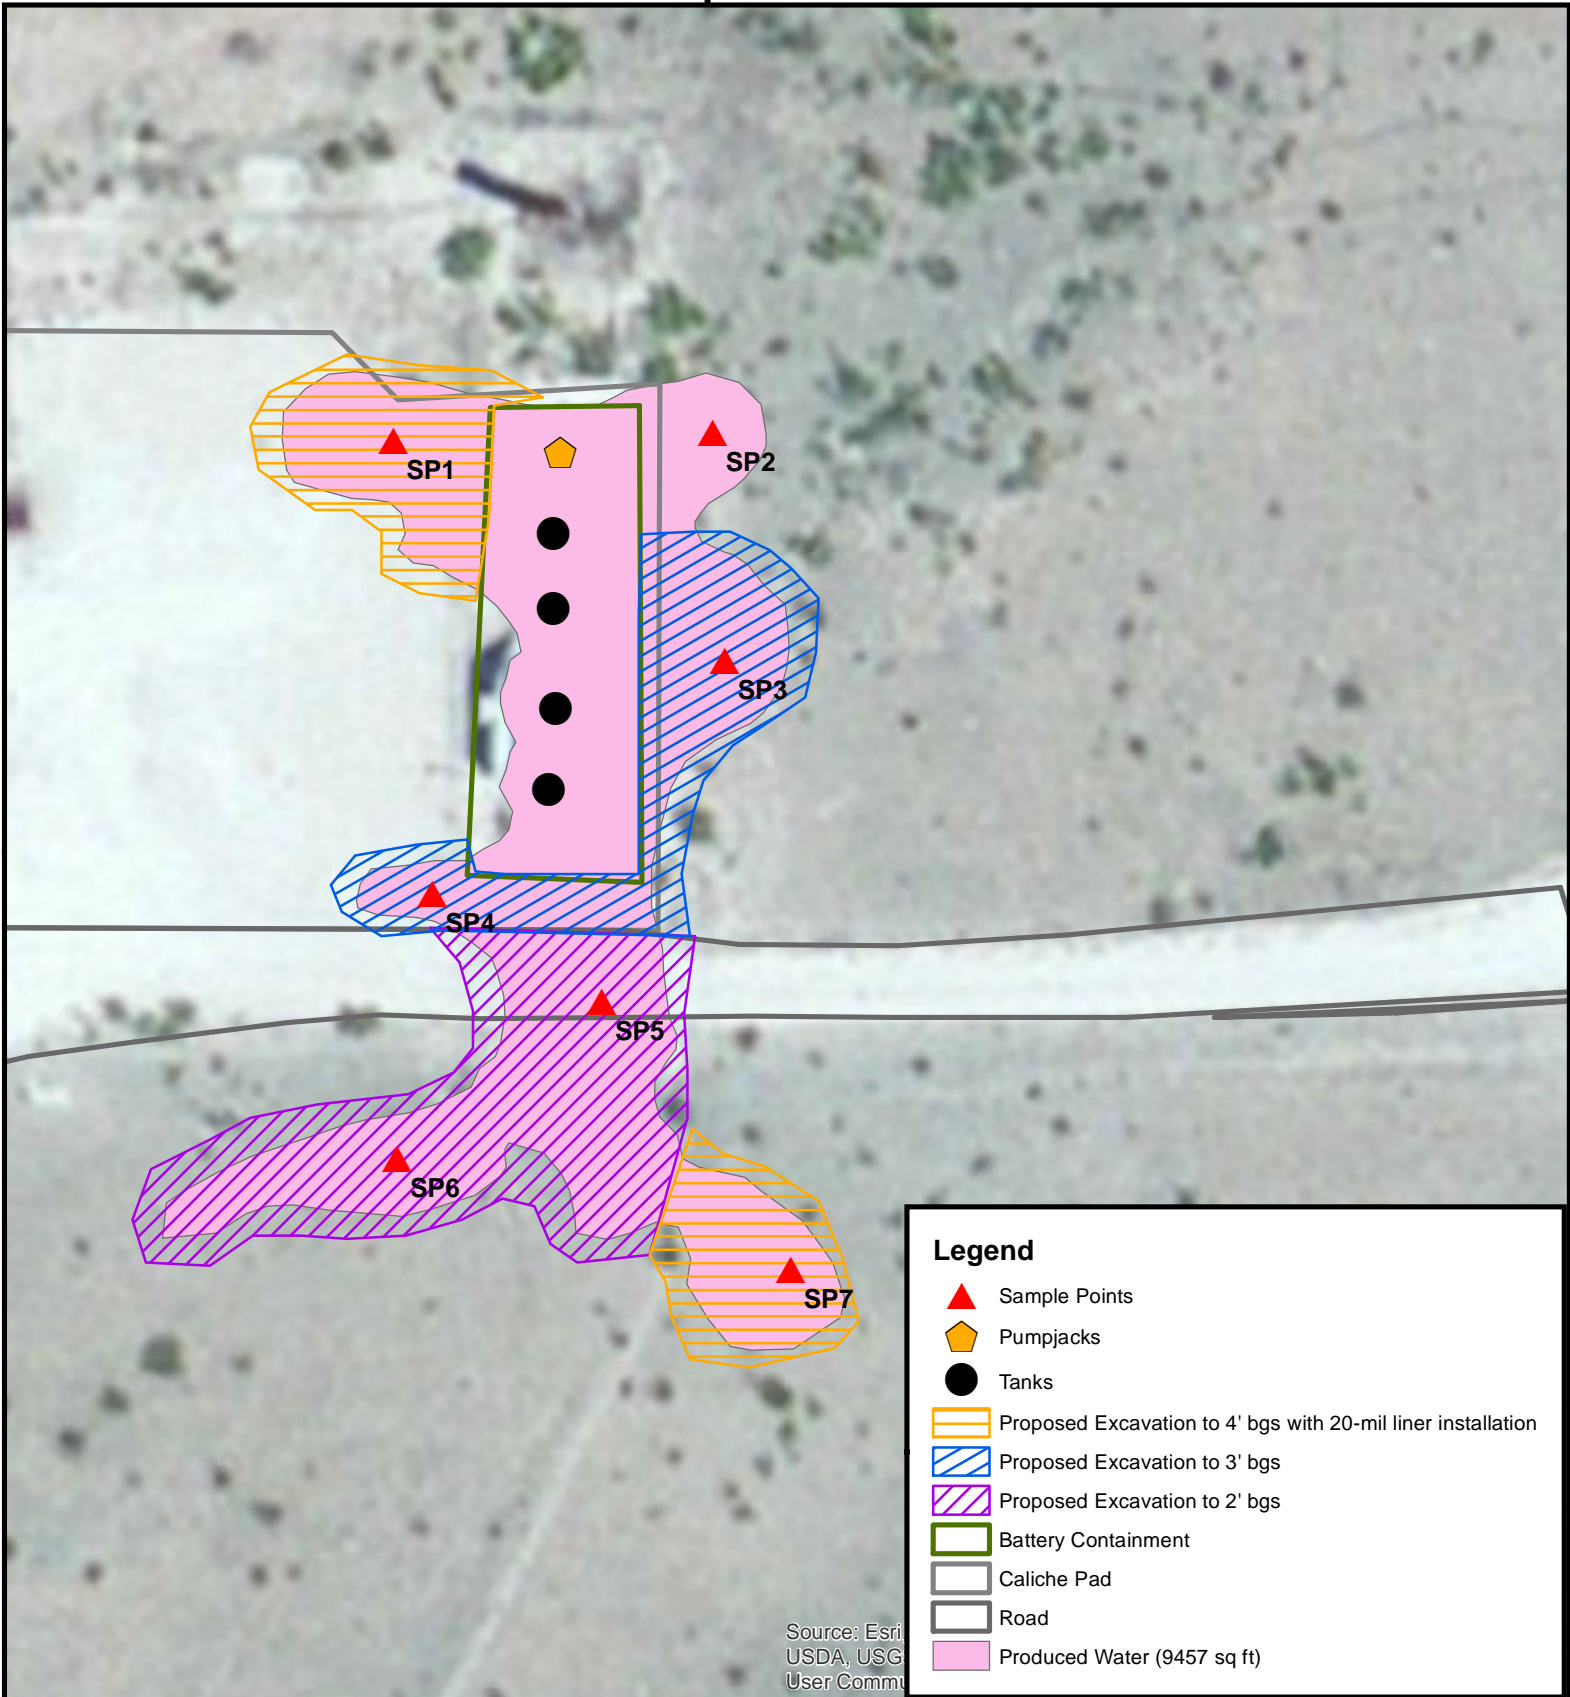
**Figure 2**

Figure 2 – Proposed Work

# Proposed Work

Excavate the area around SP1 and SP7 to a depth of 4' bgs. At the base of the excavation, a 20-mil, reinforced poly liner will be installed and properly seated. The area around SP3 and SP4 will be excavated to a depth of 3' bgs. The area around SP5 and SP6 will be excavated to a depth of 2' bgs. All excavations will be backfilled with clean, imported soil to ground surface (Figure 2). The entire area will be contoured to the surrounding area and capped with caliche around SP1, SP4 and SP5, or seeded with an approved BLM-NMOCD mix around SP2, SP3, SP6 and SP7. The bermed area will be scraped and backfilled with caliche and addressed at time of site abandonment.
