This report was prepared by Conestoga-Rovers & Associates (CRA) on behalf of Chevron Environmental Management Company (CEMC) to document assessment activities for a release of between 1.565 bbls of oil due to damage to an out of service gathering line from a well field wild fire as documented in the initial C-141 report of January 2011. Soil sampling in the release area indicate that vertical and horizontal delineation of Chlorides and hydrocarbon components has been achieved at the site. Following delineation, the site was excavated to a depth of 4 feet, lined, and backfilled. The attached report details the delineation and remediation activities for the site.

Soil Assessment and Delineation Activities Report

Abo Reef Gathering System (AB TN-9) Trunkline Release
Unit J, Section 6, Township 18 South, Range 35 East
Lovington, New Mexico

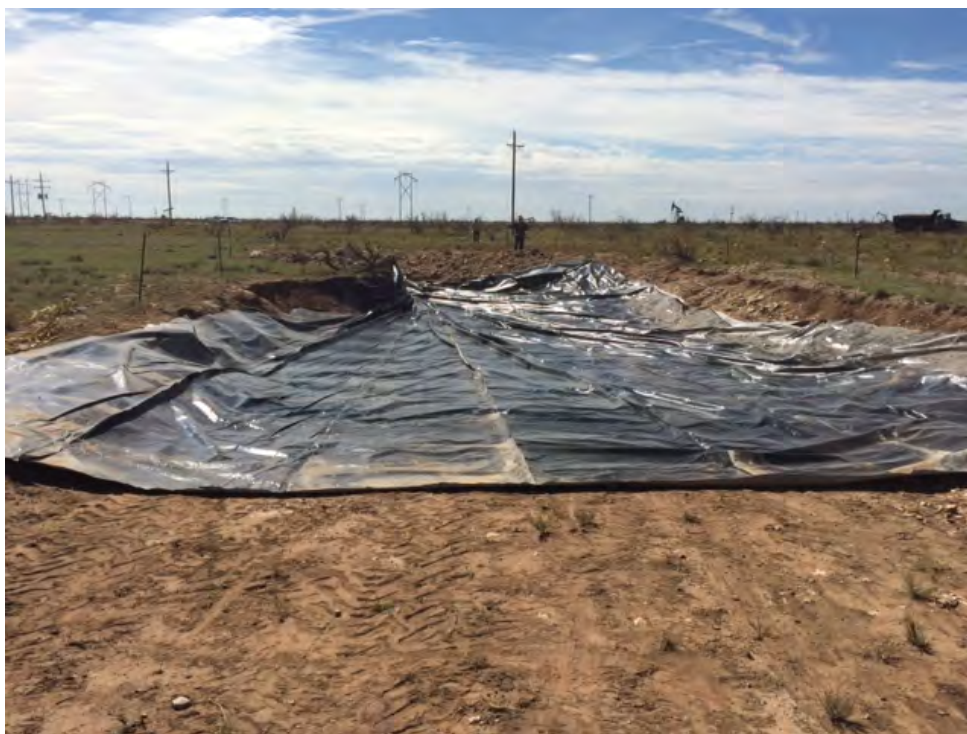
Photo 1 – View of liner placed within former excavation area.

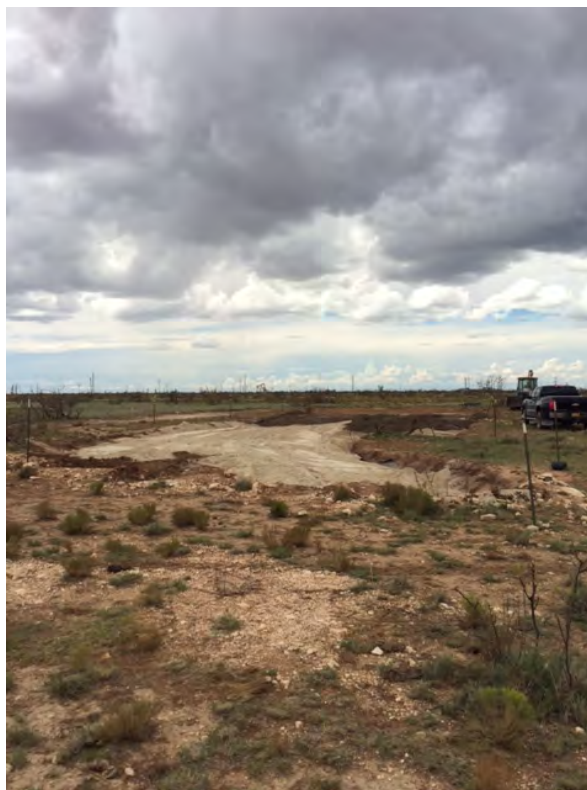
Photo 2 – View of former excavation area following initial backfilling activities.

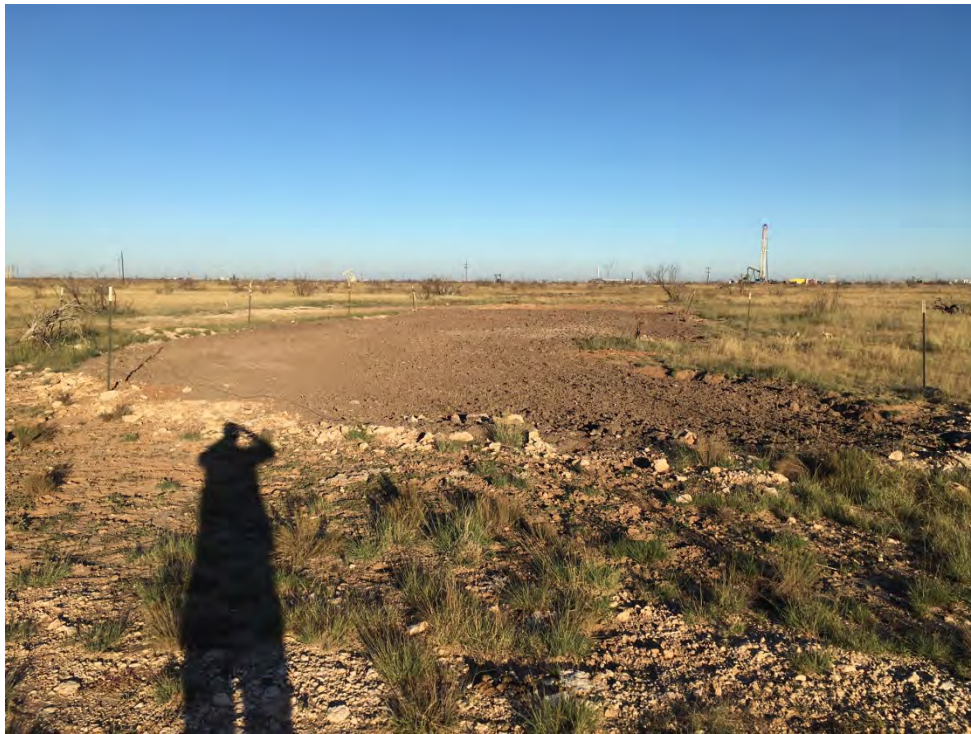
Photo 3 – View of former excavation area following top soil placement and re-seeding activities.

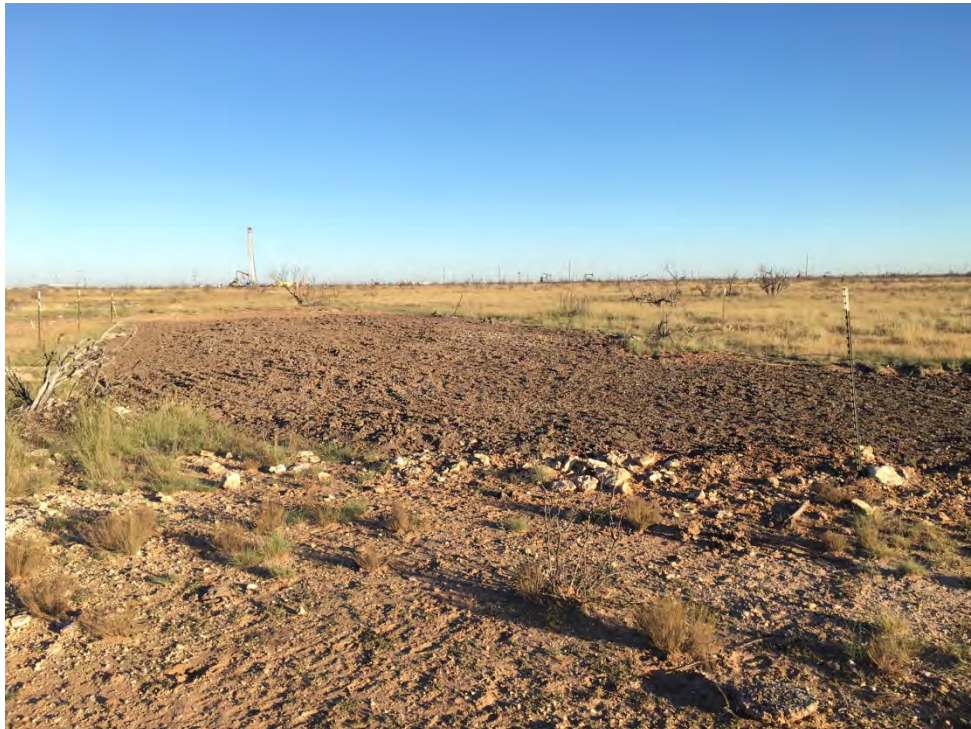
Photo 4 – Additional view of former excavation following re-seeding activities.
