CMU #035

CLOSURE REQUEST

June 7, 2017

**RE: Linn Energy CMU B #035 Truck Spill
Closure Request**
UL/B, Section 24, T17S, R32E
API No. 30-025-00665
NMOCD Case #: 1R-3932
NMOCD Score: 0

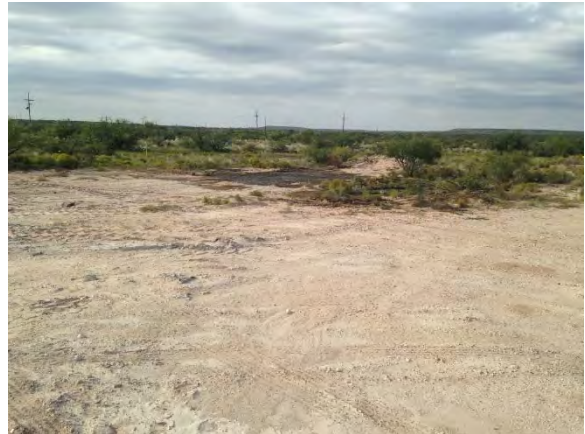
Location with evidence of tank spill

As this location site was no longer in active production, DFSI personnel completed reclamation activities by removing the caliche pad and underlying topsoil (Appendix IV). After the excavation was completed, the excavation was backfilled with the removed caliche. The remainder of the excavation was backfilled with the excavated topsoil to ground surface and contoured to the surrounding area. As per SLO requirements, the site was seeded with a blend of native vegetation, of which did not include lovegrass within the LPC seed mix (Appendix V).

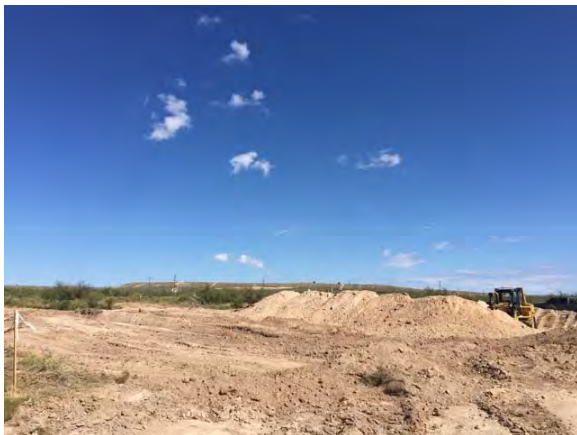
Blending soil on pad for reclaim

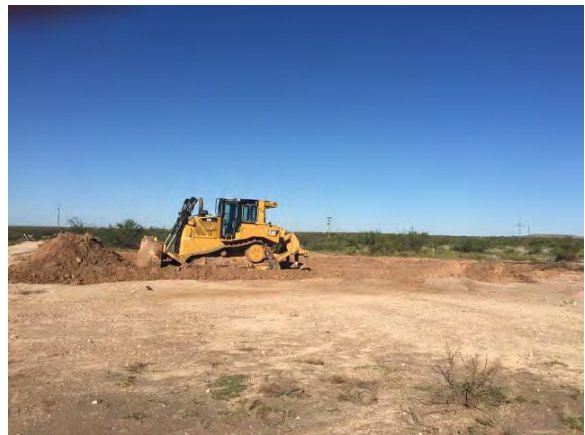
Flipping and tilling location

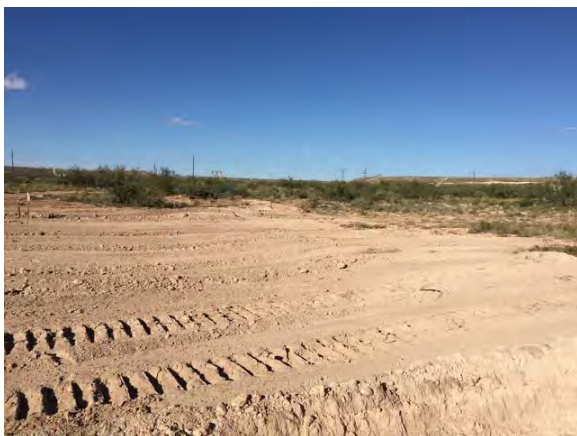
Location reclaimed before seeding

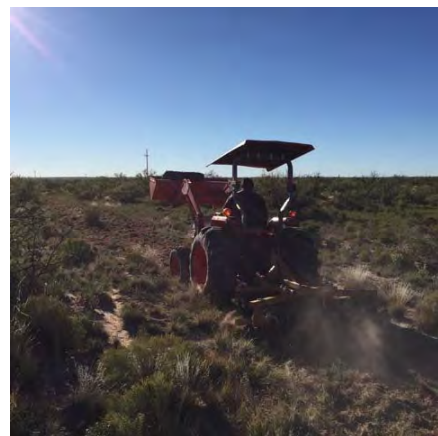
Seeding pasture area where tank spilled- after blending

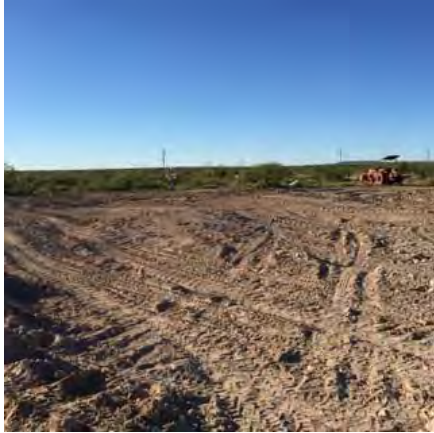
Area seeded, reclaimed

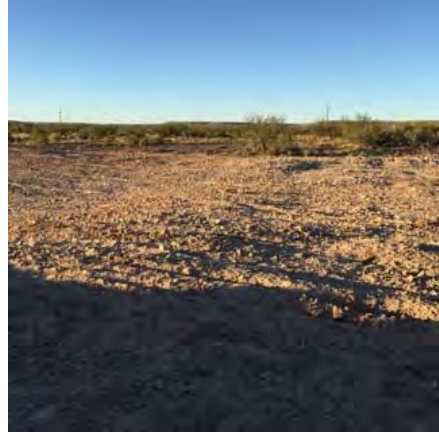
Area seeded, reclaimed

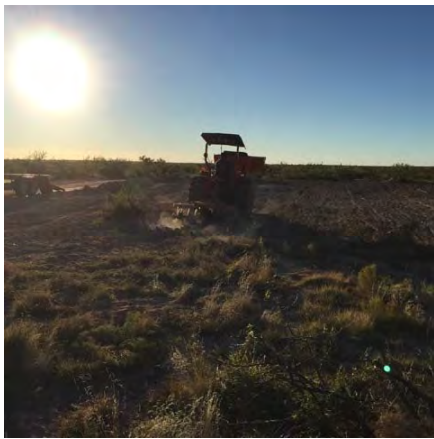
Seeding reclaimed area on old pad

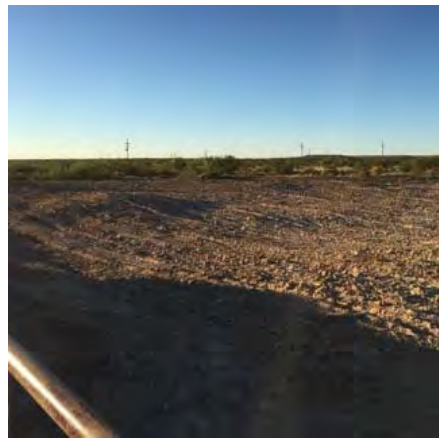
Area seeded, reclaimed

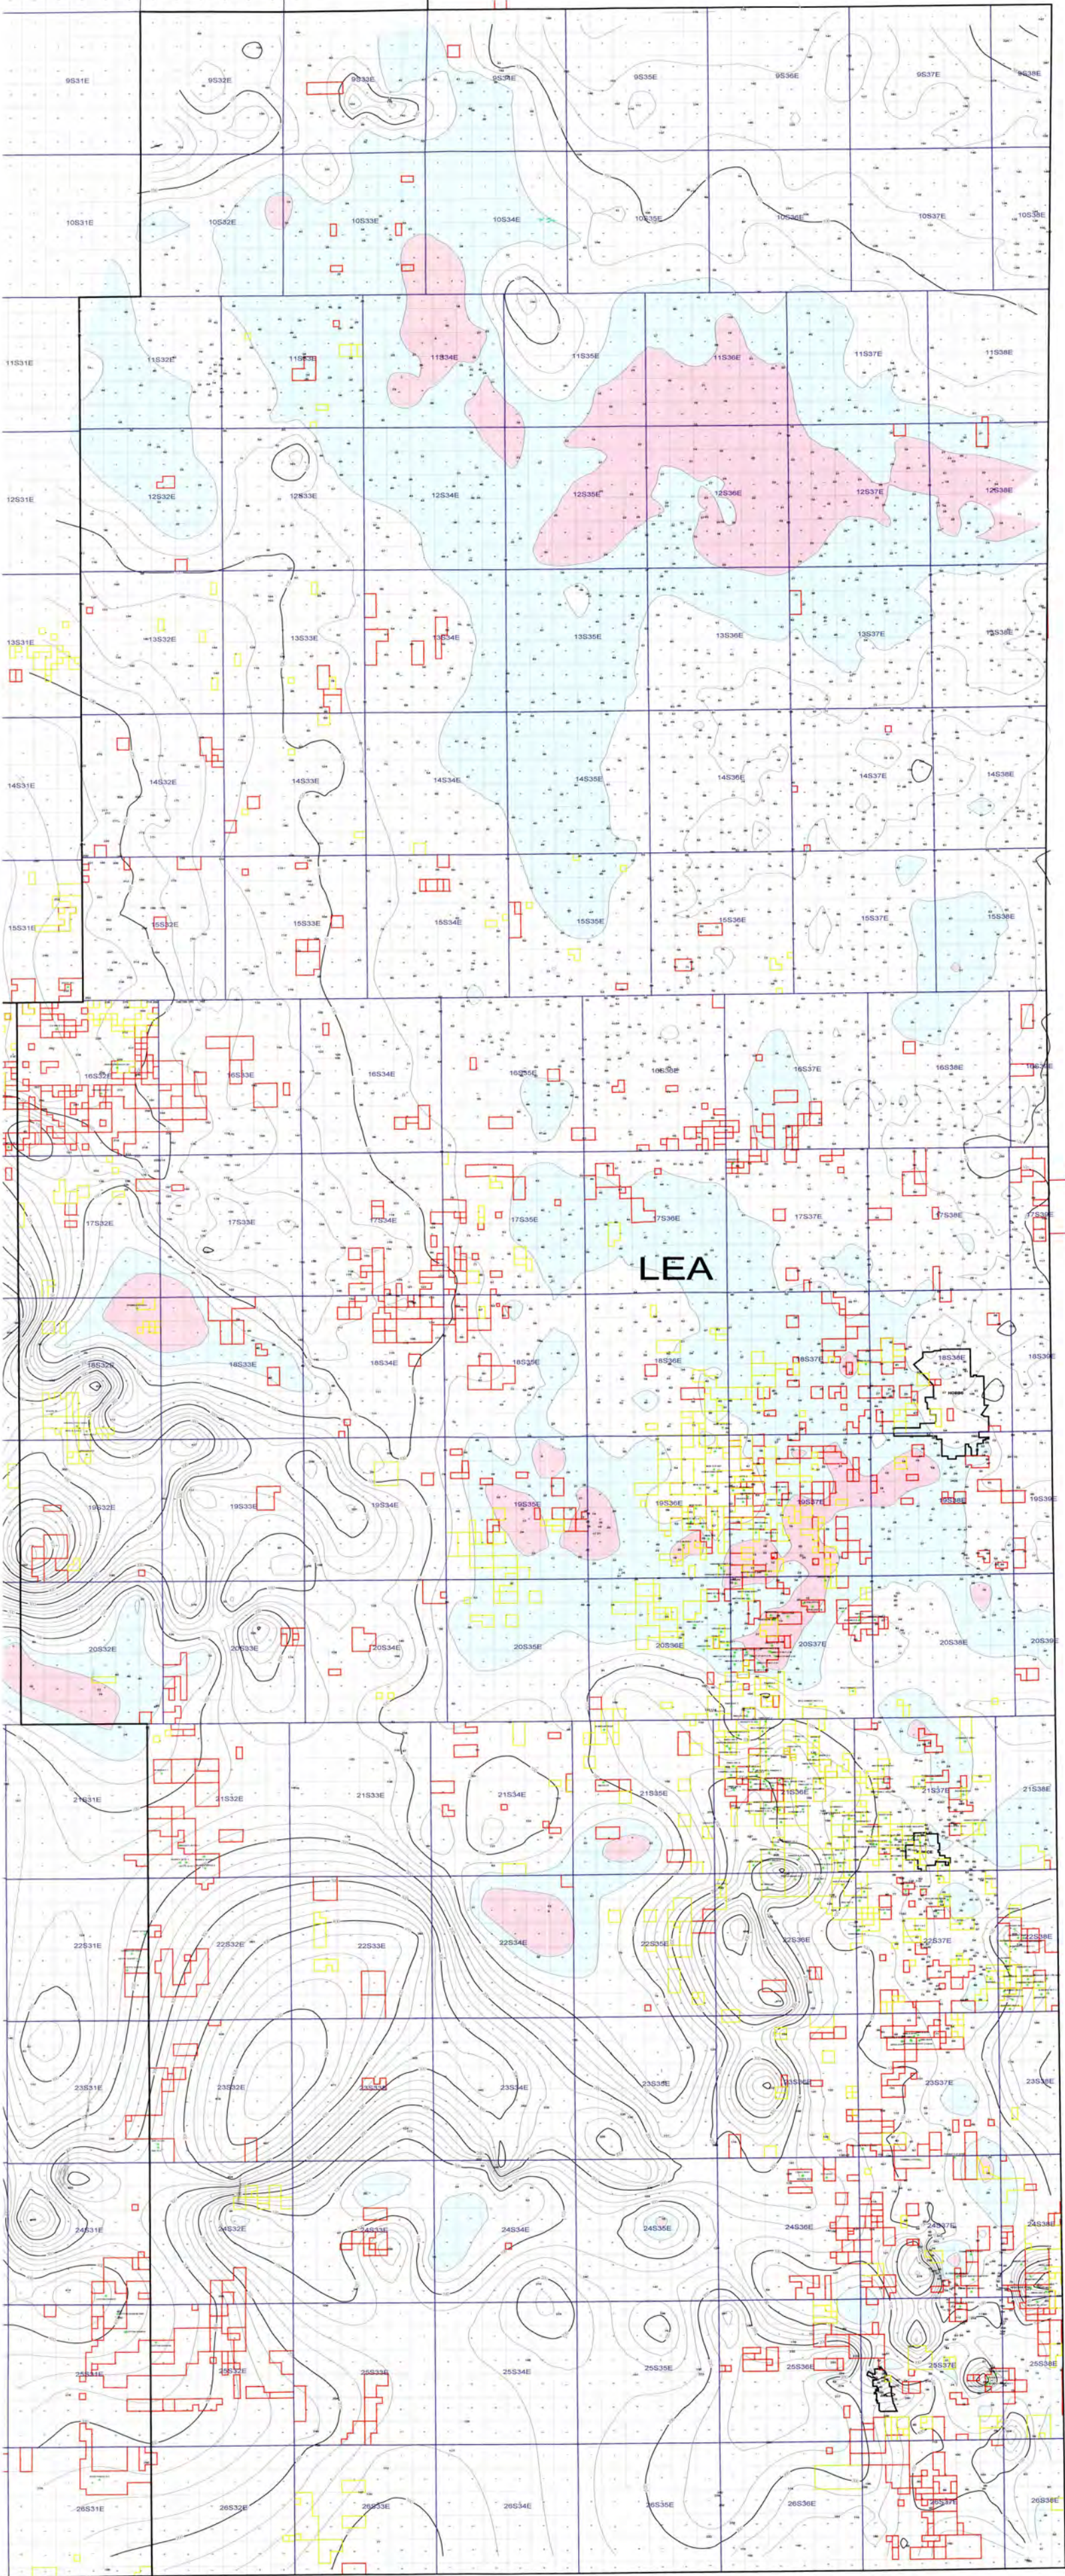
WATER COLUMN/ AVERAGE DEPTH TO WATER

DFSI has conducted a groundwater study of the area and has determined, according to the New Mexico Office of the State Engineer and Chevron Trend Map, the average depth to groundwater is approximately 125 ft bgs. Therefore, no eminent danger of groundwater impact or threat to life is anticipated (Appendix VI). Based on the report and work completed, DFSI, on behalf of Linn, submits the final C-141 (Appendix VII) and respectfully requests the closure of this regulatory file.
