State of New Mexico  
Energy Minerals and Natural Resources

Release Notification and Corrective Action

1RP-4860

Photo Exhibit

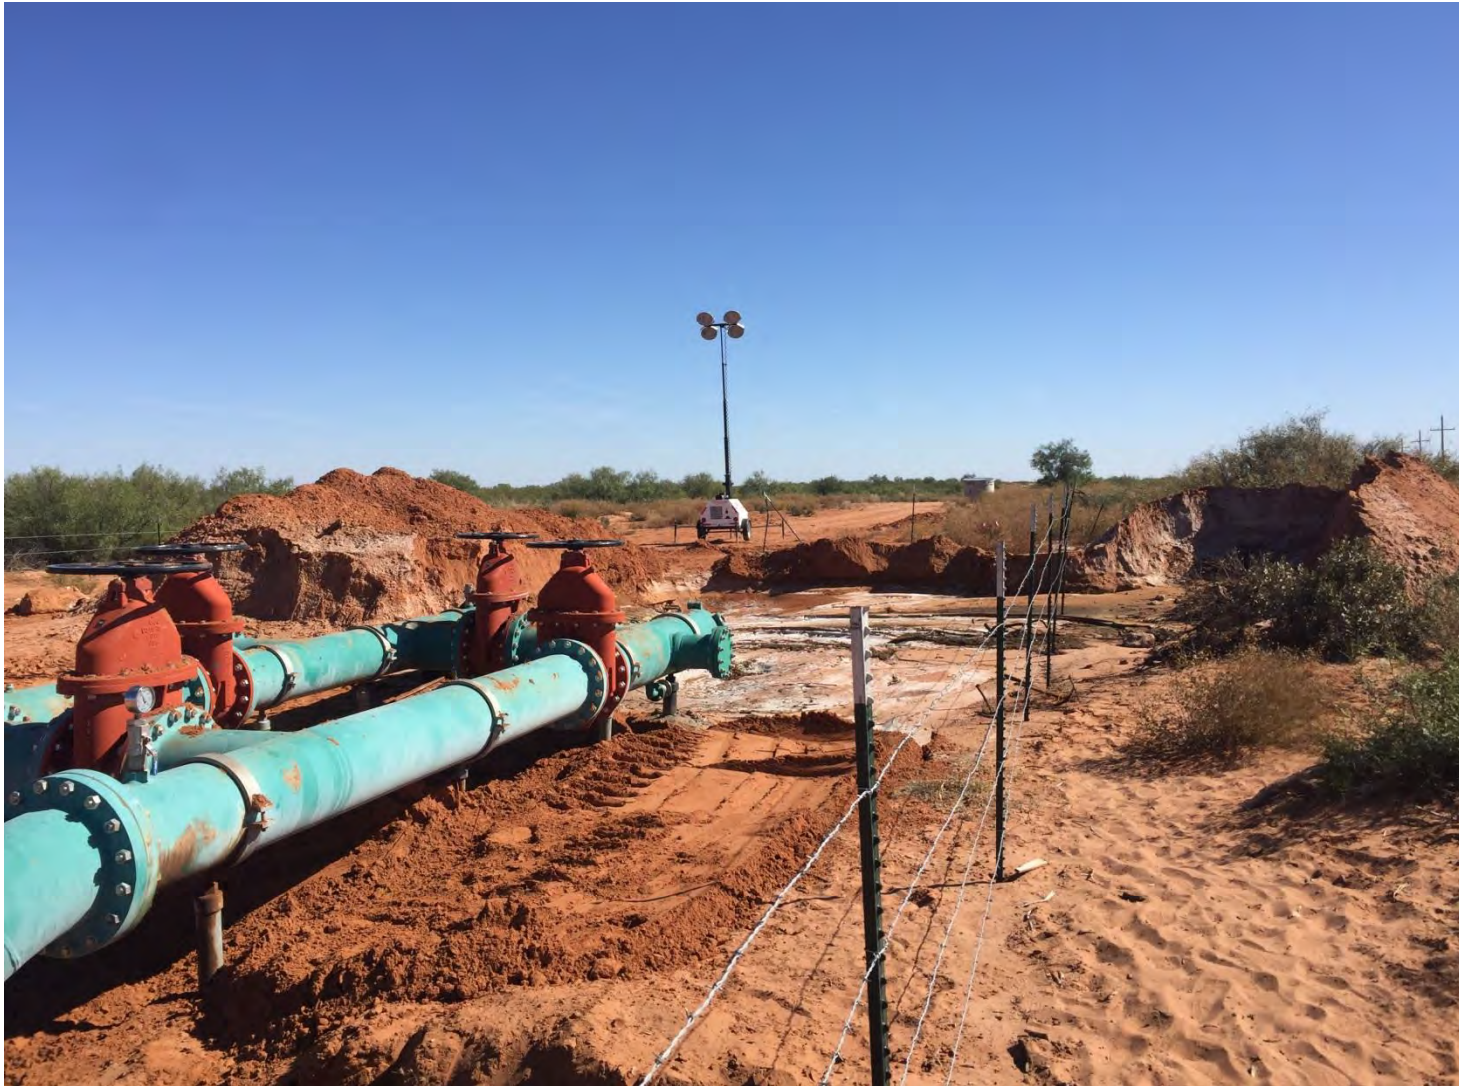
Photo No. 001. View of the source of the release on 10/24/17. The background is of a pre-constructed pit (East Pit) that held a portion of the released produced water.

A threaded nipple blew off at a pigging station. OWL employees replaced a valve and brought equipment on site to construct earthen berms preventing the spill from migrating.

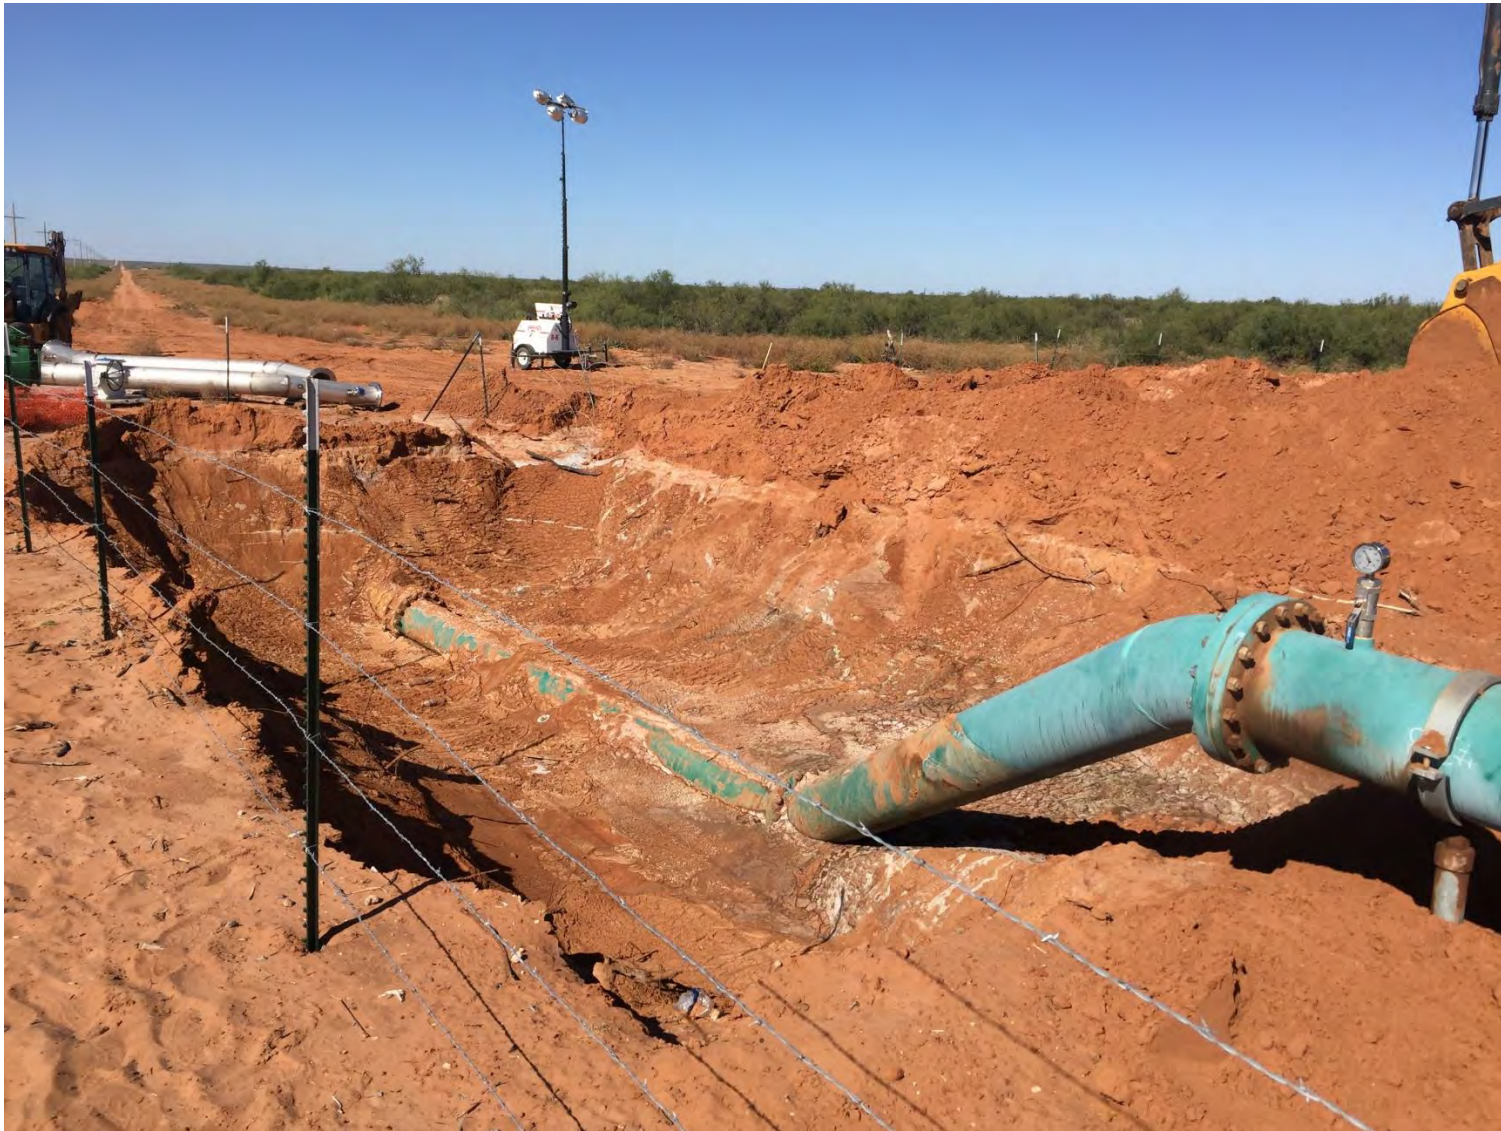
Photo No. 002. View of the second pre-constructed pit (West Pit) adjacent to the East Pit. New piping that was scheduled for installment is seen in the background. The west pit also held a large portion of the released produced water.

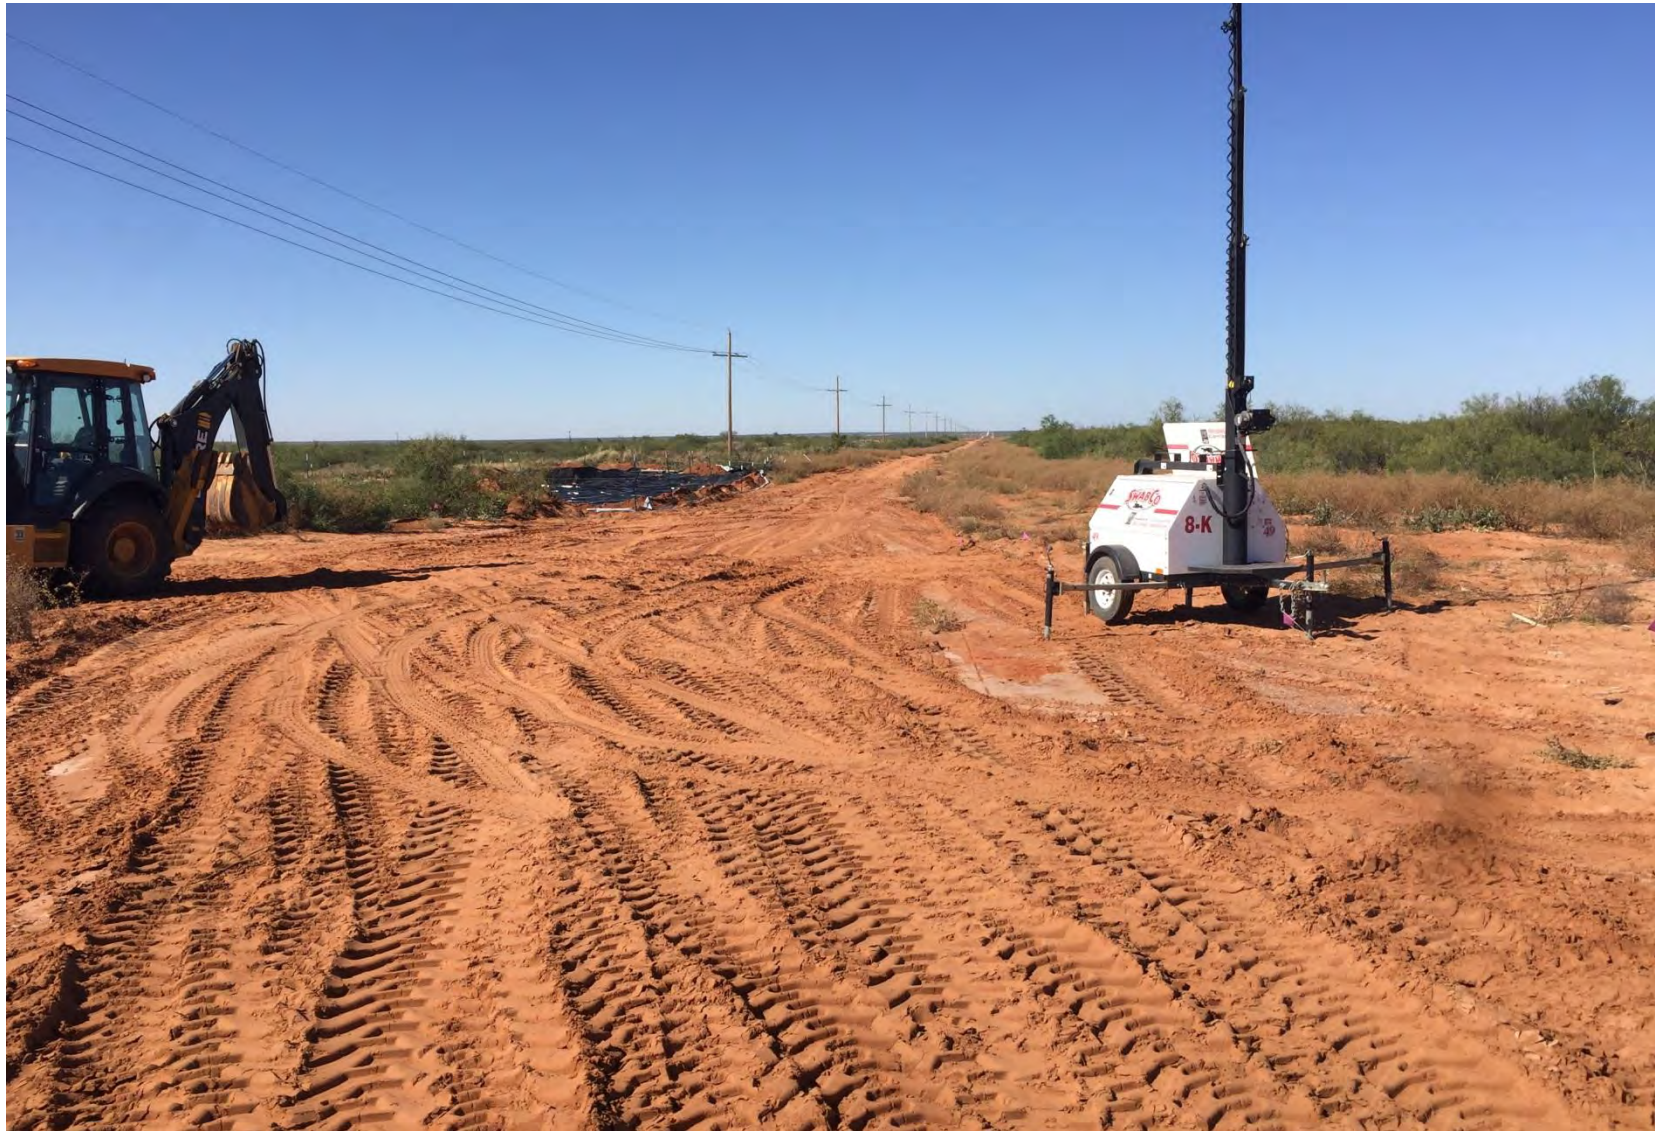
Photo No. 003. View of the spill path the produced water took west downhill eventually migrating south toward the area covered by poly in the background.

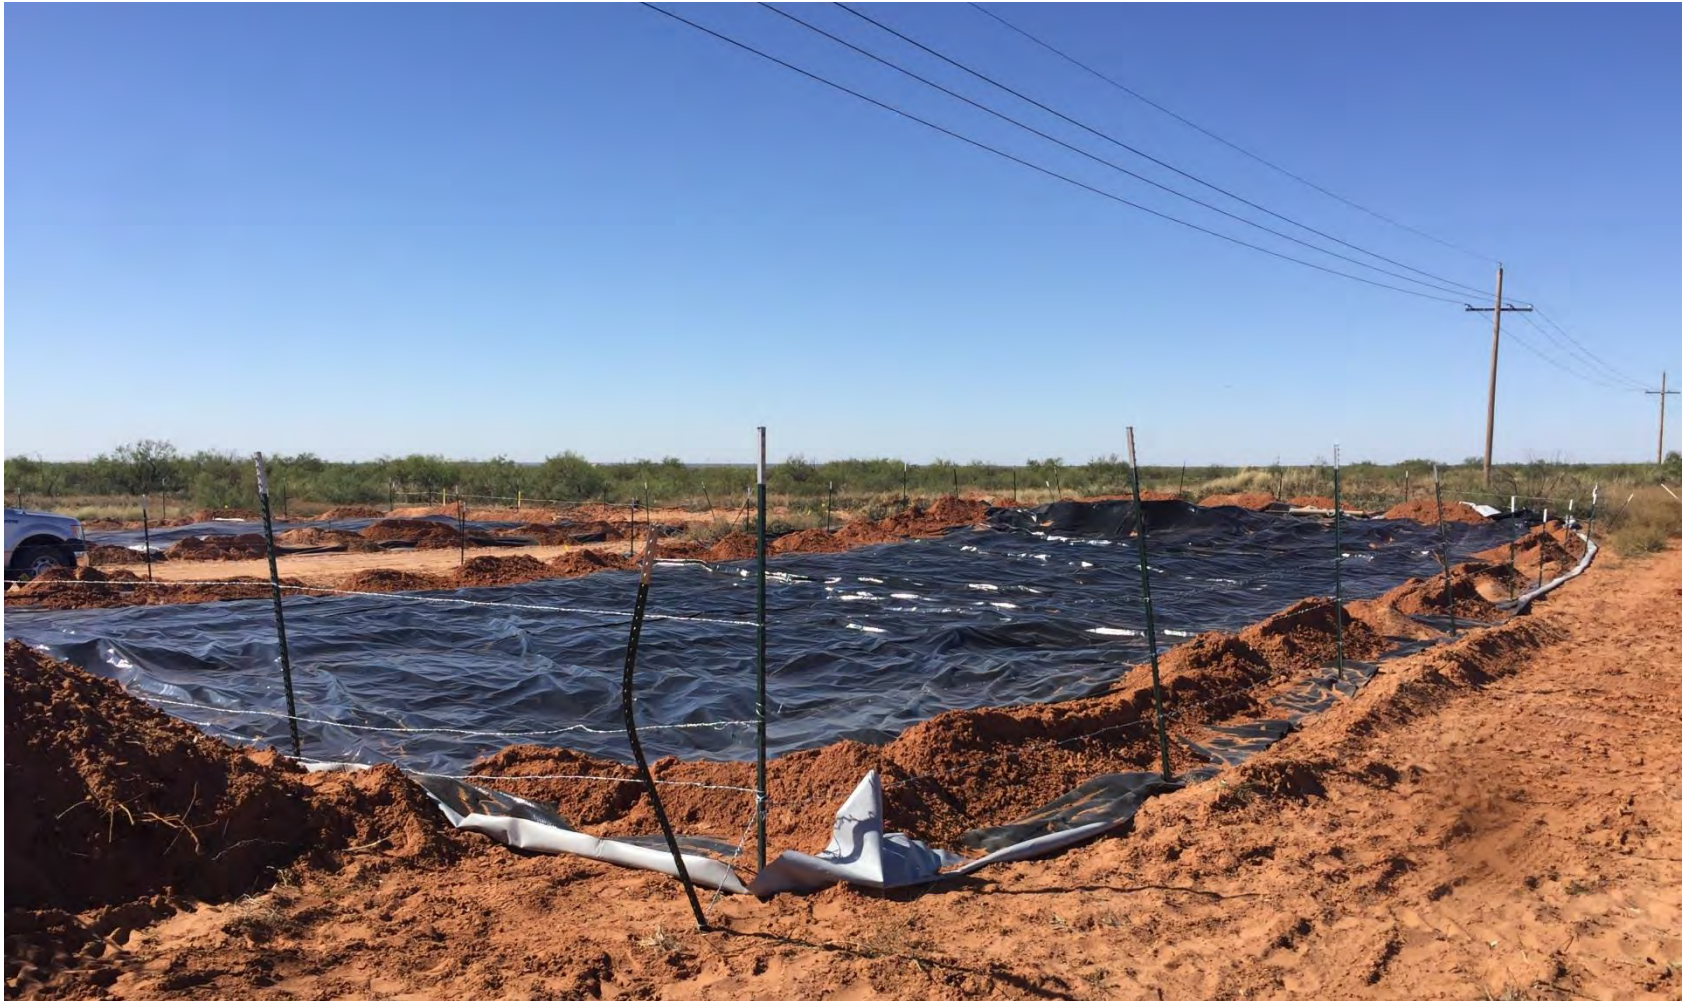
Photo No. 4. View of affected soil (north covered area) that was covered by 20 millimeter poly sheeting to prevent rainfall from causing further migration.

Vacuum trucks were brought on site to recover fluids and 20 millimeter poly sheeting was placed over affected soil to prevent rainfall from causing further migration until an investigation work plan is approved by OCD.

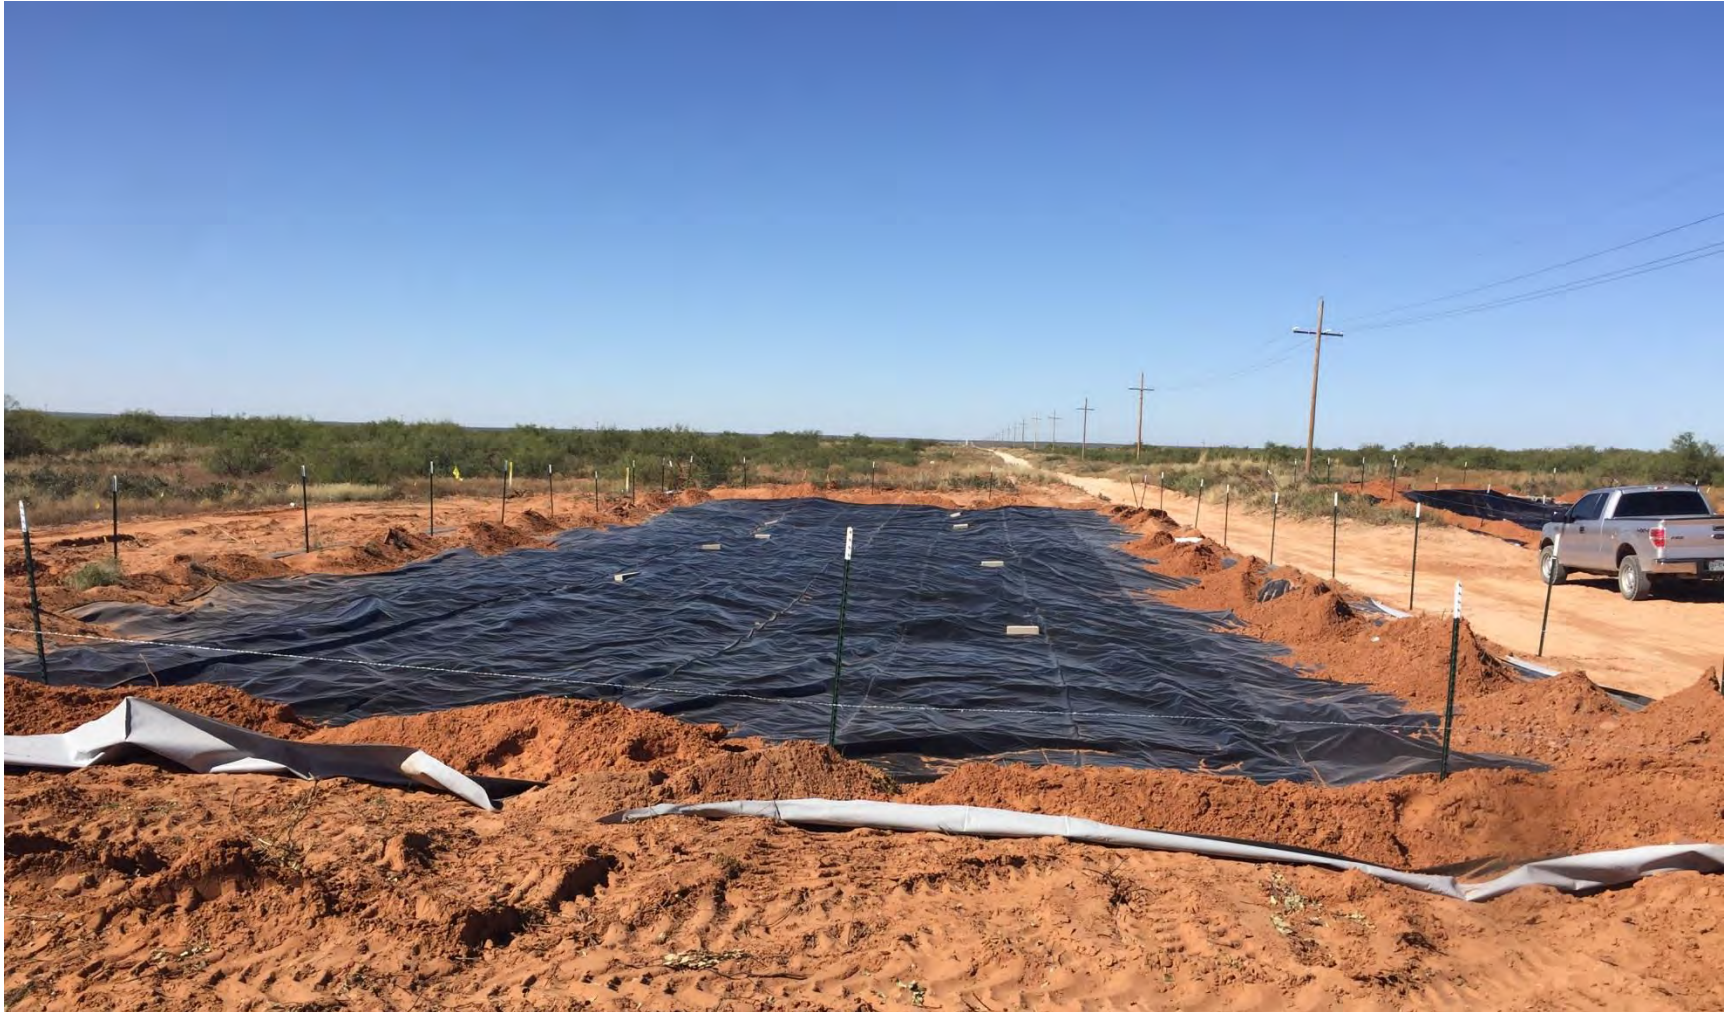
Photo No. 5. View of affected soil (south covered area) that was covered by 20 millimeter poly sheeting to prevent rainfall from causing further migration. NOTE: The NM811 identified multiple pipelines running parallel to the established caliche road.

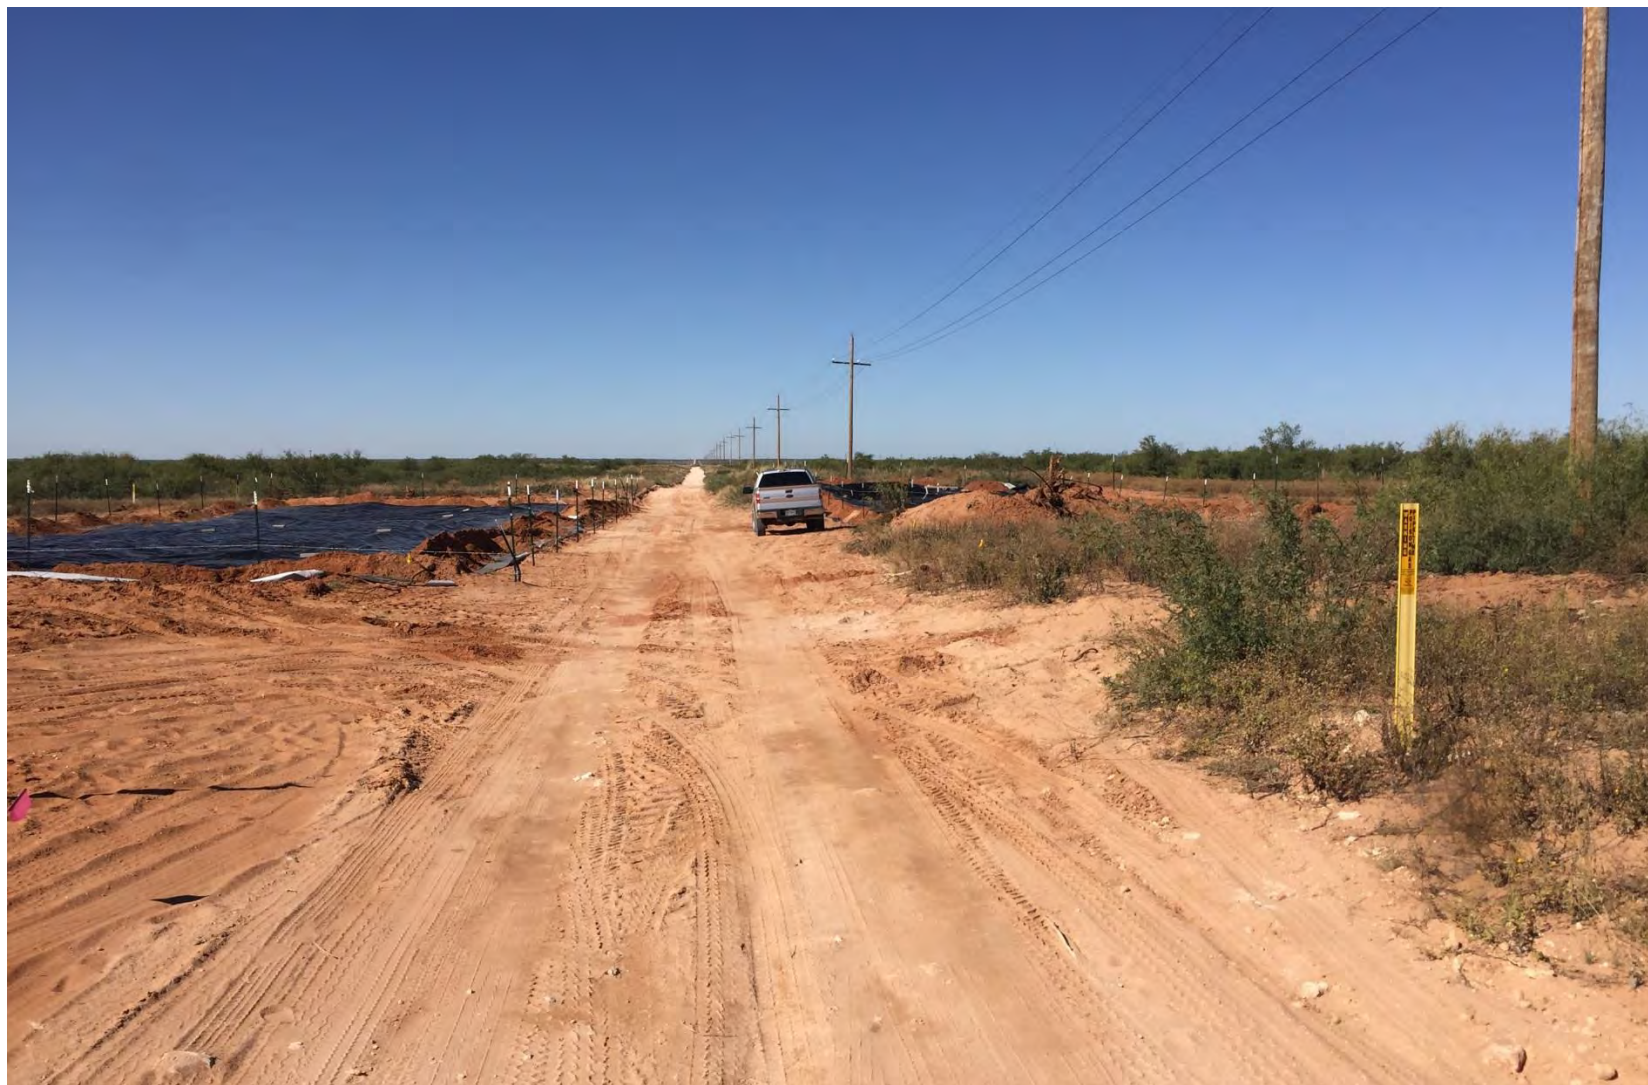
Photo No. 6. View looking west of the caliche road transecting the spill area.
