Re: Soil Investigation Summary and Proposed Remediation Workplan
A-14 Compressor Station Field Scrubber Release (1RP-4634)
GPS: N32° 14' 46.26" W103° 24' 7.2"
Unit Letter "I", Section 6, Township 24 South, Range 35 East, NMPM
Lea County, New Mexico

TRC Environmental Corporation (TRC), on behalf of ETC Field Services, LLC (ETC) has prepared this Soil Investigation Summary and Proposed Remediation Workplan (Workplan) for the A-14 Compressor Station Field Scrubber Release Site (Release Site). The purpose of this Workplan is to propose remediation activities designed to advance the A-14 Compressor Station Field Scrubber Release Site toward an NMOCD approved Site Closure Status. The legal description of the Release Site is Unit Letter "I", Section 6, Township 24 South, Range 35 East, NMPM, in Lea County, New Mexico. The GPS coordinates for the site are N 32° 14' 46.26" W 103° 24' 7.2". The subject property is administered by the United States Bureau of Land Management (BLM). A Site Location Map, Site Detail and Soil Sample Location Map, and Site Detail and Soil Sample Locations Maps are provided as Figure 1, Figure 2, and Figure 3, respectively. Release Site photographs are attached to

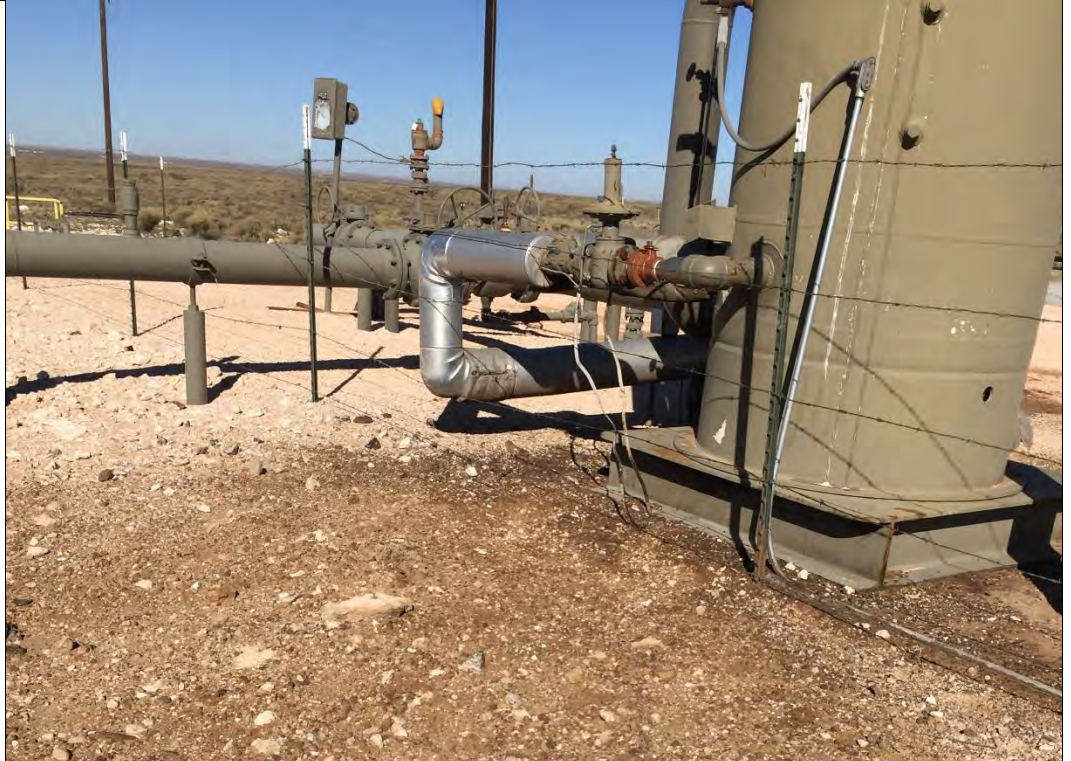
Description:
Looking west-
north west at field
scrubber.

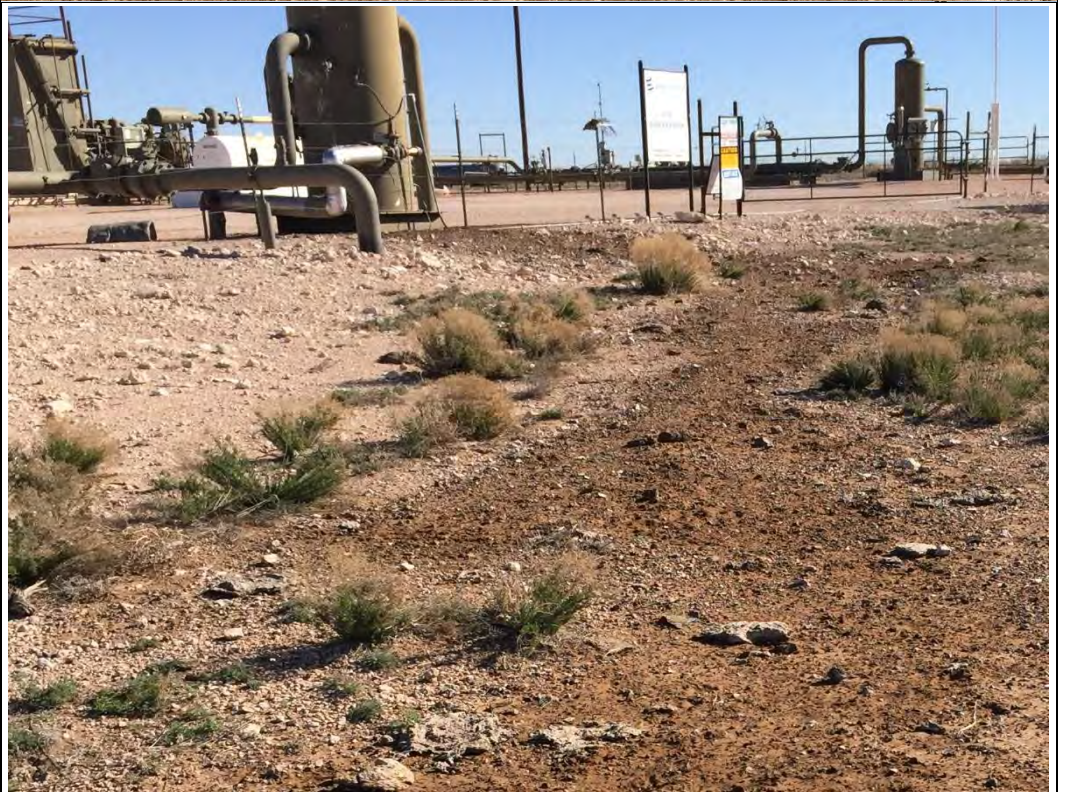
Photograph No. 2

Description:
Looking northeast
at Field Scrubber.
Release in
foreground.

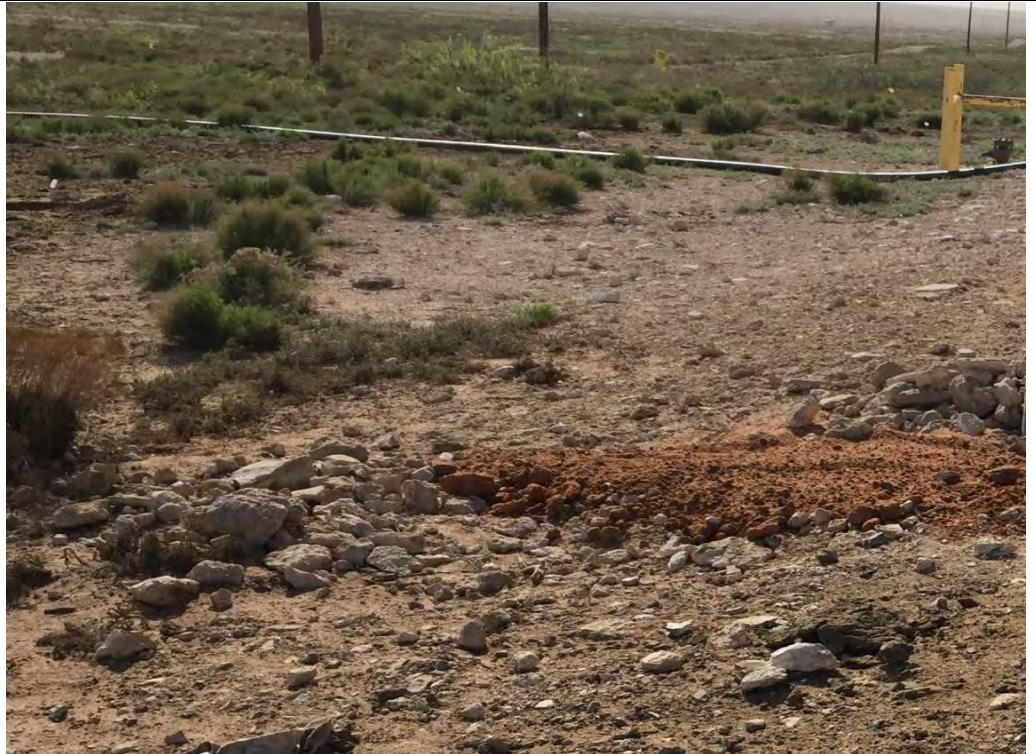
On March 23, 2017, TRC, on behalf of ETC, utilized a hand auger to collect ten (10) delineation soil samples (FS-1 6" through FS-5 6" and FS-1 1' through FS-5 1') from the stained surface soil. The soil samples were submitted to Xenco Laboratories in Midland, Texas for determination of concentrations of BTEX using Method SW 846-8021B, TPH using Method SW 846-8015M, and chloride using Method E-300.1. The analytical results indicated benzene and BTEX concentrations were less than the applicable laboratory Method Detection Limit (MDL), with the exception of soil samples FS-1 6", FS-3 6", and FS-3 1', which exhibited BTEX concentrations of 0.00480 mg/Kg, 0.2959 mg/Kg, and 0.2374 mg/Kg, respectively. The collected soil samples exhibited BTEX concentrations below NMOCD regulatory guidelines. The laboratory results indicated TPH concentrations ranged from 574.0 mg/Kg for soil sample FS-1 1' to 27,290 mg/Kg for soil sample FS-3 1'. A review of laboratory analytical results indicated soil samples FS-2 6", FS-3 6", FS-3 1', and FS-5 1' exhibited TPH concentrations above NMOCD regulatory guidelines. Chloride concentrations ranged from less than the applicable laboratory MDL for soil samples FS-4 6" and FS-4 1' to 7,910 mg/Kg for soil sample FS-1 6". A review of laboratory analytical results indicated soil samples FS-1 6" through FS-3 6" and FS-1 1' through FS-3 1' exhibited chloride concentrations above NMOCD regulatory guidelines.

Description:
Looking east
following hand
auger delineation
activities.

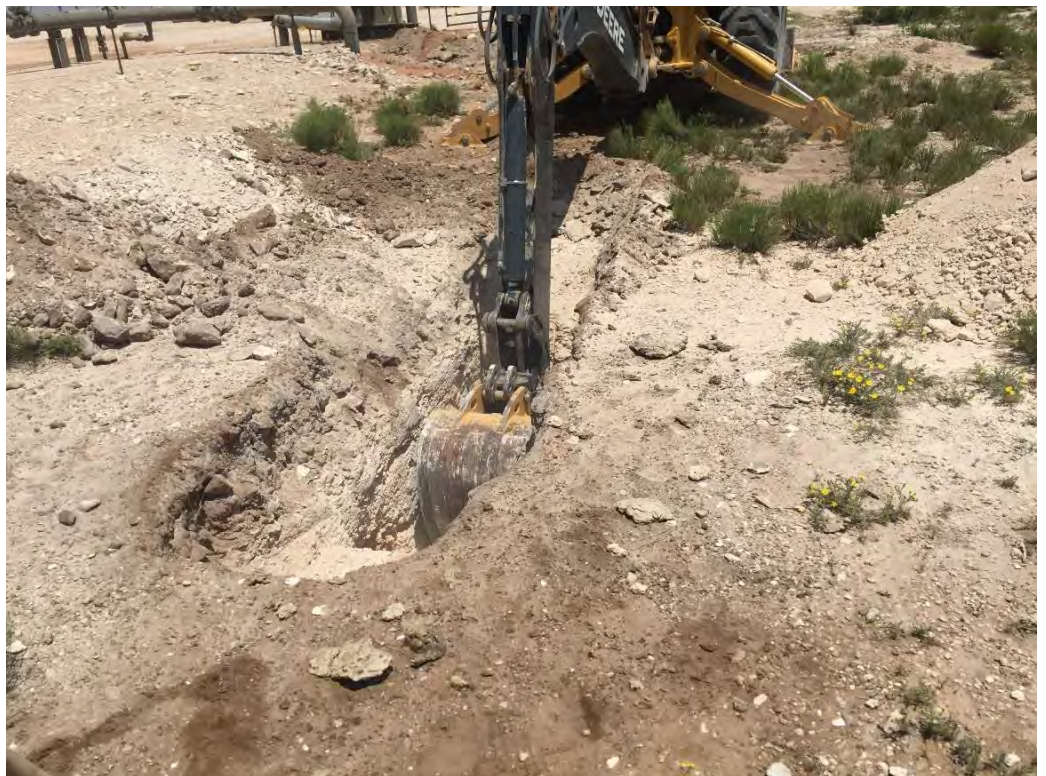
Photograph No. 4

On May 10, 2017, TRC conducted additional vertical delineation activities at the Release Site. Utilizing a backhoe, three (3) vertical trenches were advanced to approximately four (4) feet bgs. Three (3) soil samples (FS-1a 4', FS-2a 4', and FS-3a 4') were collected and submitted to the laboratory for BTEX, TPH, and chloride analysis. A review of laboratory analytical results indicated benzene and BTEX concentrations were less than the applicable laboratory MDL and below NMOCD regulatory guidelines. TPH concentrations ranged from 15.0 mg/Kg for soil sample FS-3a 4' to 23.6 mg/Kg for soil sample FS-1a 4'. A review of laboratory analytical results indicated TPH concentrations were below NMOCD regulatory guidelines. Chloride concentrations ranged from 22.8 mg/Kg for soil sample FS-3a 4' to 478 mg/Kg for soil sample FS-1a 4'. A review of laboratory analytical results indicate TPH concentrations were below NMOCD regulatory guidelines.

Description:
Looking west
during backhoe
trench activities at
sample point FS-
1a.
