REMEDIATION SUMMARY AND SITE CLOSURE REQUEST

ETC FIELD SERVICES, LLC
A-14 Compressor Station Field Scrubber Release
Lea County, New Mexico
UNIT LTR "I", Section 6, Township 24 South, Range 35 East, NMPM
Latitude 32° 14' 46.26" North, Longitude 103° 24' 7.2" West
NMOCD Reference # 1RP-4634

October 2017

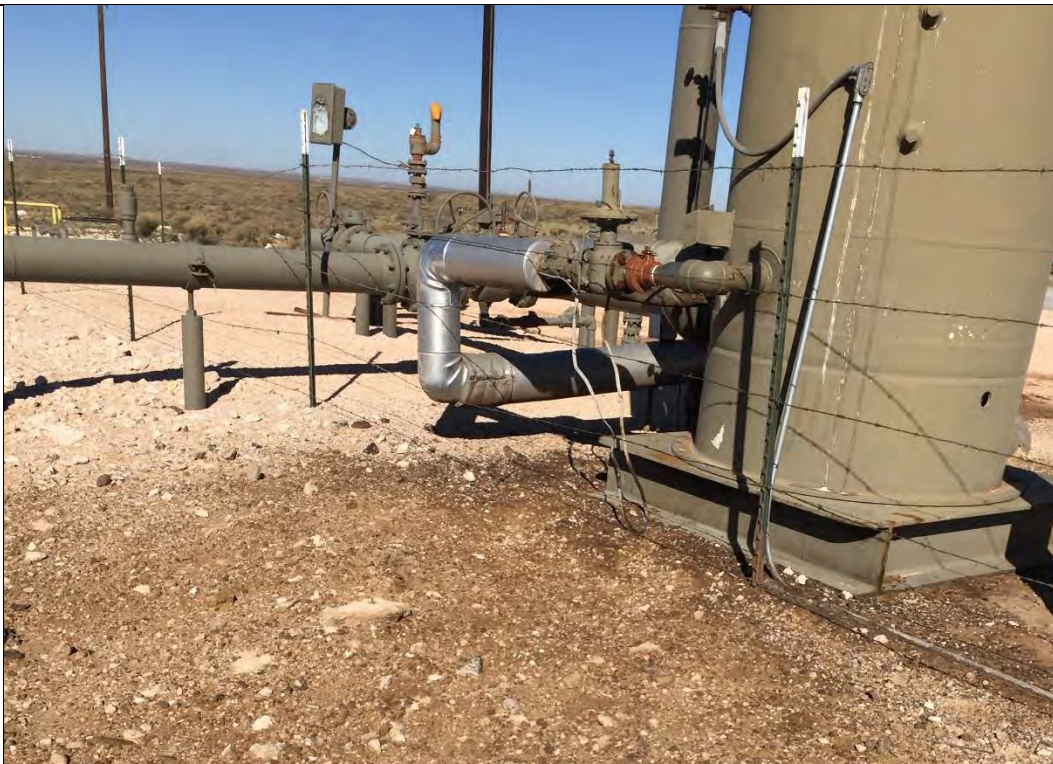
Description:
Looking northwest
at Field Scrubber.

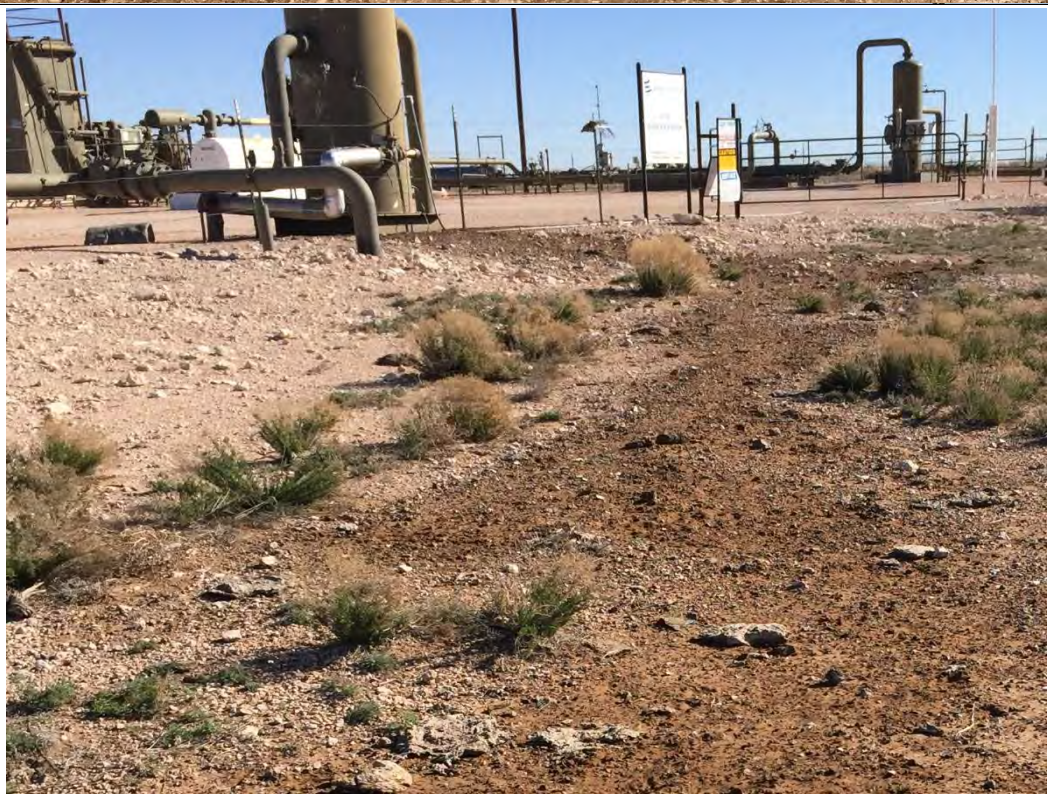
Photograph No. 2

Description:
Looking northeast
at Field Scrubber.
Release in
foreground.

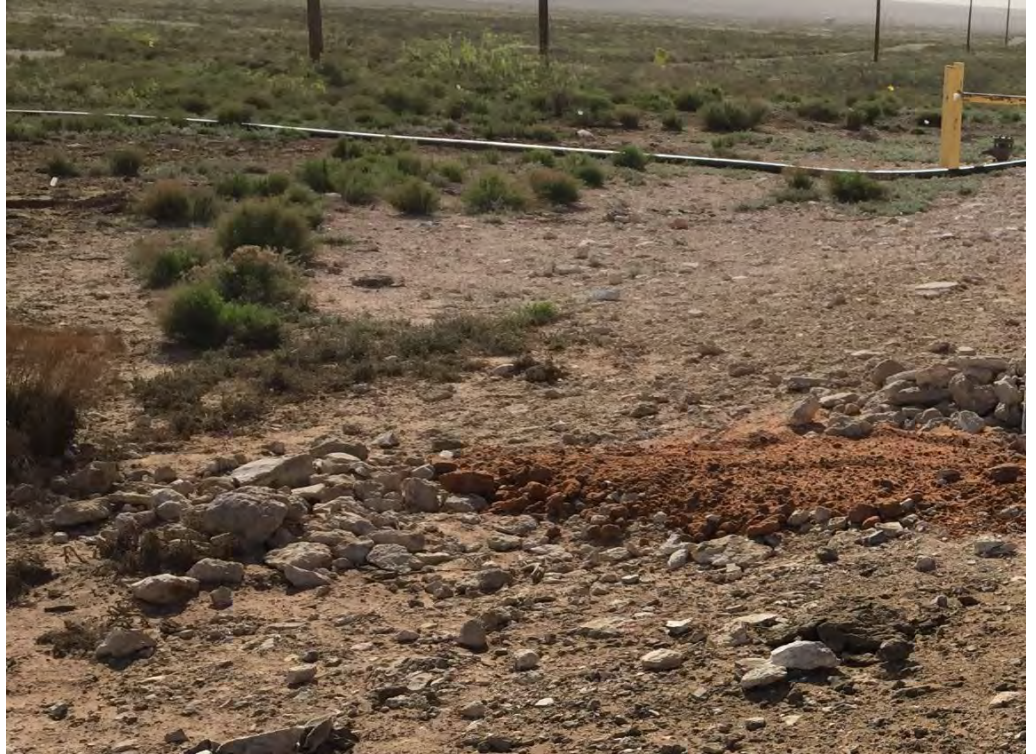
Description:
Looking east
following hand
auger delineation
activities.

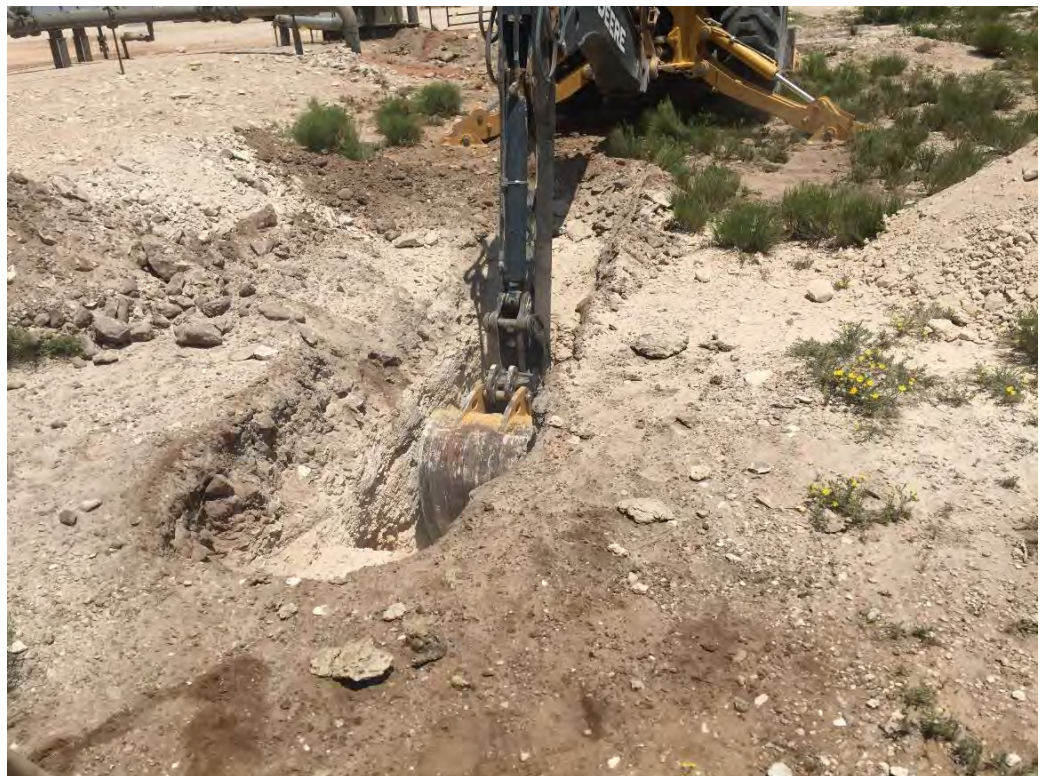
Photograph No. 4

Description:
Looking west
during backhoe
trench activities at
sample point FS-
1a.

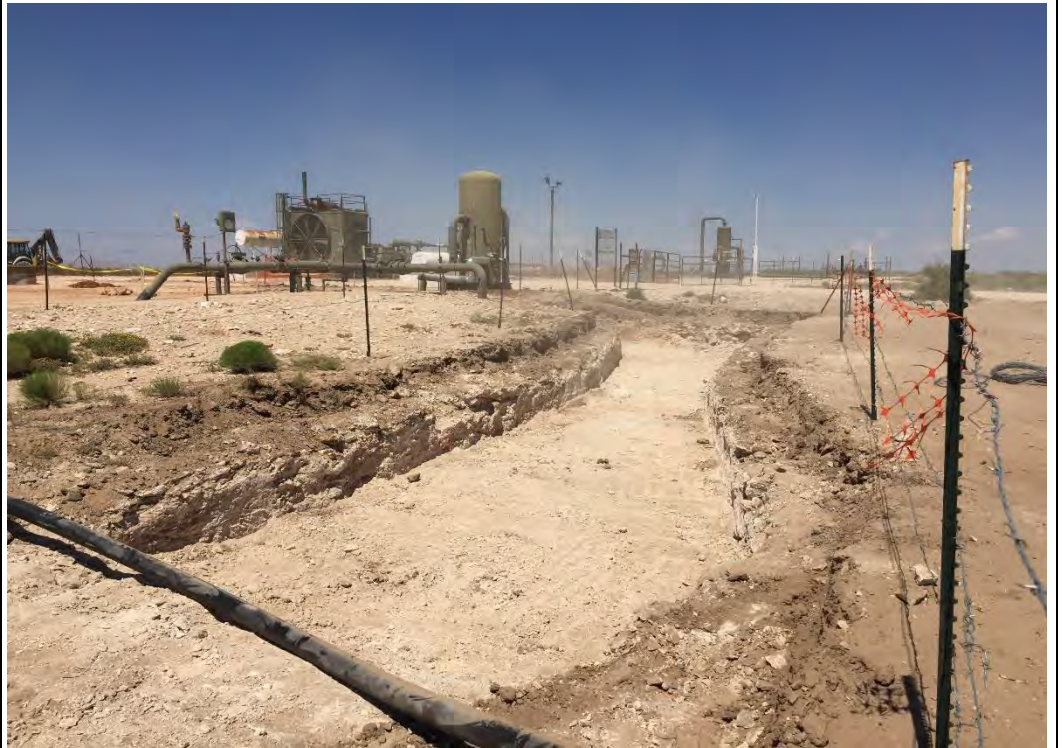
Description:
Looking east
following
excavation
activities.

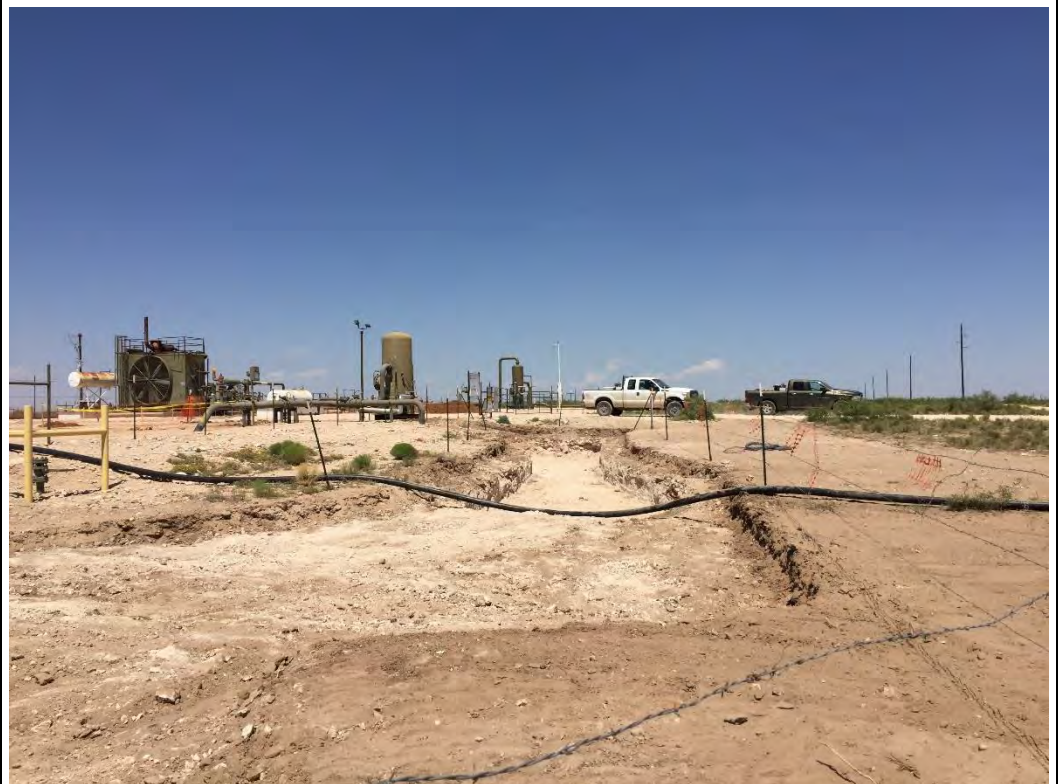
Photograph No. 6

Description:
Looking east
following
excavation
activities.

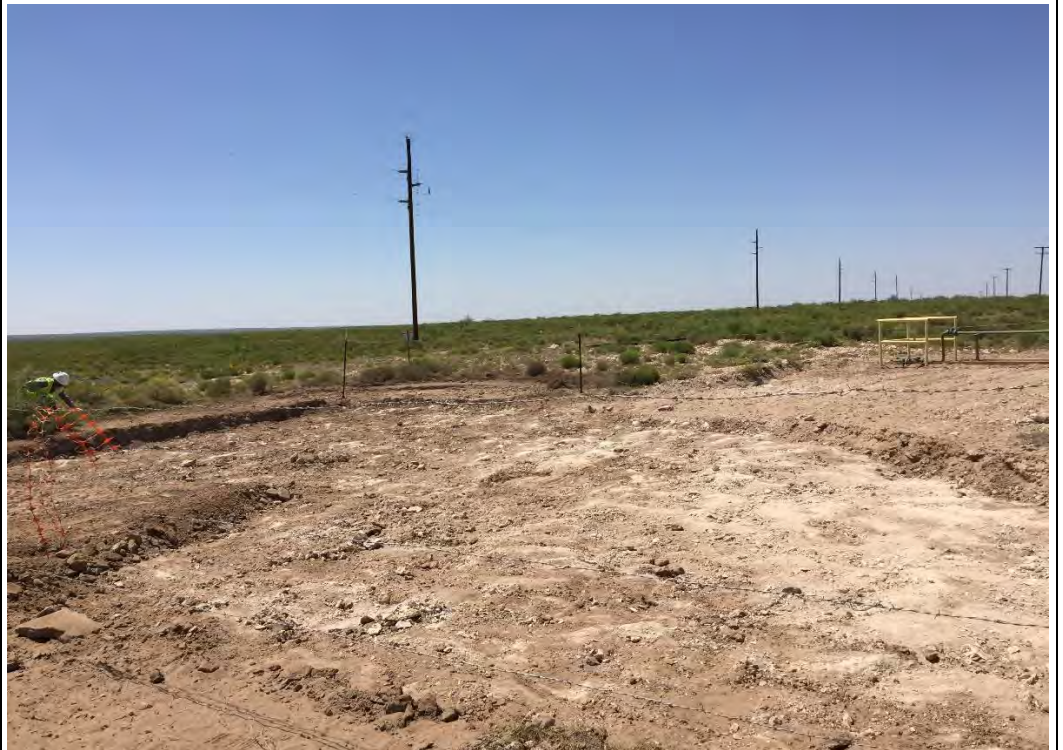
Description:
Looking northwest
following
excavation
activities.

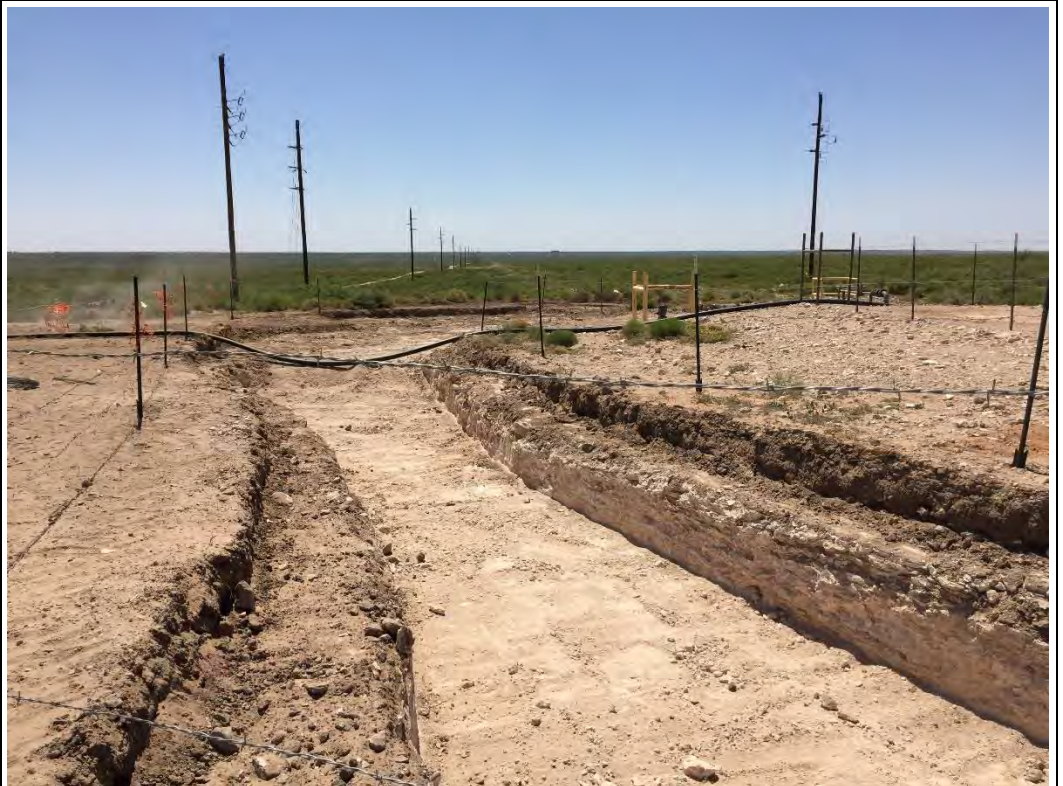
Photograph No. 8

Description:
Looking west
following
excavation
activities.

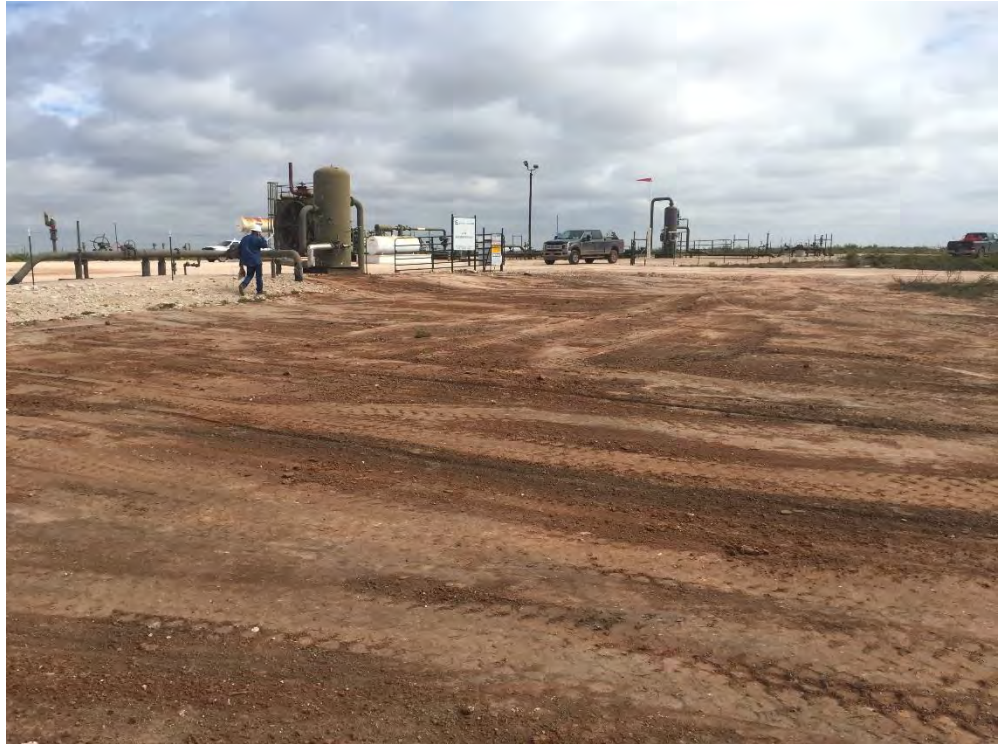
Description:
Looking northeast
following backfill
activities.

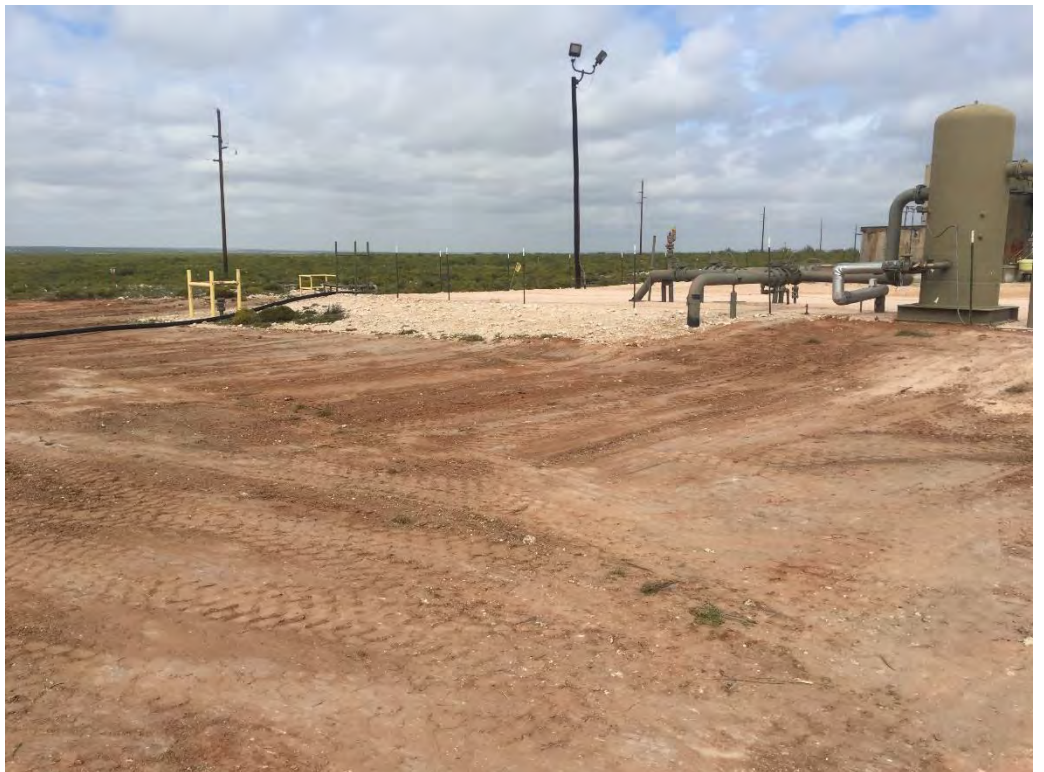
Photograph No. 10

Description:
Looking northwest
following backfill
activities.
