Release Notification and Corrective Action

Name of Company	ADVANCE ENERGY PARTNERS HAT MESA, LLC	Contact	David Harwell	Jimmy Smith
Address	11490 Westheimer Rd. STE 950, Houston, TX 77077	Telephone No.	832-672-4604	575-703-9921
Facility Name	Merchant/Dagger Containments to Merchant State 503H	Facility Type	Transfer Pipe	
Surface Owner	Merchant Land and Cattle	Mineral Owner	State of NM	API No.

RE: Advance Energy – Merchant Containment/Merchant State 503H Release(s)

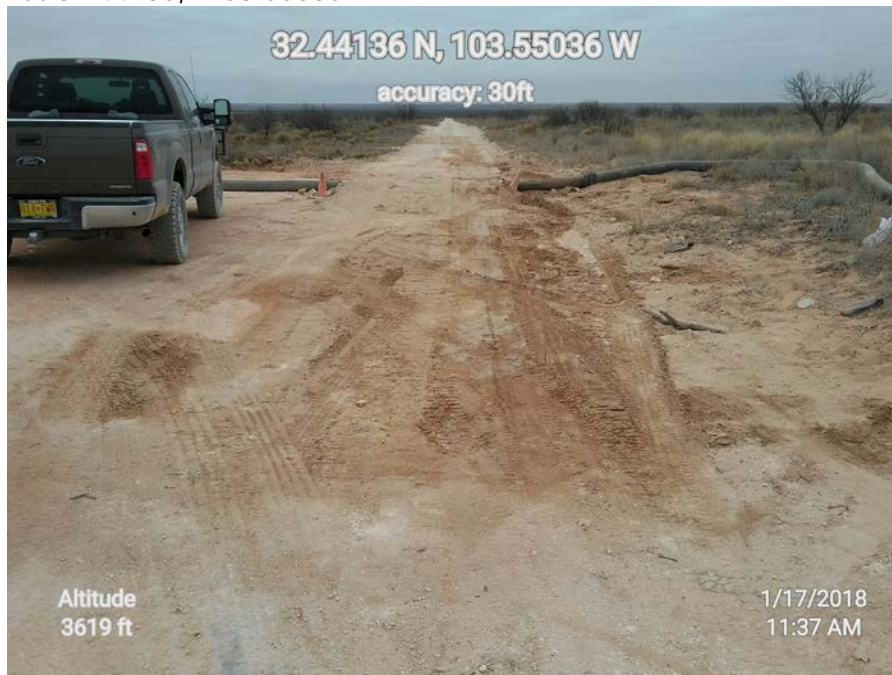
This leak is identified in samples as West of MC Jct and is on Merchant Land and Cattle surface. This release is probably more than 5 bbls but the quantity is unknown. Lat 32.44136, -103.55036

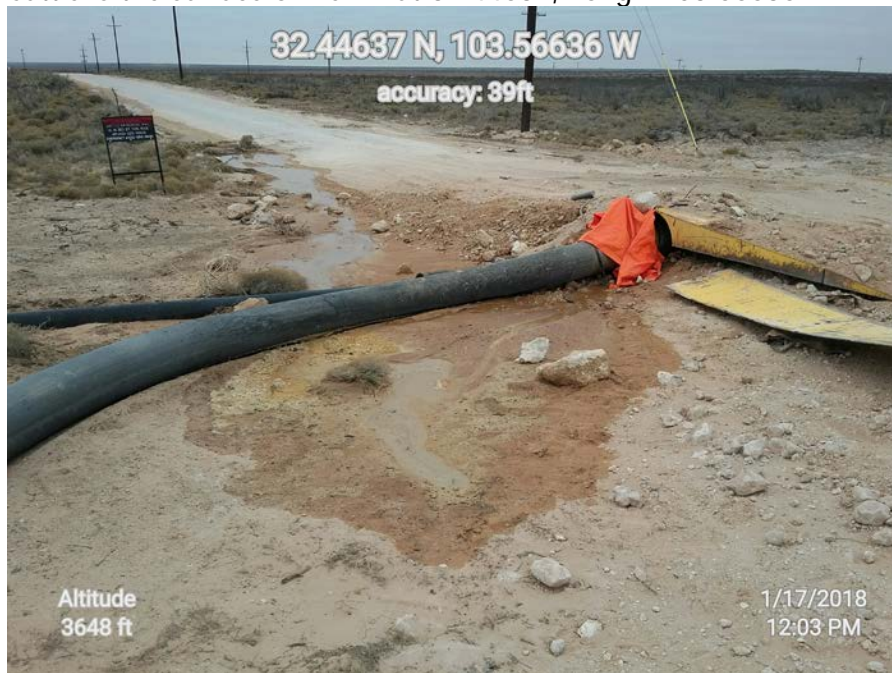
At this location, three separate releases occurred during the hydraulic stimulation. Samples at this site are identified as Battle 34 Fed 4H Jct. The aggregate of the three events is probably more than 25 bbls, but the volume is unknown. Merchant Land and Cattle is the surface owner. Lat 32.44637, Long. -103.56636

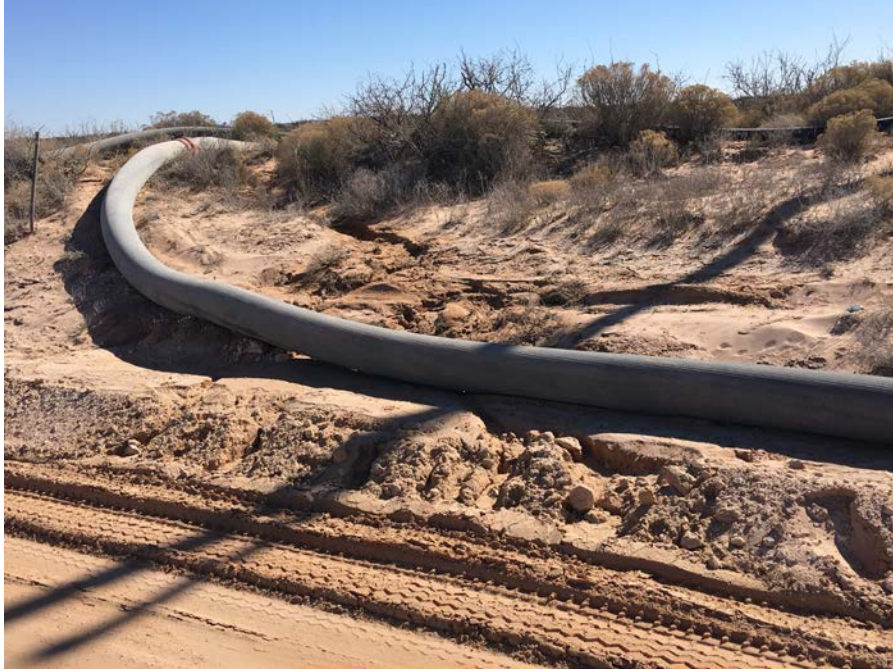
The location of this release is the identifier on the samples: 32 26 50, -103 33 50. The volume of this event is greater than 5 bbls and may be as large as 25 bbls, but the actual volume is unknown. The surface owner is Merchant Land and Cattle.

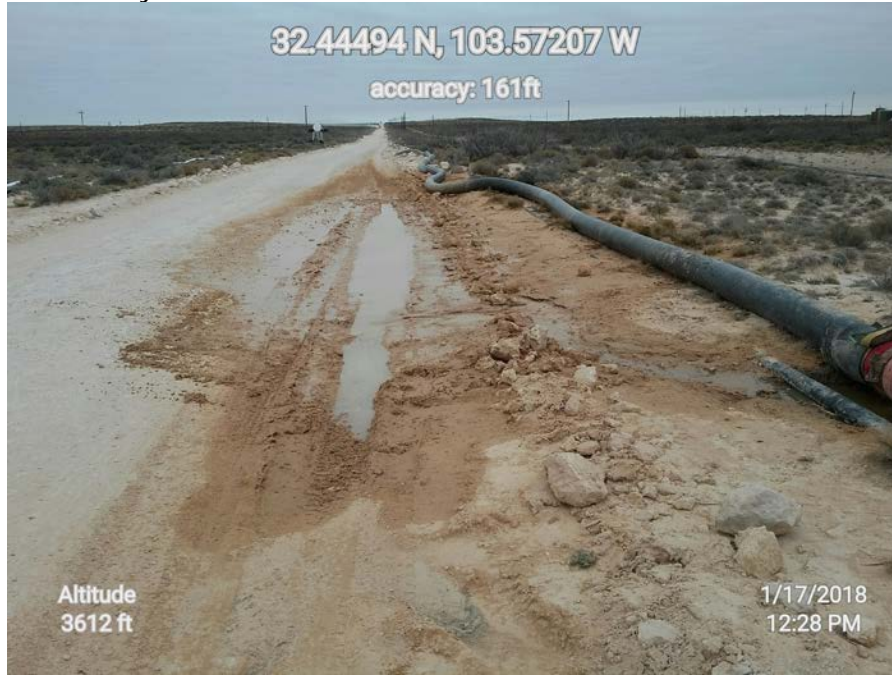
This release is on State Surface and is less than 5 bbls, therefore it is NOT listed on the attached C-141. We will characterize this release and work with the State Land Office to resolve any environmental issues.

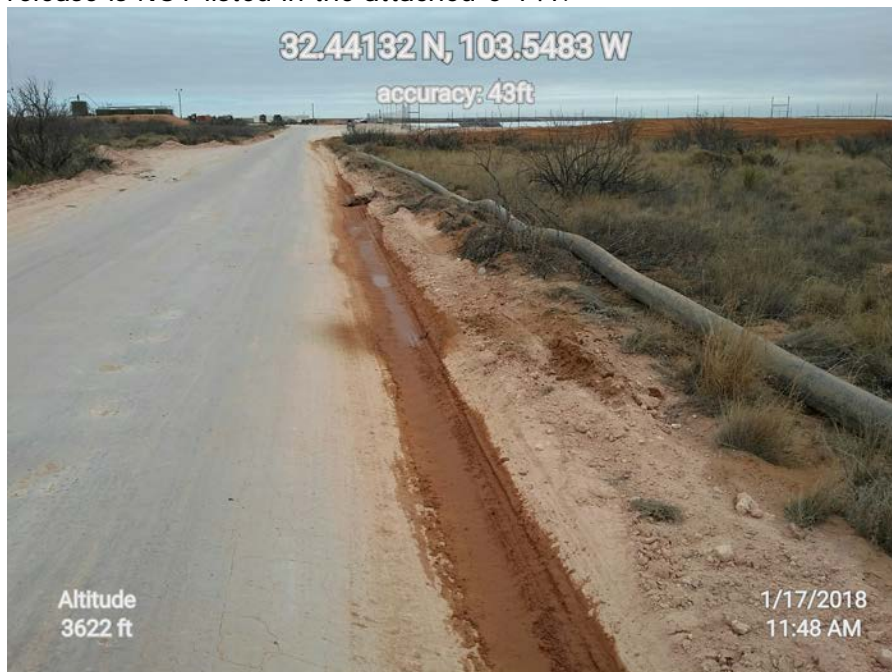
This probable diesel release from a contractor's truck is less than 5 bbls and Advance will address this release in an appropriate manner in cooperation with Merchant Cattle. This release is NOT listed in the attached C-141.
