Subject: Release Characterization Report and Remediation Work Plan

Location: Southwest Royalties, Inc.
Eilliams Battery
NMOCD Remediation Case #1RP-4918

Appendix II
Site Map 1

Site Map

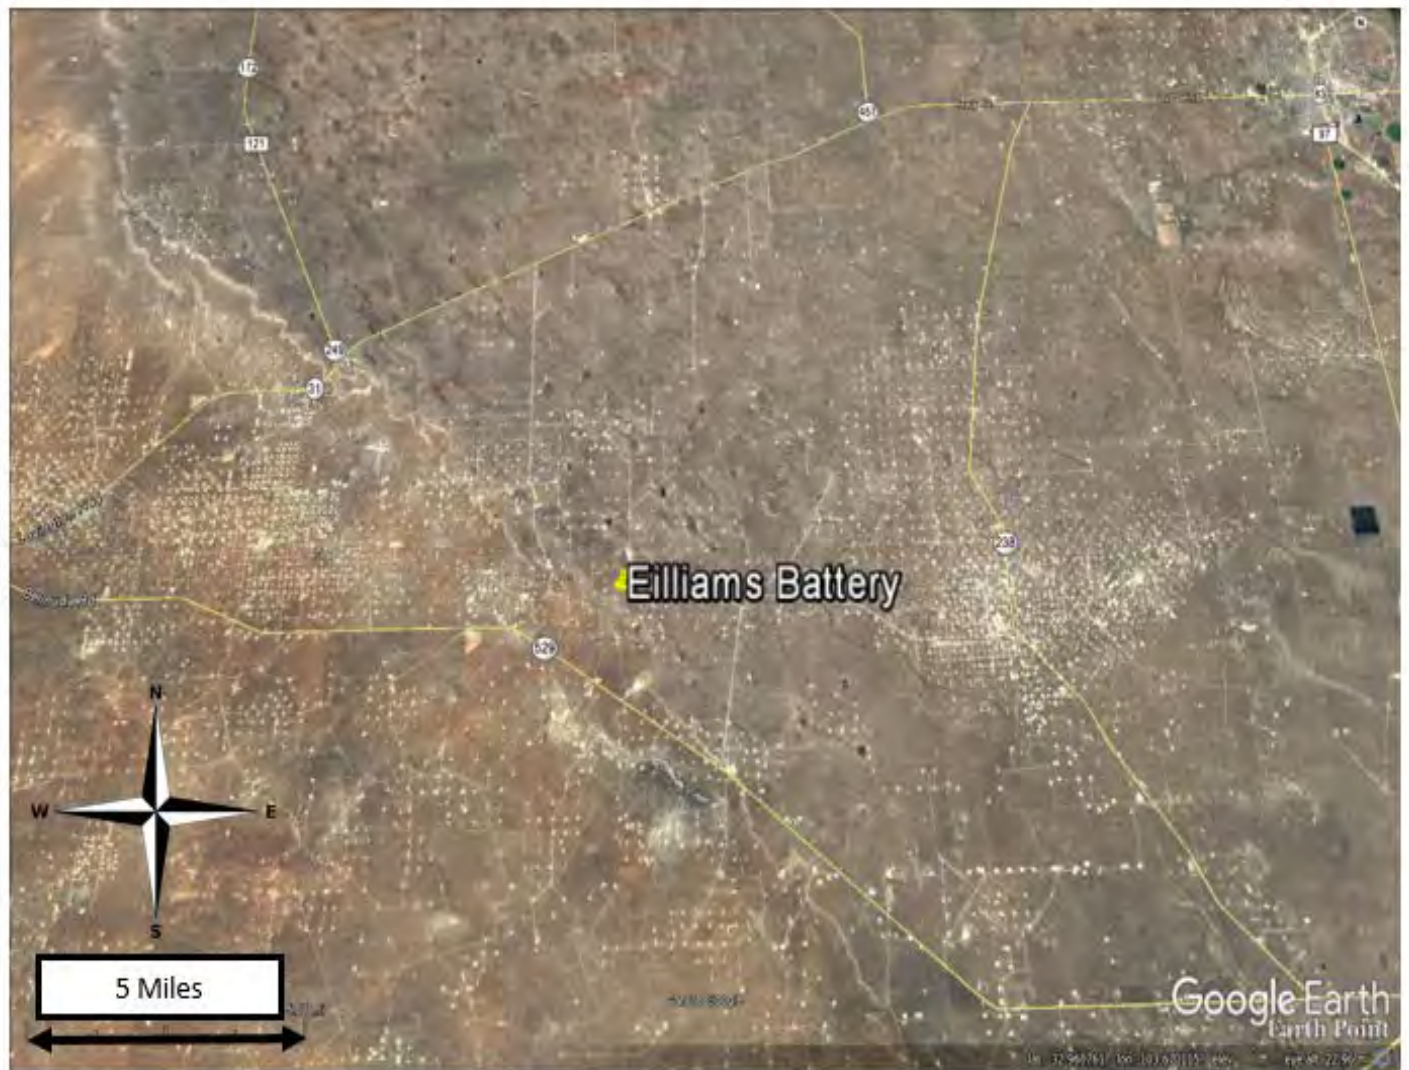
The Eilliams Battery is located approximately nine (9) miles west of Buckeye, New Mexico. The legal location for the Battery is Unit A Section 34 Township 17 South and Range 33 East in Lea County, New Mexico. The spill area was contained to the Produced Water tank area which is on the north side of the Eilliams Battery with the GPS Coordinates as follows: Latitude: 32.795246 North, Longitude: -103.644286 West. See Site Map attached in Appendix II.

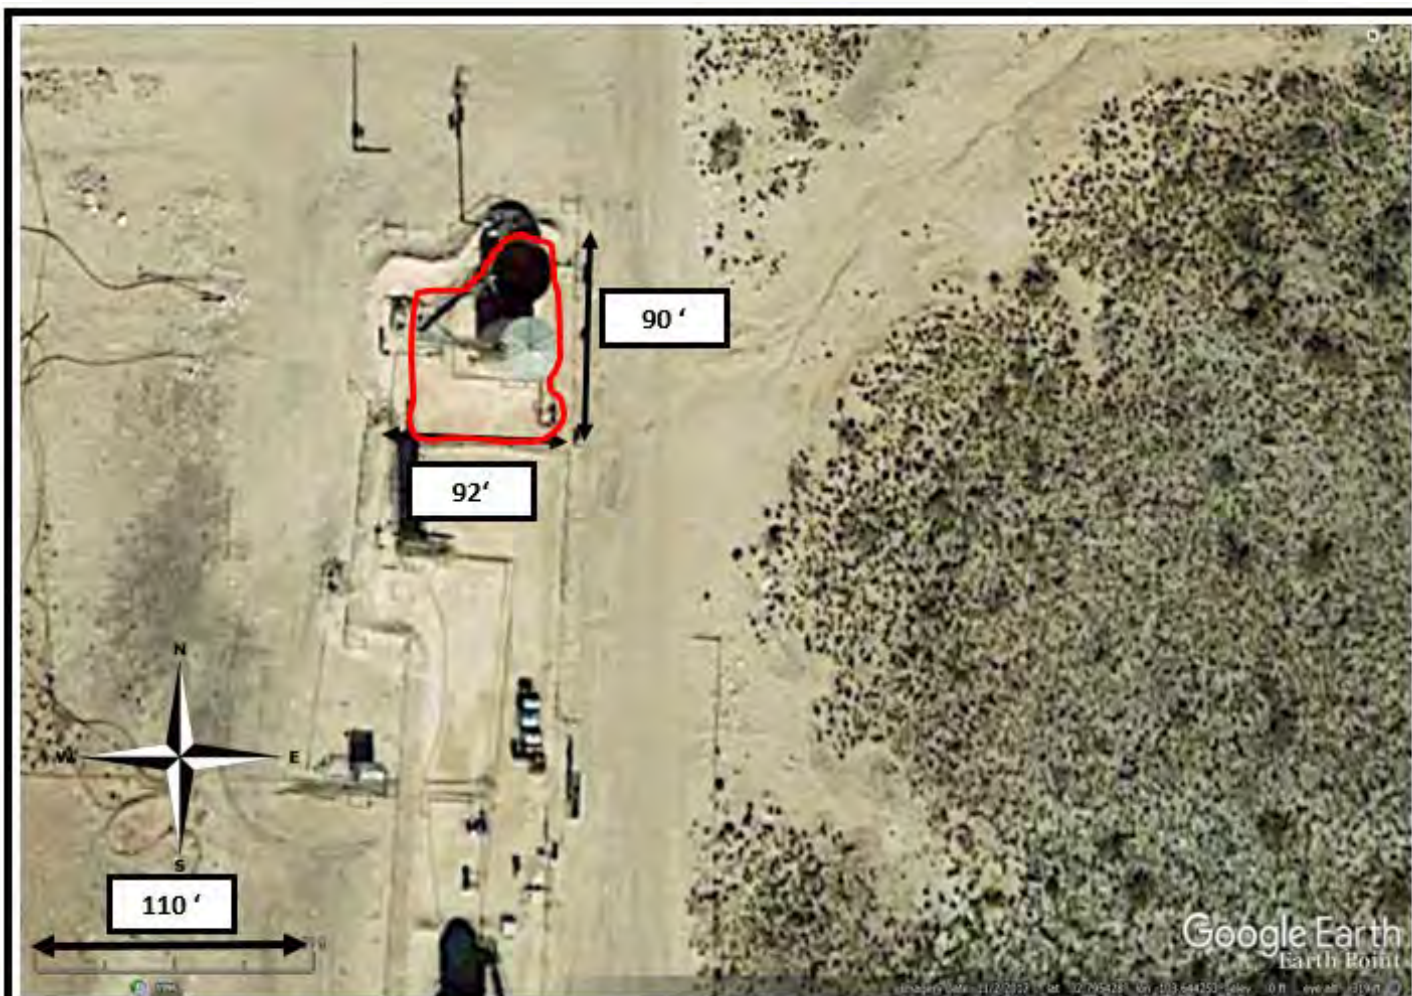
Site Map 2

On January 17 and 18, 2018, a crew with backhoe removed soil saturated with produced water from around the tanks. The area was excavated to remove saturated soil, and to provide a safe work environment for the operator. A total of 20 yards of impacted soil were hauled to NMOCD Approved Disposal Site R360. The excavated area was not backfilled.

Outlines the Spill Pool Area

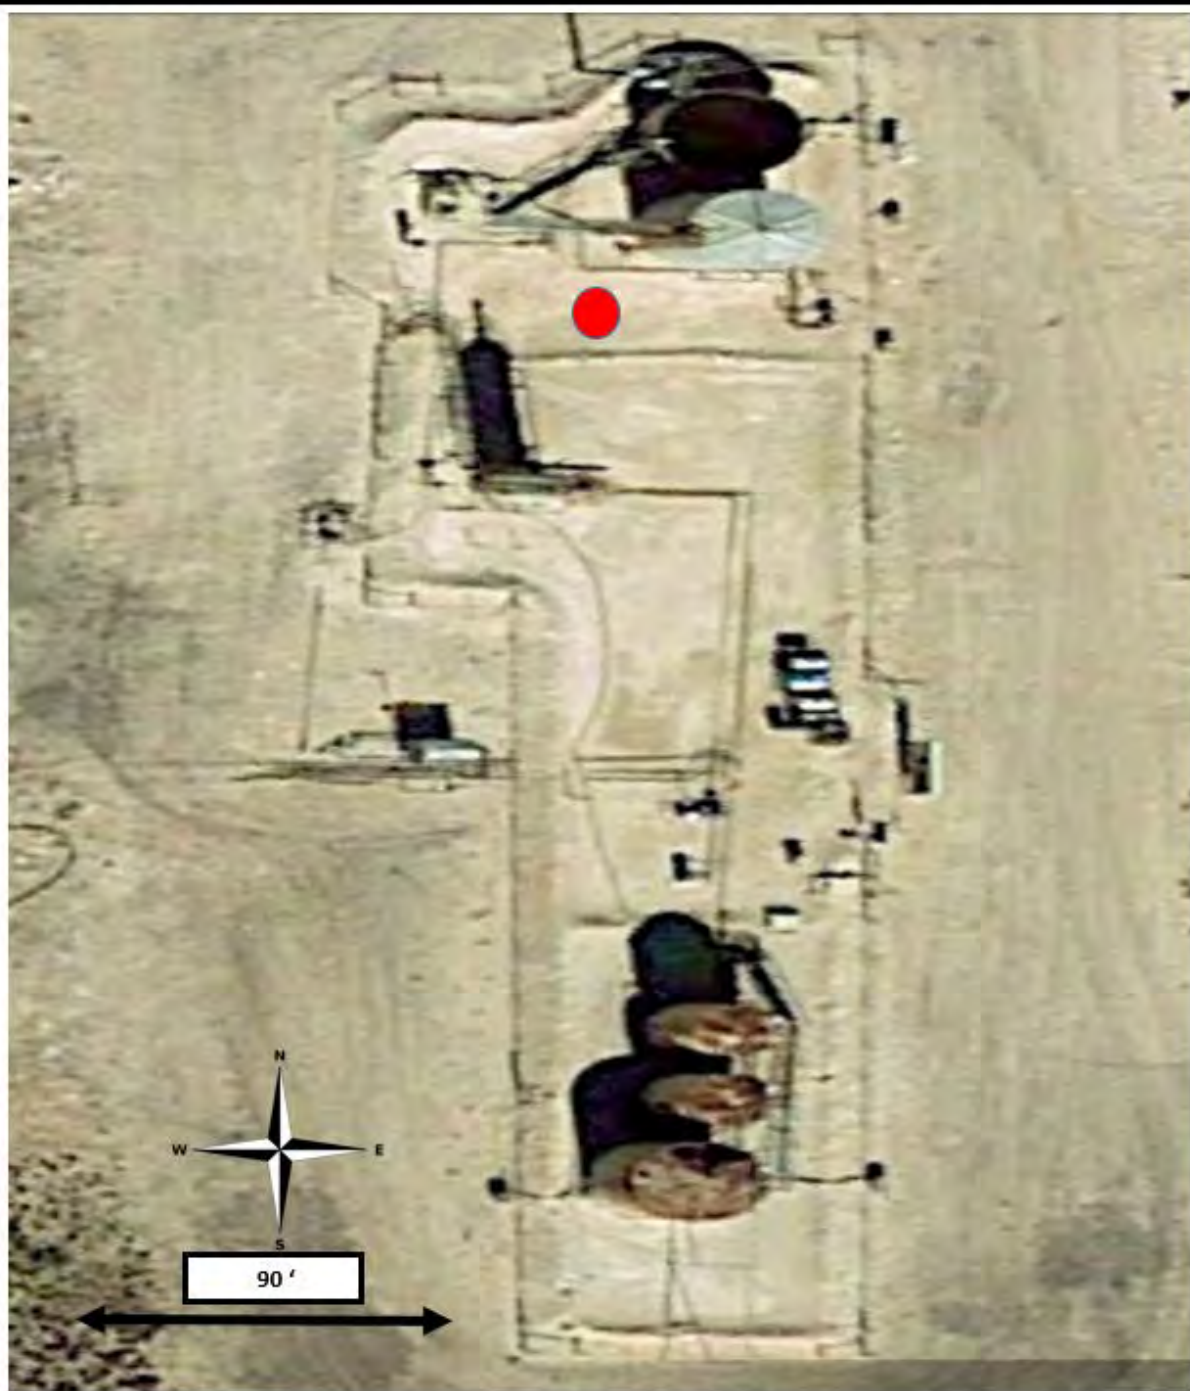
Sampling Map

On January 30 and 31, 2018, Atkins Engineering was contracted to drill a bore hole at the Eilliams Battery. One bore hole was drilled to satisfy the vertical delineation requirements. The bore hole was drilled in the area inside of the battery bermed area where the produced water had pooled at the following GPS Coordinates 32.795203N, -103.644331W (See Appendix VI). Soil samples were collected at depths of 5', 10', 15', 20', 25', 30', 35', 40', 45', 50', 55', 60', and 65'. The soil samples were placed in laboratory provided sample containers and transported to Cardinal Labs in Hobbs, NM for analysis (Appendix VII). The chlorides samples were analyzed per Method SM4500C1-B.

See Appendix VI for Site sample points.

- Bore Hole

GPS-32.795203N,-103.644331W
