Release Notification

XTO Energy, Inc.
Seven Rivers Queen – Injection Line Release 09-13-2018
32.41861°N, -103.27083°W

Form C-141 Supplement

Project Name: XTO Energy-7 Rivers Queen- Initial Release Characterization

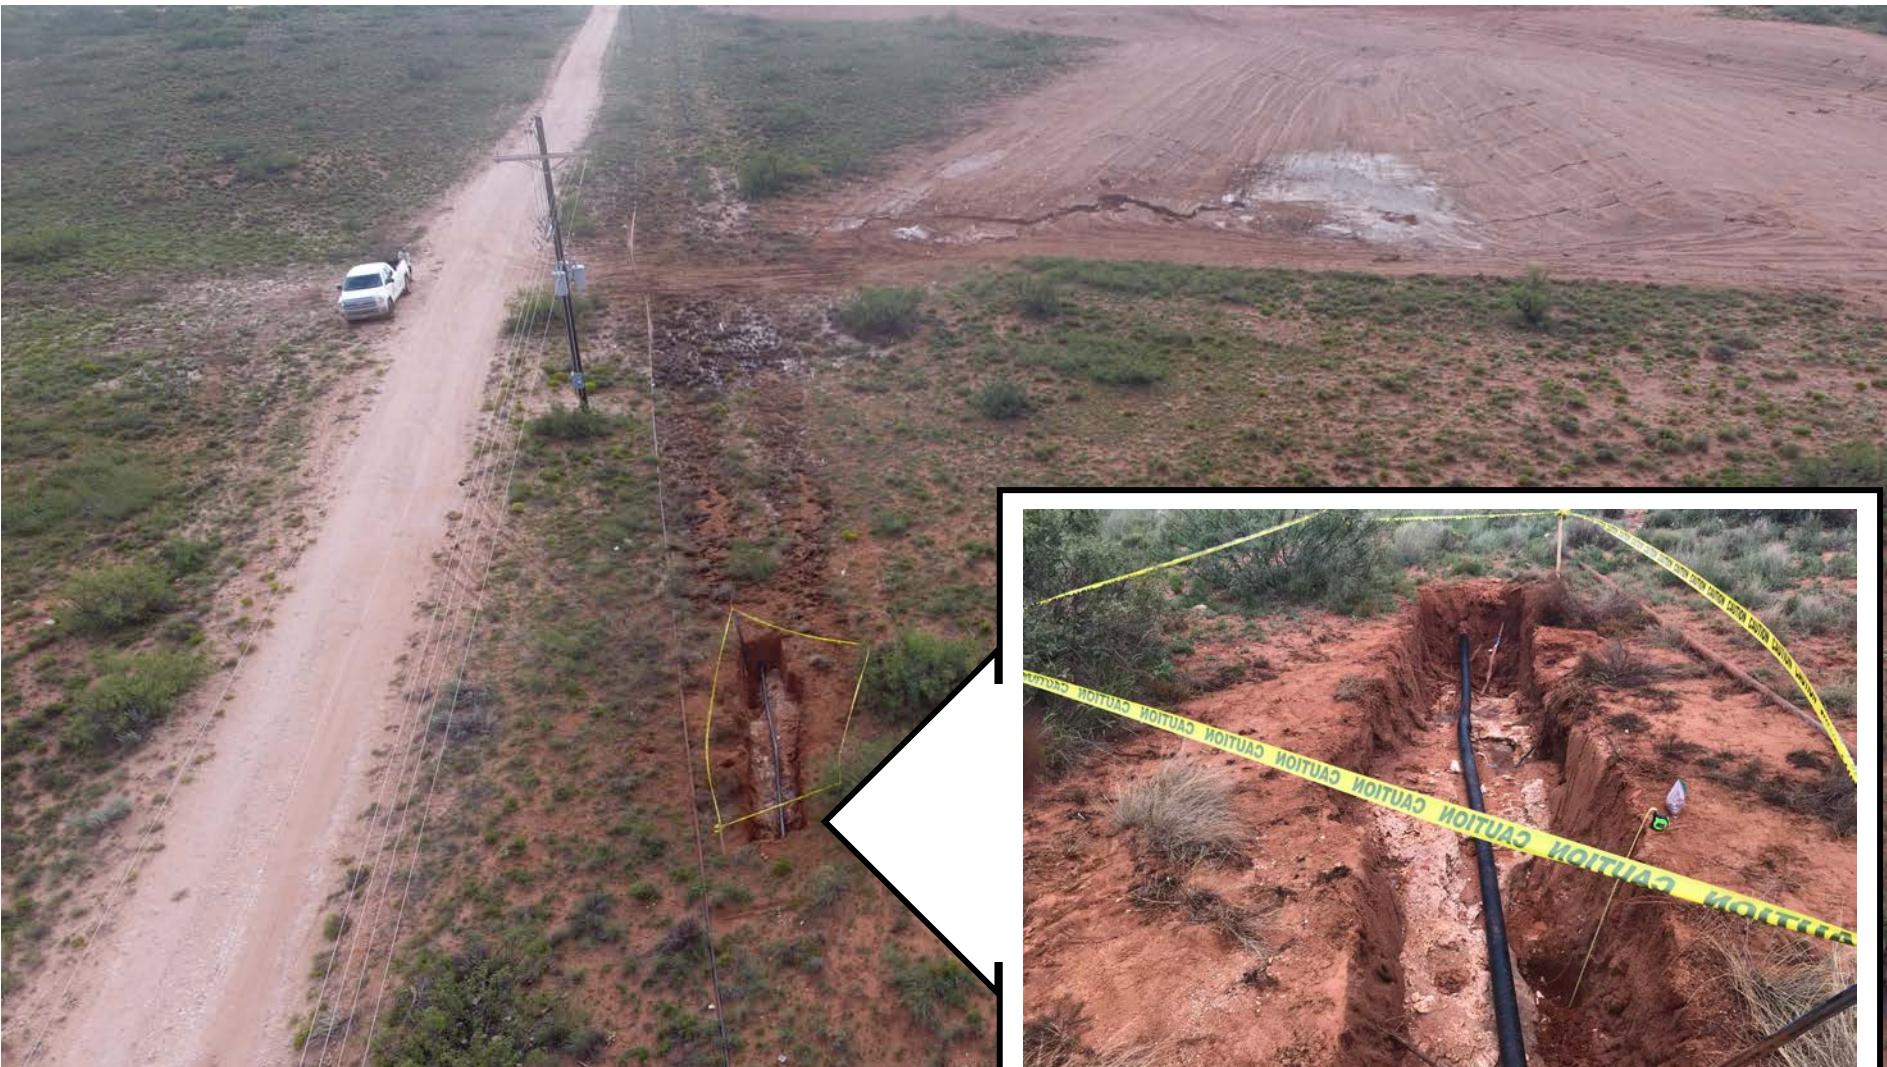
XTO Energy, Inc.
Seven Rivers Queen (Produced Water Release)
Attachment B

Photographic Documentation Confirming Release Containment

Aerial Imagery Captured with DJI Phantom 4 Pro on September 18, 2018 (FAA Registration #: FA33CWXHMA)

In addition, site photographs and drone aerial imagery were also obtained of the release site on 09-18-2018. These images will provide a better understanding of the site and how the release path overlays a reported caliche pit closure consisting of disturbed, homogenous soils. Please refer to **Attachment B**.

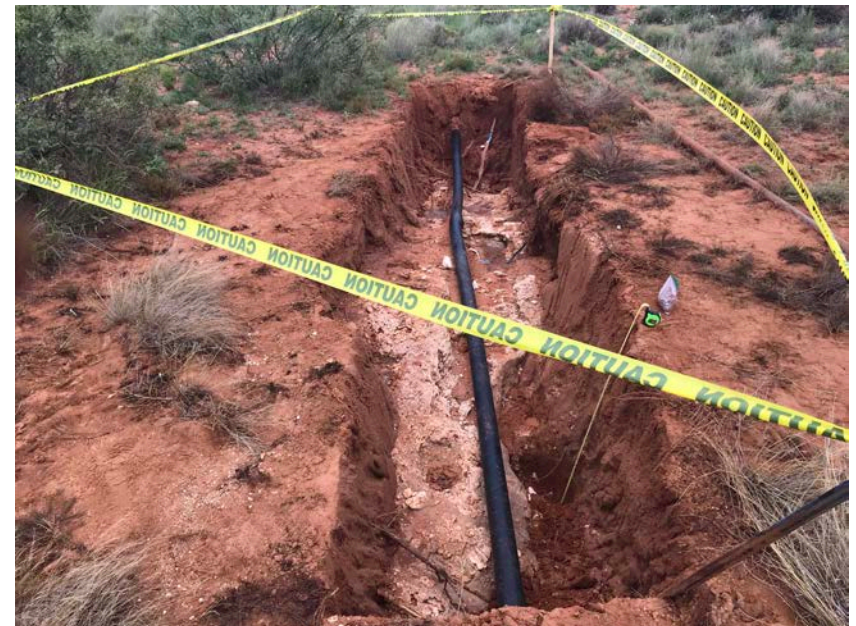
Release Point: 32.418682°, -103.270776°

Release has been stopped and the area surrounding the excavation has been marked with caution tape.
