RE: Final Closure Report  
Chevron – CDU Injection Line  
UL-M, Section 28, Township 21 South, Range 37 East  
Lea County, New Mexico  
NMOCD Reference # 1RP-4321

The following *Final Closure Report* serves as a condensed update on closure activities undertaken for the above referenced Site.

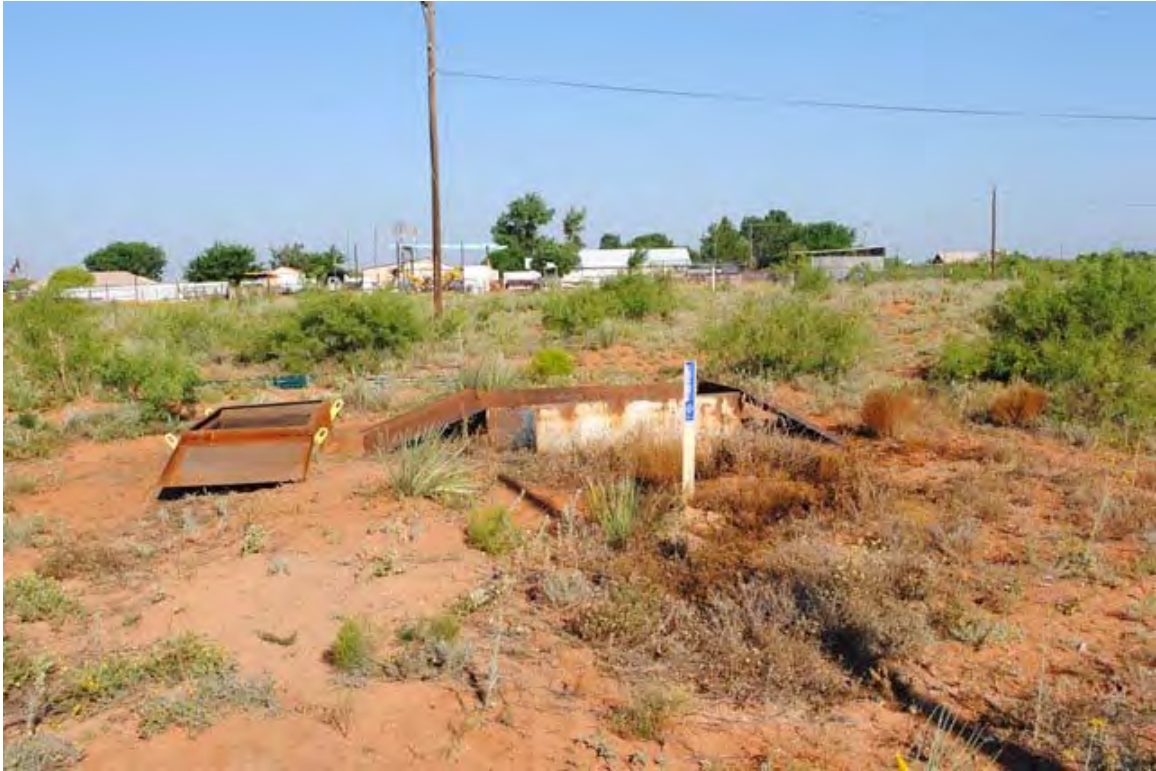
Photograph #1 – Looking east across release area

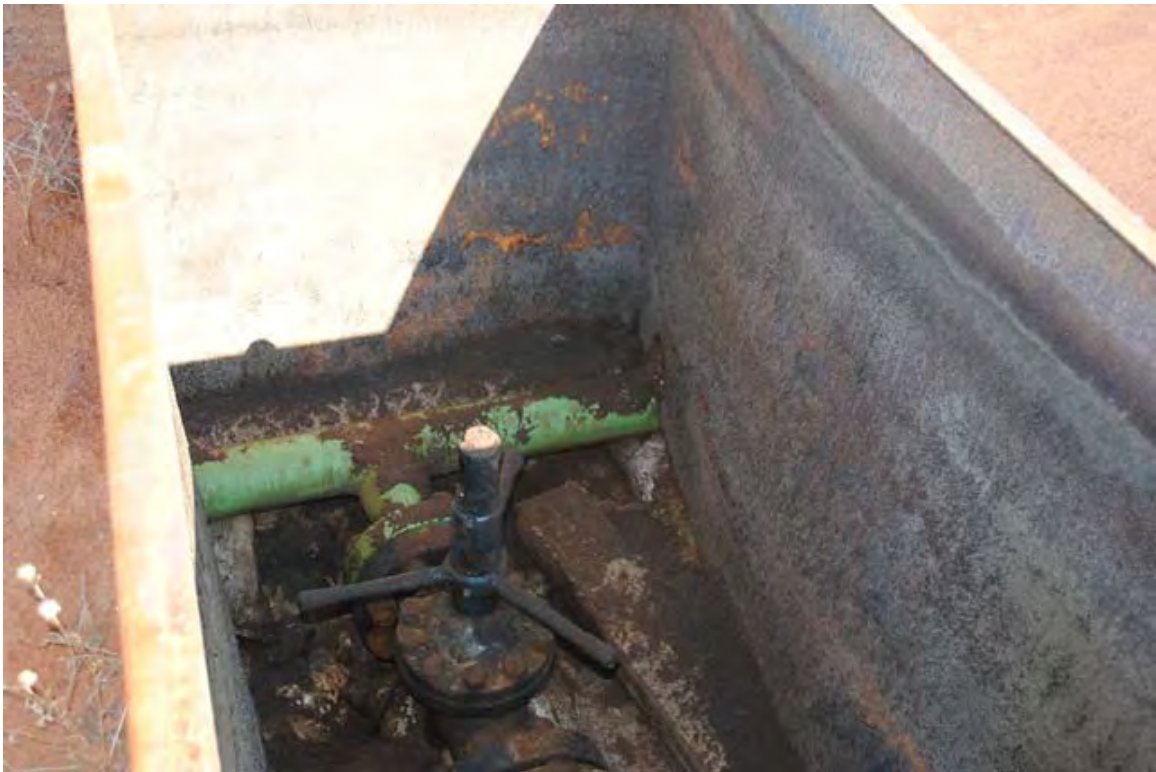
Tee on injection line developed a hole in the valve box. Vacuum truck was called to pick up fluid in secondary containment and ground.

Photograph #2 – Valve box

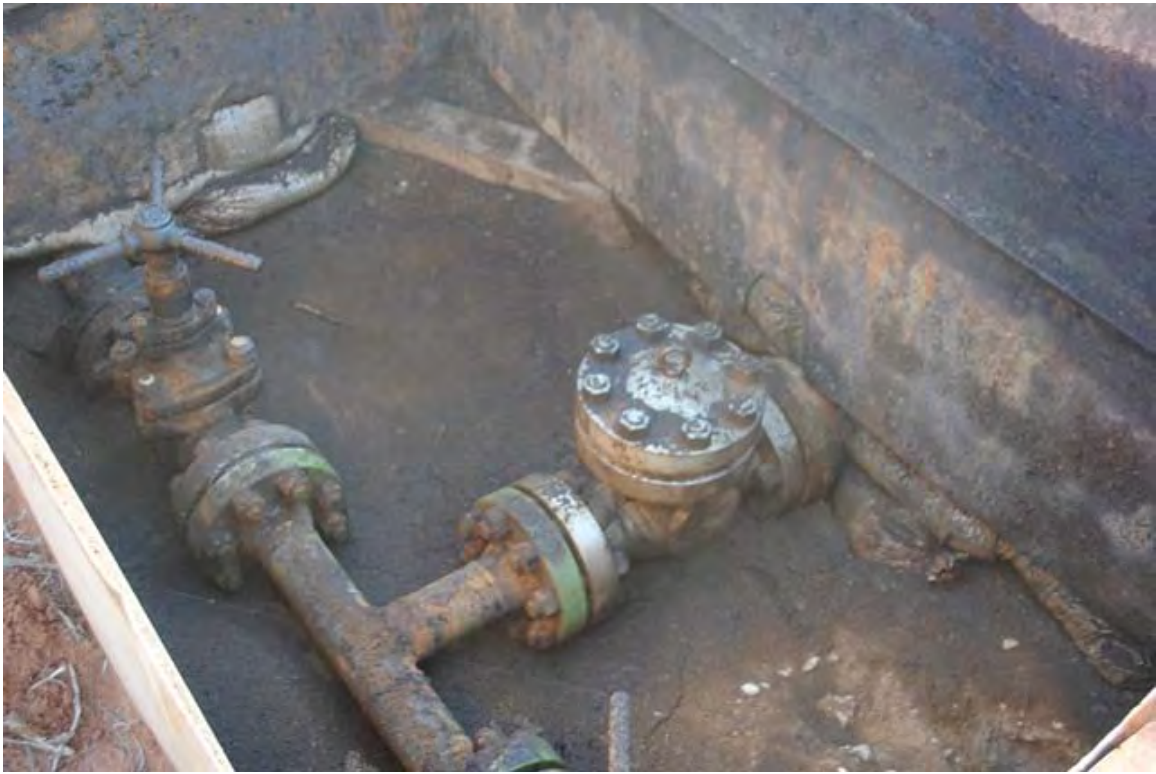
Photograph #3 – Valve box

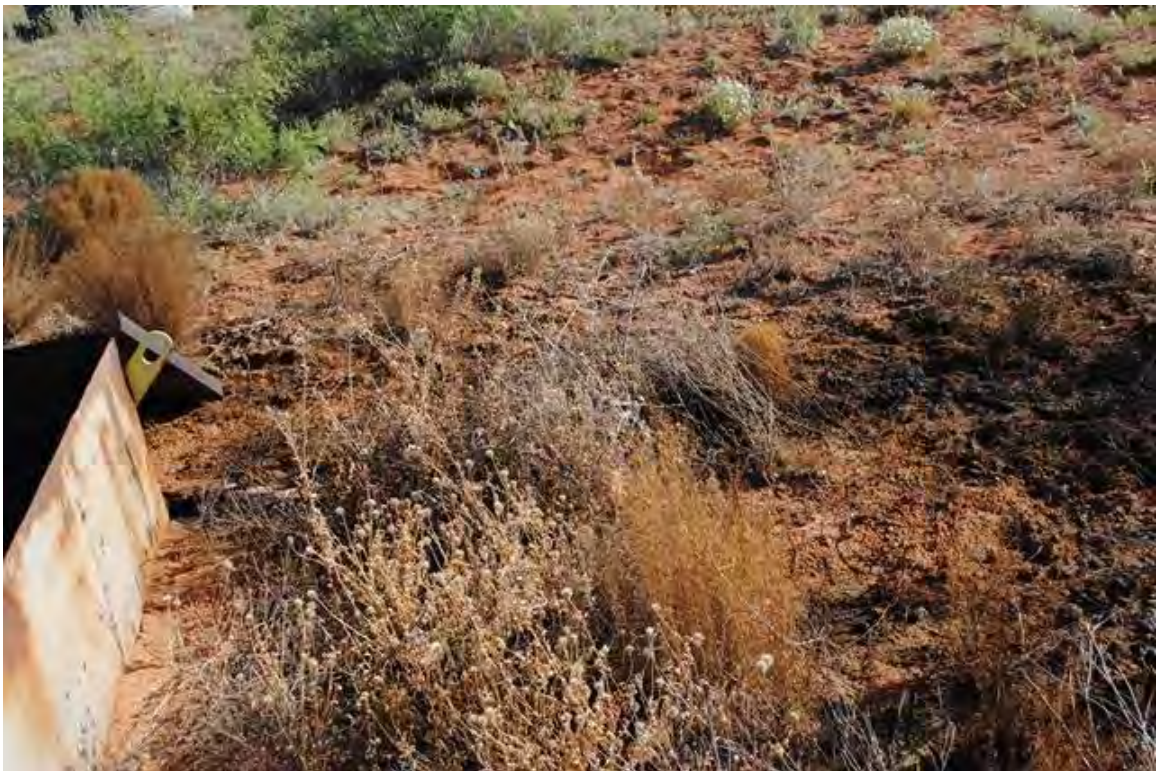
Photograph #4 – Looking across release area

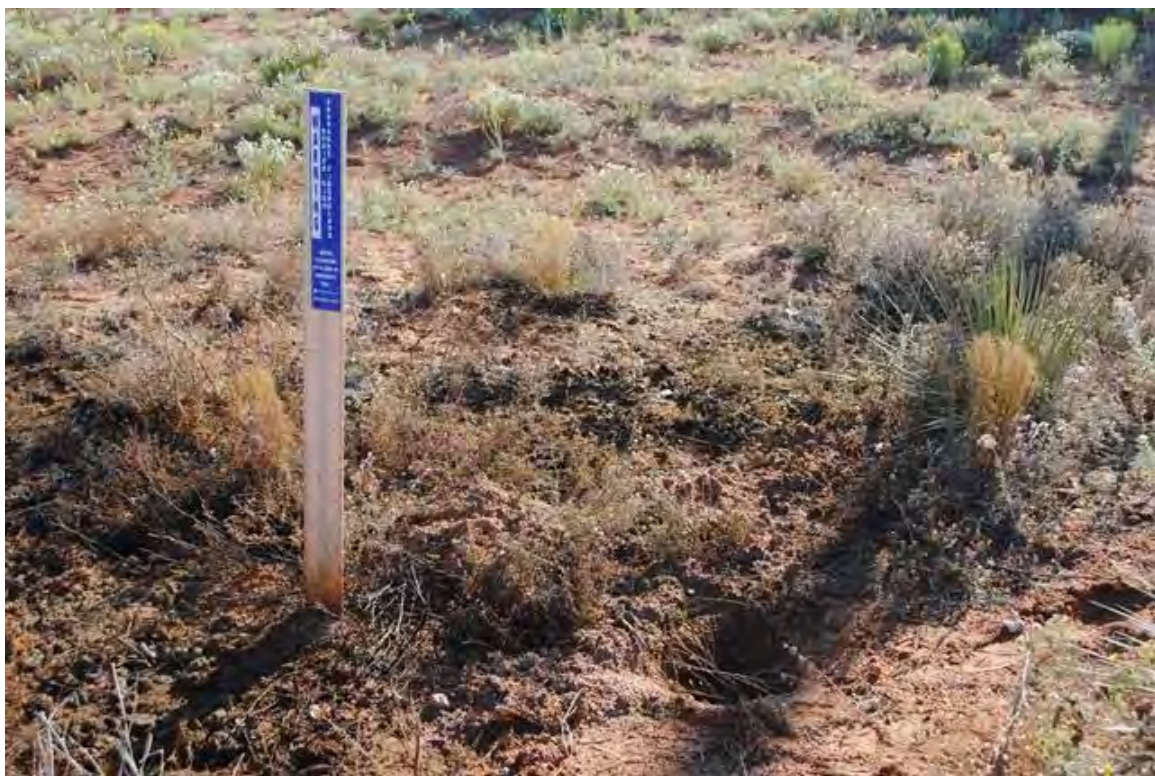
Photograph #5 – Looking across release area

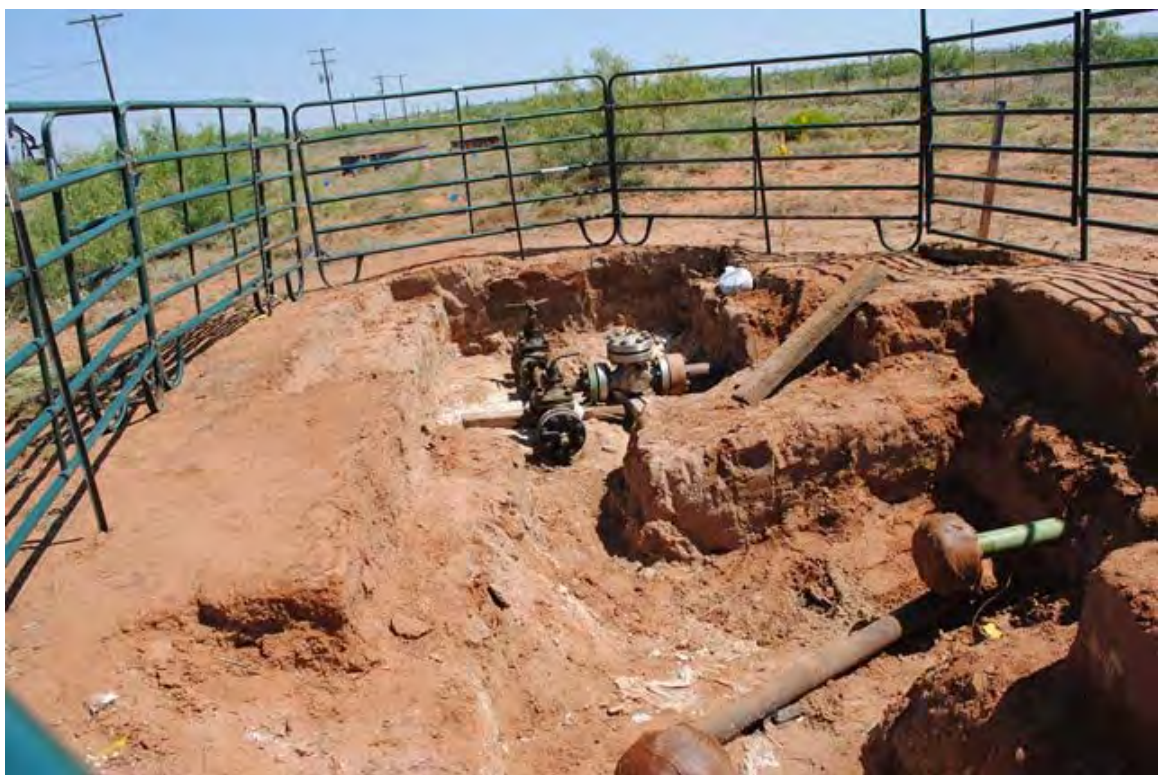
Photograph #6 – Excavated area

Based on laboratory analytical results indicating the depth of Chloride concentrations adjacent to the excavation, and with NMOCD approval, the area has been excavated to four (4) feet bgs, a 20 mil. poly-ethylene liner has been installed and the excavation backfilled with clean soil; soil is free of deleterious material or rocks or large clumps.

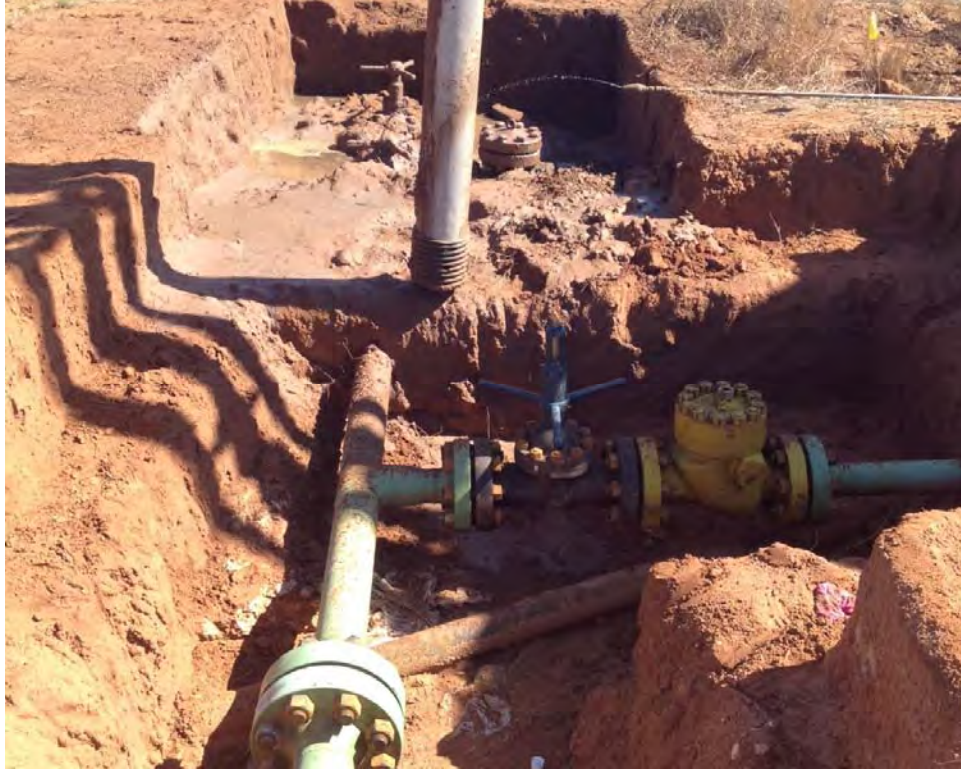
Photograph #7 – Excavated area

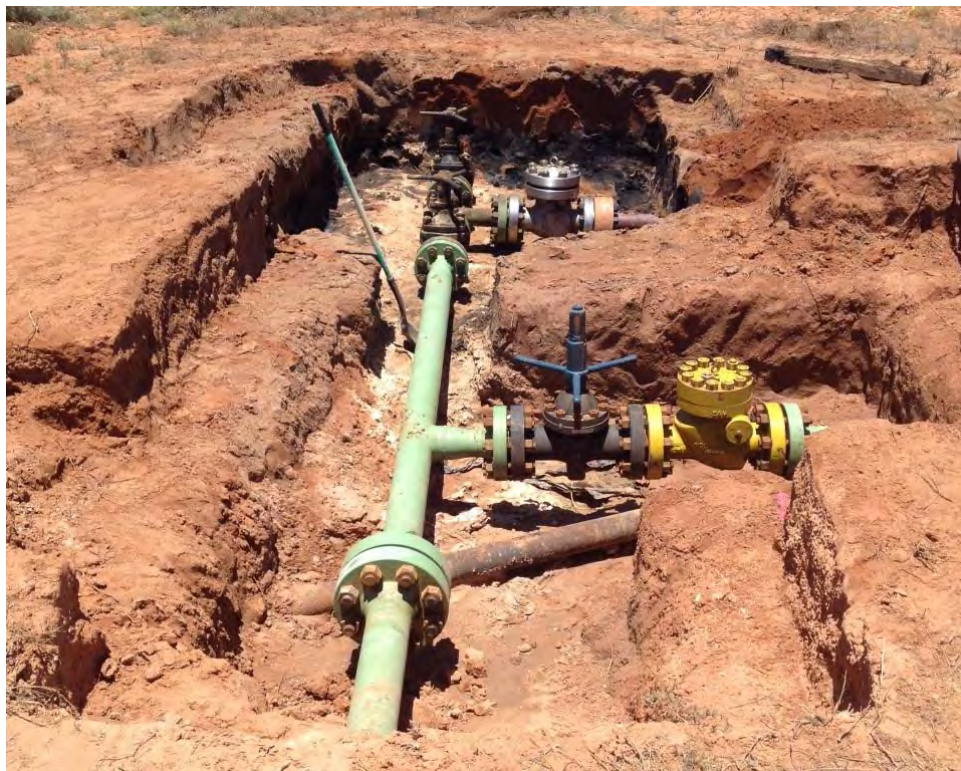
Photograph #8 – Excavated area

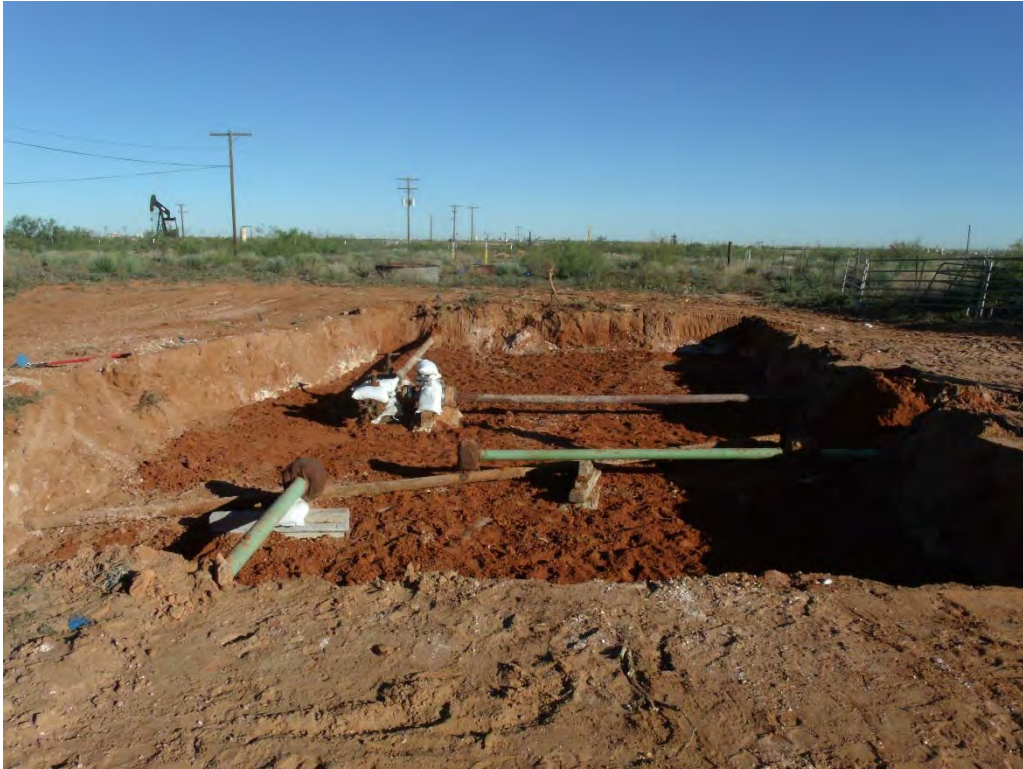
Photograph #9 – Excavated area

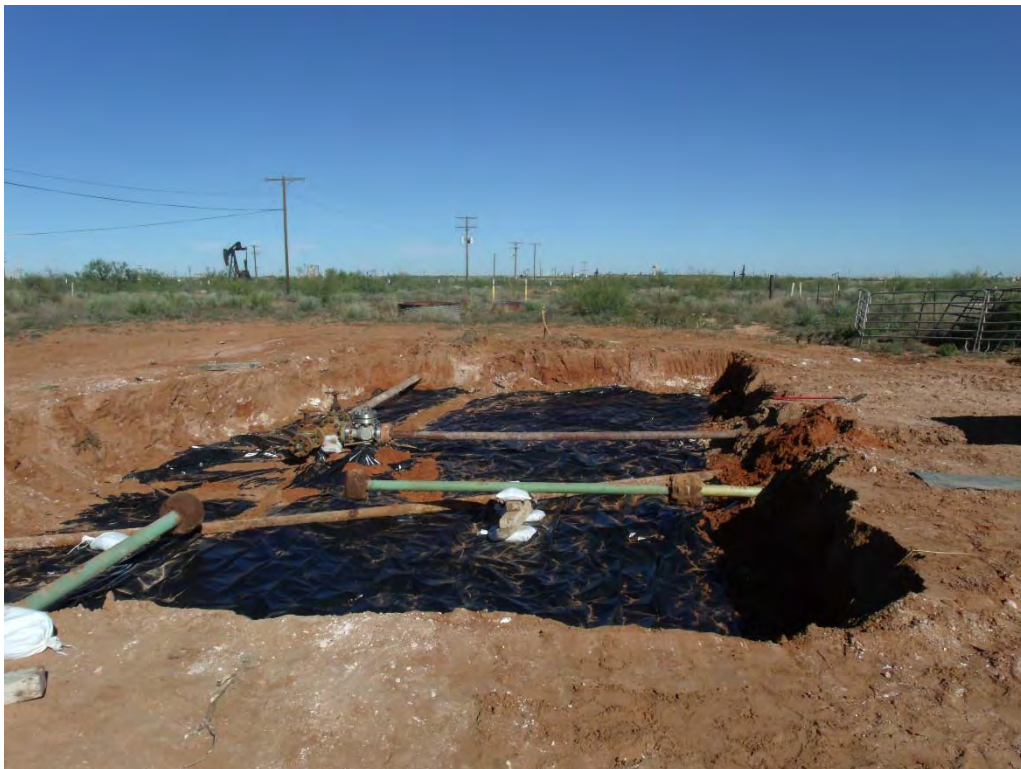
Photograph #10 – Liner installed

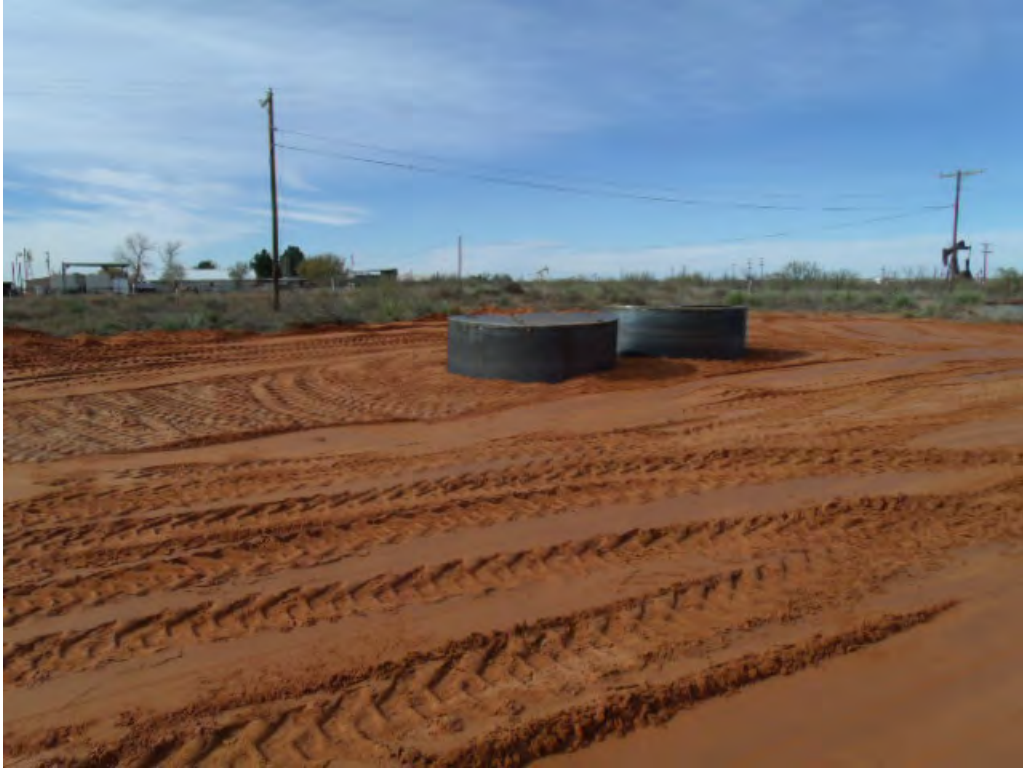
Photograph #11 – Backfilled

Backfilling continued until the entire excavation was closed. Upon completion of backfill activities, the entire disturbed area was contoured to blend with existing pasture area and protected against wind/water erosion.

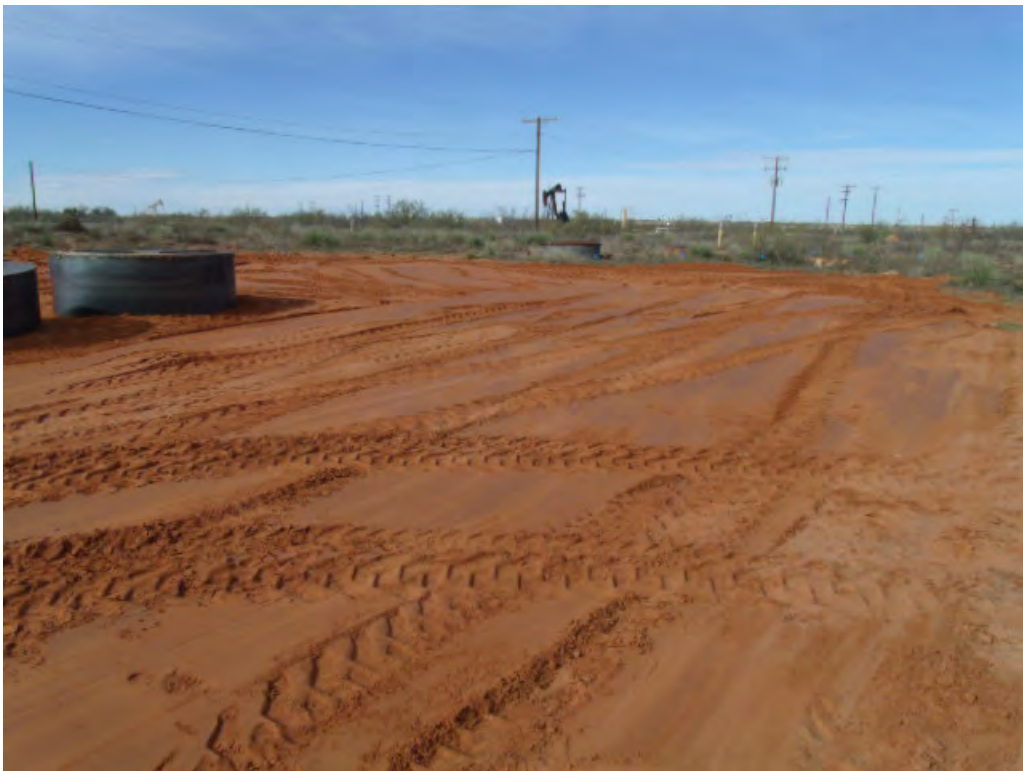
Photograph #12 – Backfilled
