**Report Type: Closure Report      1RP-4478 and 1RP-4479**

Site:	Schubert 18-4H					
Company:	Forge Energy, LLC.					
Section, Township and Range	Unit O	Sec. 18	T 19S	R 39E		
Lease Number:	API No. 30-025-43365					
County:	Lea County					
GPS:	32.65385° N			103.08413° W		
Surface Owner:	Private					
Mineral Owner:						
Directions:	From the intersection of NM-18 and E Nadine Rd, travel east on E Nadine Rd for approximately 1.5 mi, turn north onto lease road for 1 mi to fork in the road and go northeast for approximately 0.5 mi, make hairpin turn to the west for 1.6 mi to the location on the north side of the lease road.

**Re: Closure Report for the Forge Energy, LLC., Schubert 18-4H, Unit O,  
Section 18, Township 19 South, Range 39 East, Lea County, New  
Mexico. 1RP-4478 and 1RP-4479**

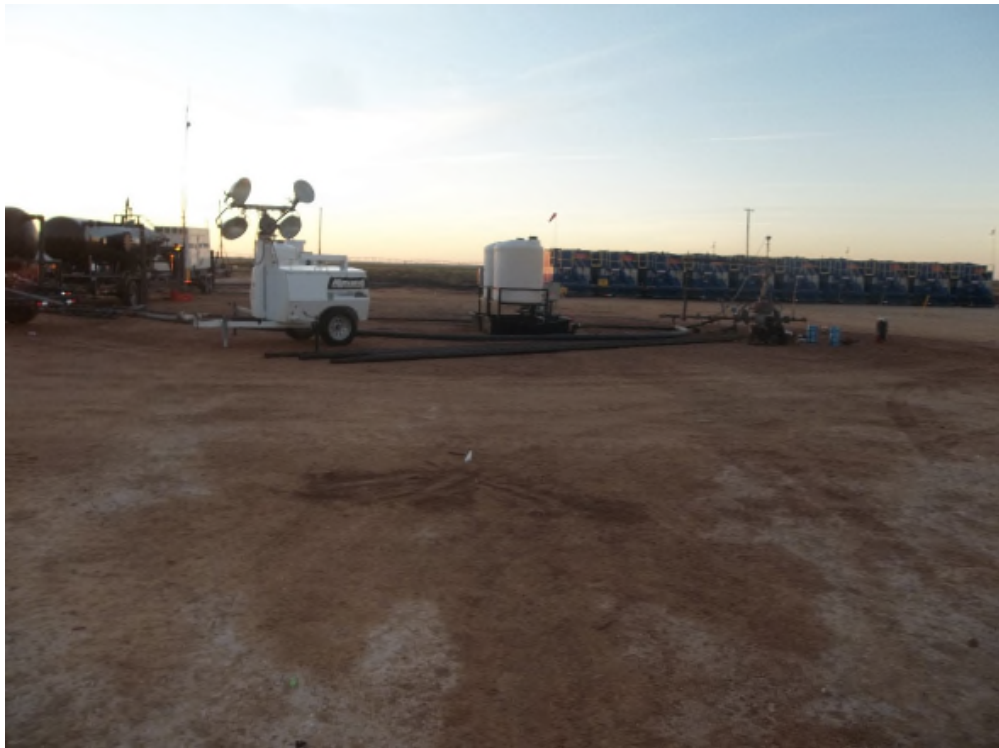
View Southeast – Area of AH-1

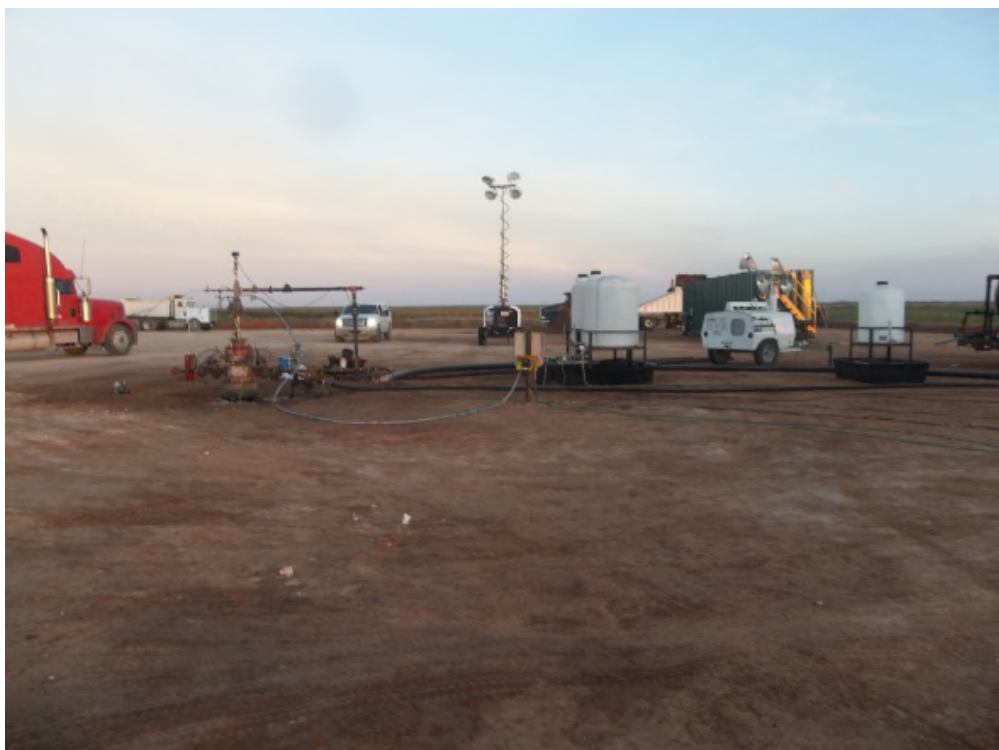
The areas of auger holes (AH-2 and AH-11) showed elevated chloride concentrations in the shallow soils. The chlorides detected at auger hole (AH-2) showed a concentration of 1,730 mg/kg at 0-1' below surface, before declining to 9.88 mg/kg at 1-1.5' below surface. The area of auger hole (AH-11) showed a chloride concentration of 1,470 mg/kg at 0-1' below the 0.5' excavation bottom, which then declined to 37.8 mg/kg at 1-1.5' below the excavation bottom.

View Northwest – Area of AH-2

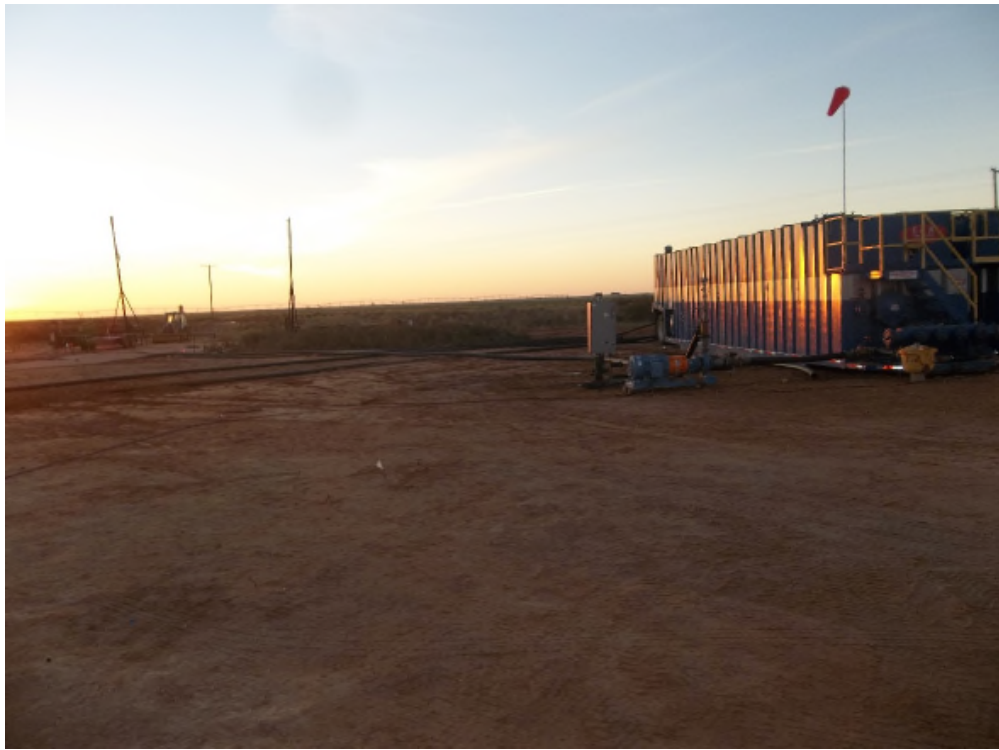
The areas of auger holes (AH-3, AH-5 and AH-7) did not show a significant chloride impact to the soils, with concentrations at 0-1' of 655 mg/kg, 617 mg/kg and 258 mg/kg, respectively. All of the deeper samples were below 250 mg/kg. In addition, the chlorides detected at auger hole (AH-10) showed concentrations of 848 mg/kg at 0-1' and 280 mg/kg at 1-1.5', but declined below 250 mg/kg at 2-2.5' below surface. These chloride concentrations are not significant and do not appear to an environmental concern.

View Southeast – Area of AH-3

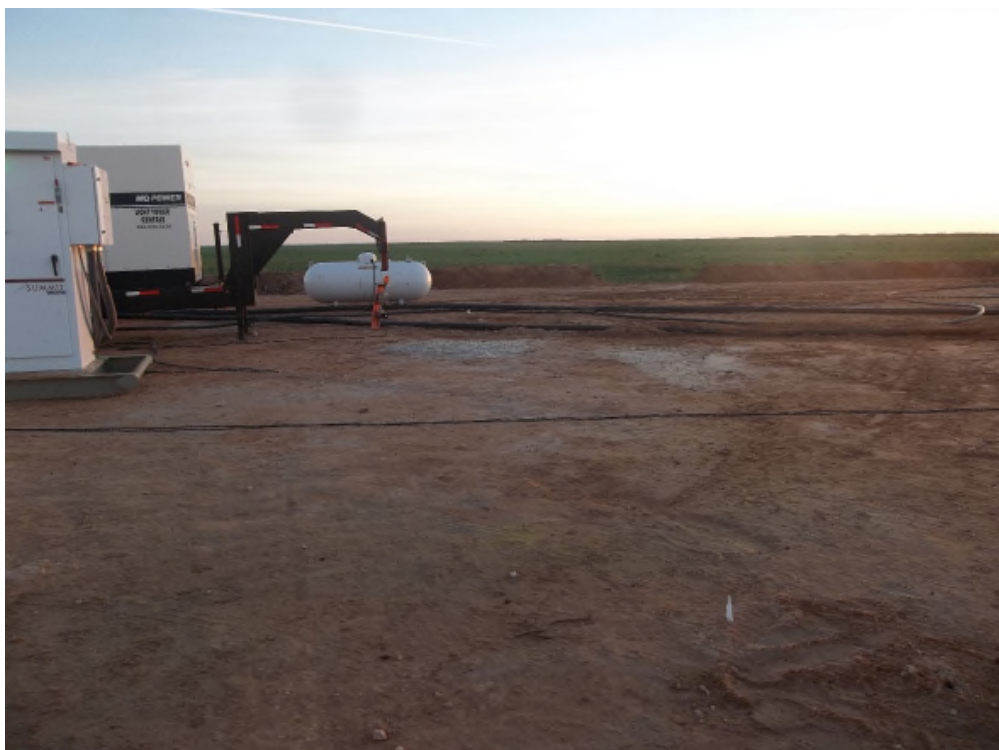
View North – Area of AH-4

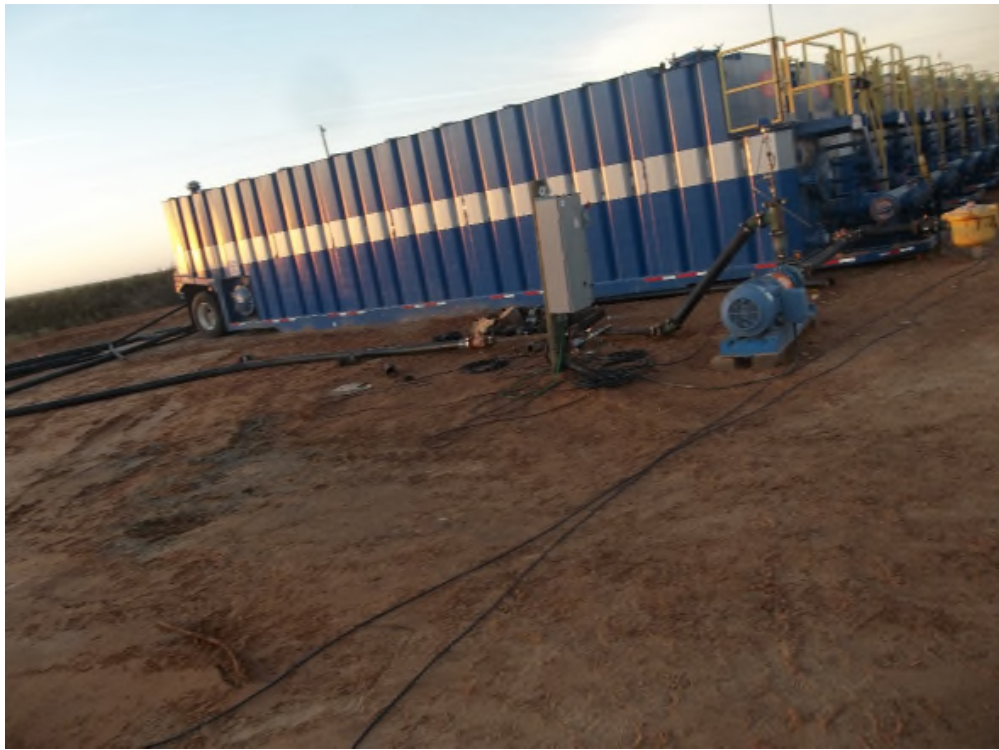
View South – Area of AH-5

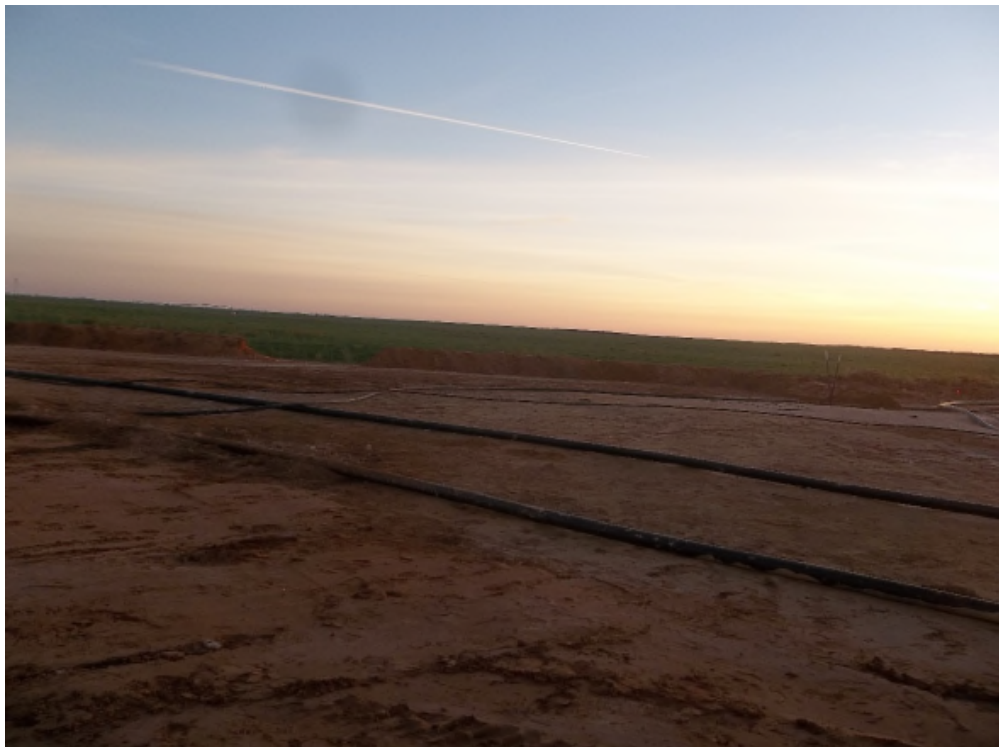
View South – Areas of AH-6 and AH-7

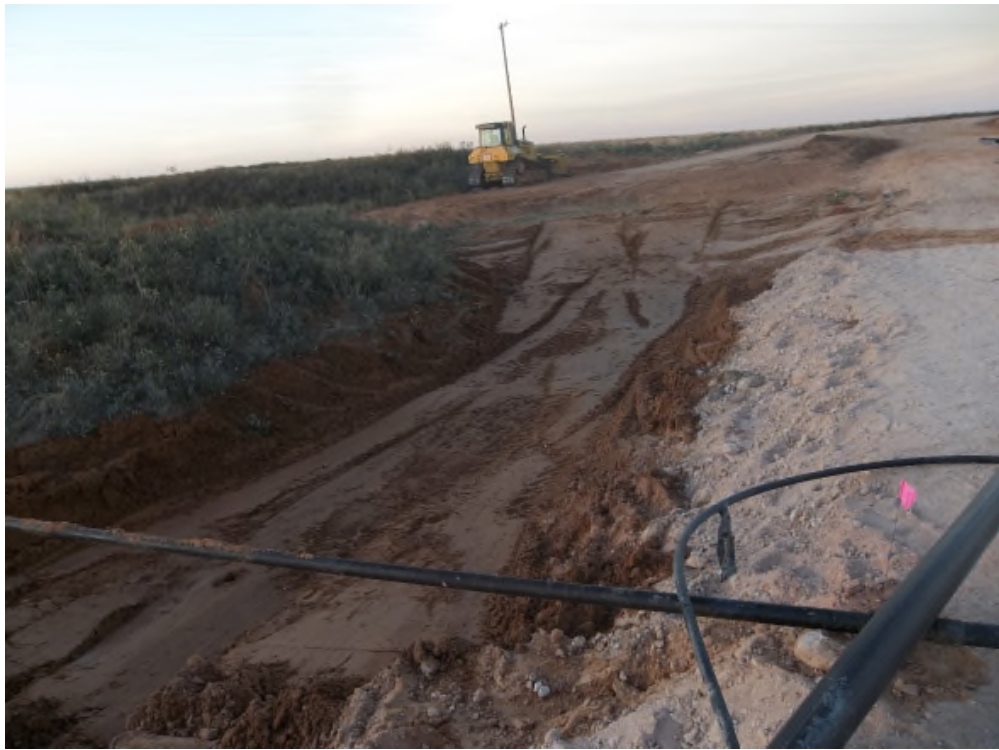
View South – Areas of AH-8 and AH-9

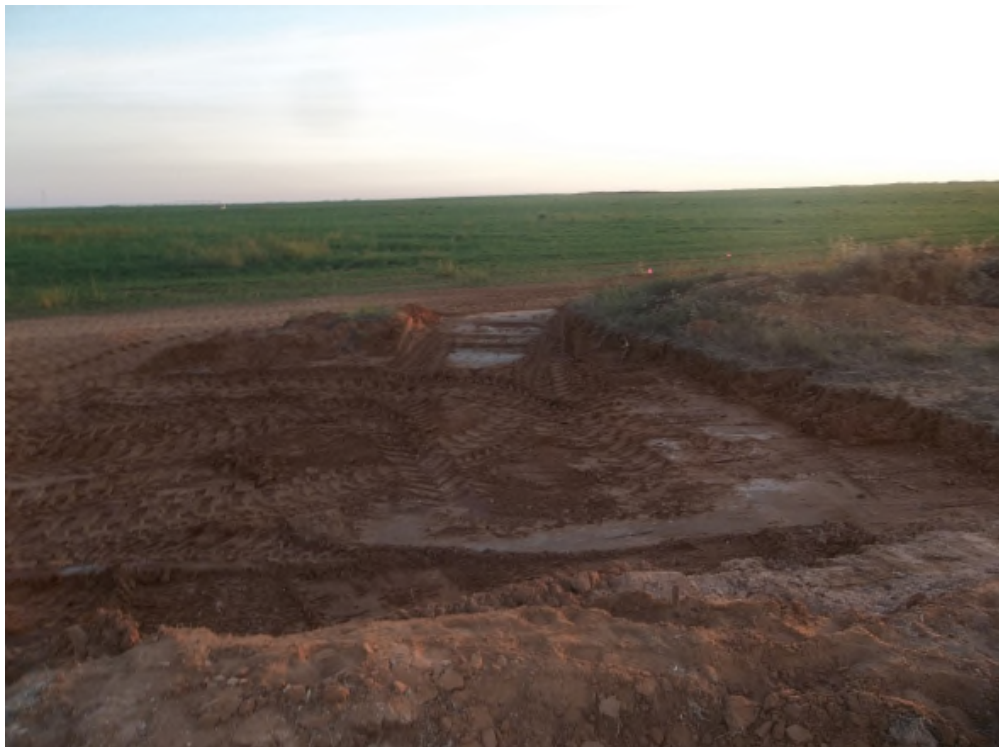
View Northeast – Area of AH-10

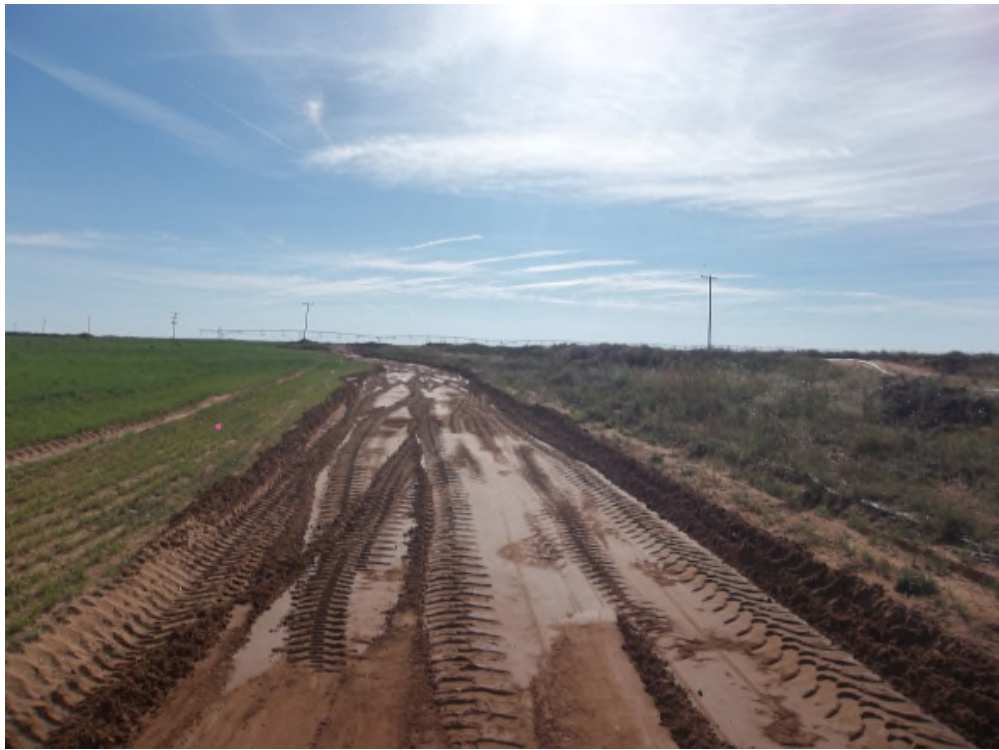
View East – Areas of AH-11 and AH-12

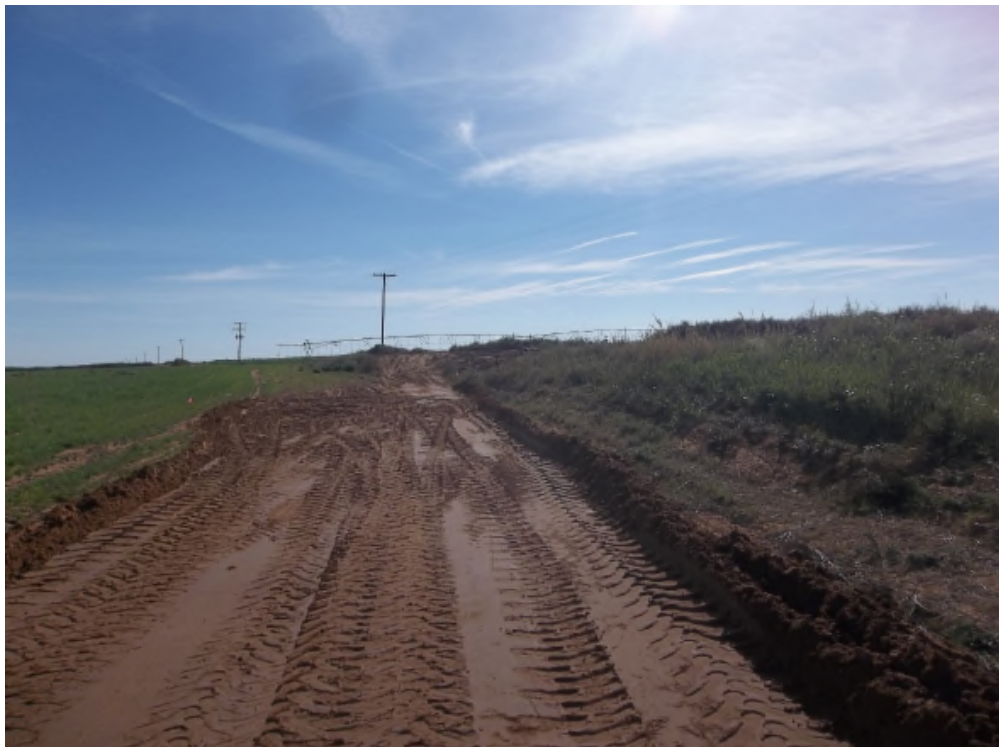
View East – Areas of AH-13 and AH-14

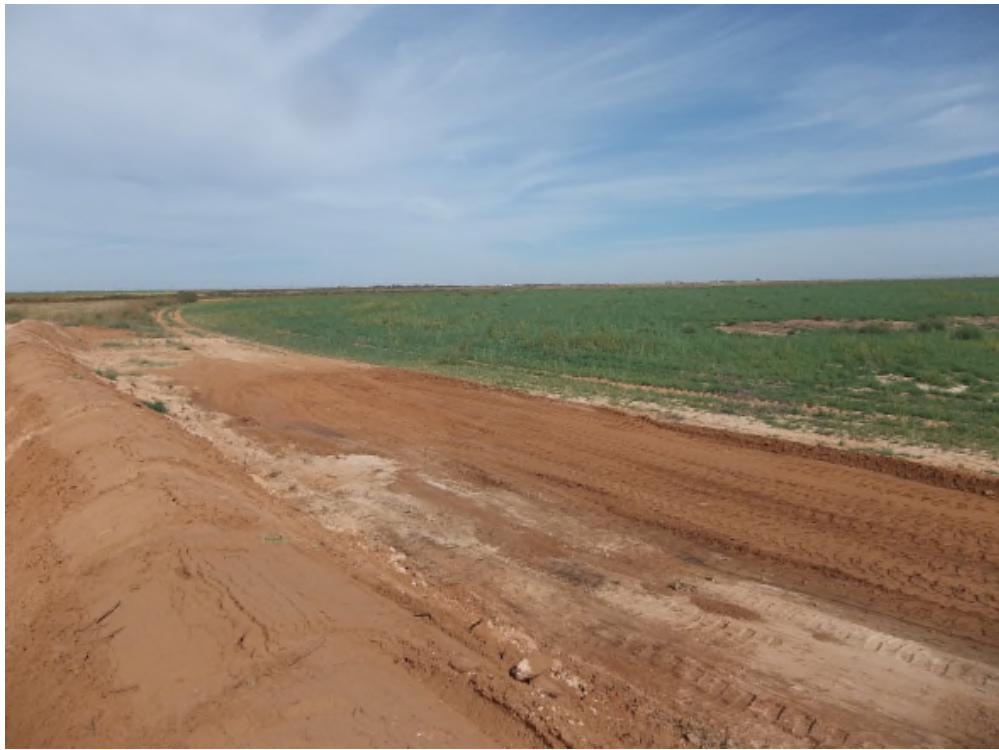
The area of auger hole (AH-15) did show a chloride concentrations of 3,150 mg/kg at 0-1' and declined to 46 mg/kg at 1-1.5' below surface. However, after the area was sampled, the impacted area was excavated/scraped to a depth of 0.5' to 1.0' below surface to remove the impacted soil from the area.

View Northwest – Areas of AH-15 and AH-16

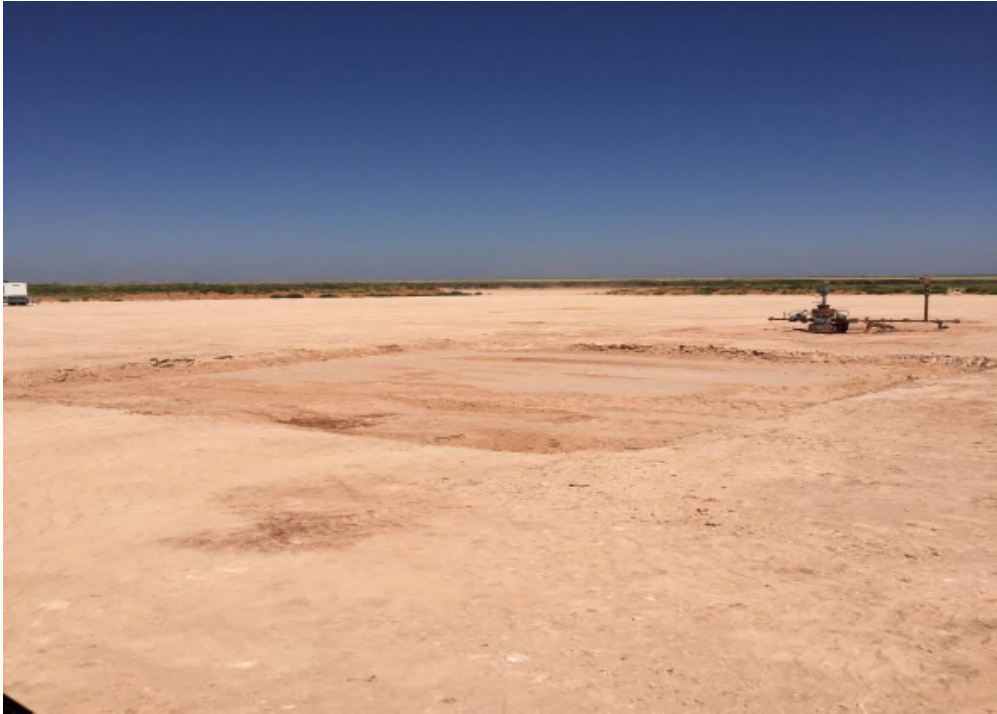
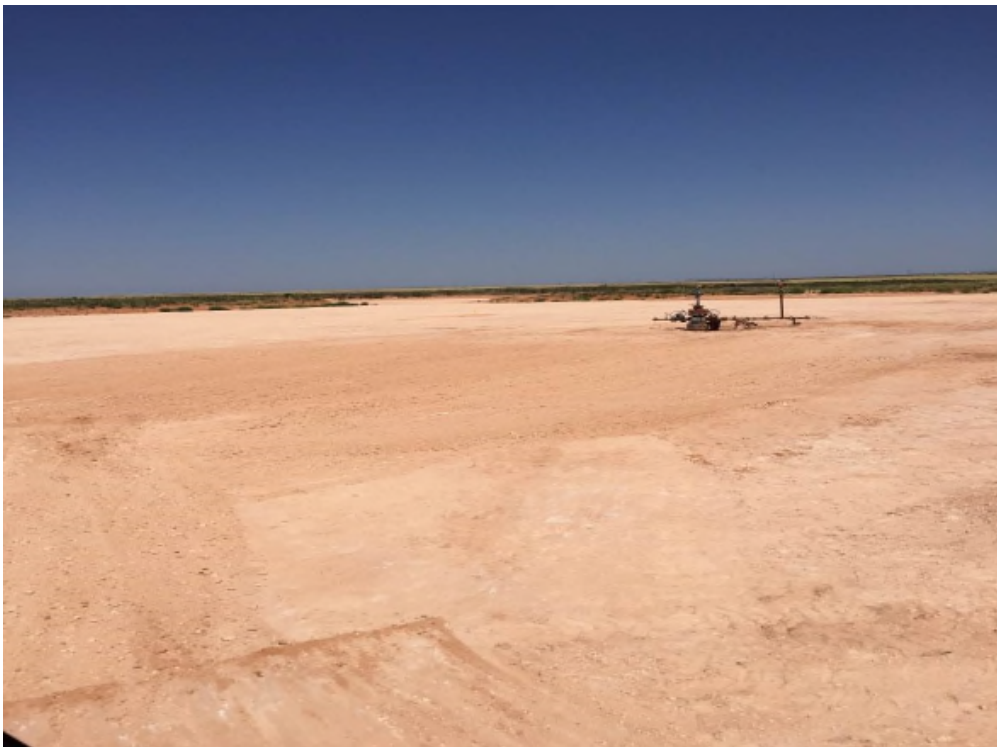
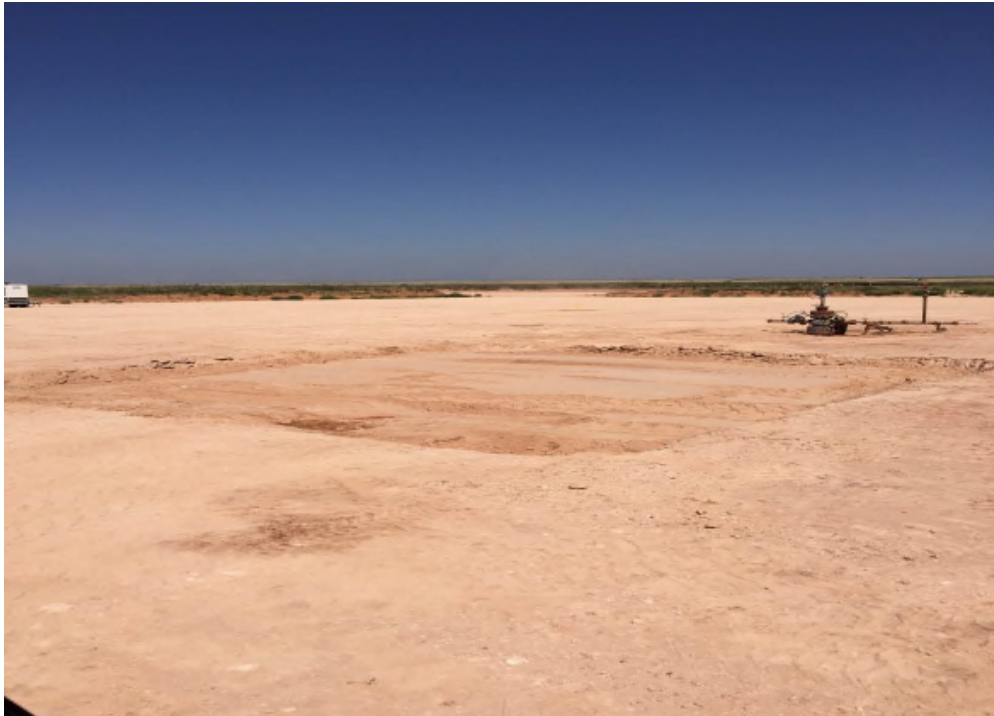
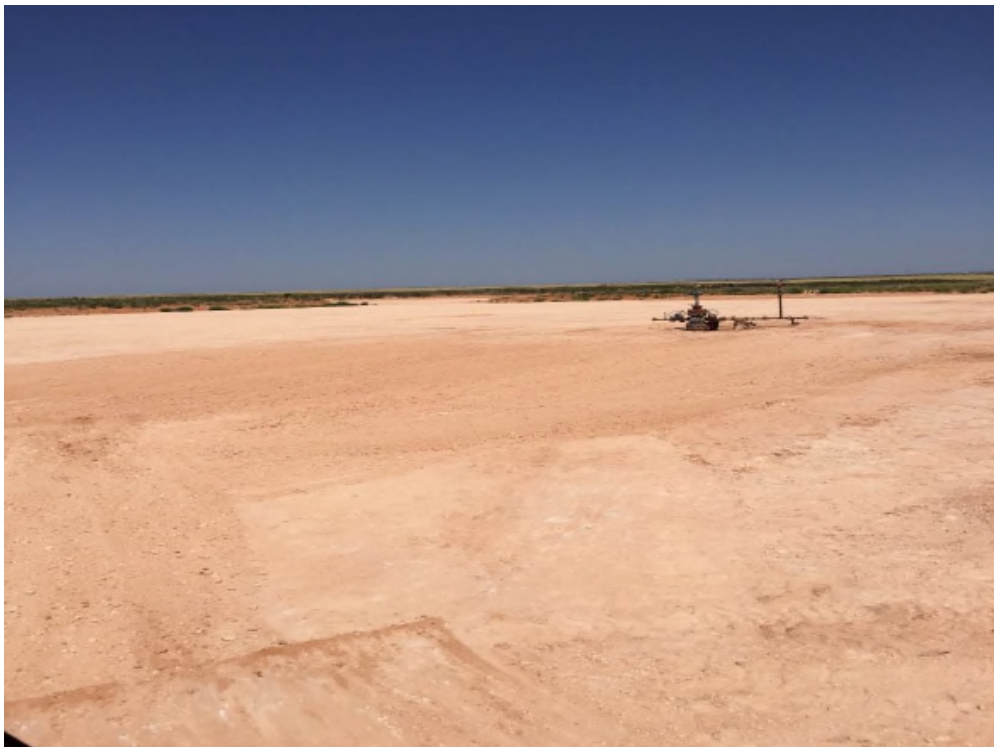
View North – Excavated area of AH-2

View North – Backfill of area AH-2

View West – Excavated Area of AH-2

View West – Backfilled Area of AH-2

A total of approximately 260 cubic yards of material was excavated from the site and hauled to Sundance Services, Inc. for proper disposal.

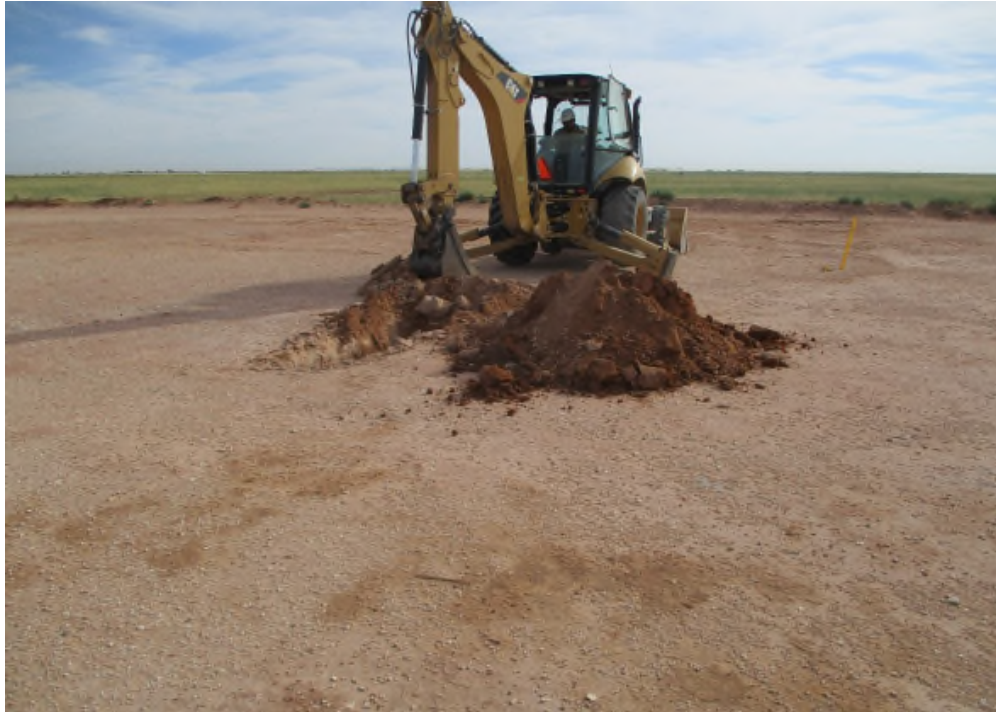
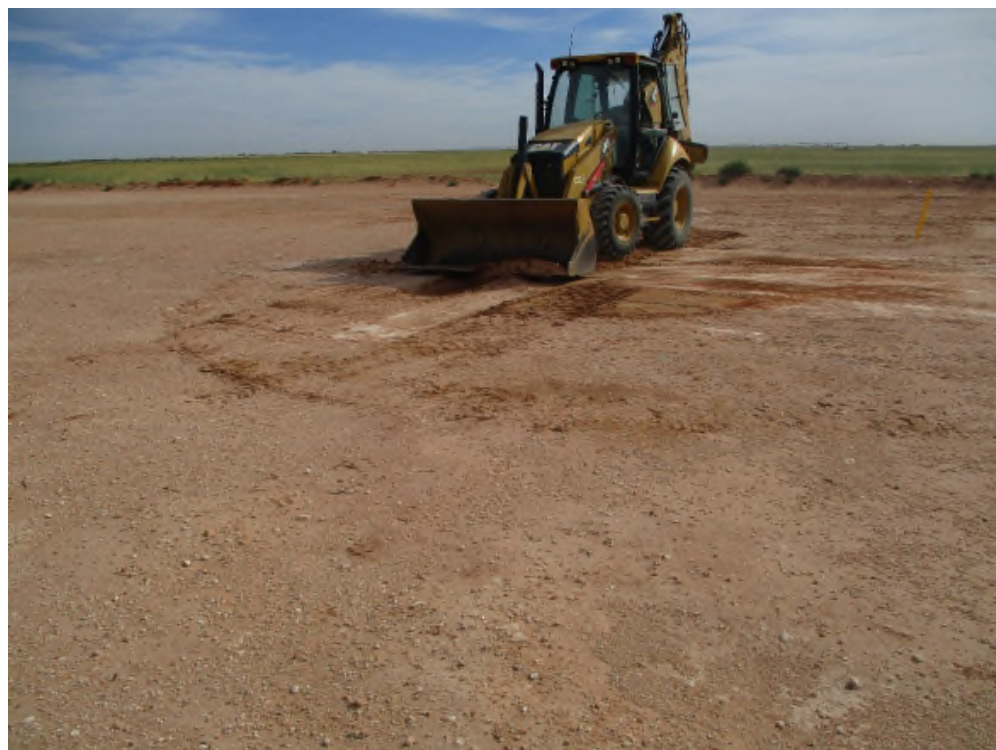
View North West – Trench Area for confirmation of AH-2

View North West – Trench Area for confirmation of AH-2,  
backfilled

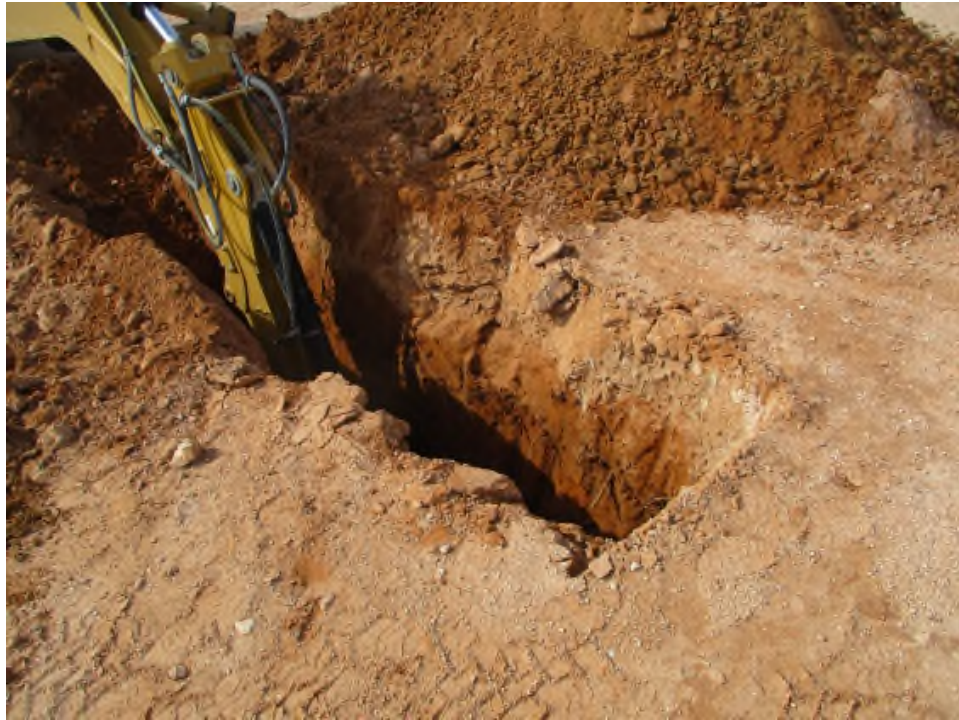
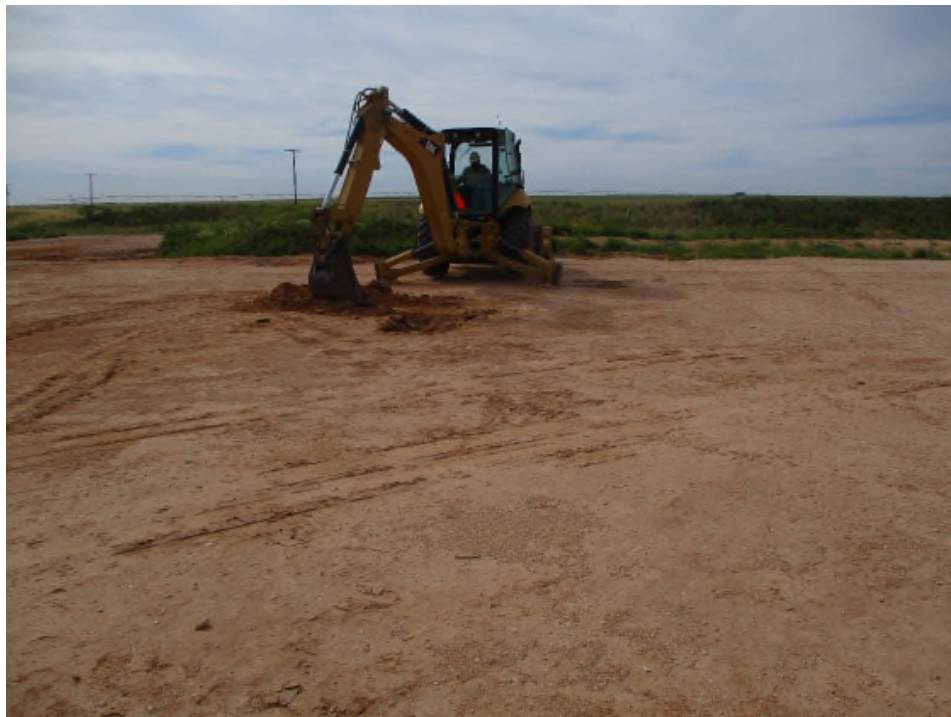
View South East-Trench Area for confirmation of AH-5

View South East- Trench area for confirmation of AH-5,  
Backfilled

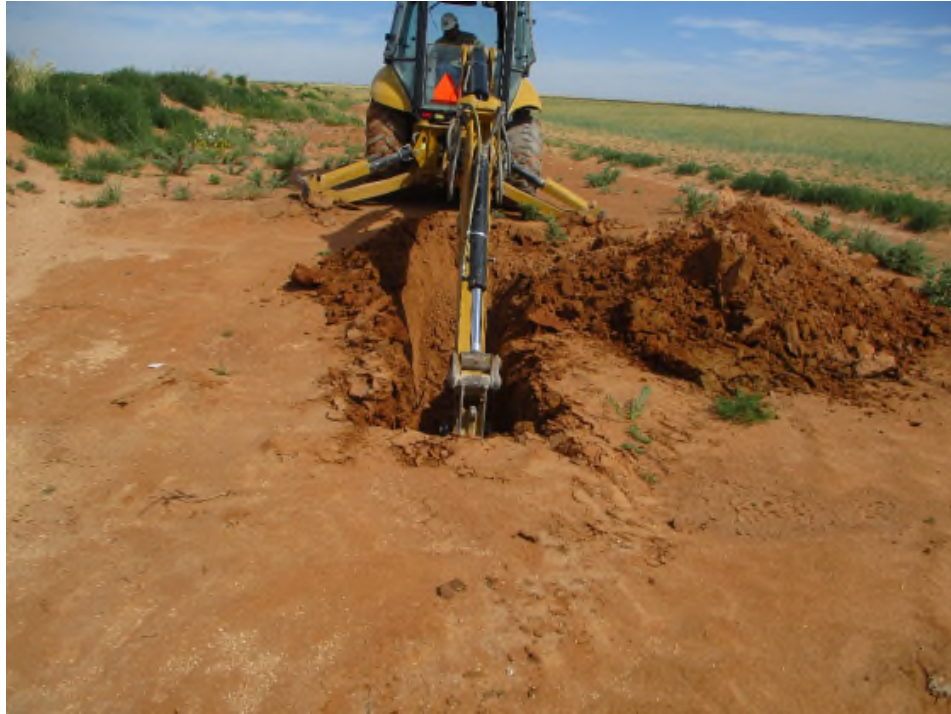
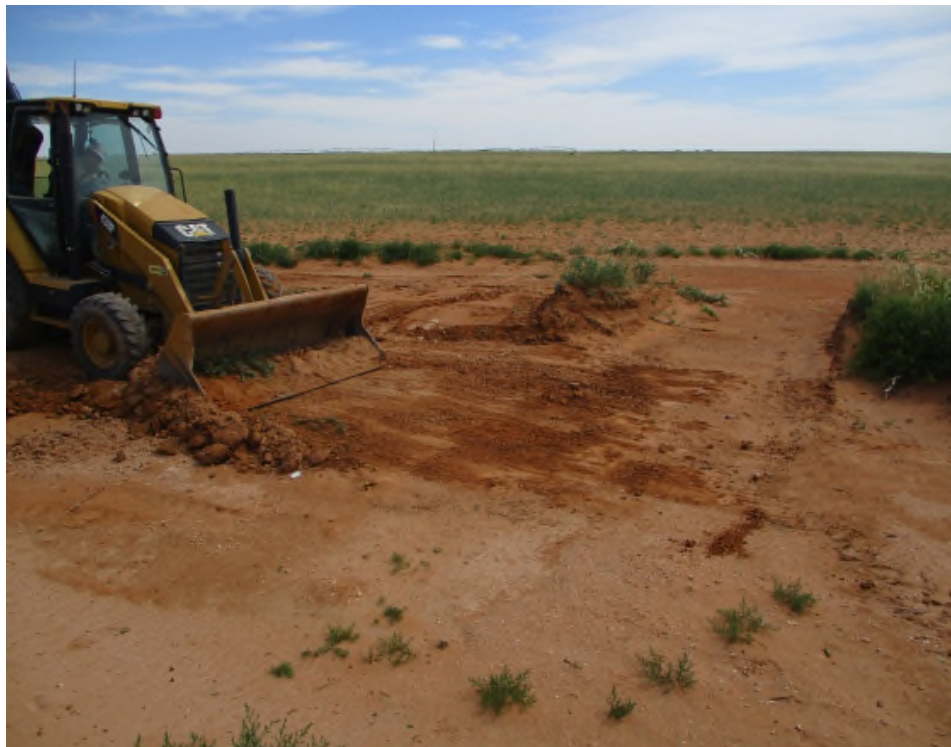
View North West – Trench Area for confirmation of AH-10

View North – Trench area for confirmation of AH-10,  
backfilled

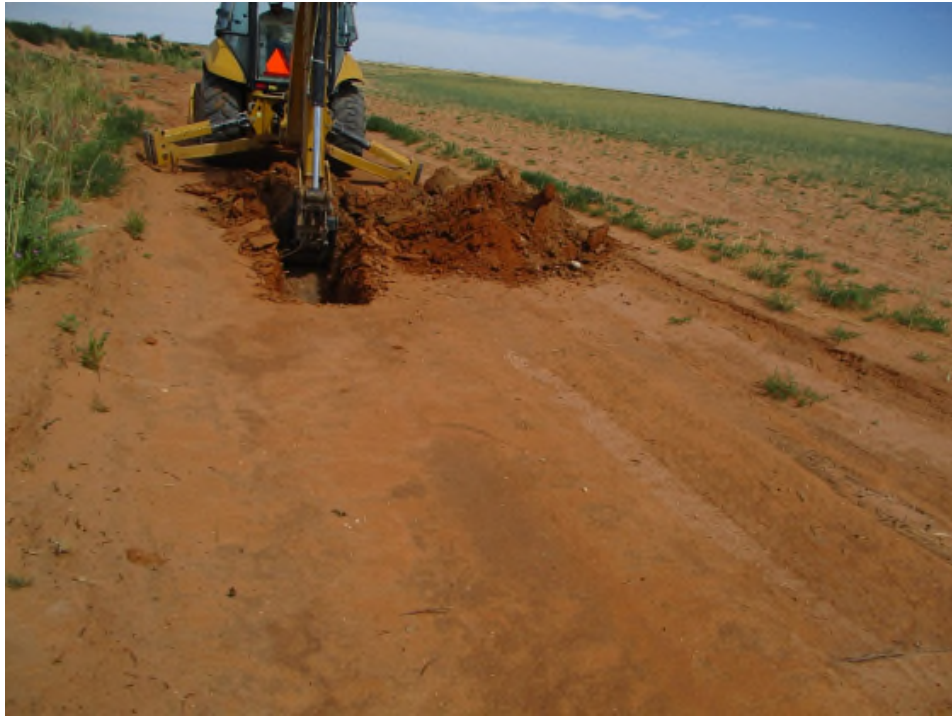
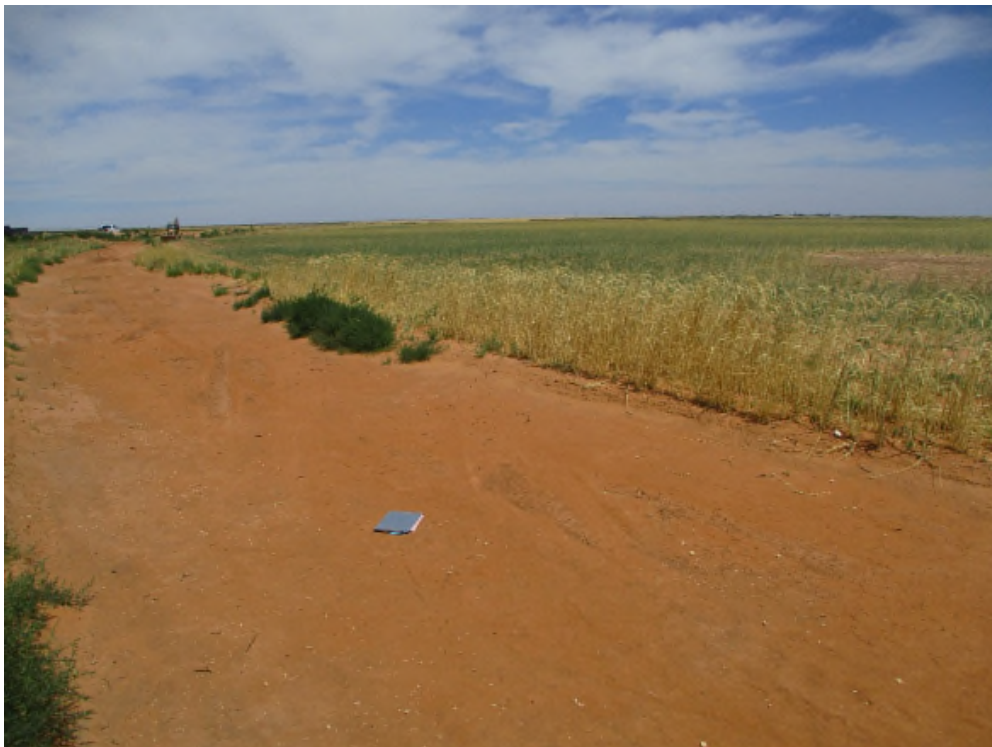
View North-Trench area for confirmation of AH-11

View North West- Trench Area for confirmation of AH-11,  
backfilled

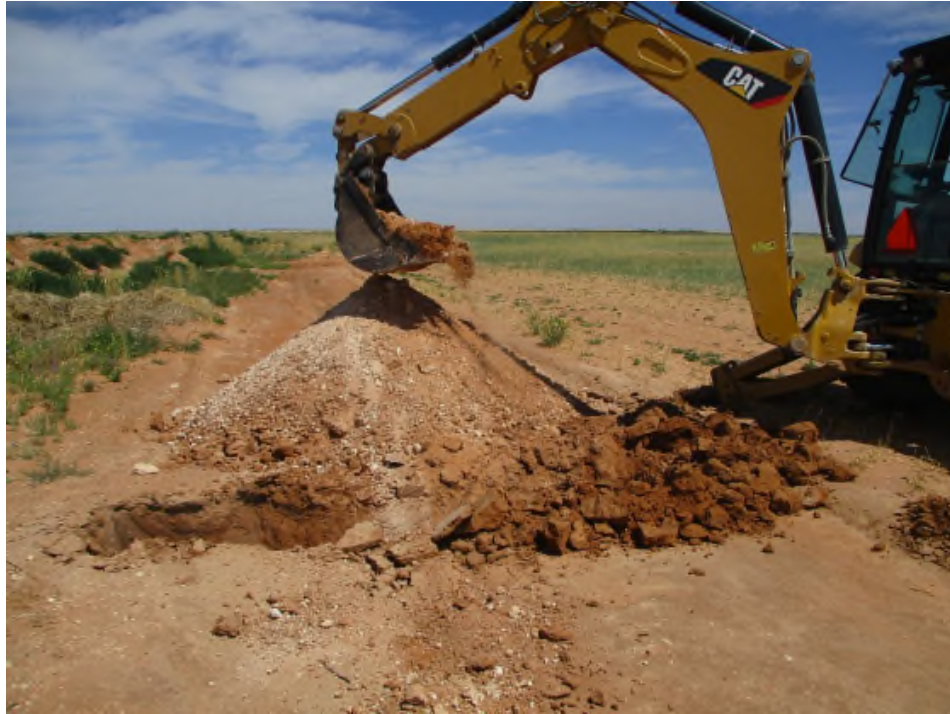
View West- Trench area for confirmation of AH-15
