Release Notification and Corrective Action

Name of Company	Plains Pipeline, LP	Contact	Camille Bryant
Address	2530 State Highway 214, Denver City, TX 79323	Telephone No.	(575)441-1099
Facility Name	Jal Tank Farm Tank 1214	Facility Type	Tank Farm

**Figure 1**  
**Site Location Map**  
 Plains Pipeline, LP  
 Jal Tank Farm Tank 1214  
 Lea County, New Mexico  
 Plains Ref. #: 2008-253

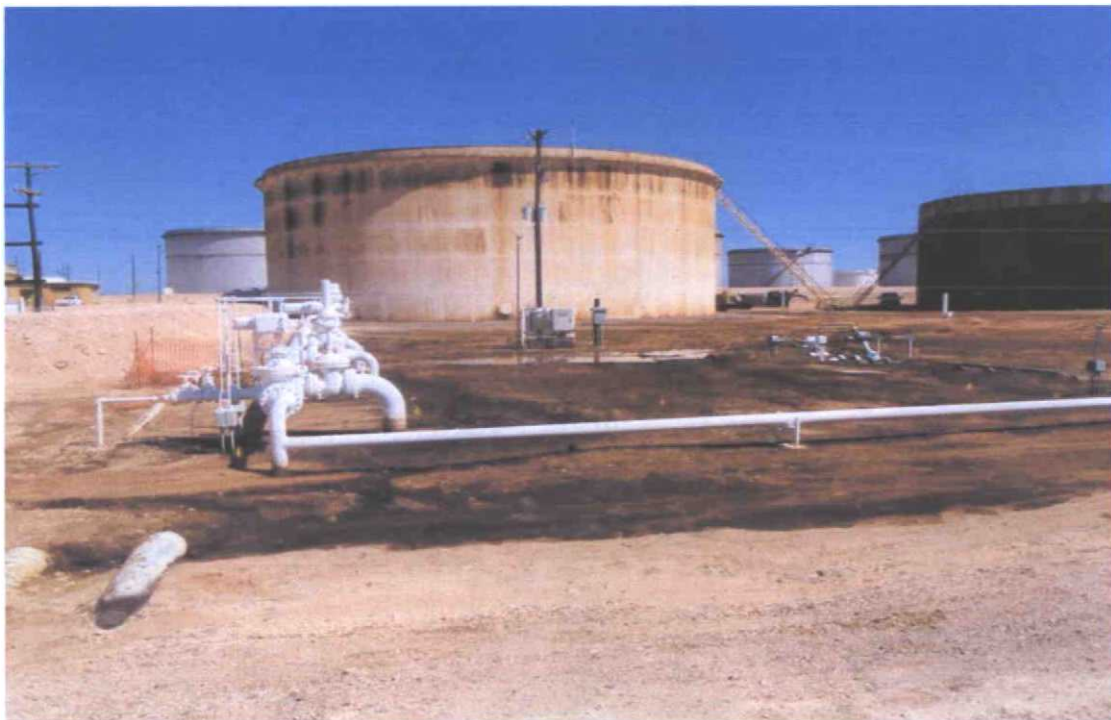
Jal Tank Farm Tank 1214 - Release Site (Looking North)

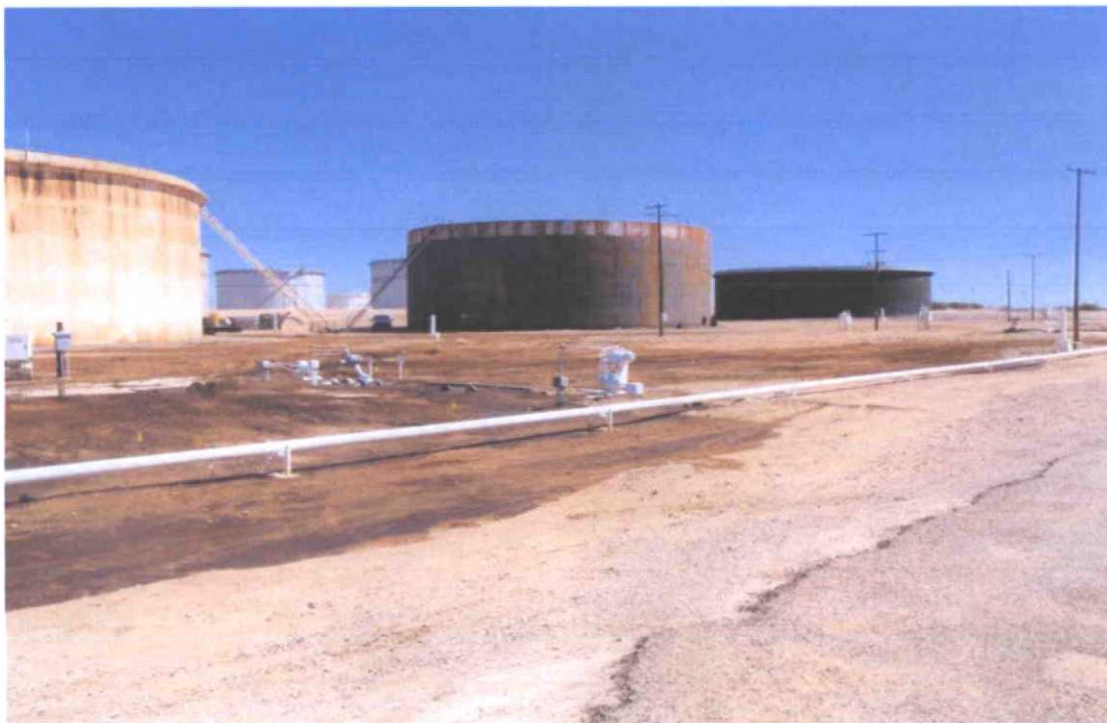
Jal Tank Farm Tank 1214 - Release Site (Looking Northeast)

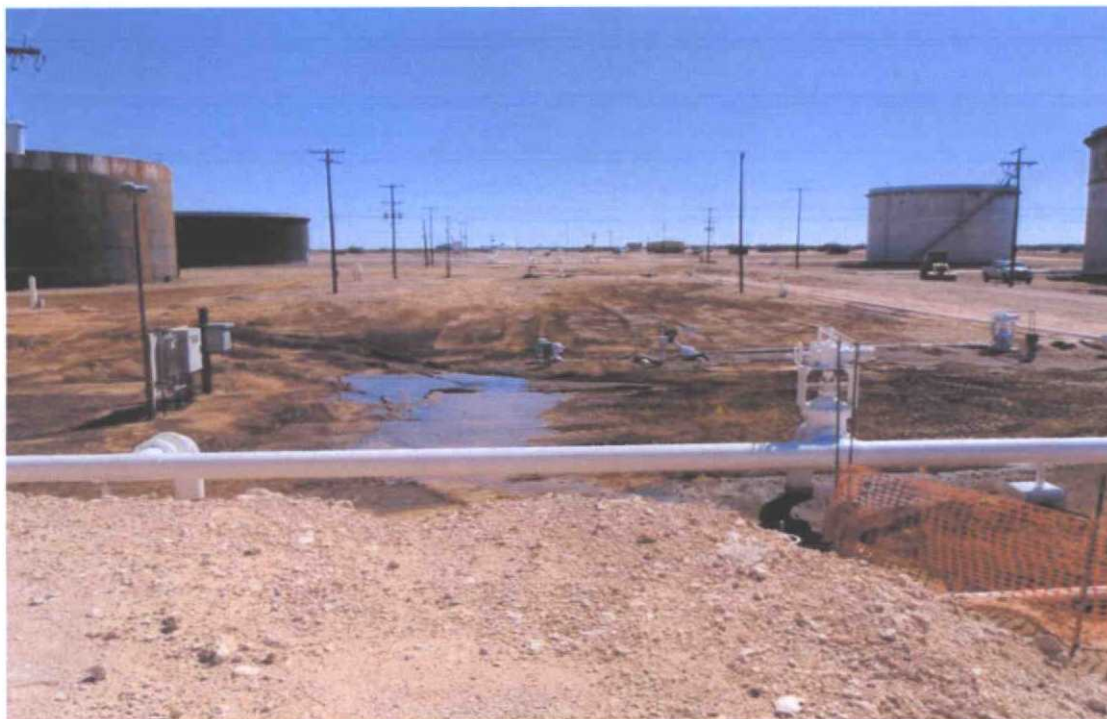
Jal Tank Farm Tank 1214 - Release Site (Looking East)

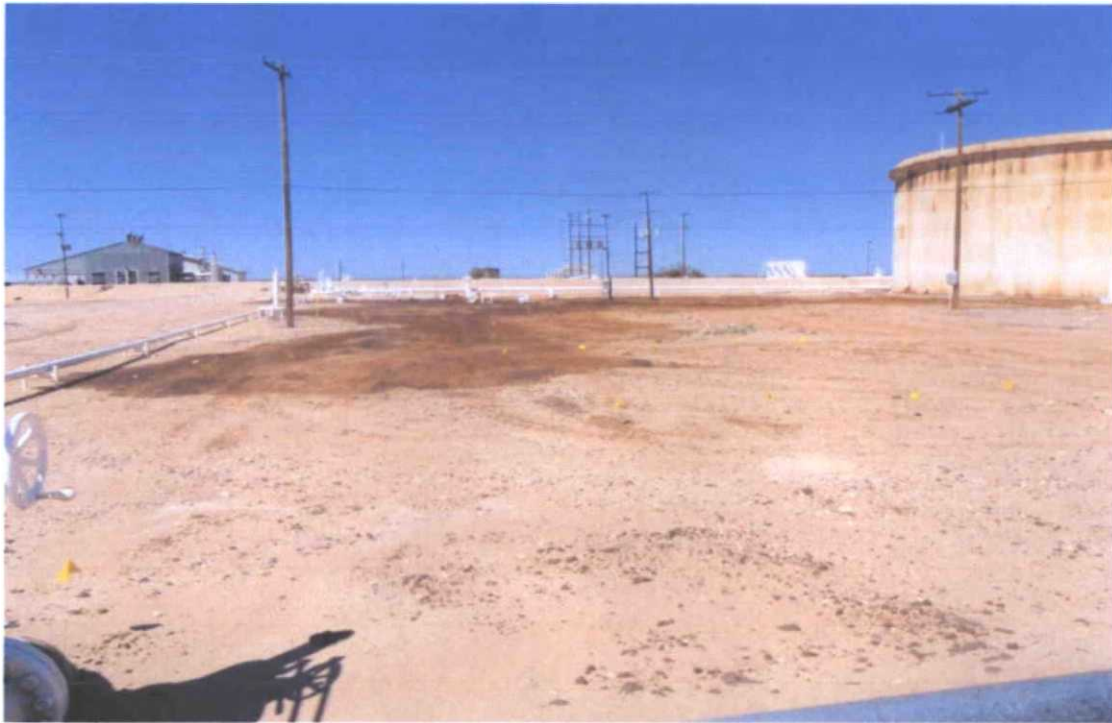
Jal Tank Farm Tank 1214 - Release Site (Looking West)

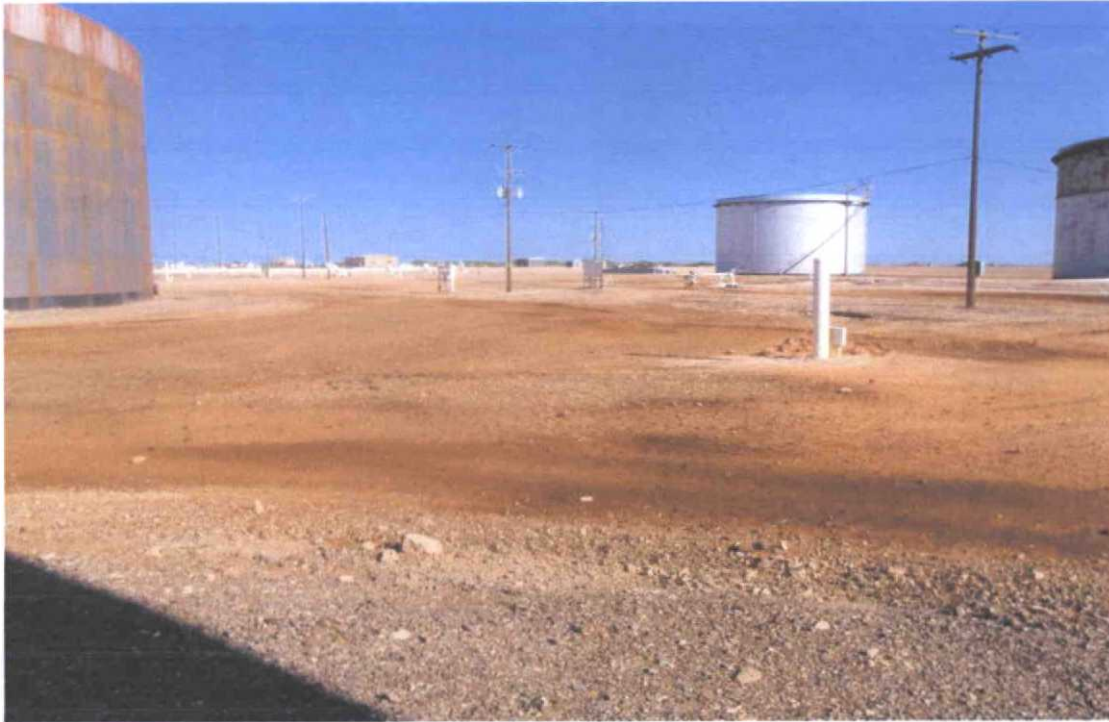
Jal Tank Farm Tank 1214 - Release Site (Following Removal of Heavily Impacted Soil)

On September 16, 2008, following initial response activities, remediation activities commenced at the site. From September 19 through September 22, 2008, visibly stained topsoil was scraped up, blended with non-impacted soil, and stockpiled on-site, pending final disposition. Further excavation was precluded by the presence of numerous underground pipes and appurtenances along the flow path of the release.

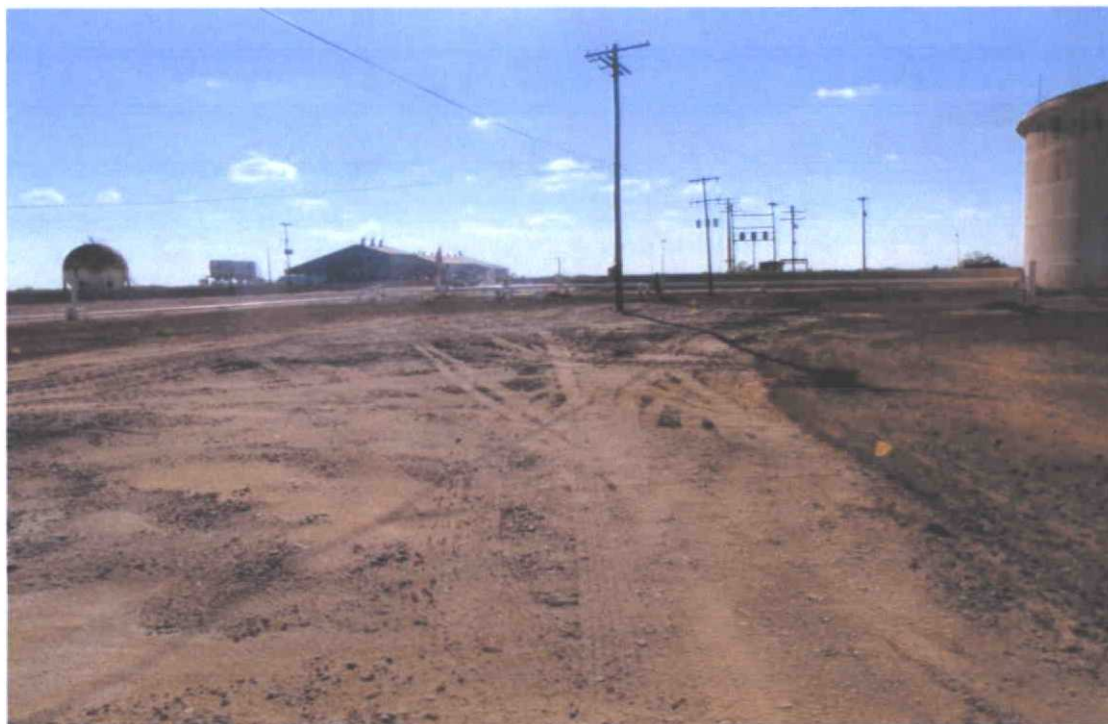
Jal Tank Farm Tank 1214 - Release Site (Following Removal of Heavily Impacted Soil)

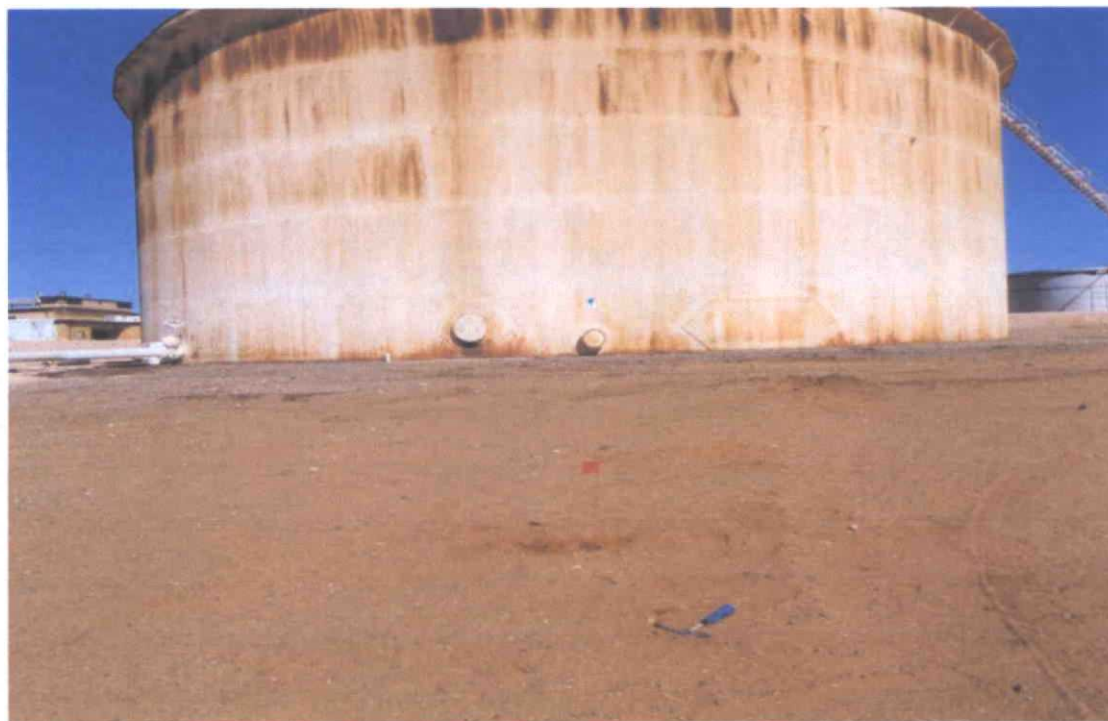
Jal Tank Farm Tank 1214 - Soil Sample Location, "South of Tank #1214"

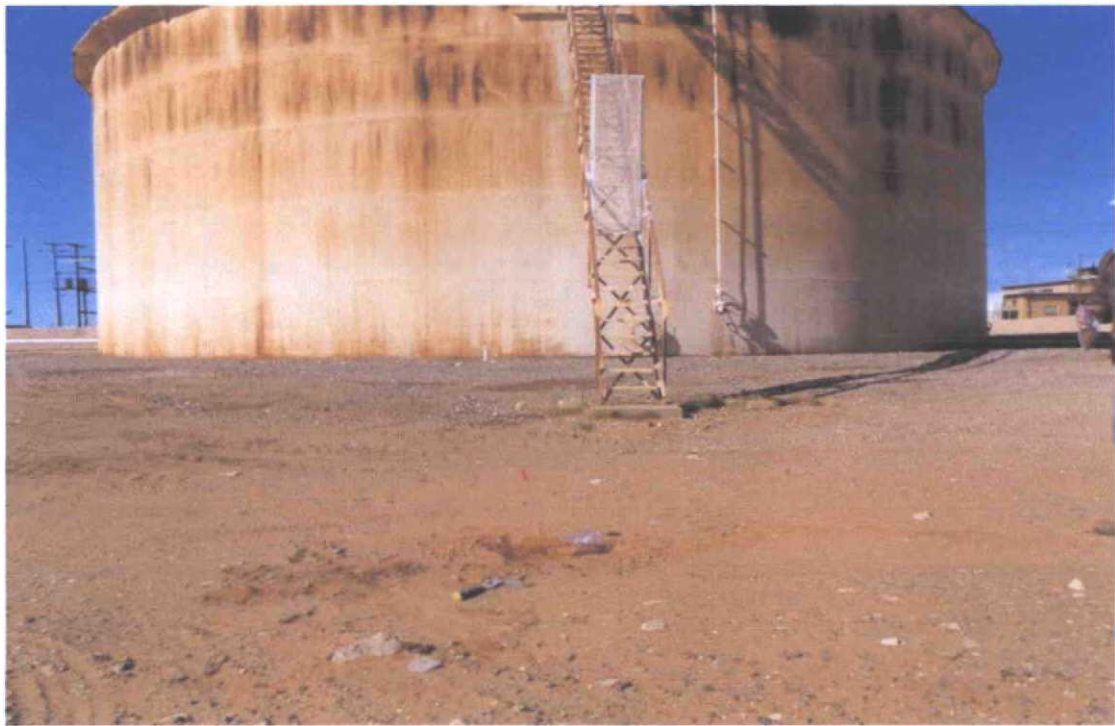
Jal Tank Farm Tank 1214 - Soil Sample Location, "East of Tank #1214"

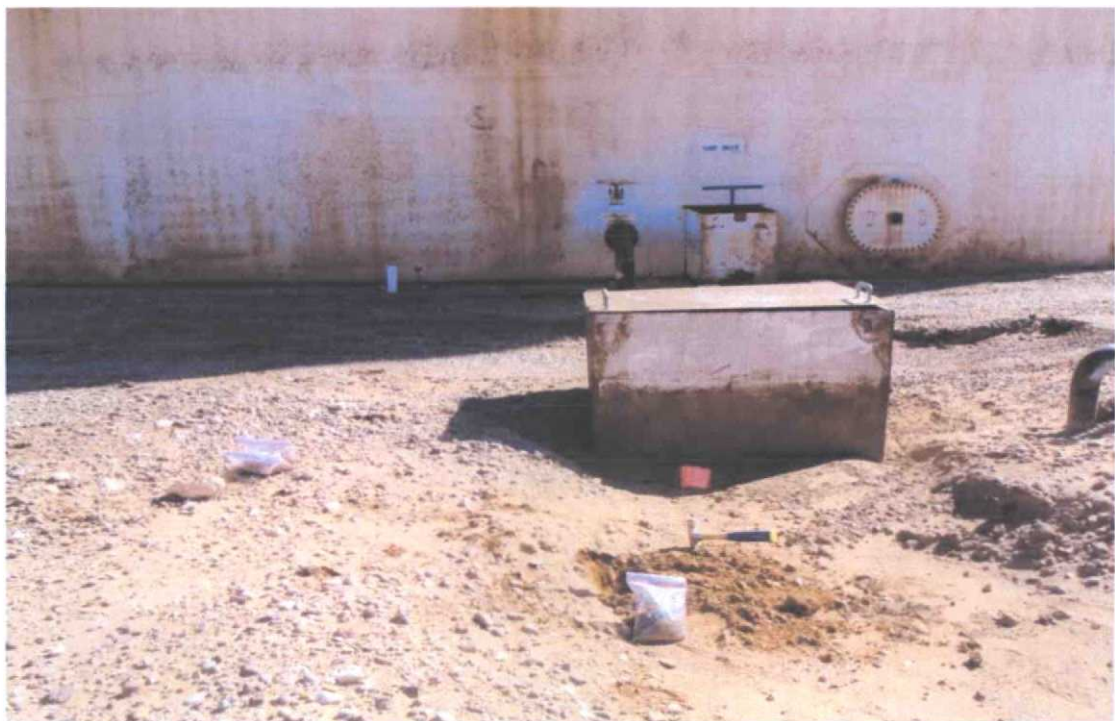
Jal Tank Farm Tank 1214 - Soil Sample Location, "West of Tank #1214"

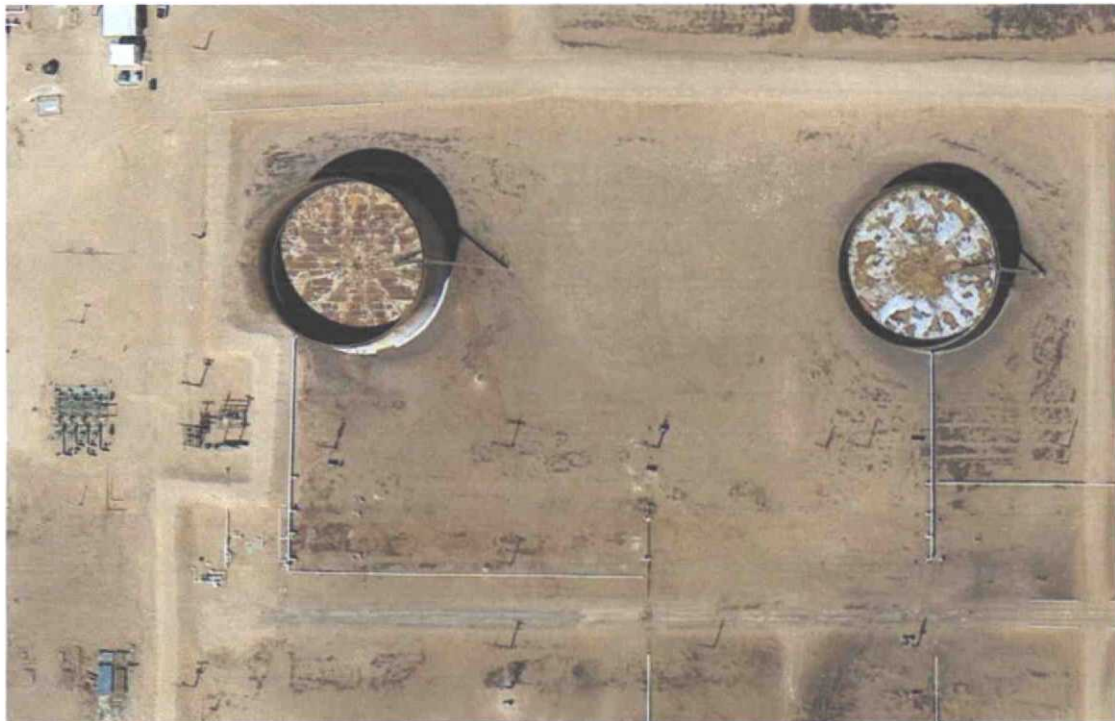
Jal Tank Farm Tank 1214 - Current Aerial Photograph of Release Site
