ENVIRONMENTAL PLUS, INC.

17 January 2014

**RE: Remediation Closure Report
Plains Pipeline, L.P.
Skelly Baker Historical Release
UL-F (SE1/4 of the NW1/4) of Section 27, T22S, R37E
Latitude: N 32° 22' 00.25"; Longitude: W 103° 09' 18.34"
NMOCD Ref. #1RP-10-10-2638; EPI Ref. #8-24-2010**

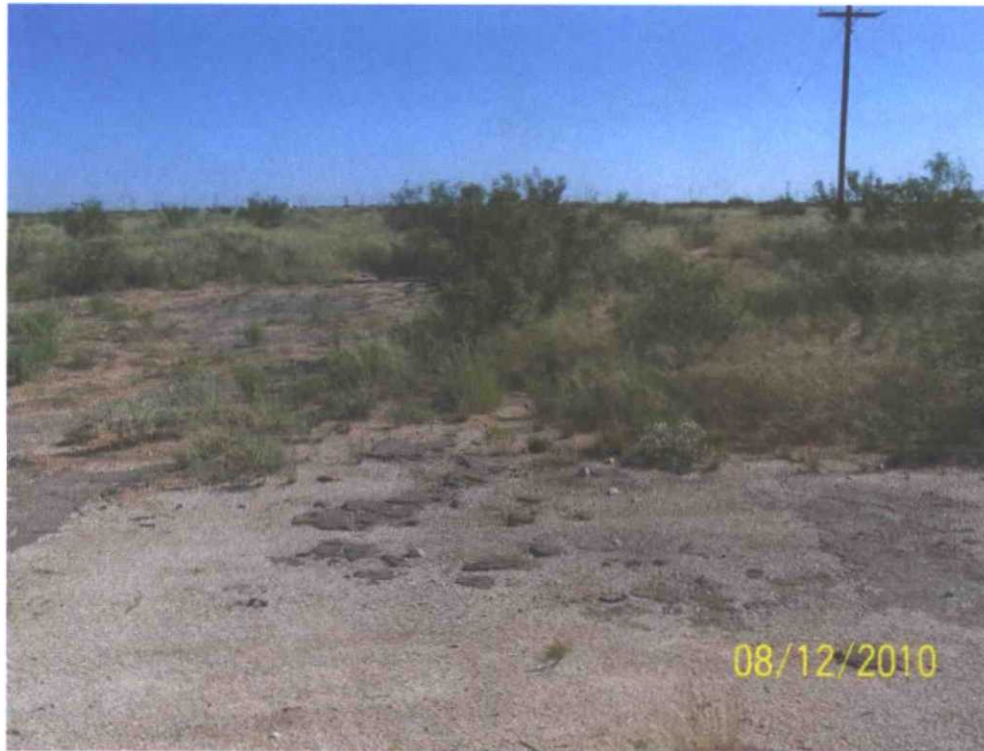
The source of release is unknown due to the historic nature of the site; suspected cause is the crude oil pump station that is near the historic staining. The historic release of crude oil resulted in an area of asphaltines measuring approximately 50' x 200'. Plains retained the services of Environmental Plus, Inc., (EPI) to GPS, photograph and delineate the release area.

Photograph #1 – Looking northerly at asphaltine and historic overflow area

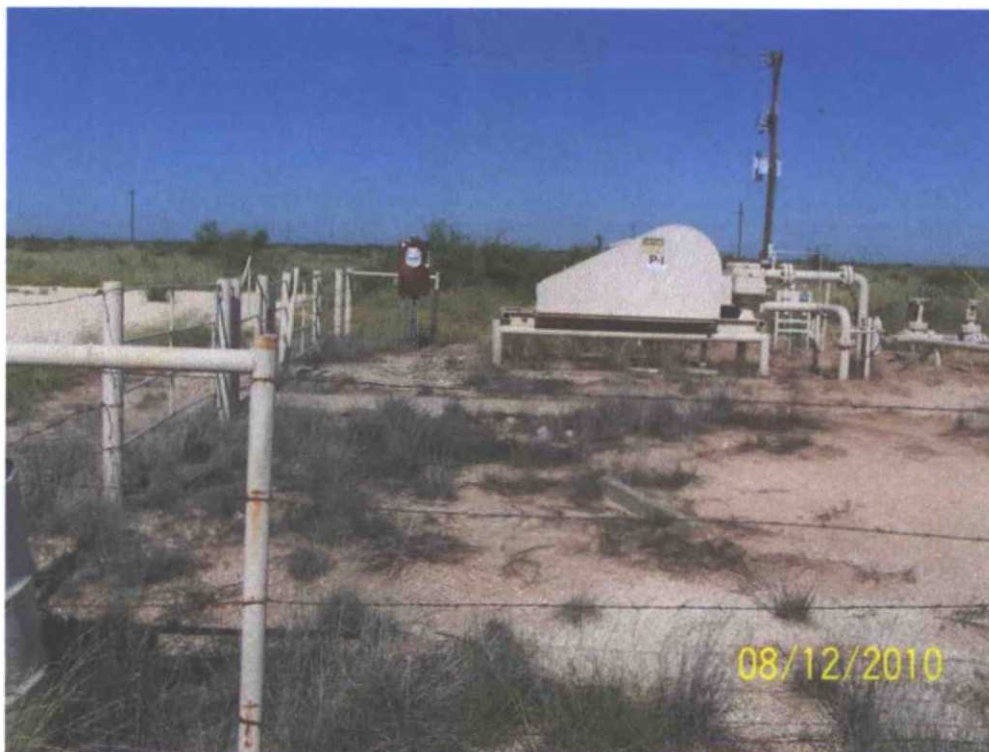
Photograph #2 – Looking westerly at active Pump Station adjacent to historic overflow area

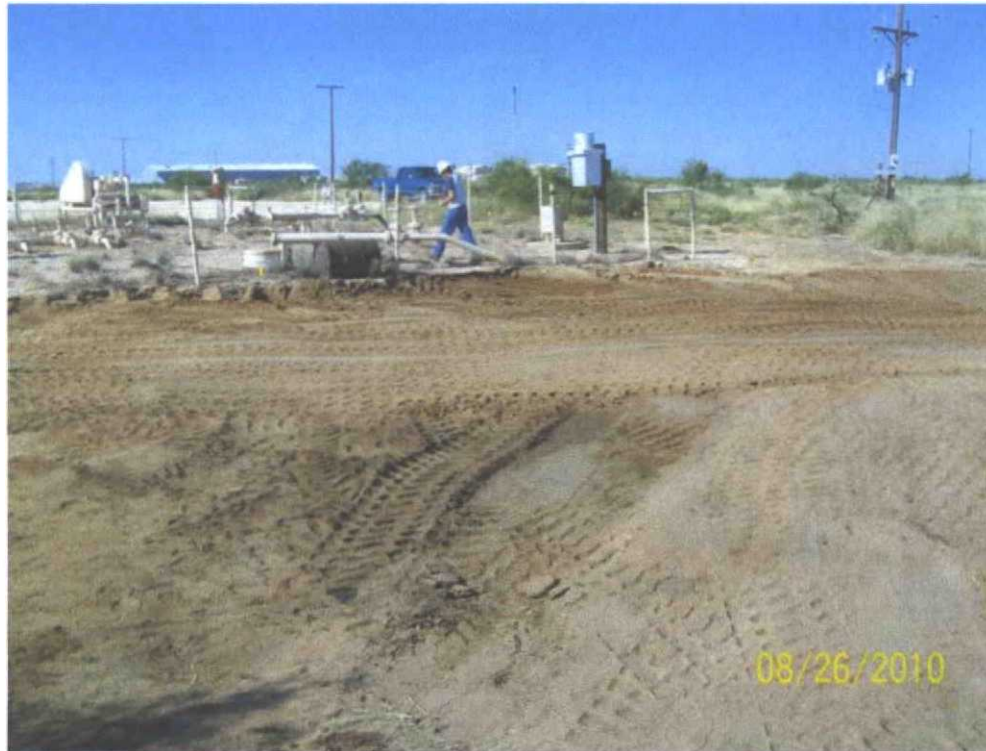
Photograph #3 – Looking southerly at Pump Station and partially remediated historic overflow area

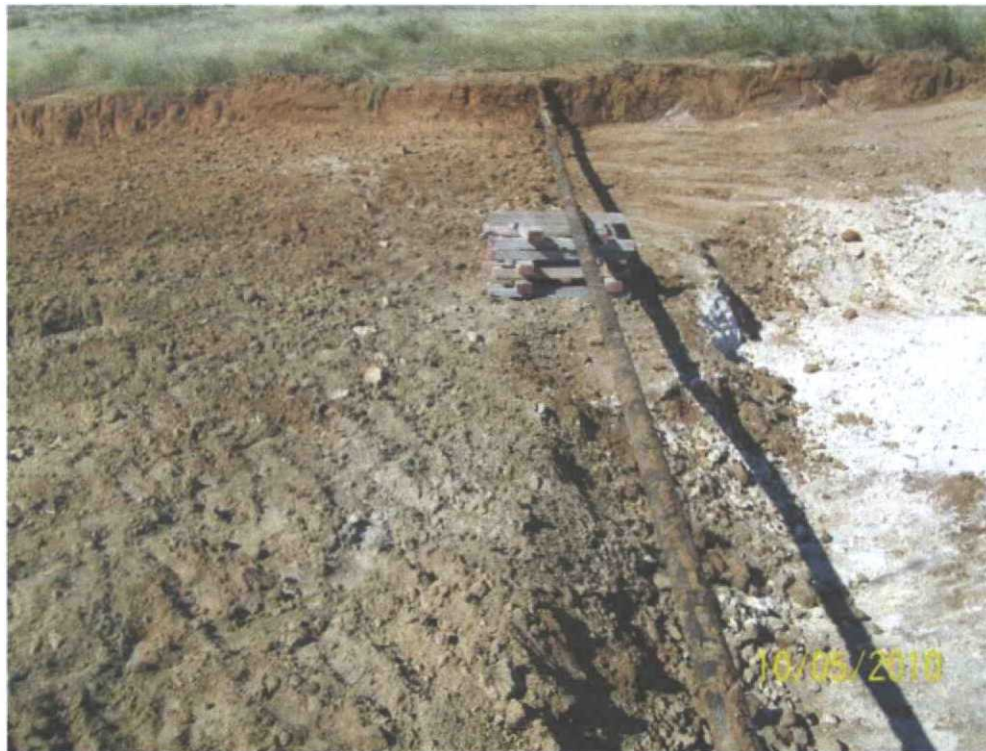
Photograph #4 – Looking northerly at initial excavated area and active pipeline supported with wooden brace

What started as a project involving shallow excavation for removal of asphaltine and discolored ground areas evolved into an excavation approximately twenty (20) feet deep covering a surface area of ~12,400 square feet. From August 24 thru December 30, 2010, approximately 6,064 cubic yards of TPH contaminated material were excavated and transported to either EPI's Land Farm or Plain's Lea Station Land Farm for reclamation. In general, east and west sidewalls of the excavation are void of TPH concentrations in excess of NMOCD Remedial Threshold Goals (NMOCD Goals) of 1,000 mg/Kg. Although the south sidewall contains areas of elevated TPH concentrations, it is contiguous with an active Pump Station which precludes additional excavation activities in the southerly direction.

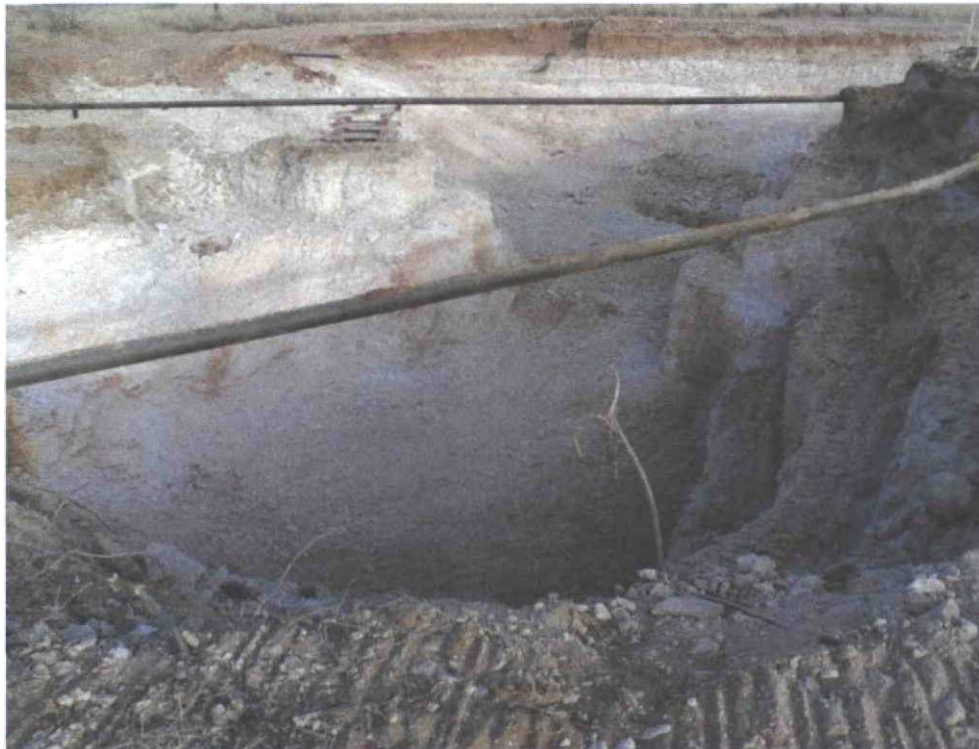
Photograph #5 – Looking north-easterly at excavation, active lines and wooden brace

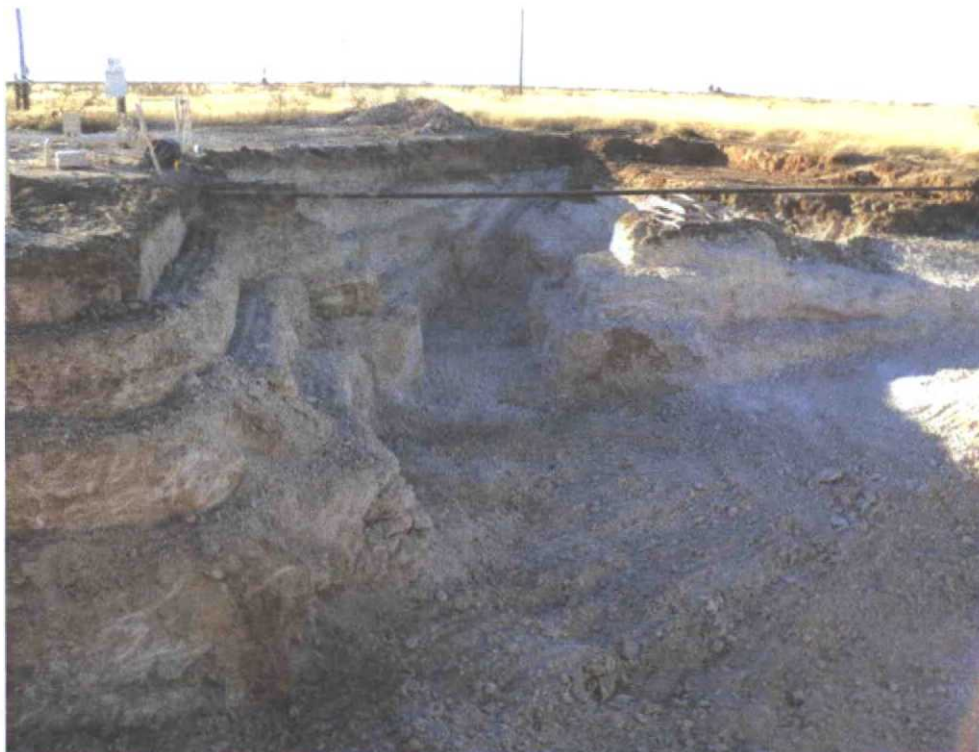
Photograph #6 – Looking westerly at excavation, active pipeline supported by wooden brace and southerly wall adjacent to Pump Station

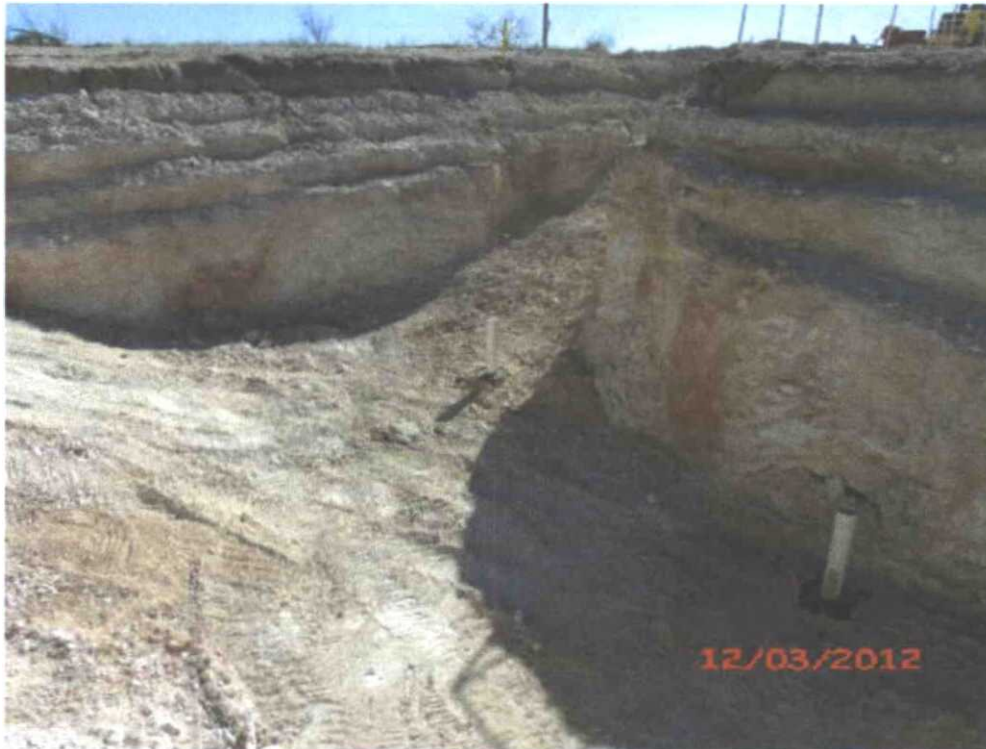
Photograph #7 – Looking south-easterly toward SB-1 and SB-2 conduits.

After excavation activities were completed, backfilling began on December 4, 2012. During backfill activities EPI installed three (3) 8" diameter PVC pipes (SB-1, SB-2, SB-3) for future soil borings to determine vertical extent of contamination (reference *Figure 3*).

On January 9, 2013, EPI personnel met Straub Corp. on jobsite and commenced advancement of soil borings in SB-1, SB-2 and SB-3 conduits. Seventeen (17) soil samples were collected, analyzed with PID for TPH concentrations and jarred. The 8" diameter PVC conduits were covered to prevent contamination. Soil samples were processed and transported to an independent laboratory per *Analytical Data and Procedures* outlined in this *Report*.

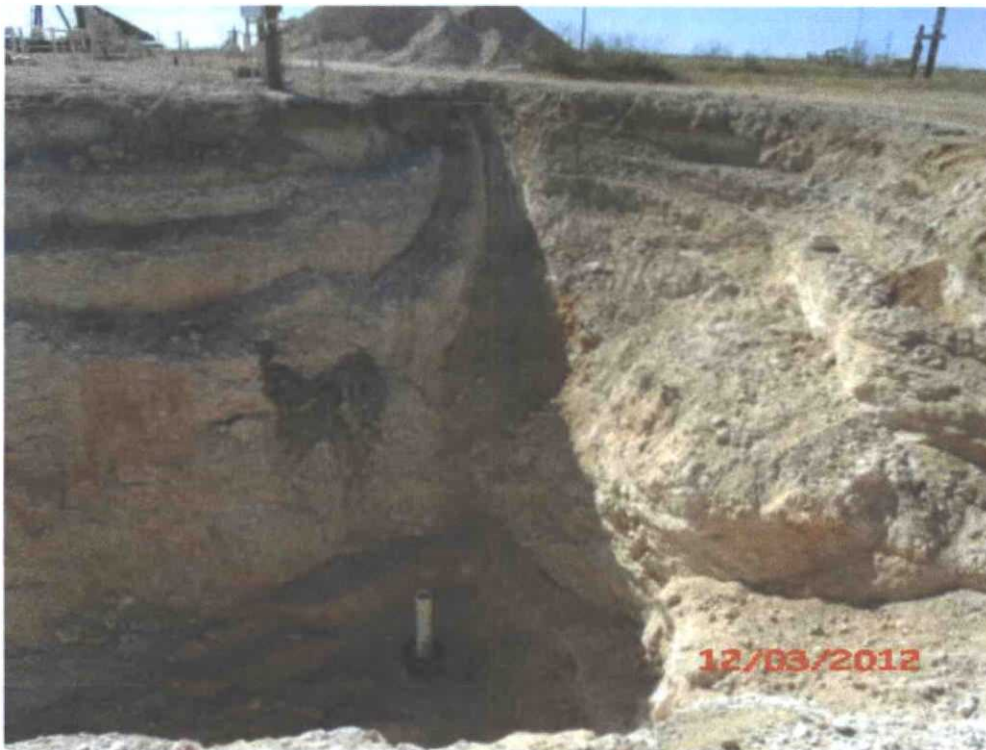
Photograph #8 – Looking south-westerly toward SB-3 conduit.

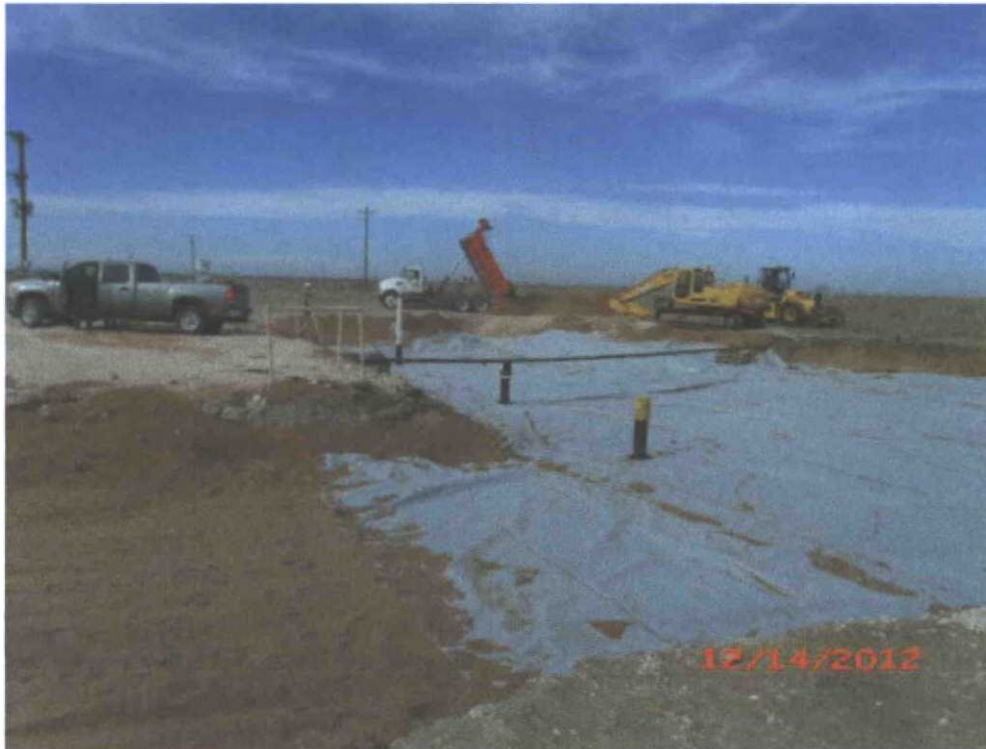
Photograph #9 – Looking north-westerly during liner installation.

On December 14, 2012, Akome, Inc. arrived on jobsite and placed a 20-mil reinforced polyethylene liner in excavation bottom and three (3) "booties" on 8" diameter PVC piping. After completing installation of the liner, backfilling continued with clean top soil free of deleterious material, large rocks and/or clods until the entire excavation was closed.

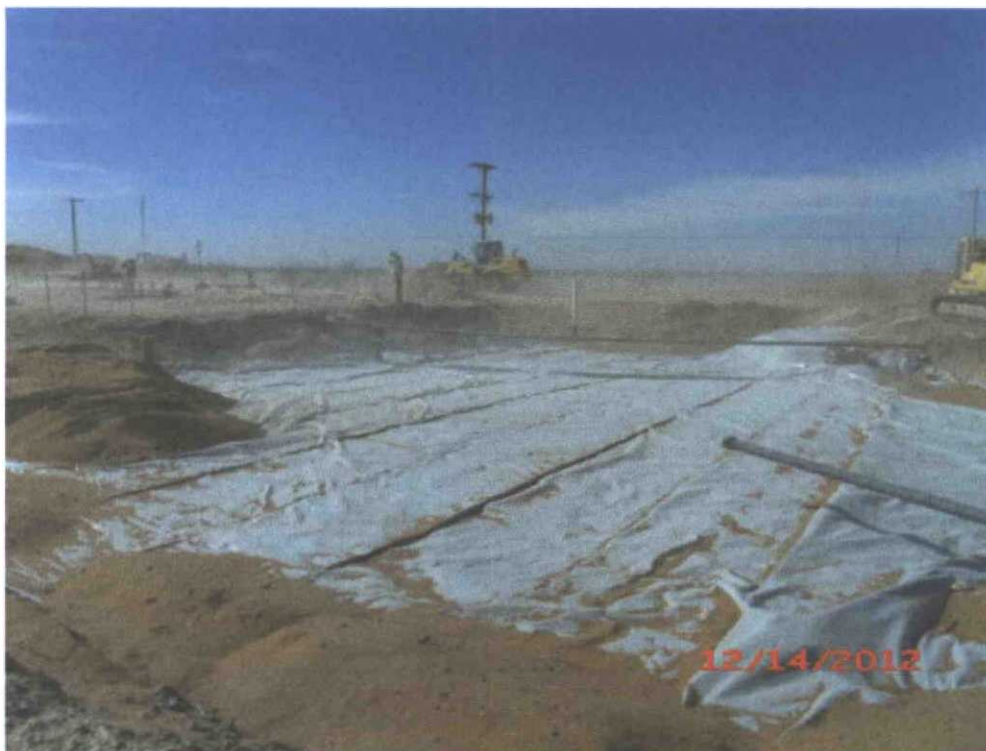
Photograph #10 – Looking south-westerly during liner installation.

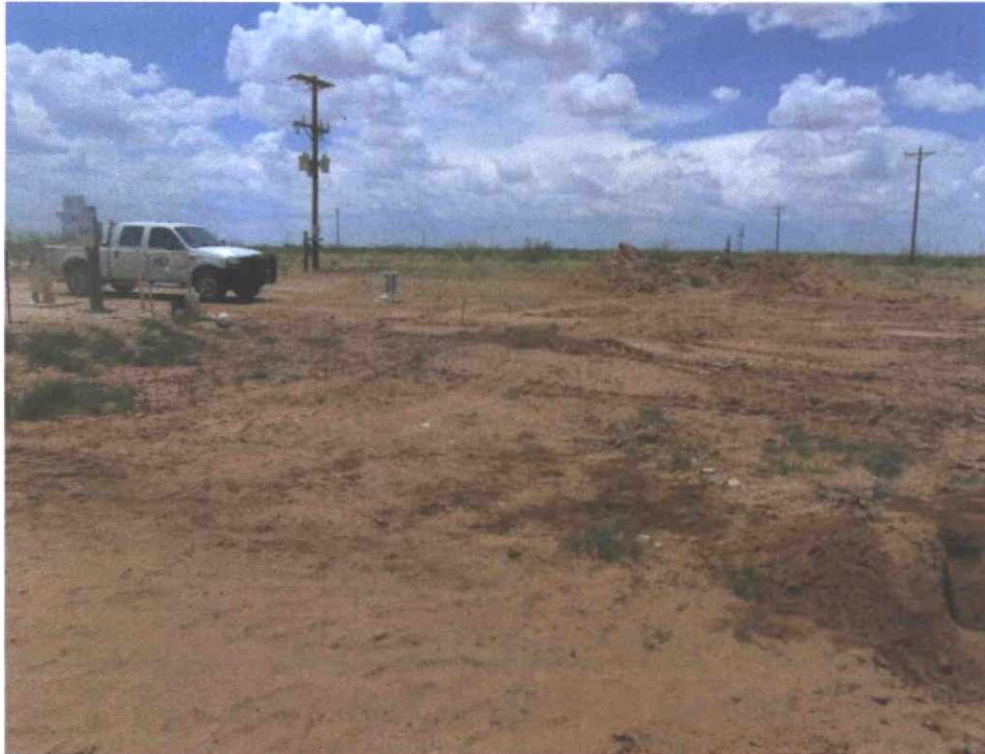
Photograph #11 – Looking south-westerly across backfilled, closed location.

Upon completion of soil boring activities, EPI personnel mobilized at jobsite to plug and abandon SB-1, SB-2 and SB-3 conduits. Plugging terminated at approximately 4-feet below ground level. Then the area around the conduits was excavated to a depth of ± 3 -feet below ground level; PVC pipe section cut off and 8" dia. cap installed. The disturbed areas were then contoured to prevent wind/water erosion, pooling of water and promote natural drainage.

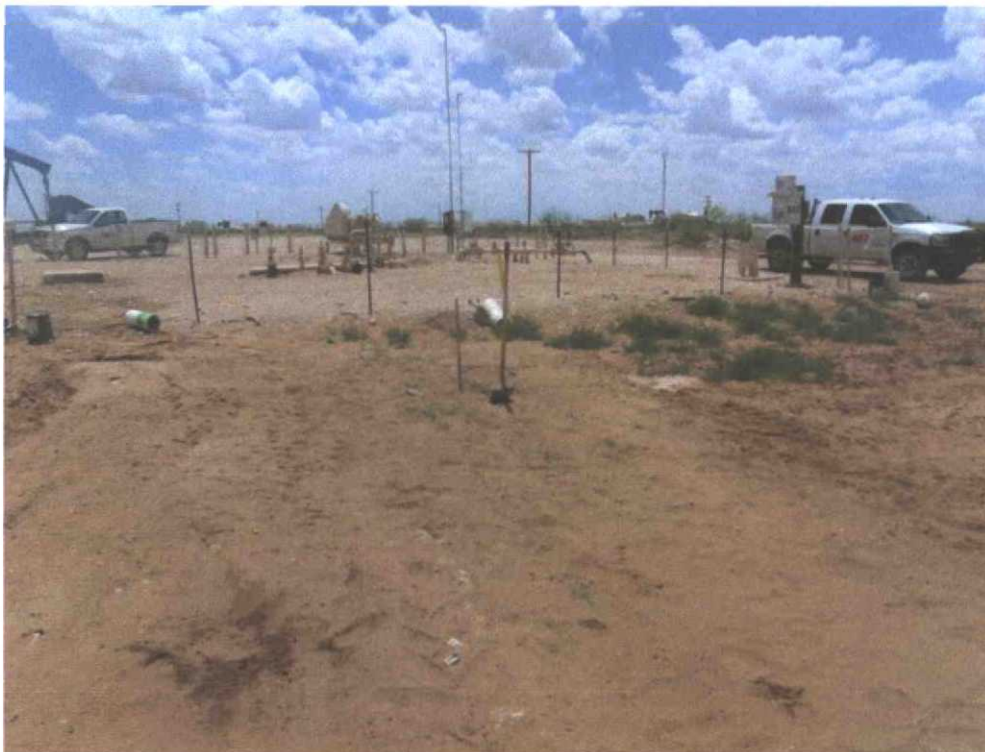
Photograph #12 – Looking southerly toward active pump station.
