## **REMEDIATION SUMMARY & SITE CLOSURE REQUEST**

**PLAINS PIPELINE, LP (231735)**

**Lea Federal 4-Inch Poly**

**NMOCD Reference # 1RP-2654**

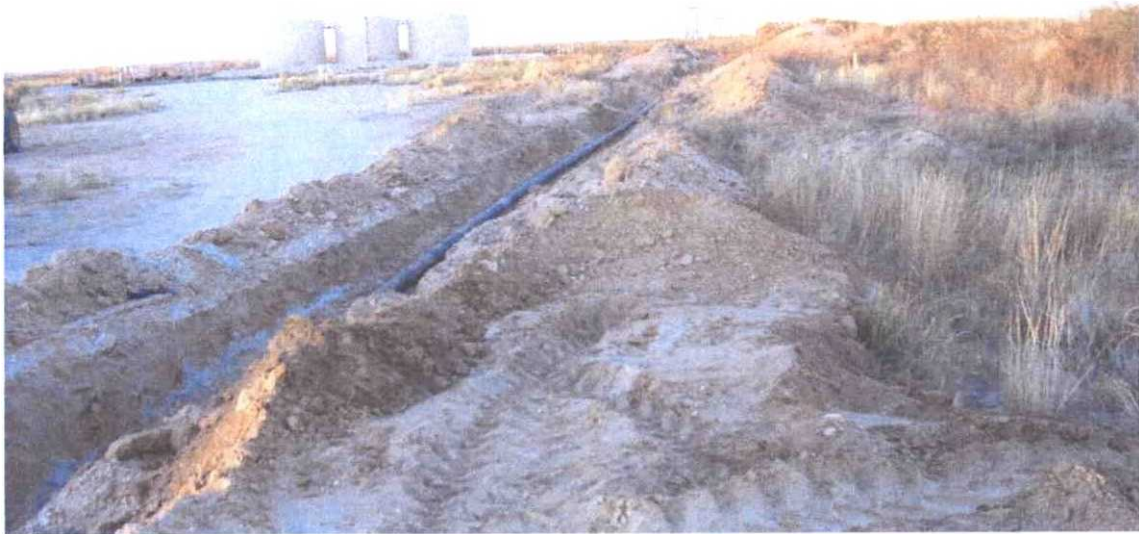
Lea Federal 4-Inch Poly Release Site (looking North)

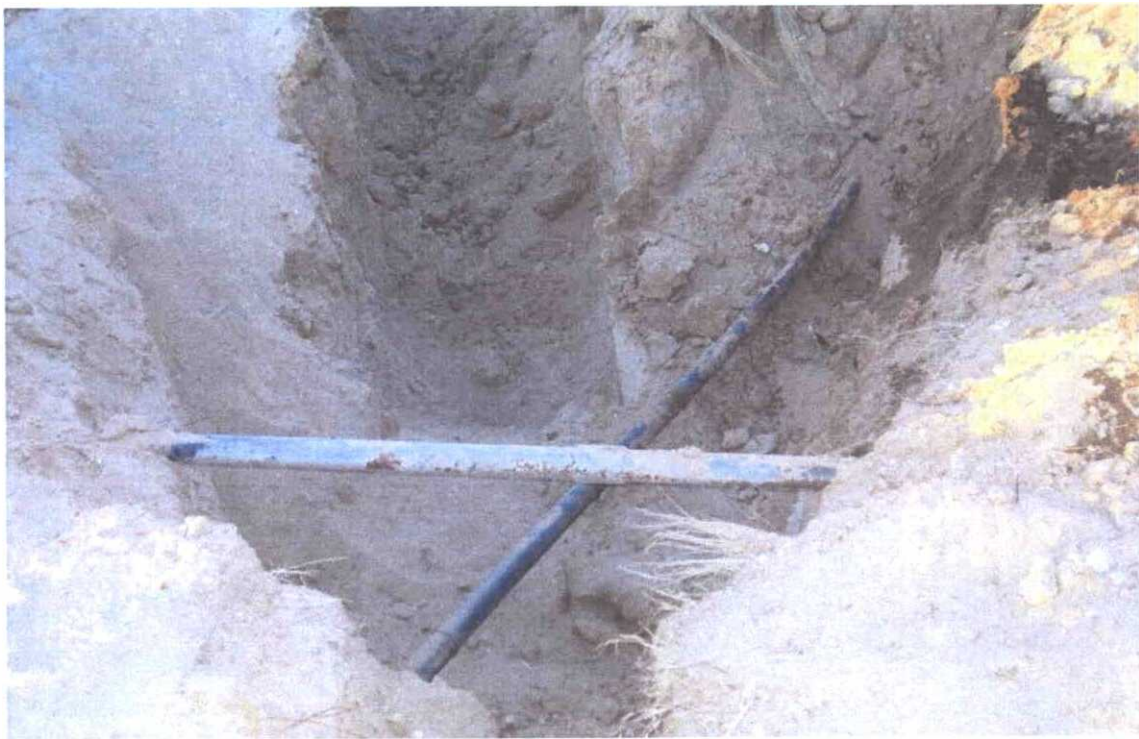
On November 10, 2010, during repairs of Plains' Scharb 8" pipeline, the Lea Federal 4-inch poly pipeline was struck by a backhoe, resulting in a release of crude oil. The release was reported to the New Mexico Oil Conservation Division (NMOCD) Hobbs District Office on November 17, 2010. The "Release Notification and Corrective Action" (Form C-141) indicated that approximately ten (10) barrels of crude oil was released. During initial response activities, a vacuum truck was utilized to recover approximately one (1) barrel of free fluids, which had pooled in an adjacent, open ditch line. The release site was excavated, and the area of impact was delineated. General photographs of the site are provided as Appendix B. The Form C-141 is provided as Appendix C.

Lea Federal 4-Inch Poly - Release Point

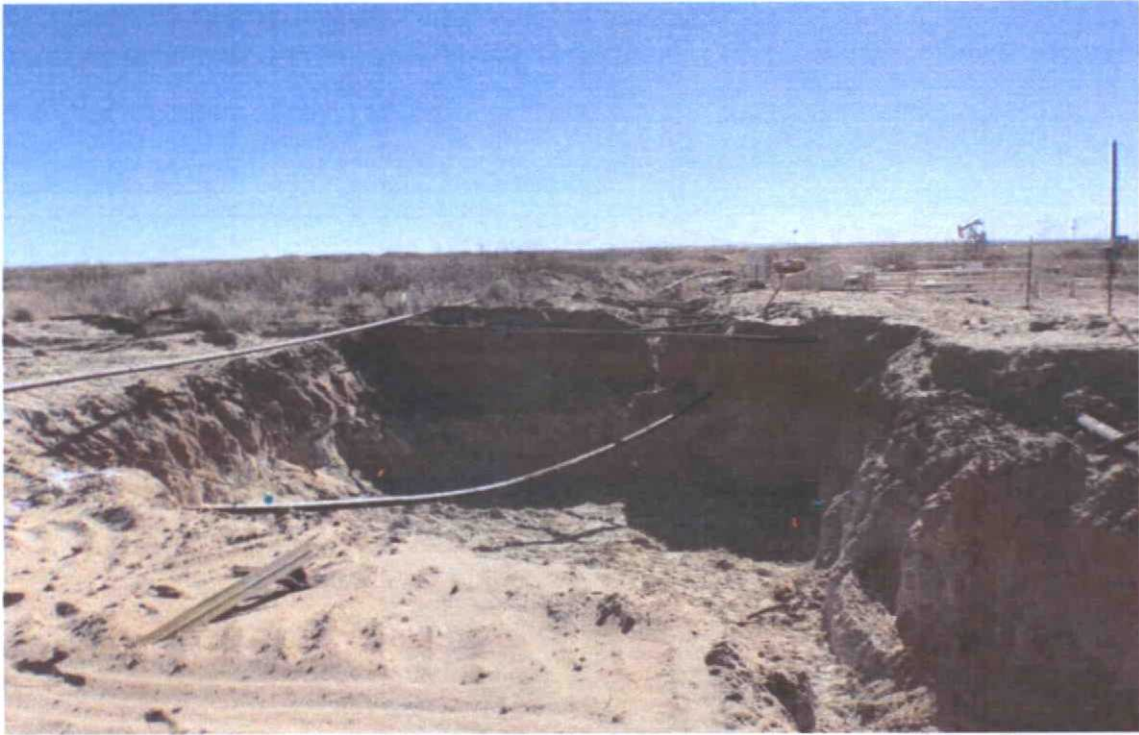
On November 17, 2010, nine (9) soil samples (Release Point, North Floor, North Sidewall, South Floor, South Sidewall, East Floor, East Sidewall, West Floor, and West Sidewall) were collected from the floor and sidewalls of the excavation. The soil samples were submitted to Xenco Laboratories, Inc., in Odessa, Texas, for analysis of total petroleum hydrocarbons (TPH) and benzene, toluene, ethyl-benzene, and xylenes (BTEX) constituent concentrations using EPA Methods SW 846-8015M and SW 846-8021b, respectively. Laboratory analytical results indicated TPH concentrations ranged from less than the laboratory Method Detection Limit (MDL) in soil sample "North Floor" to 130 mg/Kg in soil sample "Release Point". BTEX constituent concentrations were less than the appropriate laboratory MDL in all soil samples submitted. Table 1 summarizes the "Concentrations of Benzene, BTEX, TPH & Chlorides in Soil". Soil sample locations are depicted in Figure 2, "Site & Sample Location Map". Laboratory analytical reports are provided as Appendix A.

Lea Federal 4-Inch Poly - Excavation (looking South, sample locations flagged)

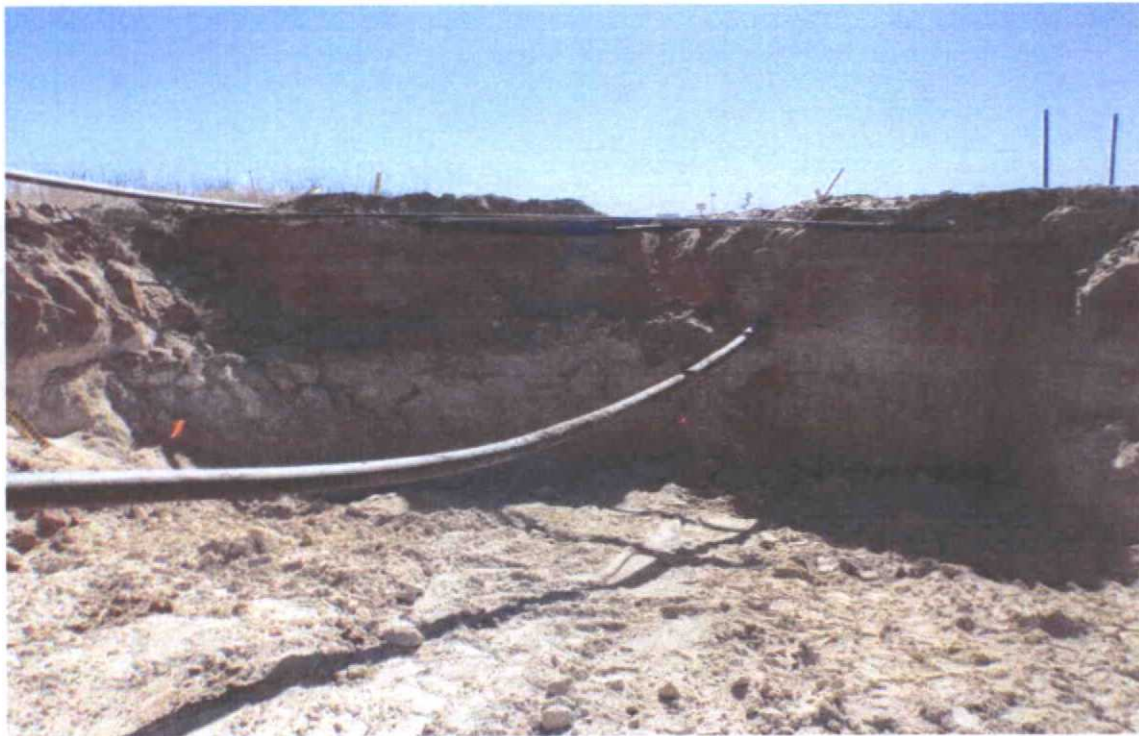
On December 3, 2010, two (2) soil samples (Release Point and Release Point #2) were collected from the floor of the excavation. Field test results indicated chloride concentrations were less than that measurable by the Hach Quantab Chloride Low Range (30-600 mg/Kg) Titrators utilized to perform the field analyses. A two-point composite soil sample, "Release Point", was submitted to Xenco Laboratories for confirmatory analysis of chlorides using EPA Method 300.1. Laboratory analytical results indicated the chloride concentration was less than the laboratory MDL. Field-test results are provided in Table 2, "Chloride Field-Test Results".

Lea Federal 4-Inch Poly - Excavation Floor (looking South, sample locations flagged)

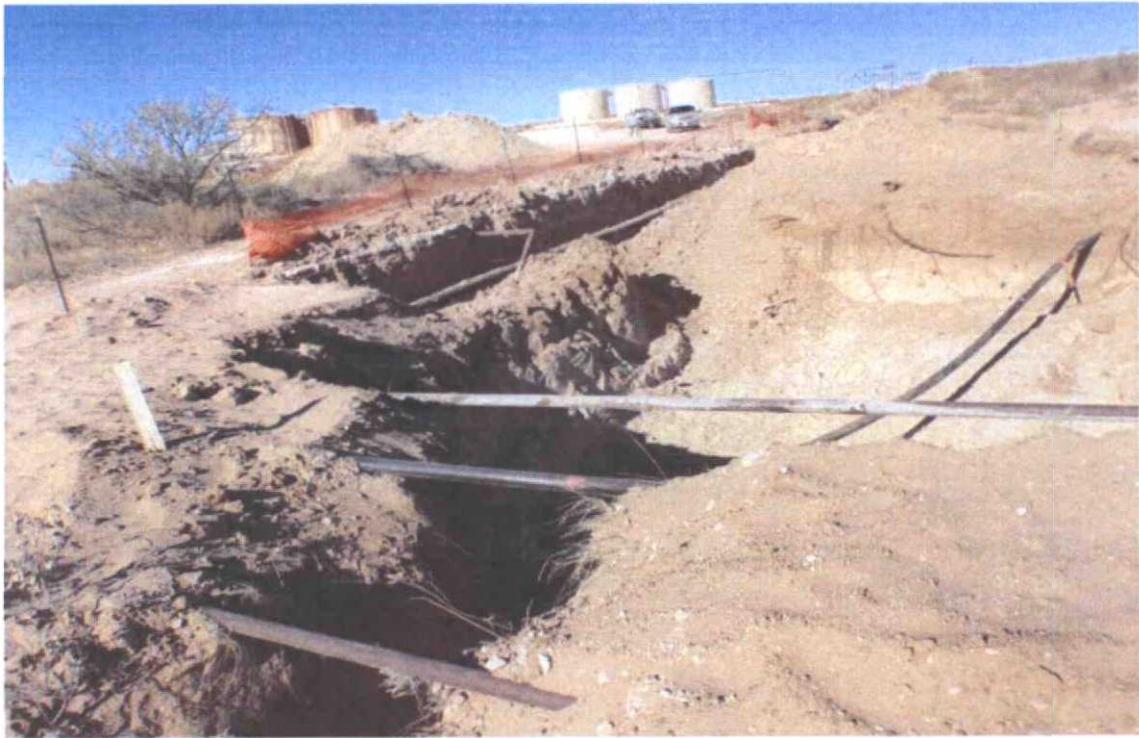
On November 16, 2010, excavation of impacted soil commenced at the site. Hach Quantab Chloride Low Range (30-600 mg/Kg) Titrators were used to field-screen the horizontal and vertical extent of impacted soil and to guide the excavation. From November 16 through November 18, 2010, approximately four hundred and fourteen (414) cy of impacted soil was excavated and transported to the Lazy Ace Landfarm for disposal.

Lea Federal 4-Inch Poly - Excavation (looking North)

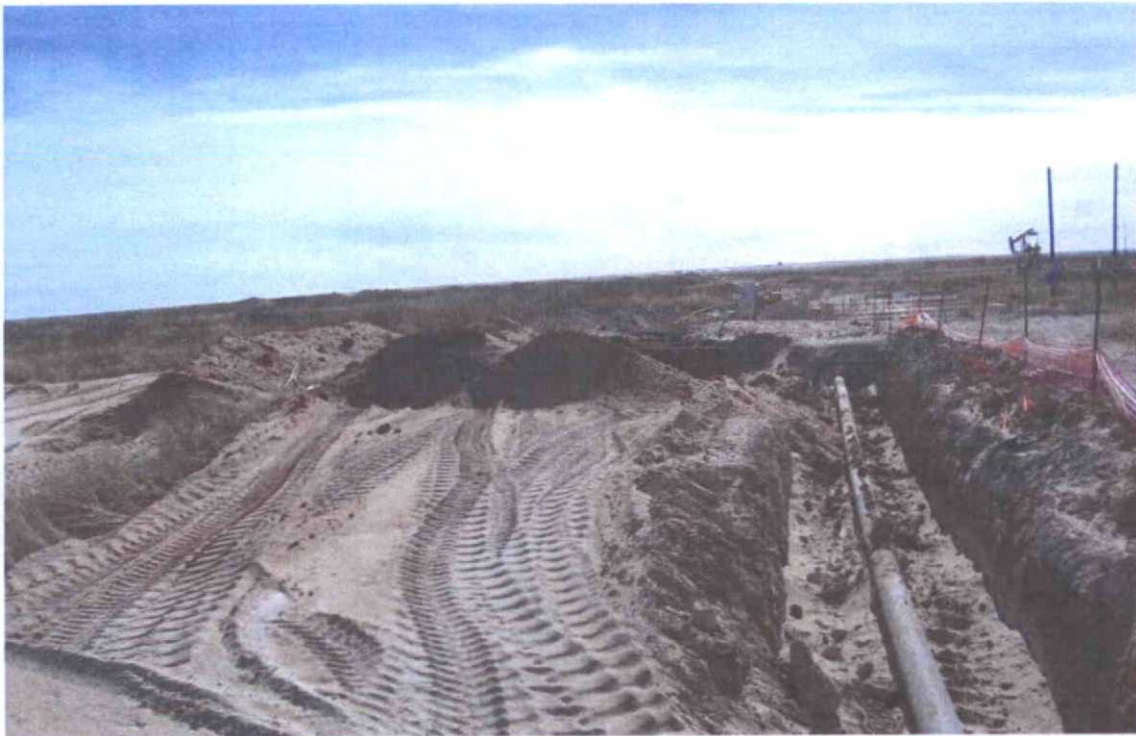
Lea Federal 4-Inch Poly - Excavation (following backfill)
