Release Notification and Corrective Action

**RE: Remediation Closure Report
XTO Energy
New Mexico "S" State Tank Battery #5
UL-F (SE1/4 of the NW1/4) of Section 02, T22S, R37E
Lea County, New Mexico
NMOCD Ref. #1RP-10-4-2489; EPI Ref. #190041**

The below *Remediation Closure Report (Report)* is an abbreviated version depicting prominent remedial activities conducted on the above referenced Release Area. However for clarity and cross reference elimination purposes, the *Report* includes *Release History, Site Background, Preliminary Field Work, Analytical Data and Procedures* and *Field Remediation Activities*.

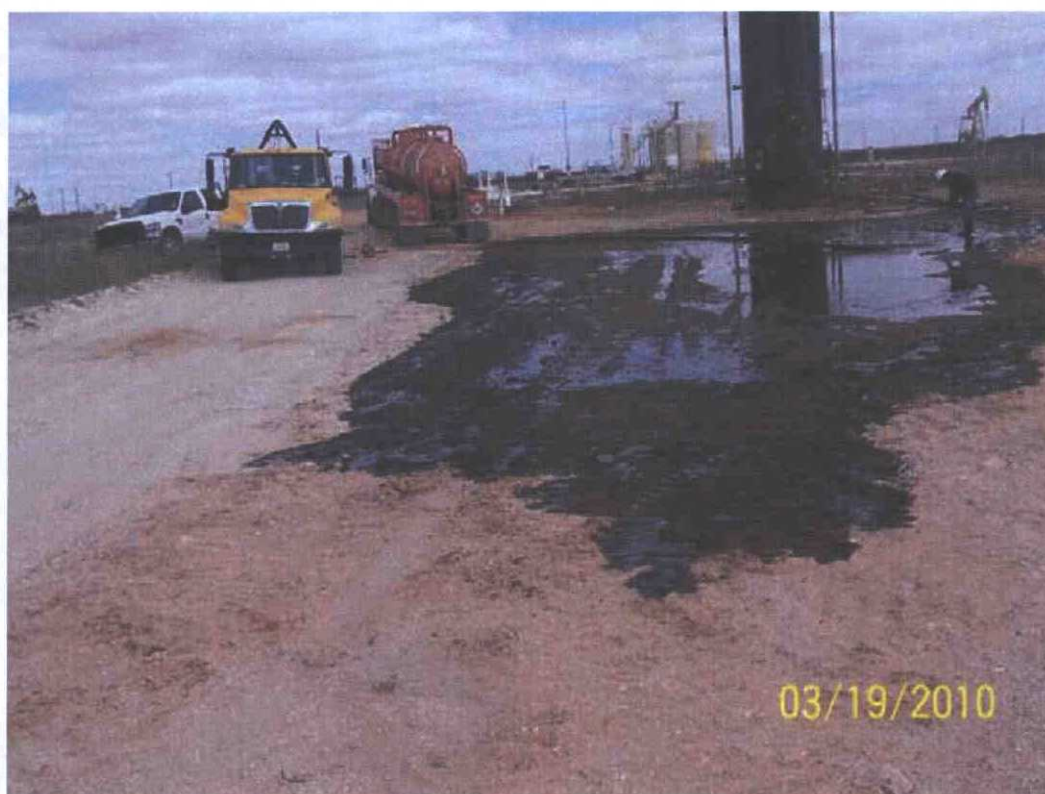
Photograph No. 2 – Looking northerly at release area and cleanup effort

On March 20, 2010 at 8:00 a.m. approximately 78.4-bbls of petroleum products and 8.7-bbls of produced water were released when a water leg broke away from an active heater treater. Approximately 75-bbls of petroleum and 8.3-bbls of produced water were recovered. The combined fluids covered a release area of $\pm 5,300$ square feet. After vacuuming petroleum products and produced water, field activities were initiated to mitigate the Release Area. Oily impacted material within the Release Area were blended with existing soil to stiffen and then transported to Sundance Services, Inc., for disposal. ExxonMobil (XTO) retained the services of Environmental Plus, Inc., (EPI) to GPS, photograph and delineate the release area.

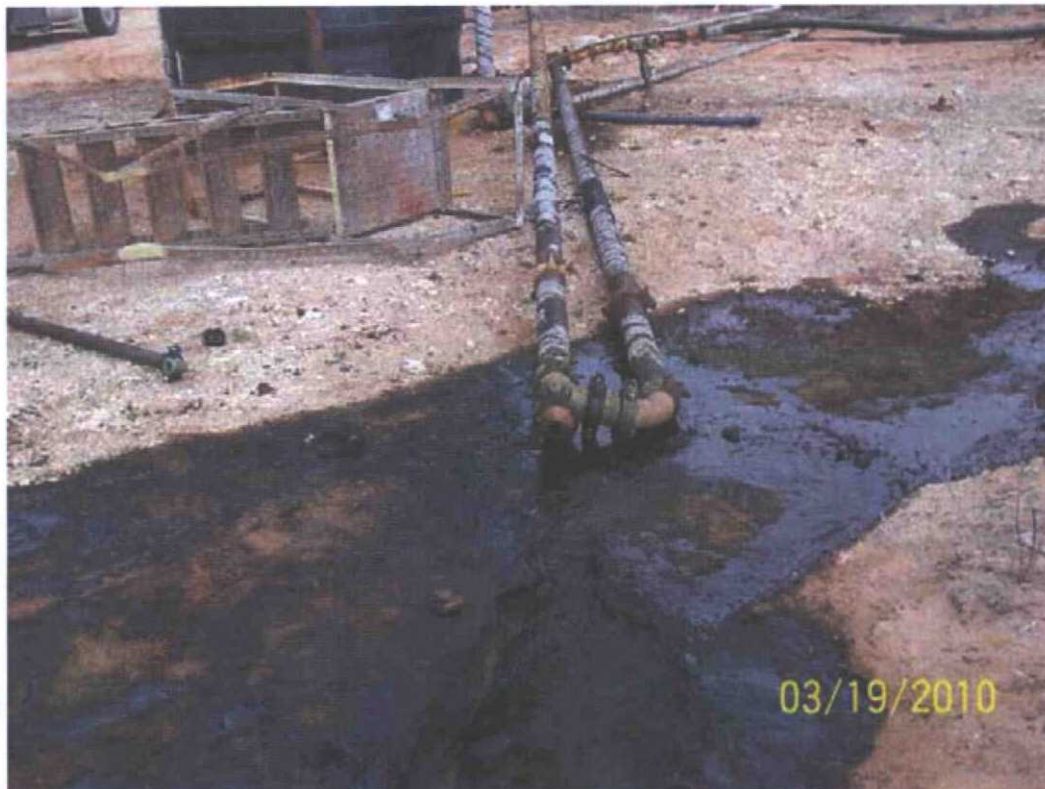
Photograph No. 3 – Looking a broken water leg

2" drain line water leg on heater broke off of heater due to groove in piping developing corrosion.

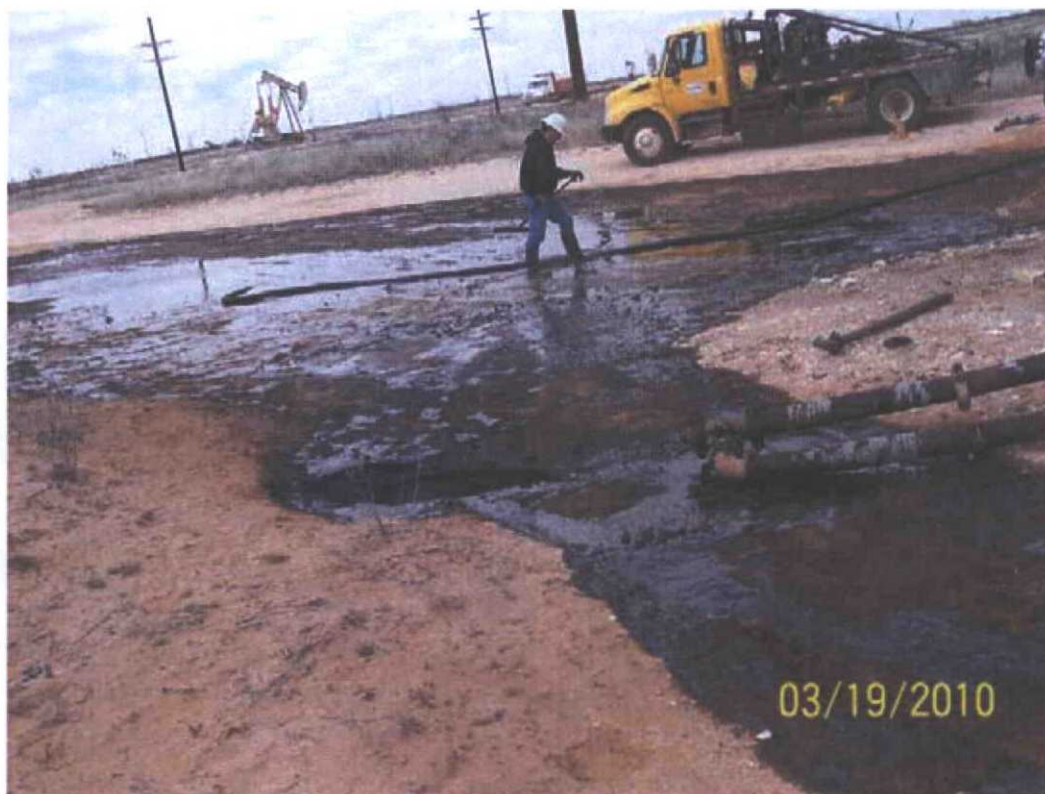
Photograph No. 4 – Looking southerly at release area and cleanup efforts

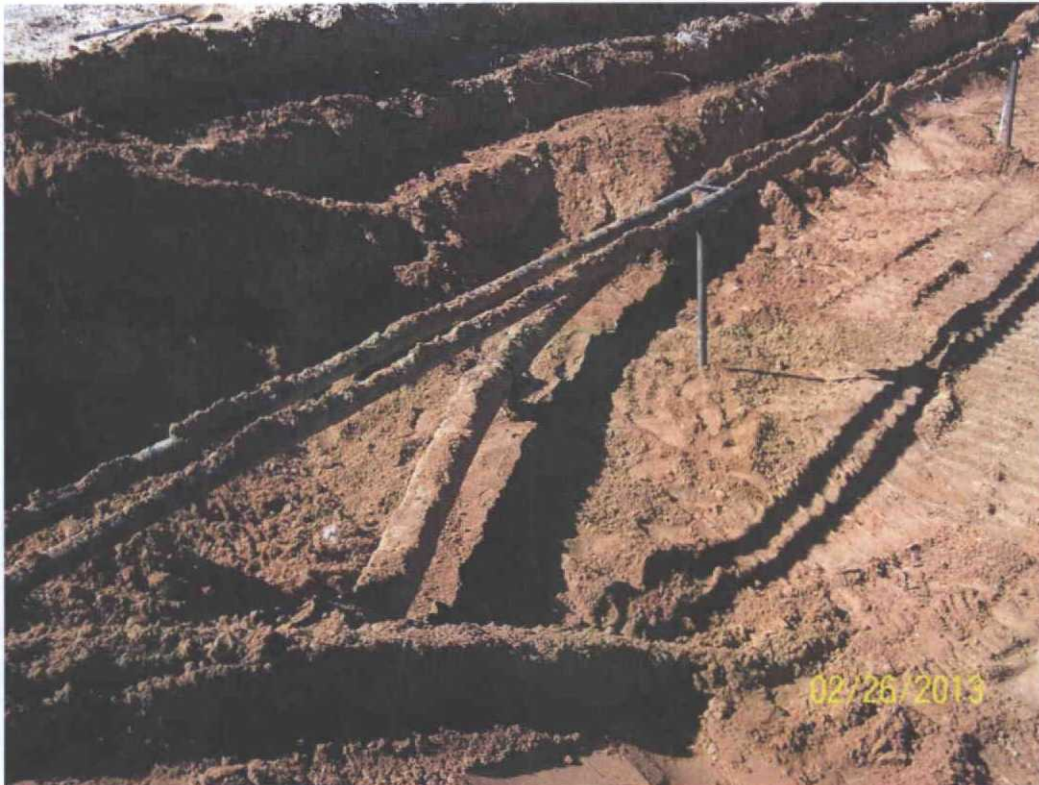
Photograph #5 – Looking at intersection of two (2) three-inch steel and 8-inch poly pipelines

EPI mobilized to the Release Area on February 18, 2013 and began remedial activity. The two (2) 3-inch diameter steel lines were uncovered full length of the Release Area. Remainder of Release Area was surveyed using a pipe locator to ensure all pipelines had been identified. Excavation activities started on the north-east corner of the Release Area and proceeded in the southerly direction. From February 18-25, 2013, $\pm 1,626$ cubic yards of impacted material were excavated by a trackhoe and temporarily stockpiled on the southerly portion of Release Area. The impacted material was then loaded into dump trucks by a front end loader and transported to Sundance Services for disposal. As excavating activities started to undermine and expose the two (2) 3-inch steel pipeline, extendable metal pipe supports were installed to prevent sagging. This procedure was repeated by extending them until total depth was achieved. The 8-inch polyethylene pipe was rigid requiring no pipe supports.

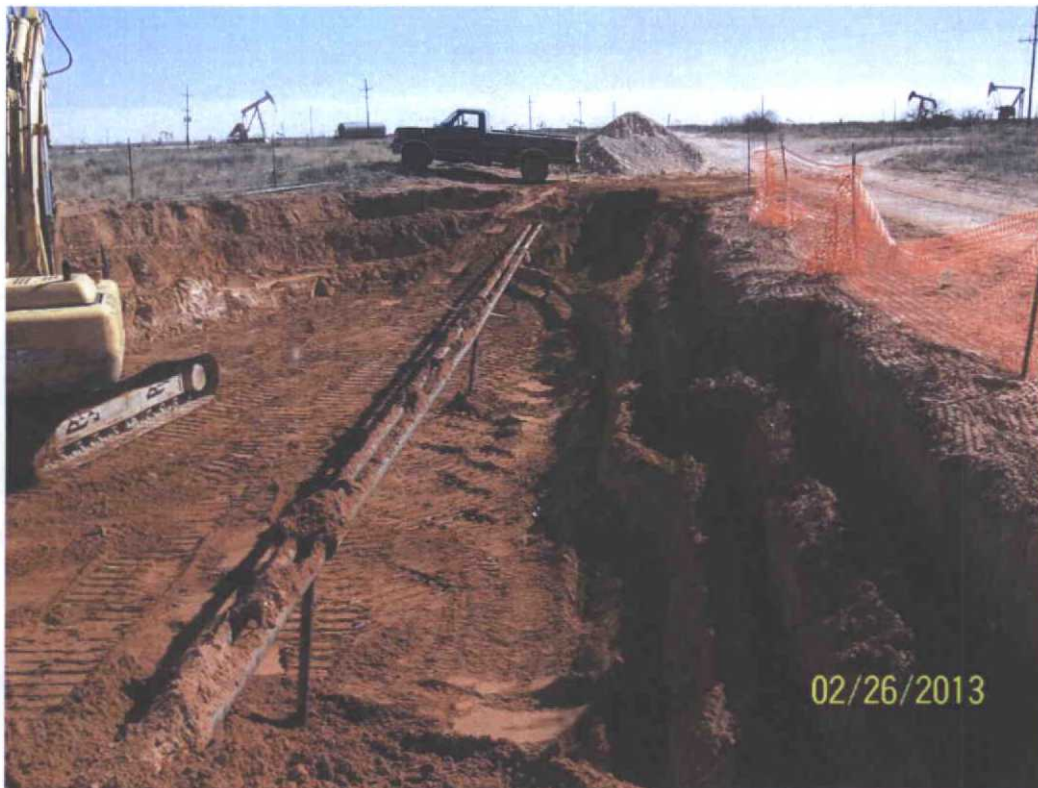
Photograph #6 – Looking southerly at two (2) three-inch steel pipelines with pipe supports and compaction of cushion material layer

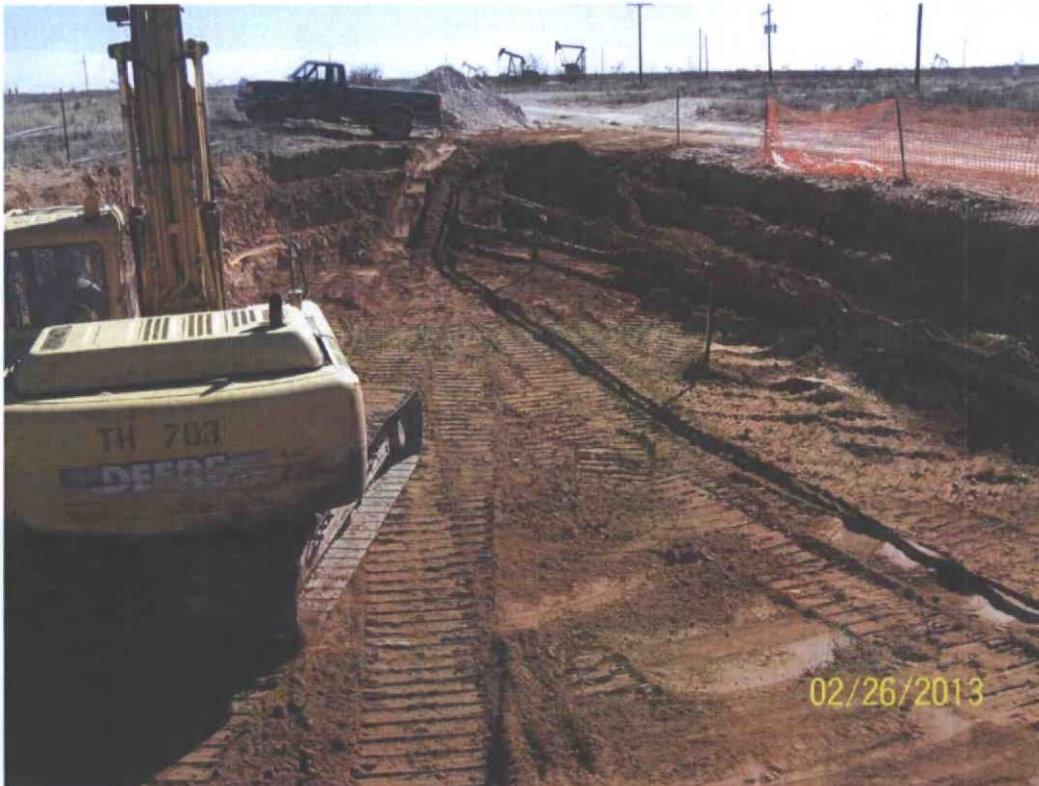
Photograph #7 – Looking southerly at placement and compaction of cushion material layer for placement on 20-mil Polyethylene reinforced liner

After reaching excavation physical constraints for width and predetermined depth of seven (7) feet bgs, the bottom area was smoothed of irregularities and two (2) feet layer of cushion top soil deposited, smoothed and compacted via use of the trackhoe. On February 28, 2013 Akome Incorporated arrived at the excavation and installed $\pm 4,230$ square feet of 20-mil reinforced polyethylene liner in the bottom. After completing installation of the liner, a two (2) feet thick

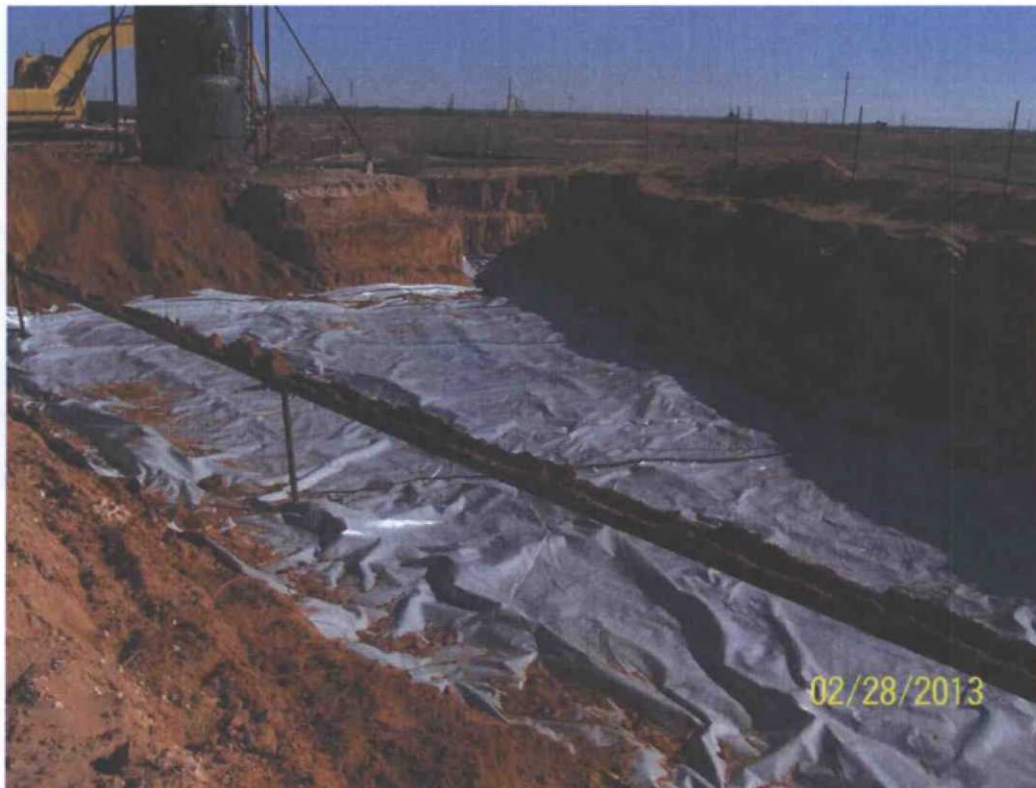
Photograph #8 – Placement of 20-mil Polyethylene reinforced liner

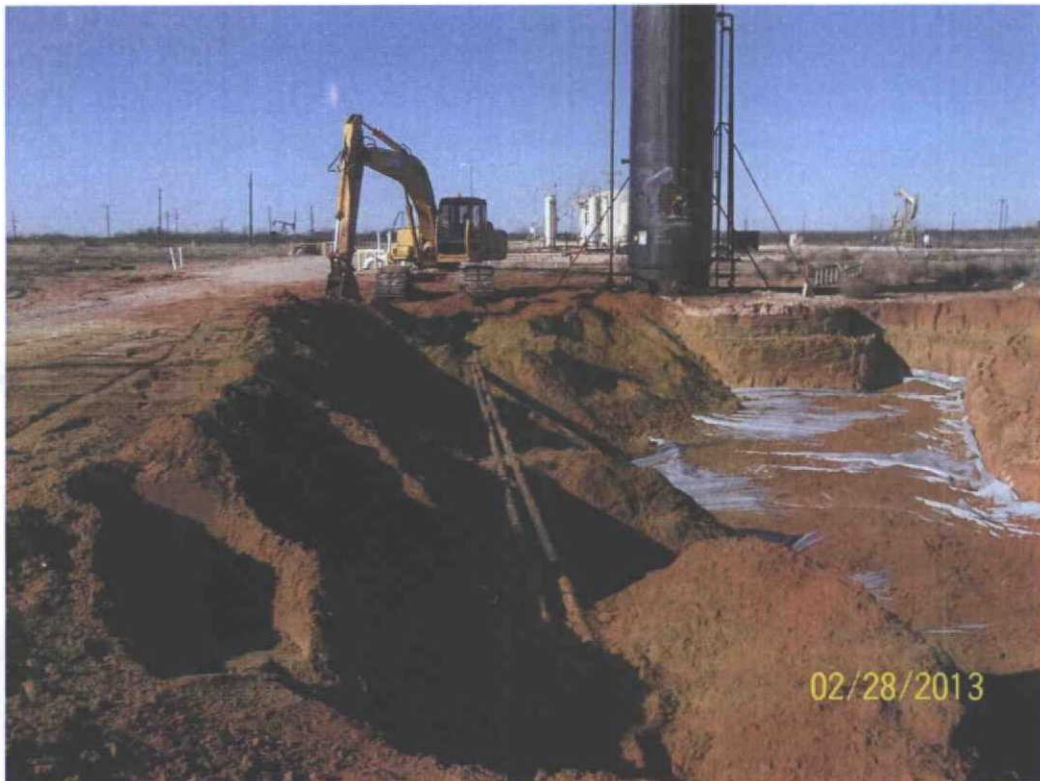
Photograph #9 – Looking northerly at placement of top soil over 20-mil Polyethylene Liner

layer of cushion top soil free of large clods, rocks or deleterious material was placed over the westerly portion. During backfill activities pipe support elevations were adjusted with height of backfill cushion material avoiding direct contact with the liner. Once the buried pipelines on the west side of the excavation were covered and all pipe supports removed, the trackhoe carefully placed cushion material in the easterly direction over the liner coincidental with backfill activities. From February 26 through March 5, 2013, $\pm 1,596$ cubic yards of topsoil were placed and compacted in the excavation.

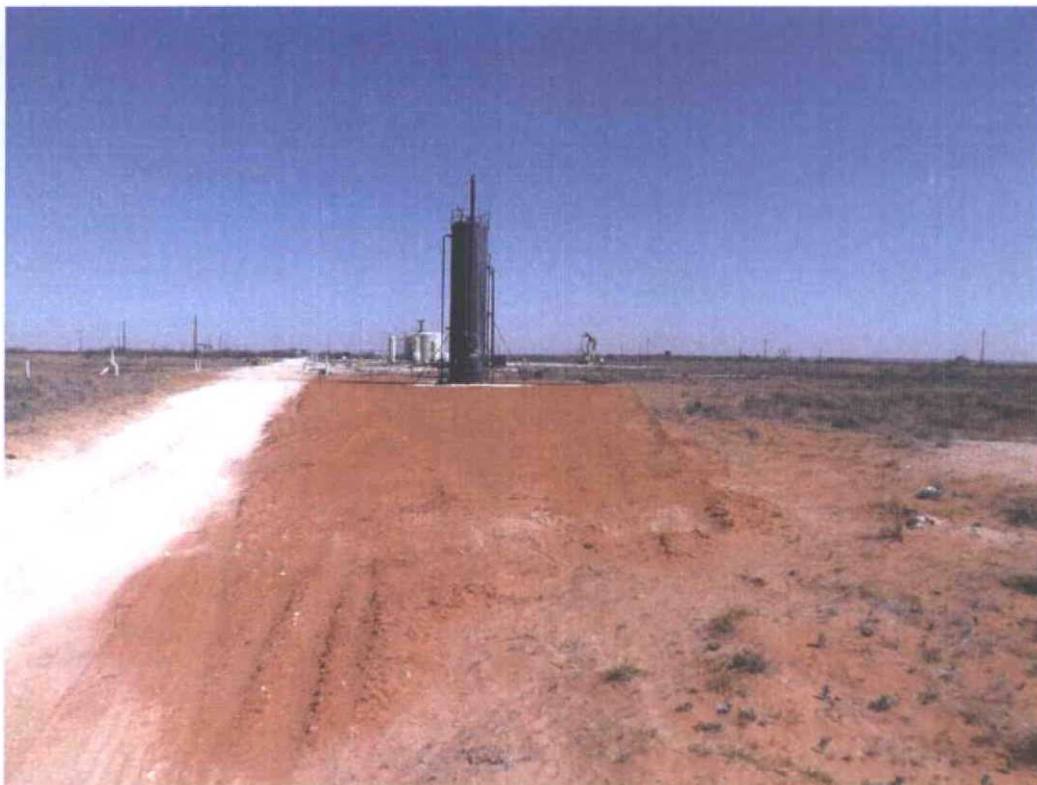
Photograph #10 – Looking northerly at surface of backfilled area and caliche material around heater treater

Upon completion of backfill activities, the disturbed areas were contoured to prevent wind/water erosion, pooling of water and promote natural drainage. Remaining activity for completion of project is discing and deep drill seeding the disturbed areas with a seed mixture approved by the NMSLO. However, in view of drought conditions, it is recommended postponing this activity until ground and weather conditions are conducive to vegetative growth.
