Date: 3 October 2011  
To: **Mr. Geoffrey Leking**  
Company Name: New Mexico Oil Conservation Division  
Address: 1625 North French Drive  
City / State / Zip: Hobbs, New Mexico 88240  
From: David P. Duncan  
CC: John W. Gates, ConocoPhillips – Lead HSE Permian-Buckeye Operations  
Myra Harrison, Land Manager, NMSLO – Hobbs, NM  
Steven Ikeda, Environmental Specialist, NMSLO – Santa Fe, NM  
Project #: EPI Ref. #150030  
Project Name: VAC ABO Well #13-16 Release Area  
Subject: **Remediation Closure Report**

**RE: Remediation Closure Report**  
**ConocoPhillips Company – VAC ABO Well #13-16 Release Area**  
**UL-D (NW1/4 of the NW1/4) of Section 04, T 18 S, R 35 E; Lea County, New Mexico**  
**Latitude: 32° 46' 49.99"; Longitude: 103° 28' 11.64"**  
**EPI Ref. #150030**

Encl: Figure 1 - Area Map  
Figure 2 – Site Location Map  
Figure 3 – Initial Release Area Map  
Figure 4 – Final Release Area Map with Sample Points  
Table 1 – Well Data  
Table 3 – Summary of Excavation Field Analyses and Laboratory Analytical Results  
Attachment I - Photographs  
Attachment II – Copy of Initial NMOCD Form C-141  
Final NMOCD Form C-141

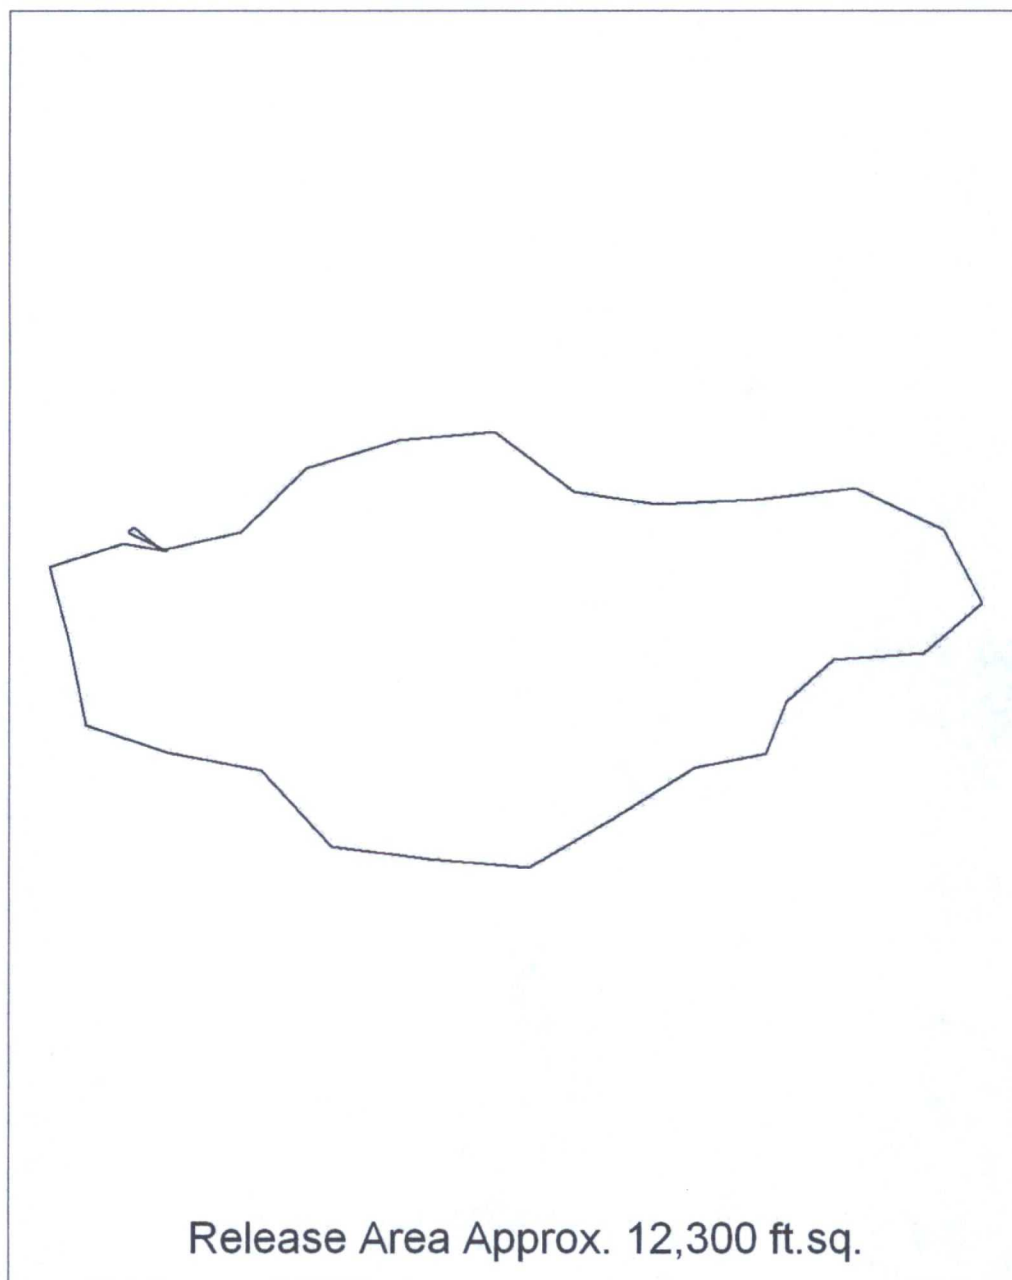
# Figure 3

VAC ABO #13-16 Release.ssf  
3/4/2011

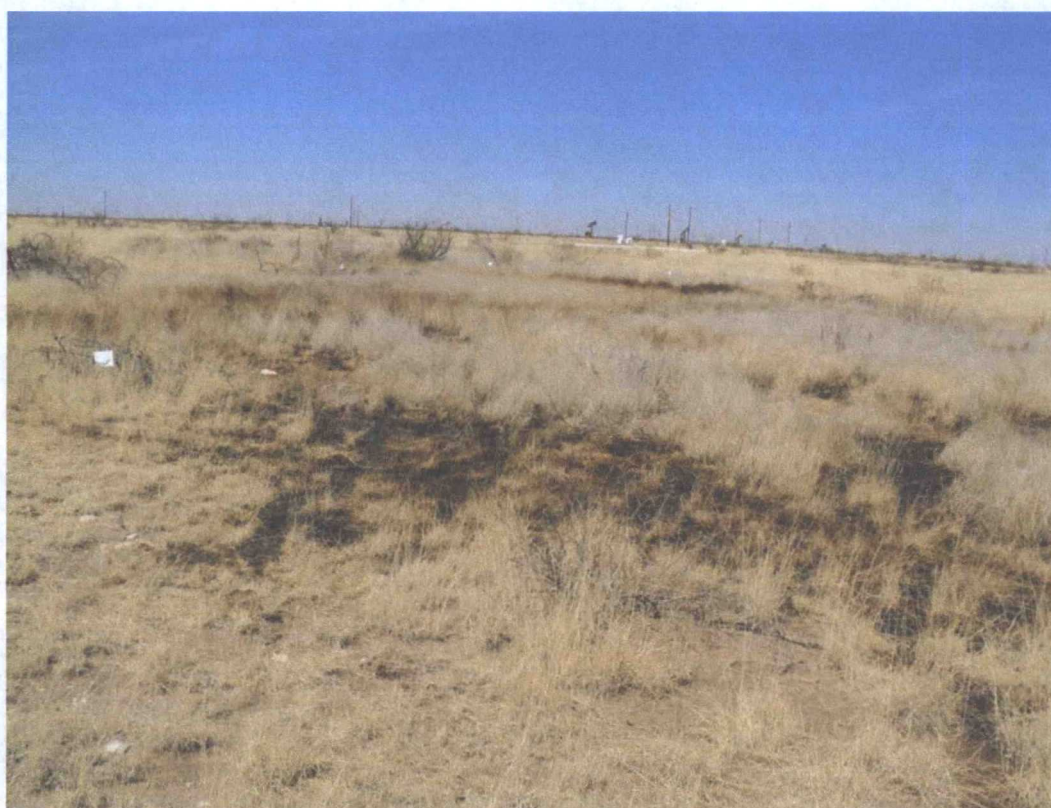
Photograph No. 2 - Looking easterly at Release Area

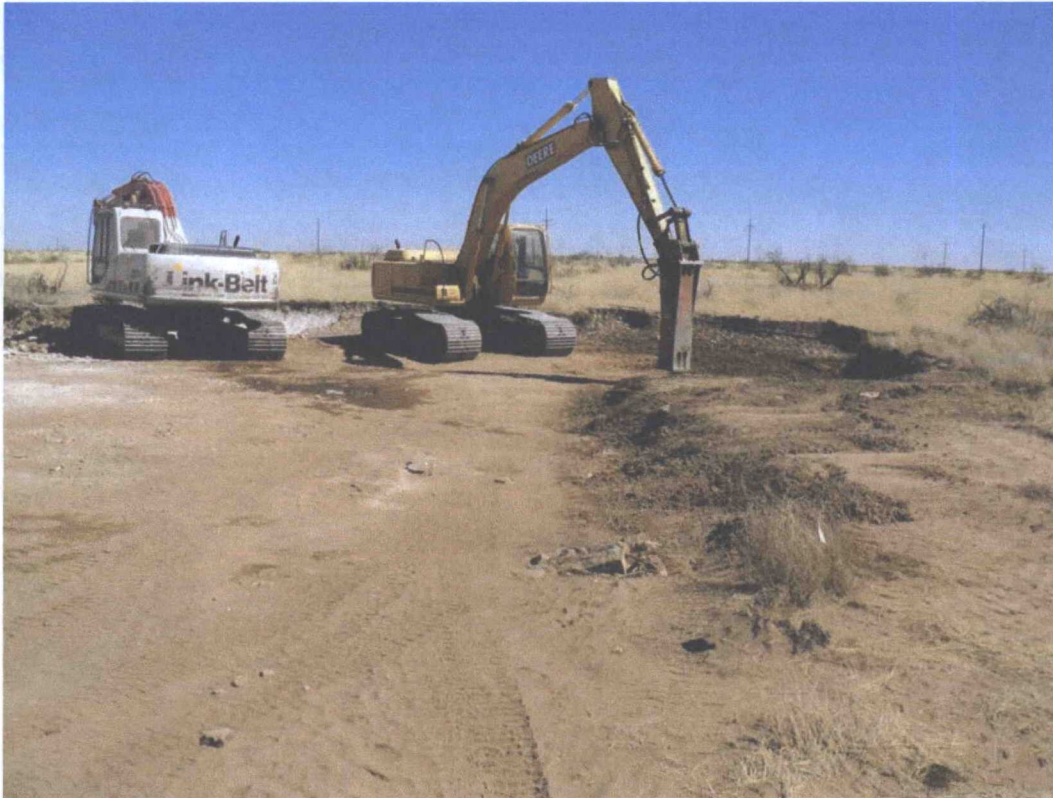
**Photograph No. # 3 – Trackhoes with Rock Bucket (left) and Hammerhoe attachment (right)**

combination rock bucket and hammer hoe attachment, approximately 2,454 cubic yards of impacted material were excavated and transported to Controlled Recovery, Inc., (CRI) for remediation or disposal. Depth of excavation varied from 2-8 vertical feet with a surface area of 12,322 square feet.

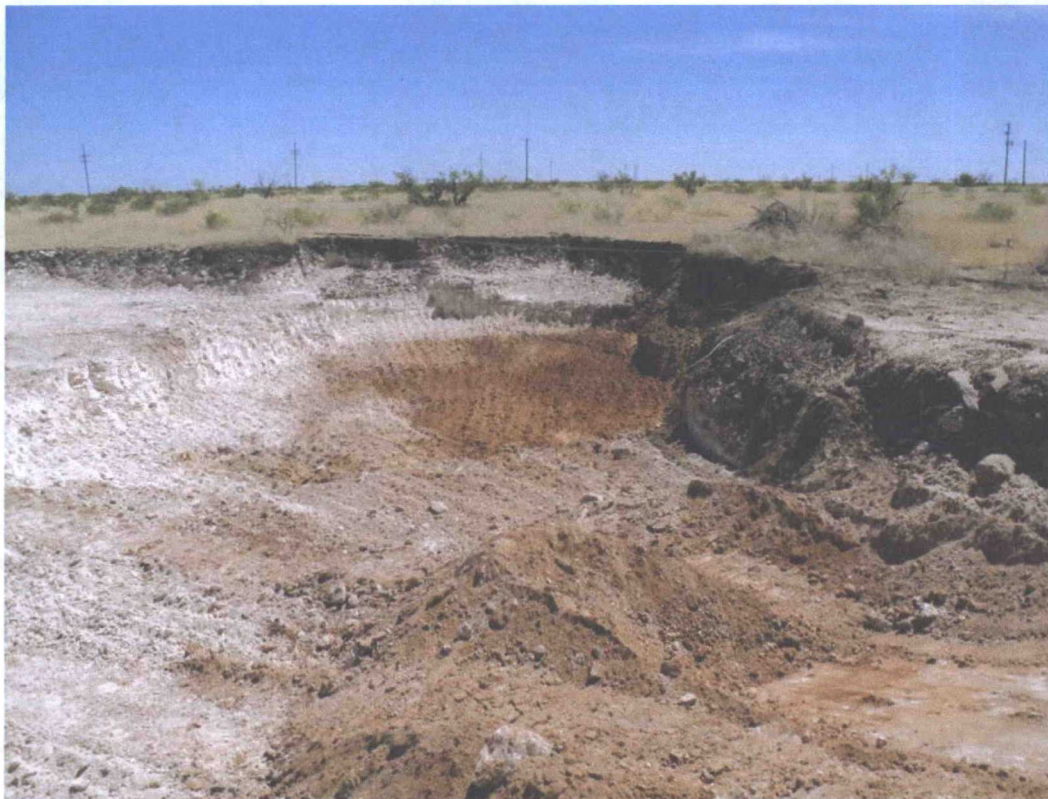
**Photograph No. 4 – Looking southeast at excavation bottom and sidewalls**

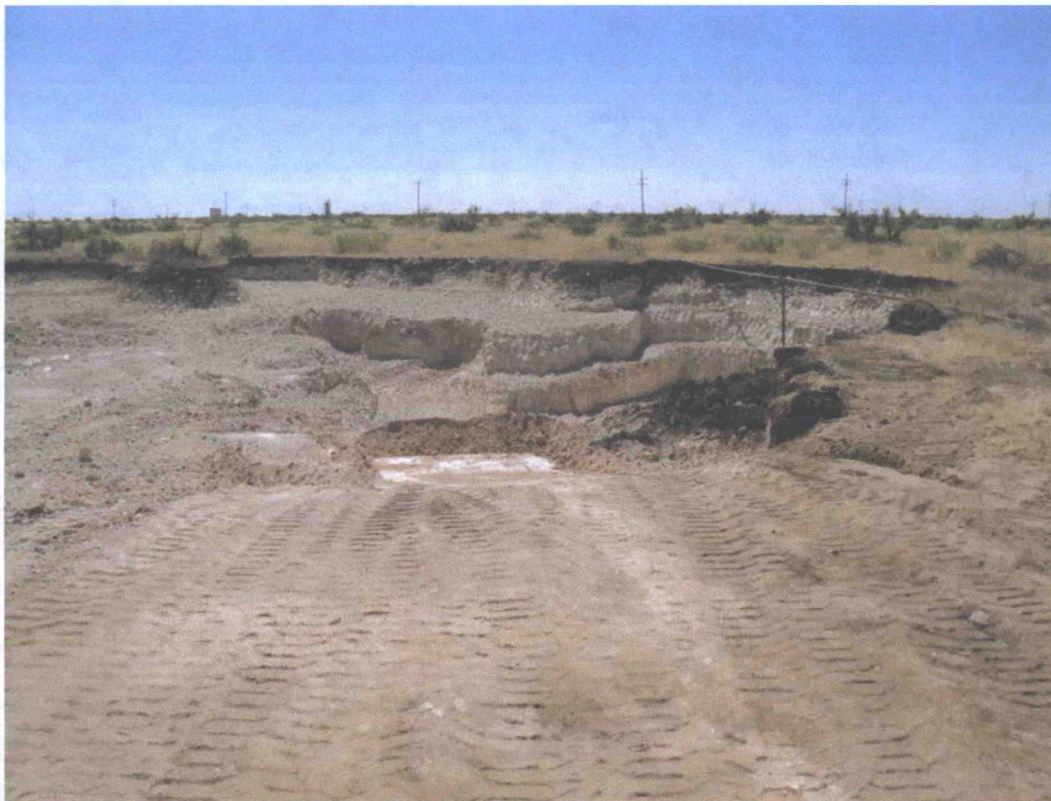
**Photograph No. 5 – Looking southerly at excavation and ingress/egress ramp**

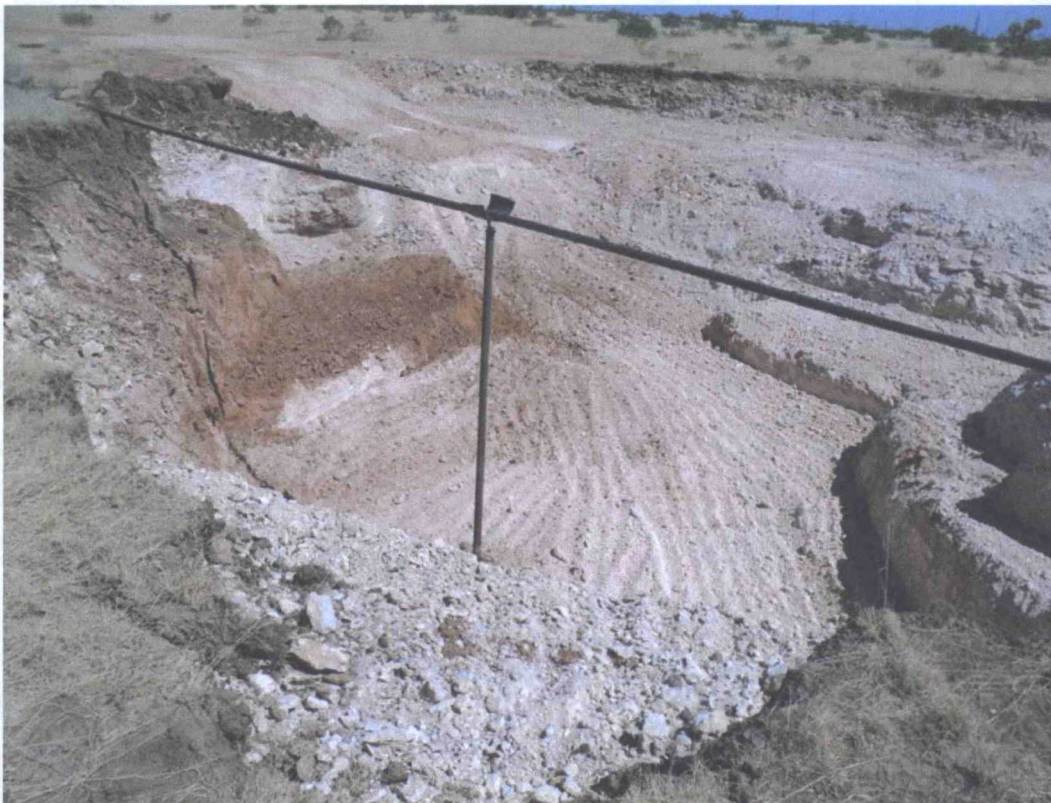
**Photograph No. 6 – Looking northerly at excavation, steel pipeline with pipe support and ingress/egress ramp**

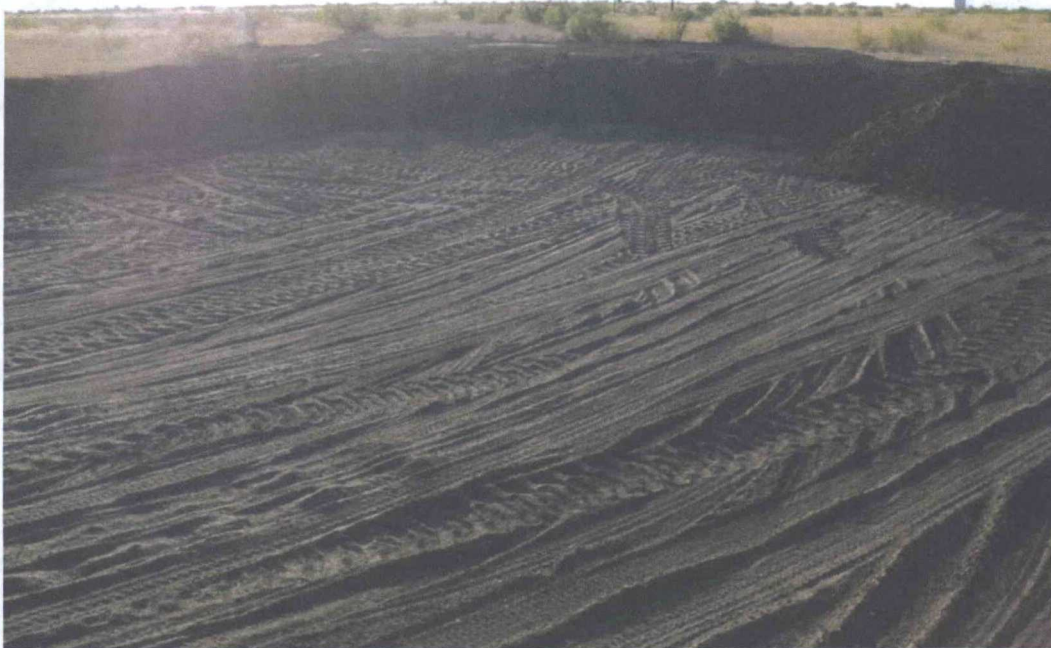
**Photograph No. 6 – Looking southwesterly at partially backfilled excavation**

From April 20, 2011 through August 4, 2011, approximately 2,604 cubic yards of clean top soil were transported from the Pearce Trust Pit located approximately two (2) miles west of the release area. Top soil was free of deleterious material, rocks and large earthen clumps. The resultant surface area was sloped to promote natural drainage and prevention of wind/water erosion.

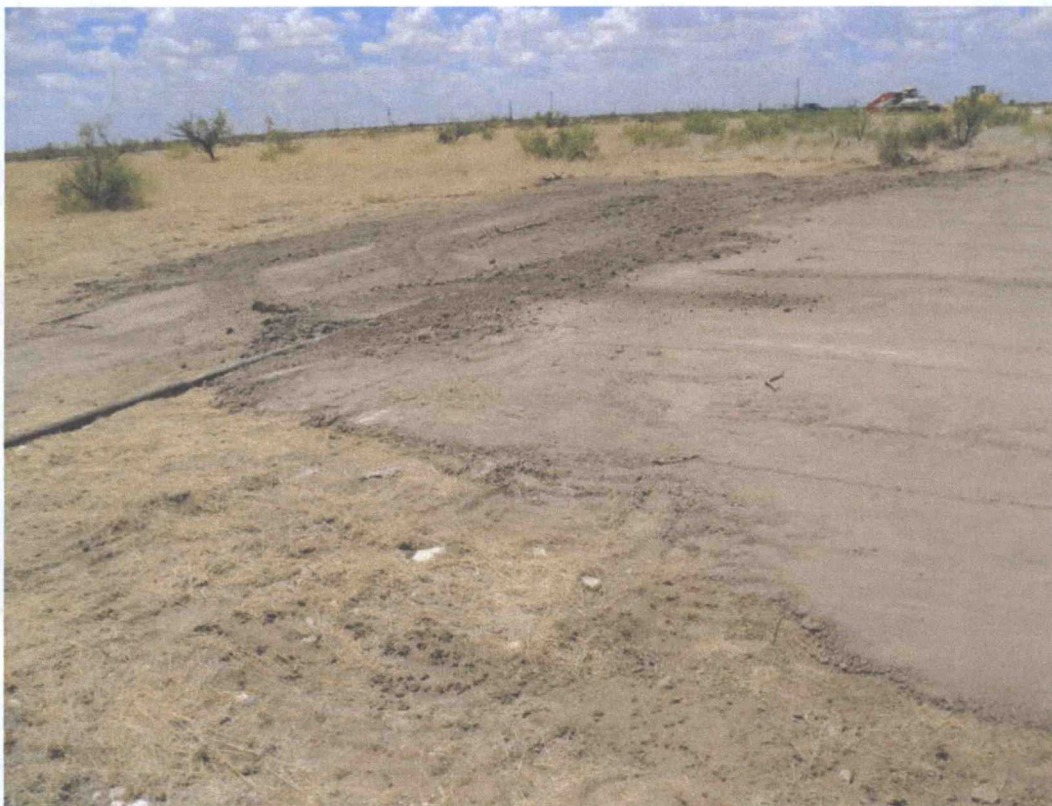
**Photograph No. 8 – Looking easterly at completed backfilled excavation and steel flowline**
