RE: Temporary Pit Closure Report, Jackson Unit #16H  
API #30-025-41167, Pit Permit #P1-06185  
Unit B, Section 15, T24S, R33E, Lea County

## On-Site Burial Location of Temporary Pit

Murchison Oil and Gas, Inc.  
 Jackson Unit #16H

**Closure Letter Attachment 4**  
**Murchison – Jackson Unit #16H**  
**API #30-025-41167**

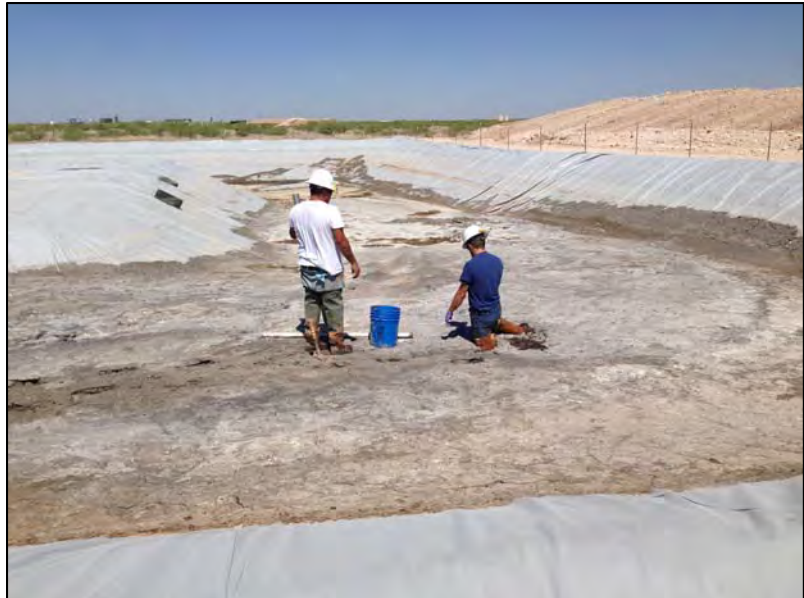
Sampling cuttings of outer cell 6/4/2014

On June 4, 2014, an 8-point composite sample was collected from the temporary pit location and stabilized in the field in a 3:1 ratio using 3 parts available mixing material from the berms of the pit below the liner. The stabilized composite sample was submitted to Hall Environmental Analysis Laboratory in Albuquerque for BTEX (8260B), GRO+DRO (8015M), TPH (418.1), and Chloride (SM4500) analyses. Concentrations from the sample confirm that this site meets criteria for in-place closure in accordance with the limits listed in Table II (19.15.17.13 NMAC) of the Pit Rule.

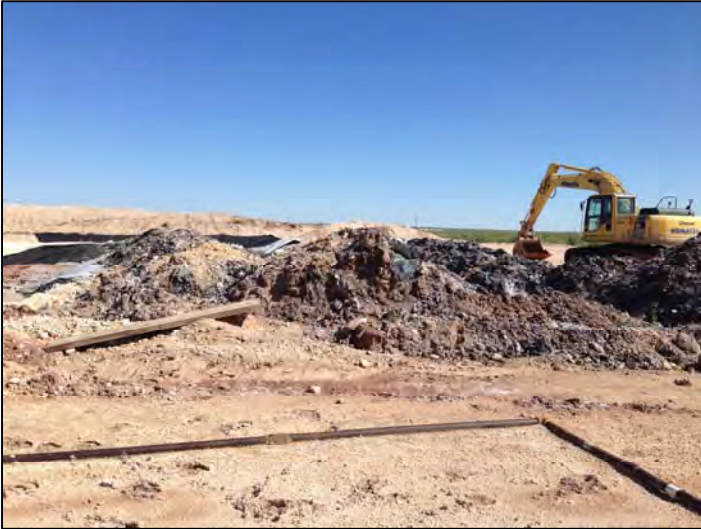
Stabilization mixing 9/10/2014

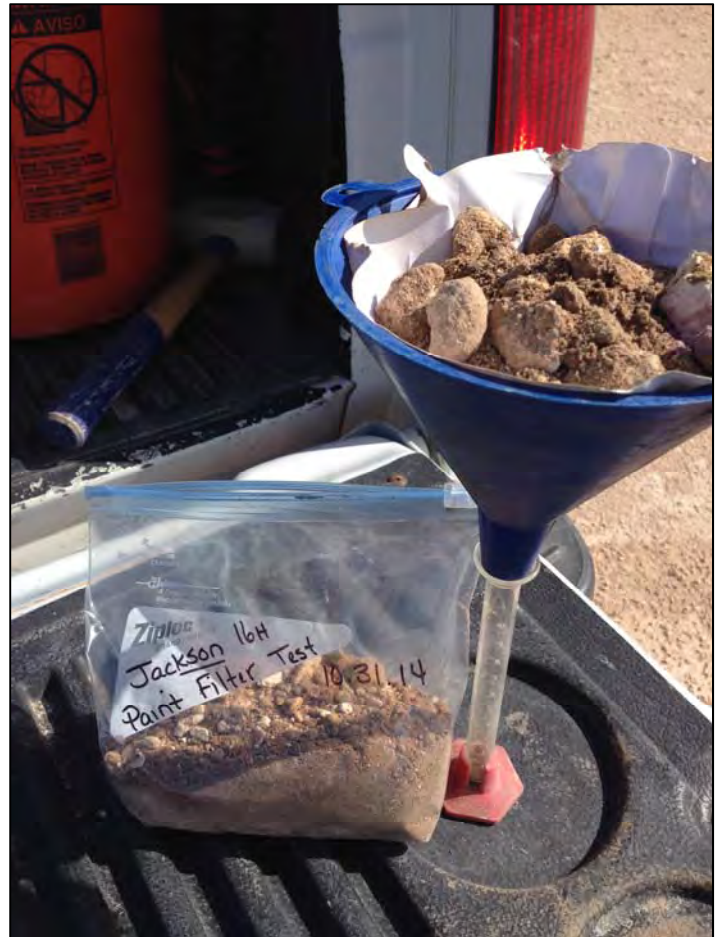
Paint filter test of stabilized cuttings 10/31/2014

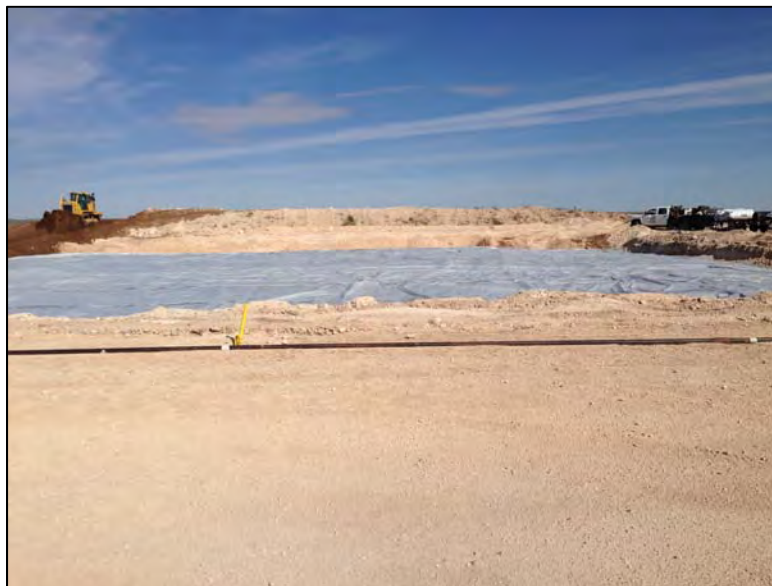
Geomembrane cover installed; backfilling 10/31/2014

5. Having achieved all applicable stabilization requirements associated with in-place burial, a geomembrane liner was installed to completely cover the stabilized cuttings on October 31, 2014. The pit contents and liner were shaped to shed infiltrating water, slightly higher in the center.

6. Once the geomembrane cover was in place, approximately 4 feet or more of non-waste containing, uncontaminated, earthen material and the reserved topsoil were replaced to their relative positions in accordance with Subsection (3) of Paragraph H of 19.15.17.13

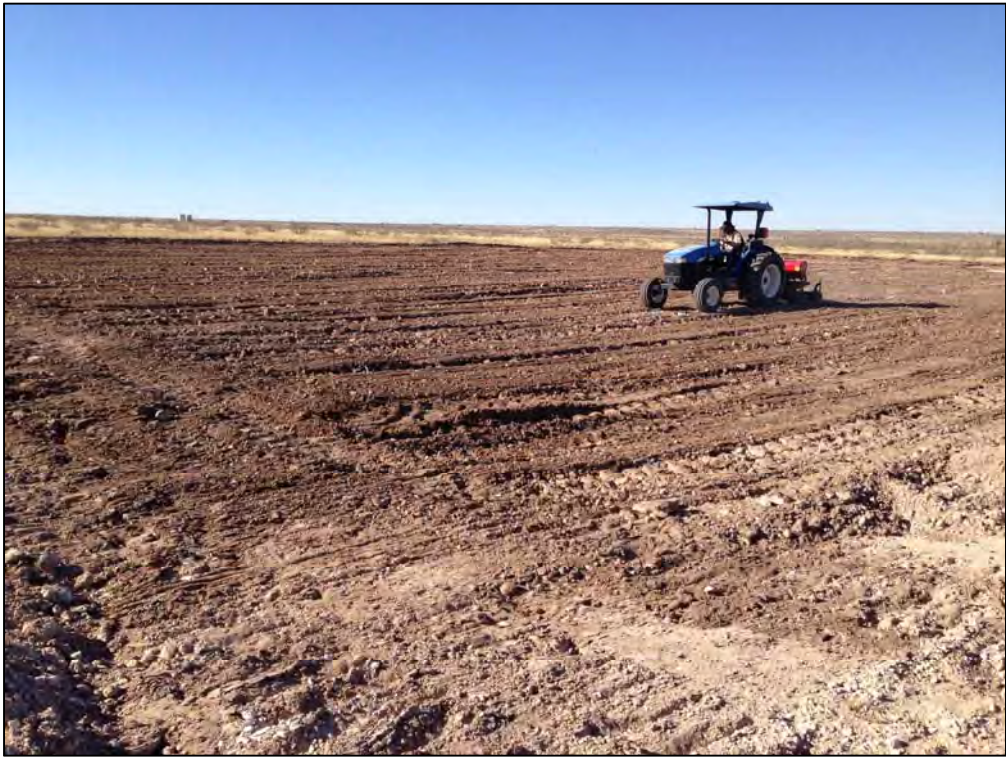
Seeding surface of pit burial location  
11/25/2014

3. After seeding, a steel plate marking the site as an in-place pit closure has been placed on the surface at the center of the former pit location in accordance with Subsection (3) of Paragraph F of 19.15.17.13 NMAC.
4. The seeded area will be monitored for growth and the operator will repeat seeding until a successful vegetative cover is achieved as outlined in Subsection (5) of Paragraph H of 19.15.17.13 NMAC.
5. If conditions are not favorable for the establishment of vegetation, such as periods of drought, the operator may request that the division allow a delay in additional seeding until soil moisture conditions become favorable. The operator will notify the division and provide photo-documentation when it successful re-vegetation is achieved.
