# R. T. HICKS CONSULTANTS, LTD.

RE: Temporary Pit Closure Report  
Bettis 20 State Com #3H, API #30-025-41437, Pit Permit #P1-06546  
Unit O, Section 20, T24S, R33E, Lea County

On behalf of Murchison Oil and Gas, R.T. Hicks Consultants submits this closure report for the above-referenced temporary pit in accordance with the approved C-144 closure plan. This report includes the following information listed in Part 21 of the C-144 form:

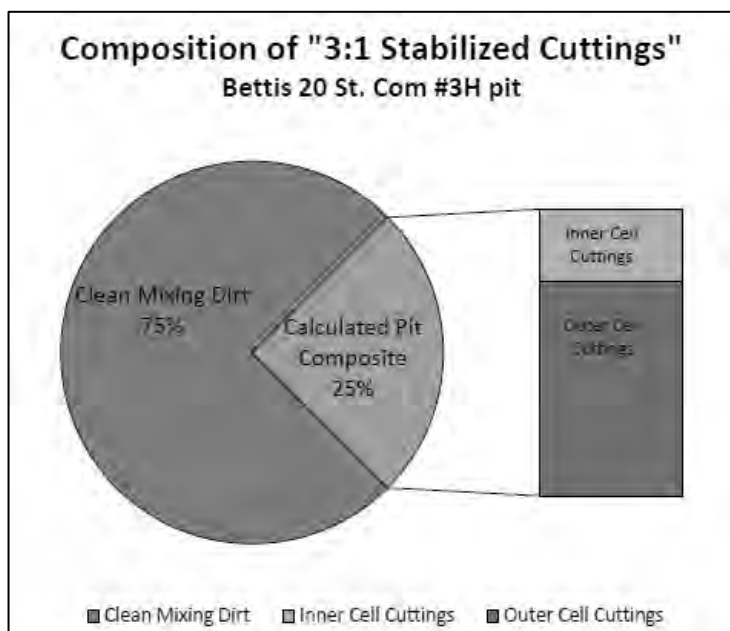
On December 3, 2014, 4-point composite samples were collected from the inner horseshoe cell, outer horseshoe cell, and from the clean soil of the berms (beneath the liner) of the pit for laboratory analyses. The table on page 2 of this notice demonstrates the calculated concentration for "3:1 stabilized" material that results when the pit contents are combined with available mixing soil during the closure process. The calculated value mathematically mixes 3 parts clean soil (mixing dirt) with 1 part of the weighted pit composite calculation, as depicted in the adjacent chart. The pit composite consists of 25% solids from the inner cell of the drilling pit and 75% of the solids from the outer cell (1:3 ratio), representative of the volume of cuttings in each cell.

Bettis 20 St. Com #3H pit Sample Name	Sample Type	Sample Date	Chloride 80,000	Benzene 10	BTEX 50	GRO+ DRO 1000	TPH 418.1 2500
Inner Composite	4-pt field comp.	12/3/2014	4,400	ND	ND	2,000	4,400
Outer Composite	4-pt field comp.	12/3/2014	23,000	1.0	16.0	2,500	5,500
Mixing Dirt	5-pt field comp.	12/3/2014	ND	ND	ND	ND	ND
<b>3:1 Stabilized CALCULATED</b> (3 parts mixing dirt, 1 part weighted pit cuttings)			4,597.50	0.19	3.00	593.75	1,306.25

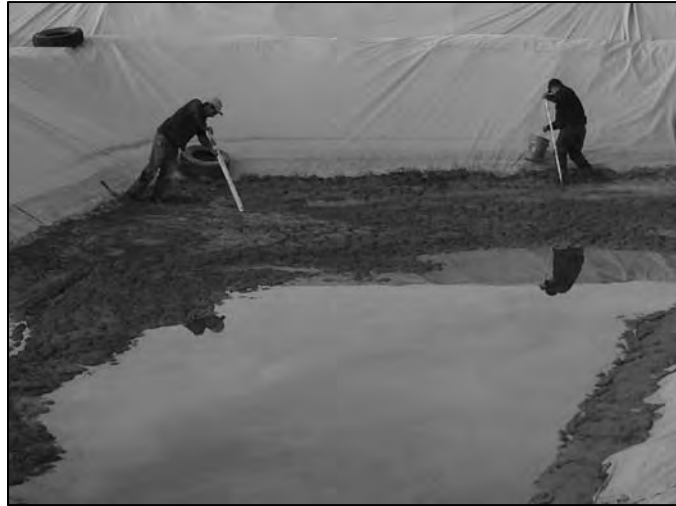
After NMOCD approved a 3-month extension for closure on November 24, 2014, 4-point composite samples were collected from the contents of the outer and inner cells of the temporary pit and from the clean soil of the berms beneath the liner on December 3 2014. The composite samples were submitted to Hall Environmental Analysis Laboratory in Albuquerque for BTEX (8260B), GRO+DRO (8015D), TPH (418.1), and Chloride (SM4500) analyses. These component samples were used to determine a calculated concentration for the “3:1 stabilized cuttings” by mathematically combining 1 part pit

Sampling Pit Contents 12/3/2014

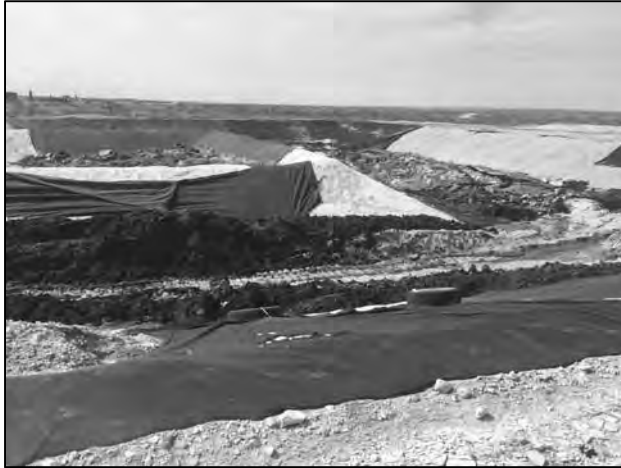
Beginning closure mixing      2/24/2015

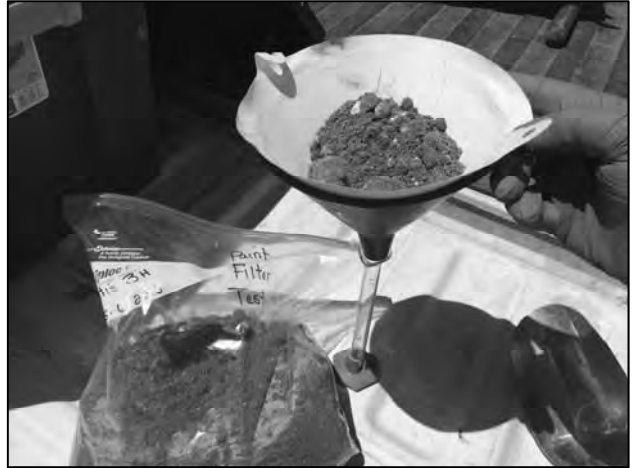
Paint filter test on stabilized cuttings  
5/6/2015

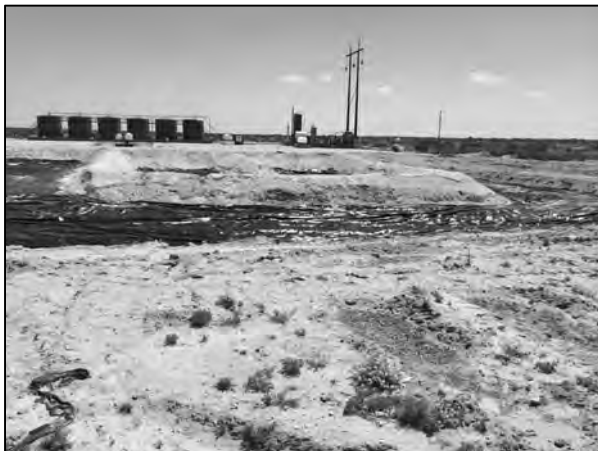
Geomembrane cover over stabilized cuttings  
5/8/2015

7. Once the geomembrane cover was in place, approximately 4 feet or more of non-waste containing, uncontaminated, earthen material and the reserved topsoil were replaced to their relative positions in accordance with Subsection (3) of Paragraph H of 19.15.17.13 NMAC. The soil cover consists of at least four feet of compacted, non-waste containing, earthen material. The uppermost topsoil is equal to the background thickness at least one foot. The surface was contoured to blend with the surrounding topography and to prevent erosion and the ponding of water over the on-site closure. This work was completed on May 12, 2015.
