RE: EOG CAMANCHE STATE #4

Received: 01/29/2013
Reported: 02/01/2013
Project Name: EOG CAMANCHE STATE #4
Project Number: GAN-12-001
Project Location: LEA COUNTY, NM

Closed-Loop System Permit or Closure Plan Application

Facility or well name: Comanche State Unit 4

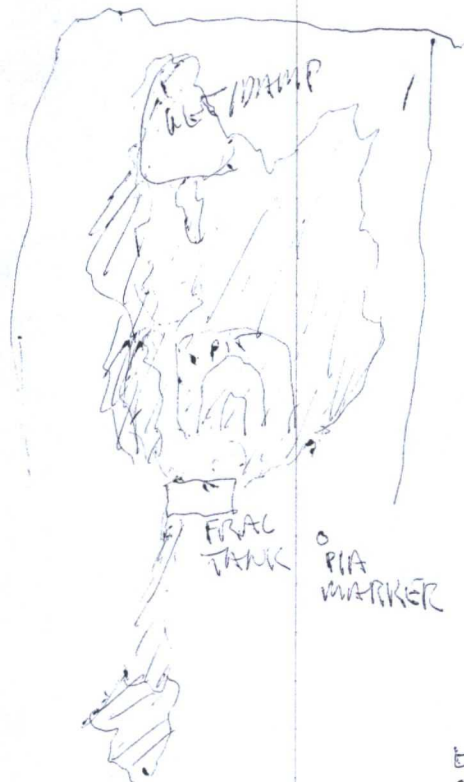
- KENNY ROUMBS, McDONNOLD
- ALBERT SANCHEZ, BIG TIME
- 2' SCRAPPED @ AREA W
OF FORMER TANK AREA
- 1' AT REST OF SITE
- CALC HE MARK WORKED
TO REPLACE FORMER
CALICHE
- SAND & SEED REST
- WILL RETURN FOR
CHECK OUT FINAL COVER

- PA MARKER, FRAC TANK
& OPEN REWORK PIT (WORKOVER)
PRESENT
- GREAT VOLUME OF
BRINE RELEASED
FROM PIT AND FRAC
TANK - HUY STAIN
& RESIDUE
- TORN LINER - RESIDUE IN

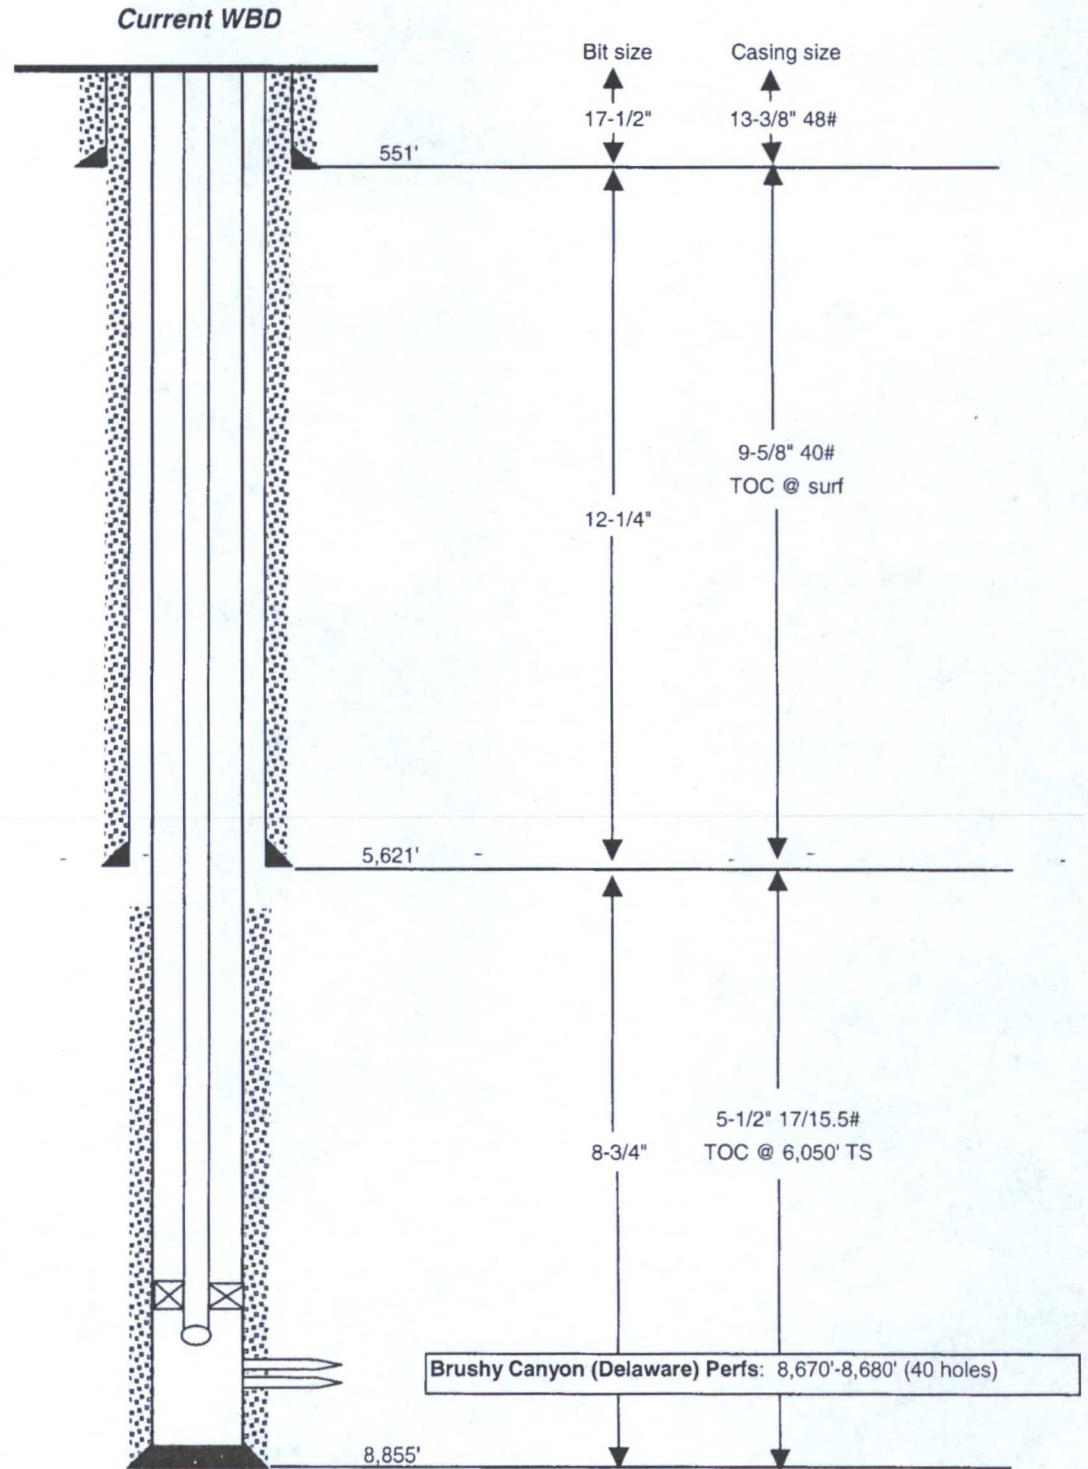
Comanche State Unit No. 4

1,980' FNL & 660' FEL
Sec. 9, T21S, R33E
Lea County, New Mexico
API 30-025-27828

PBTB 8,829'

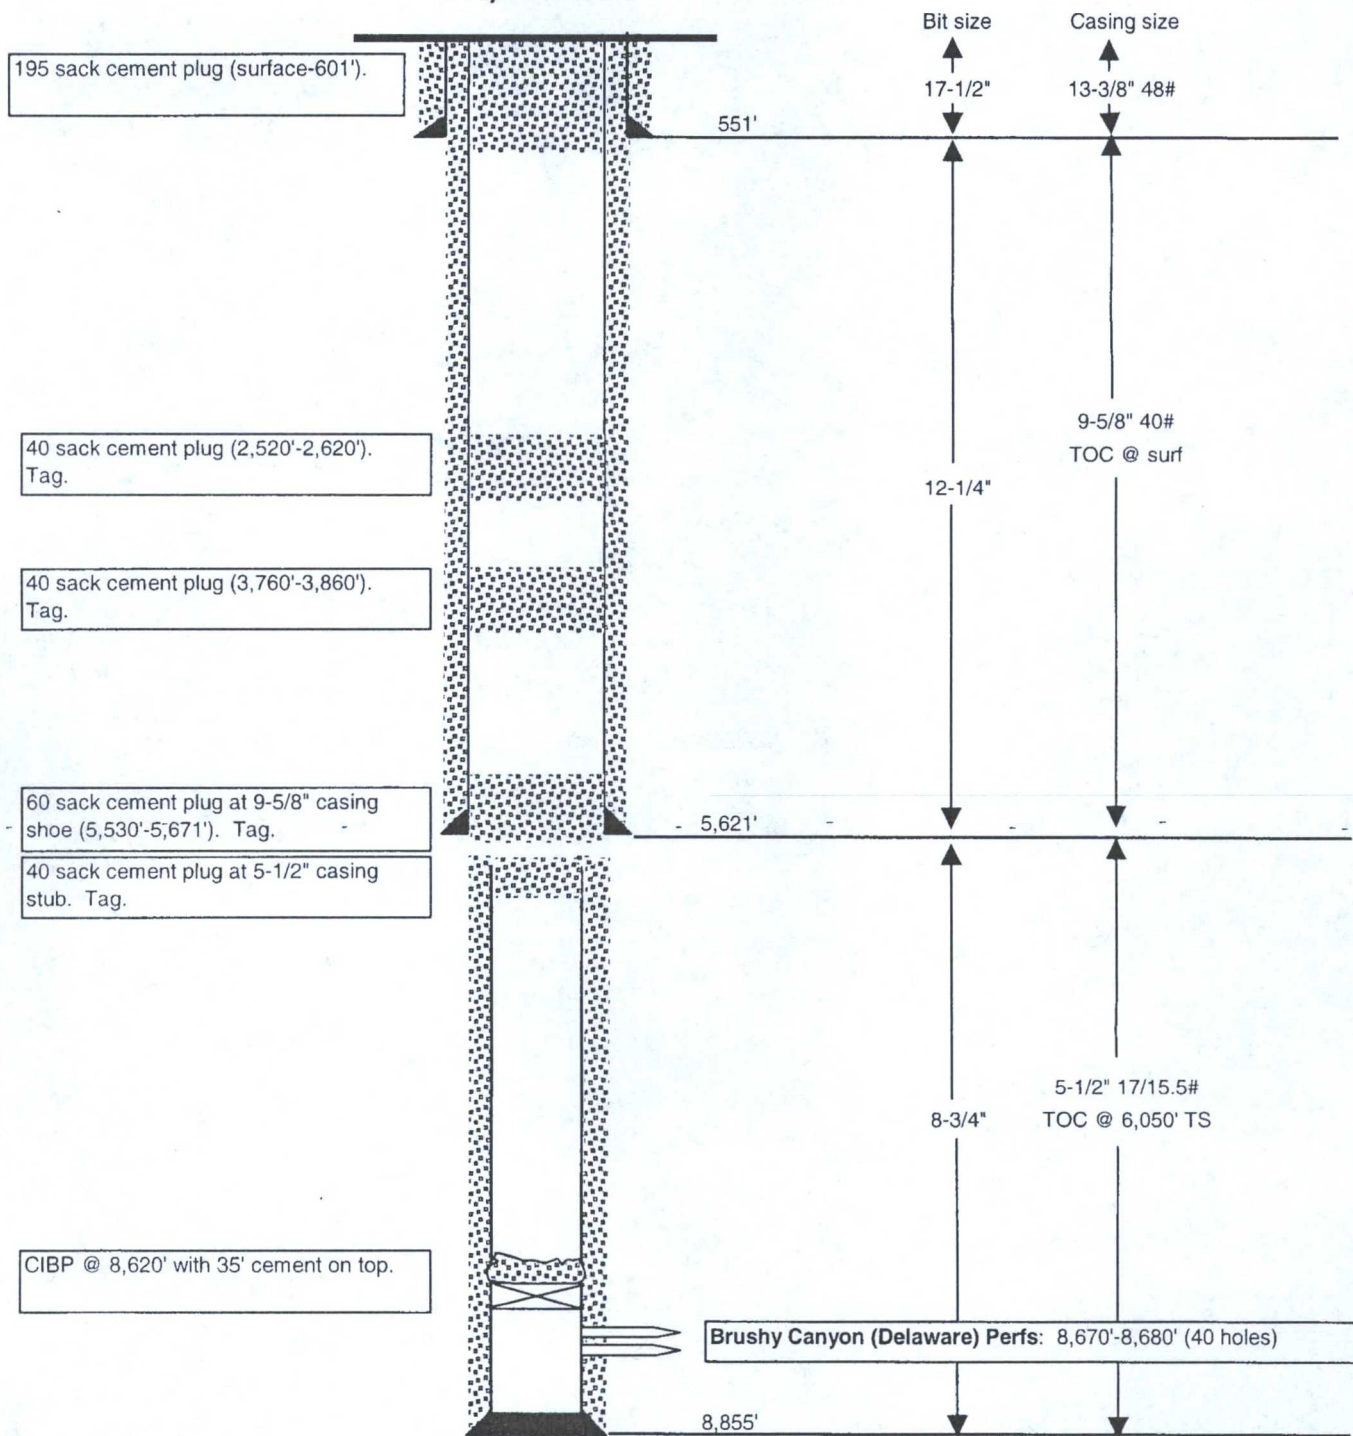
Proposed P&A

- Set CIBP @ +/- 8620' and cap w/ 35' of cement.
- Cut and pull 5-1/2" casing @ +/- 5950'.
- Spot 40 sx cement plug at 5-1/2" casing stub. Tag.
- Spot 60 sx cement plug from 5530' to 5671'. Tag.
- Spot 40 sx cement plug from 3760' to 3860'. Tag.
- Spot 40 sx cement plug from 2520' to 2620'. Tag.
- Pump 195 sx cement plug from 601' to surface.
- Cut off wellhead and weld on dry hole marker.

1,980' FNL & 660' FEL
Sec. 9, T21S, R33E
Lea County, New Mexico
API 30-025-27828

PBTD 8,829'
