Closure Report

Lea 4011 State #1

Lea County, NM

Linn Energy
Lea 4011 State #1
UL 'N' Sec. 8 T18S R35E
Lea County, NM

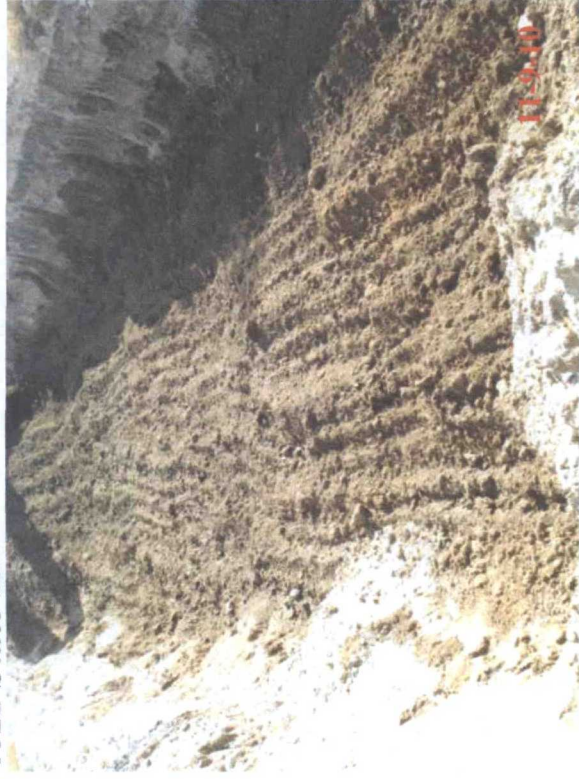
Pit facing West after excavation of mud and liner.

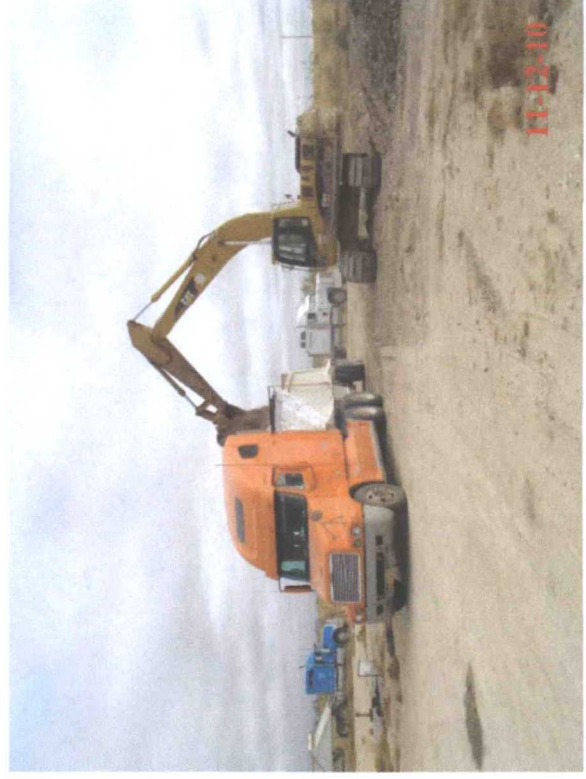
Excavating and loading impacted soil for disposal.

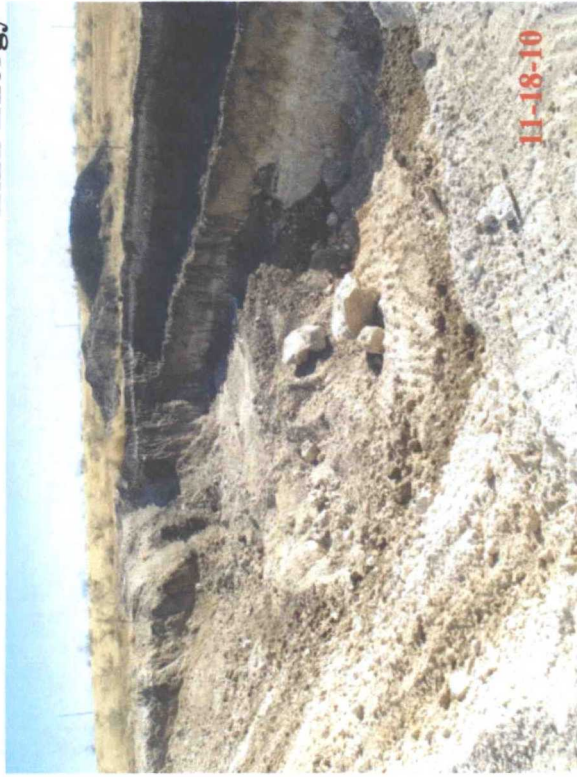
11-18-10

Site facing East after excavation of impacted soil.
