Pit or Below-Grade Tank Registration or Closure

# Closure Report

**G T Hanners #1**  
**API # 30-025-07182**  
**Lea County, NM**

Re: Saber Resources – G T Hanners #1  
UL 'O' Sec. 18 T12S R38E Lea County, NM  
API # 30-025-07182

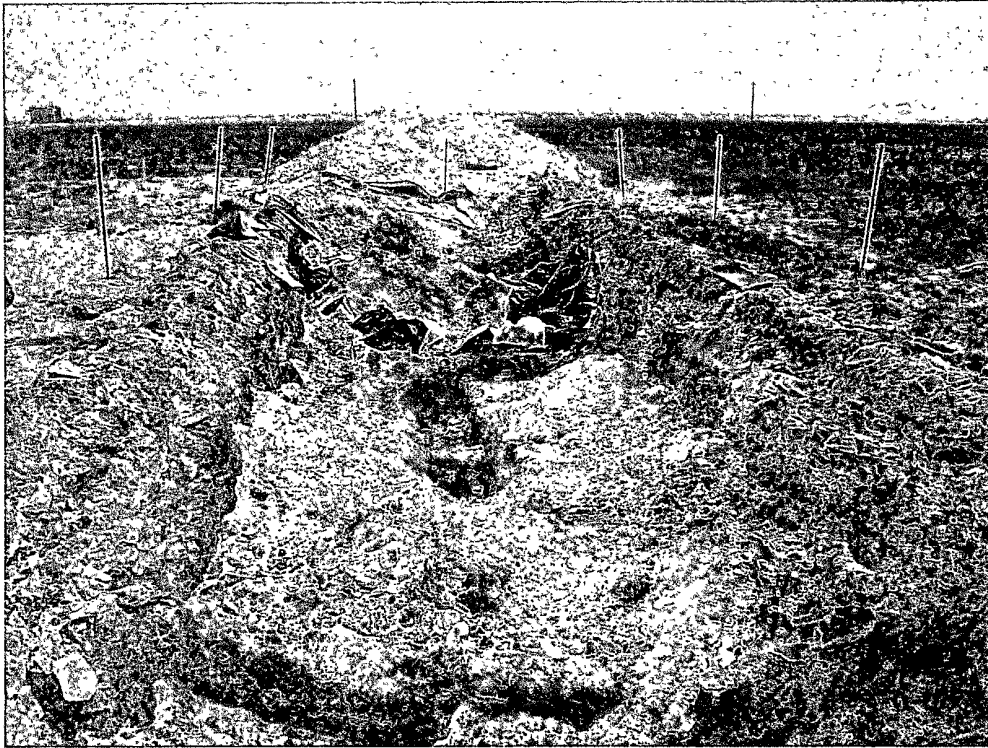
Drilling pit before closure.

Additional Comments: All drilling mud and liner was excavated and hauled to Gandy Marley Disposal. After mud was removed, bottom and wall samples were analyzed per NMOCD Guidelines. The samples met NMOCD standards for this site. The pit was backfilled with clean native soil and contoured to the surrounding area.

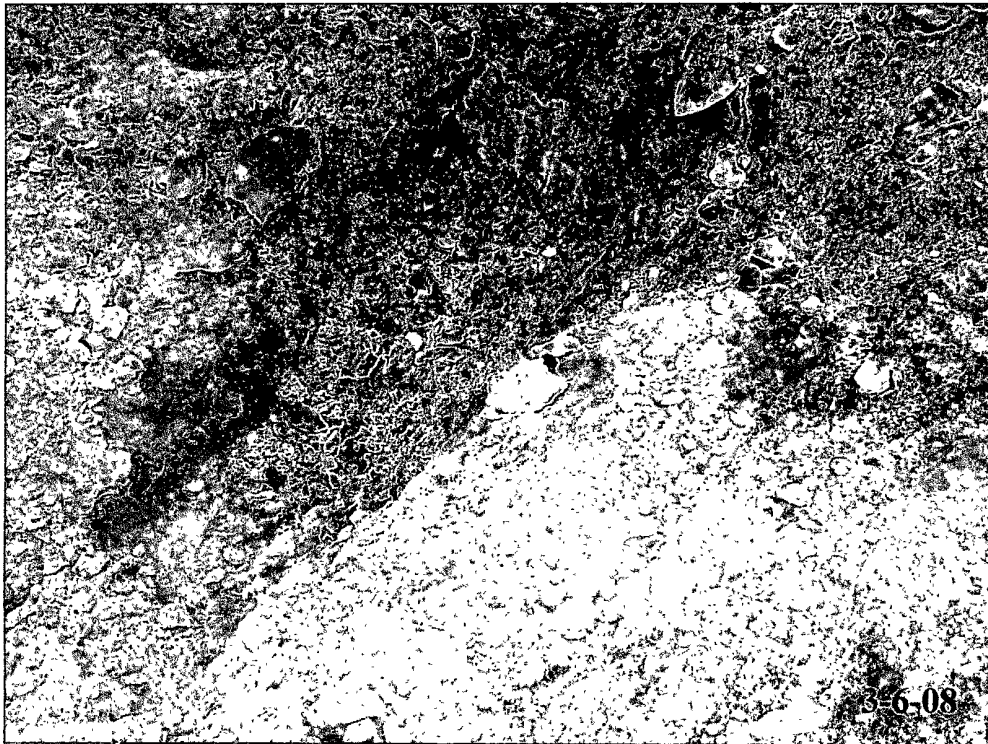
Delineation trench of drilling pit.
