RE: Temporary Pit Closure Report, Jackson Unit #21H  
API #30-025-41140, Pit Permit #P1-06109  
Unit P, Section 21, T24S, R33E, Lea County

RE: Murchison – Jackson Unit 21H Temporary Pit  
In-place Burial Notice  
Unit P, Section 21, T24S, R33E, API #30-025-41140

**Closure Letter Attachment 4**  
**Murchison – Jackson Unit #21H**  
**API #30-025-41140**

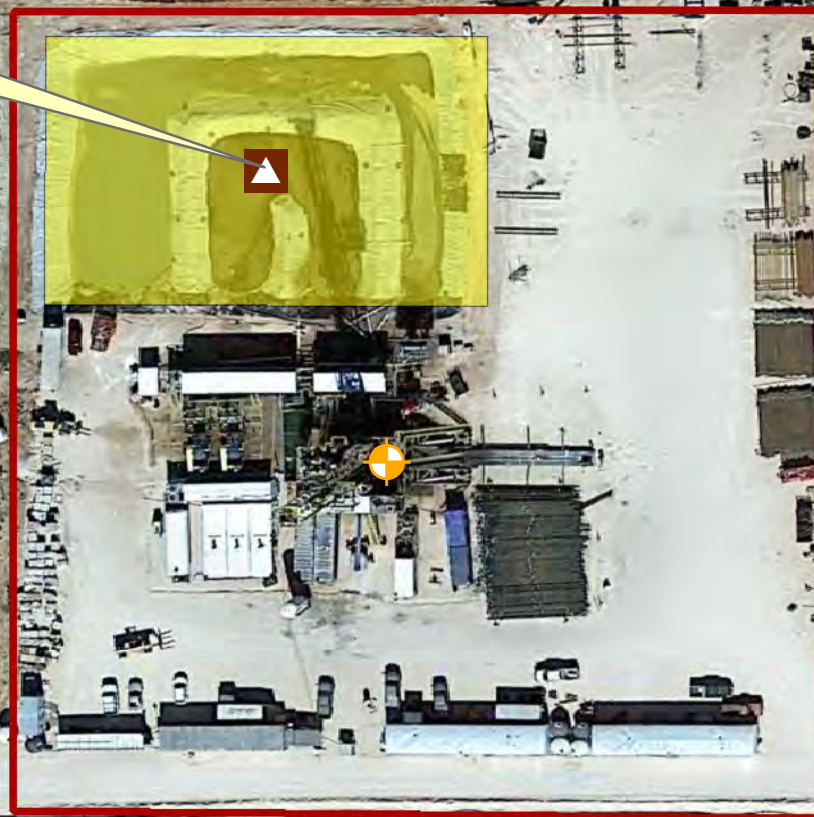
Plate 1  
 form C-105  
 December  
 2014

On-site Burial Center  
 Lat: 32.19683  
 Long: -103.572024  
 (NAD 83)

On-Site Burial Location of Temporary Pit

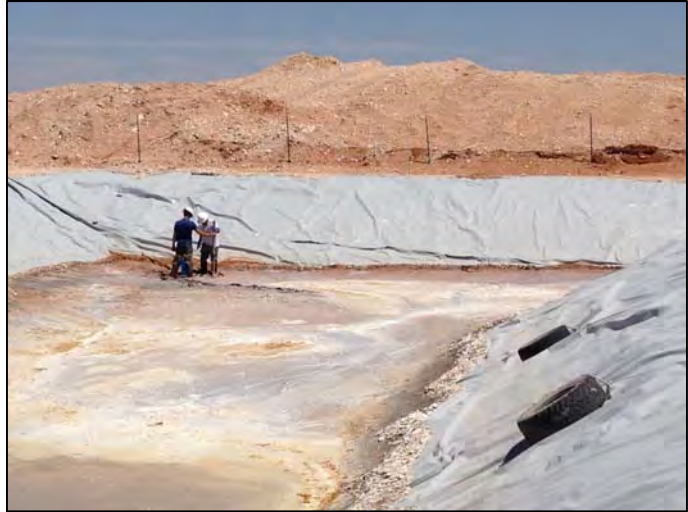
Sampling cuttings of outer cell 6/4/2014

Six weeks later on June 4, 2014, the pit contents were sampled again and another 3:1 stabilized cuttings sample was composed and submitted for laboratory analyses. This time, all of the Table II constituents were met, demonstrating that this site qualifies for the in-place burial method for closure of the temporary pit. The table below depicts this stabilized sample and its concentrations of the parameters of Table II in the Pit Rule.

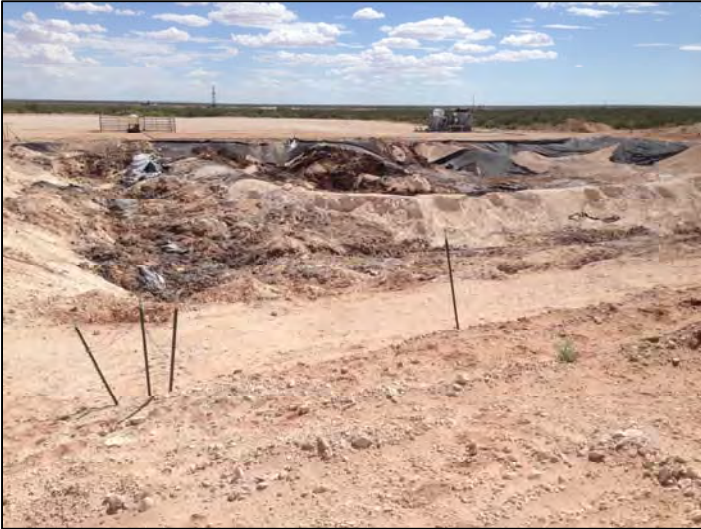
First day of stabilization mixing 8/20/2014

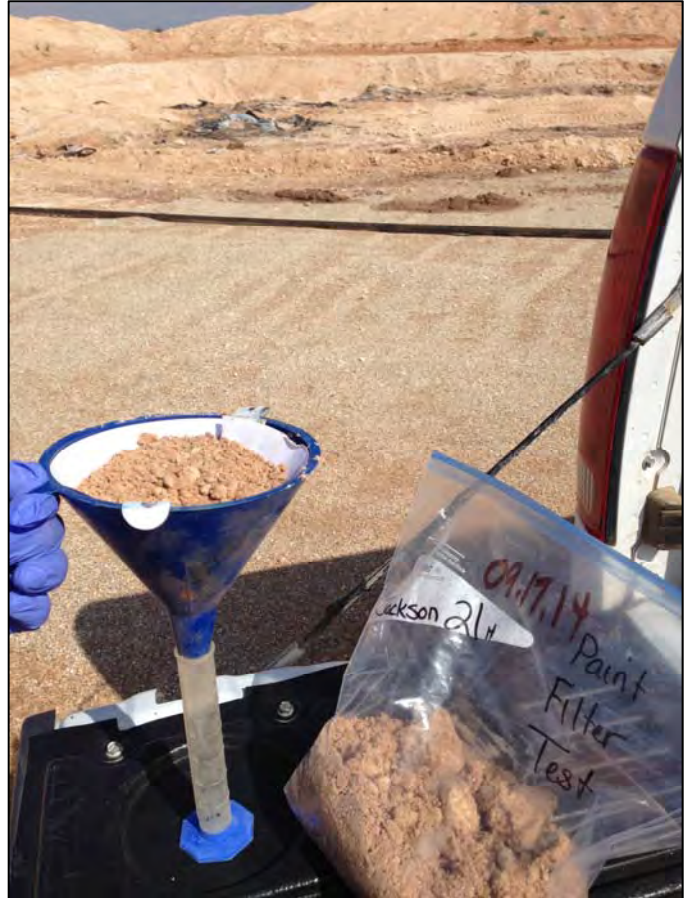
Paint filter test of stabilized cuttings 9/17/2014

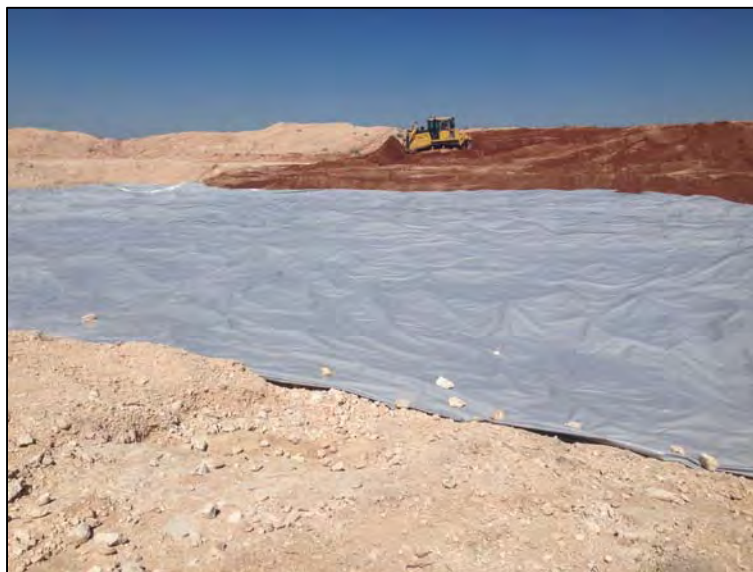
Geomembrane cover installed 10/9/2014

5. Having achieved all applicable stabilization requirements associated with in-place burial, a geomembrane liner was installed to completely cover the stabilized cuttings on October 9, 2014. The pit contents and liner were shaped to shed infiltrating water, slightly higher in the center.
