R. T. HICKS CONSULTANTS, LTD.

RE: Temporary Pit Closure Report
Bettis 20 State Com #5H, API #30-025-41439, Pit Permit #P1-06549
Unit M, Section 20, T24S, R33E, Lea County

RE: Bettis 20 State Com #5H Temporary Pit, In-place Burial Notice
API #30-025-41439, Pit Permit #P1-06549
Unit M, Section 20, T24S, R33E, Lea County

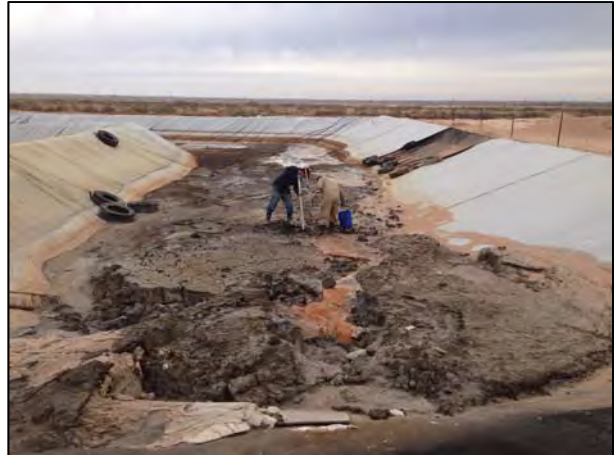
Sampling Pit Contents 12/4/2014

After the rig was released and the well was completed, Micro-Blaze® microbial product was applied to the cuttings in October 2014 in anticipation of elevated hydrocarbons. On December 3, 2014, a 5-point composite sample was collected from the clean soil of the berms beneath the liner (mixing dirt) and 4-point composite samples were collected from the contents of the outer and inner cells of the temporary pit on December 4. The samples were submitted to Hall Environmental Analysis Laboratory in Albuquerque for BTEX (8260B), GRO+DRO (8015D), TPH (8015D), and Chloride (SM4500) analyses. These component samples were used to determine a calculated concentration for the “3:1 stabilized cuttings” by mathematically combining 1 part pit contents and 3 parts clean soil (mixing dirt). The weighted pit composite calculation consisted of 21% solids from the inner cell of the drilling pit and 79% of the solids from the outer cell, representative of the volume of cuttings in each cell. These samples did not meet Table II concentrations for in-place closure and the pit was treated with additional Micro-Blaze®.

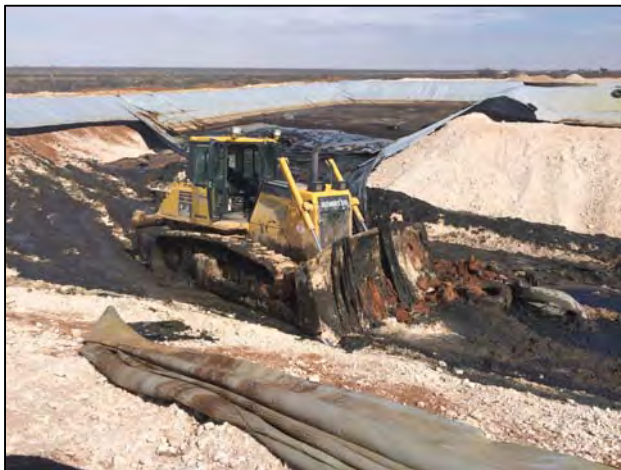
Beginning closure mixing 2/24/2015

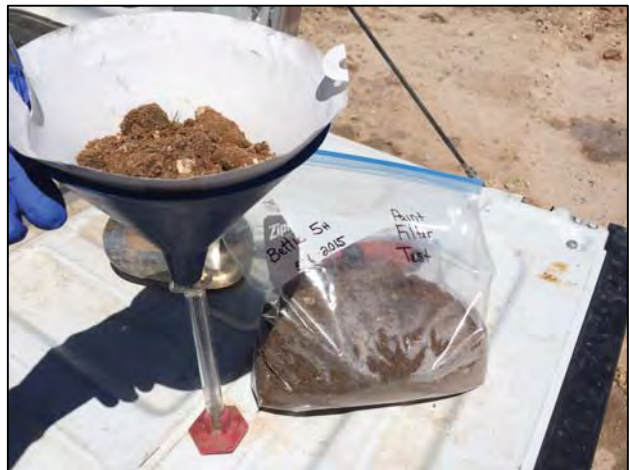
Paint filter test on stabilized cuttings
5/6/2015

6. Following the May 6, 2015 inspection, having achieved all applicable stabilization requirements associated with in-place burial, a geomembrane liner was installed to completely cover the stabilized cuttings on May 8, 2015. The pit contents and liner were shaped to shed infiltrating water.

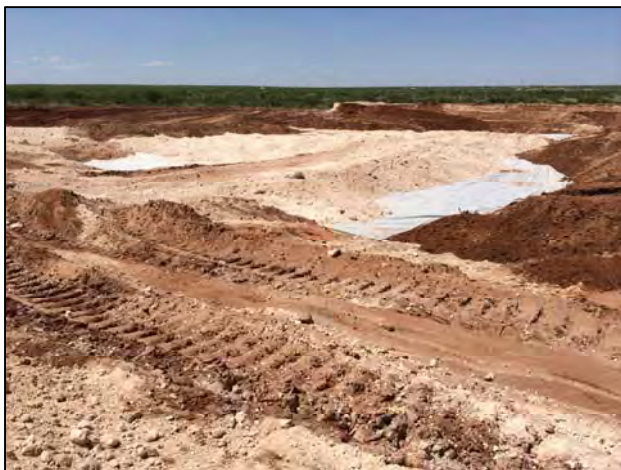
Backfilling over geomembrane cover
5/8/2015

containing, uncontaminated, earthen material and the reserved topsoil were replaced to their relative positions in accordance with Subsection (3) of Paragraph H of 19.15.17.13 NMAC. The soil cover consists of at least four feet of compacted, non-waste containing, earthen material. The uppermost topsoil is equal to the background thickness at least one foot. The surface was contoured to blend with the surrounding topography and to prevent erosion and the ponding of water over the on-site closure. This work was completed on May 11, 2015.
