R. T. HICKS CONSULTANTS, LTD.

RE: Temporary Pit Closure Report
Caravan "BVW" State No. 9H API #30-025-41641
Unit C, Section 33, T24S, R33E, Lea County

Waste Material Sampling Analytical Results

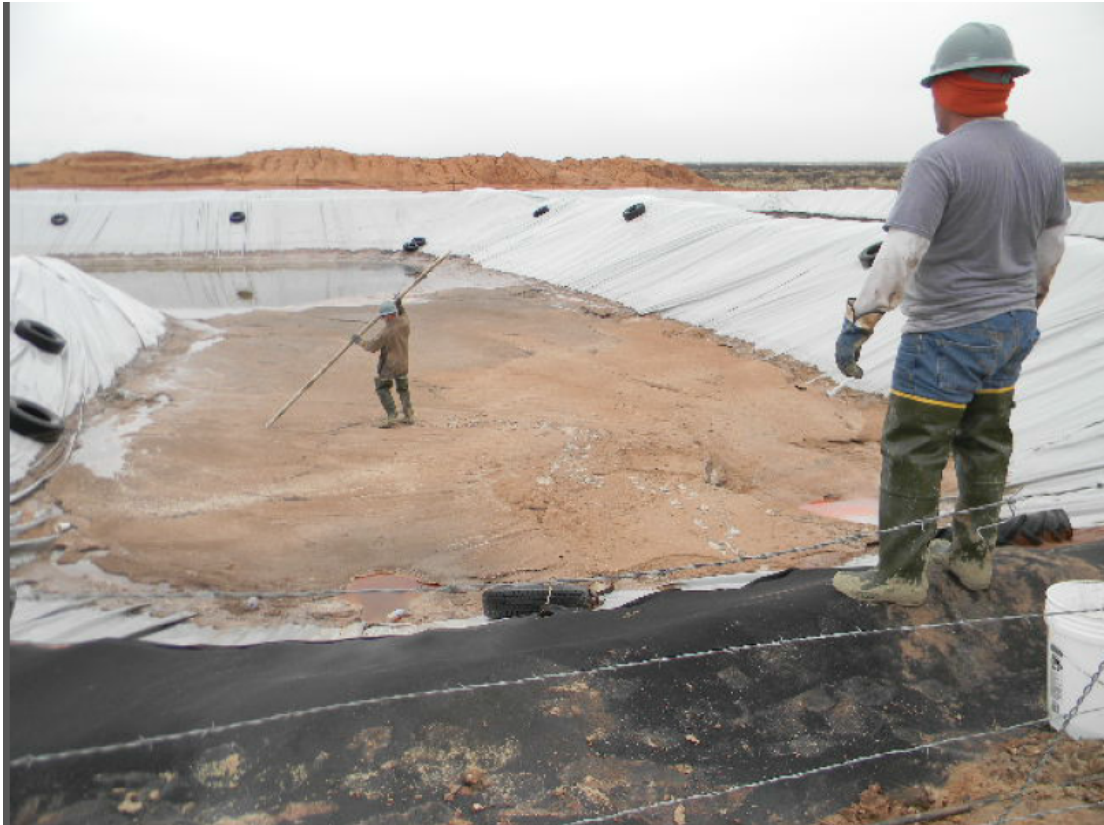
On March 4, 2015, eight-point composite samples were collected from the temporary pit. Clean mixing soil was collected from under the liner. The composite samples was submitted to Hall Environmental Analysis Laboratory in Albuquerque, New Mexico for BTEX (8260B), GRO/ GRO (8015M), and Chloride (SM4500) analyses.

The table below depicts the samples collected from the cuttings in this pit and their concentrations of the parameters listed in Table II of 19.15.17.13 NMAC (June 2013 Pit Rule). These analyses demonstrate that this site meets the criteria for in-place closure.

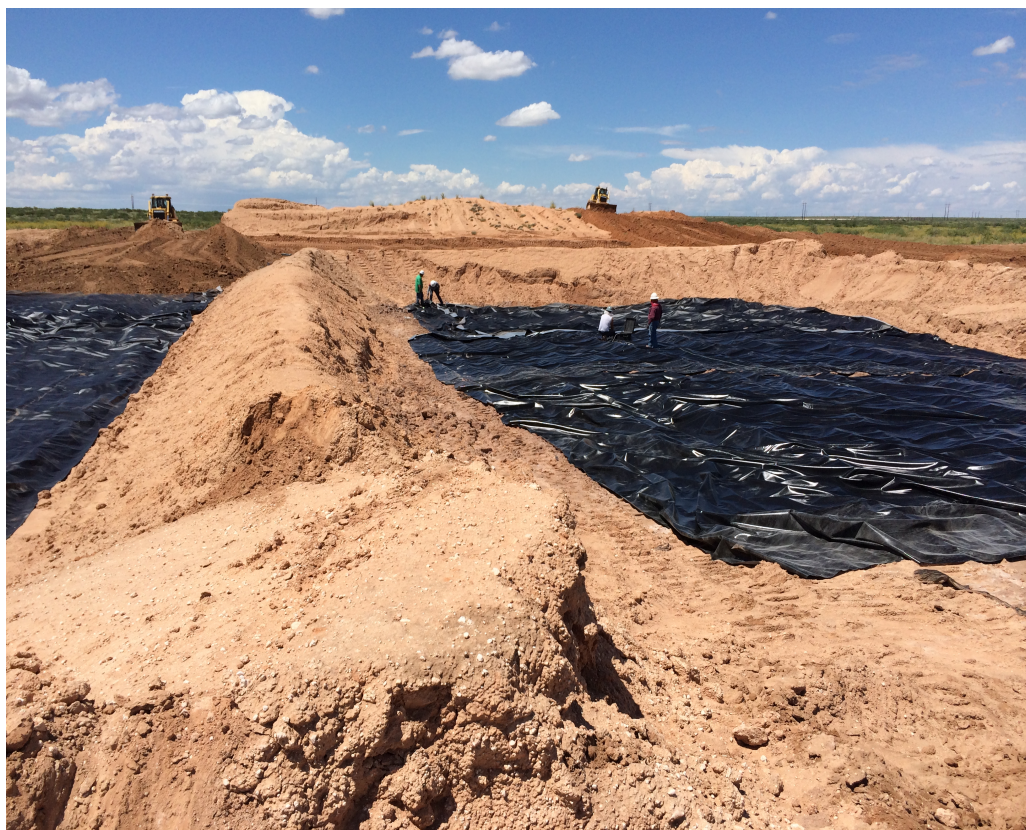
Paint Filter Test on 6/10/15.

5. Following the June 10, 2015 inspection, having achieved all applicable stabilization requirements associated with in-place burial, a 20 Mil. geomembrane liner was installed to completely cover the stabilized cuttings on June 10, 2015. The pit contents and liner were shaped to shed infiltrating water, sloping from west to east.
