Release Notification

| Site Name: Mesa 2H | Site Type: Production Facility |

A Victaulic clamp on the three stage vessel failed and leaked produced water to containment. No produced water leaked outside of the containment.

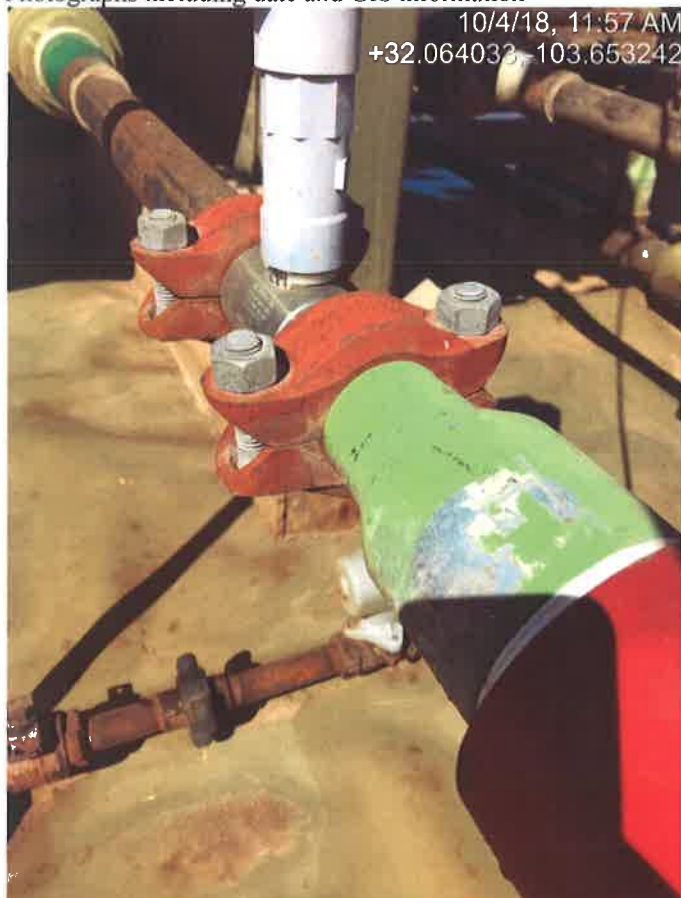
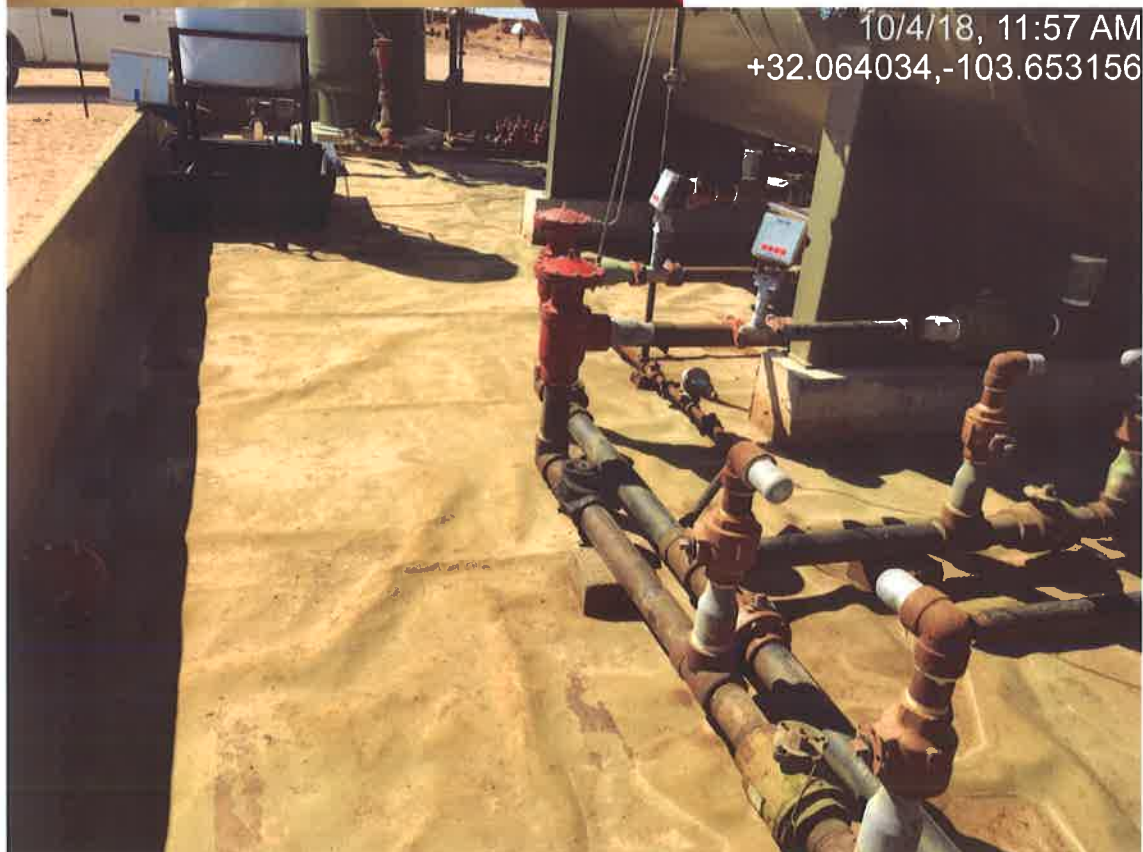
Photographs including date and GIS information

We had a minor spill to containment at the Mesa 2H battery. GPS coordinates 32.064124°, -103.653310°. About 20 barrels leaked from a water clamp on the three stage vessel.

Produced water was immediately removed with vacuum truck and Victaulic clamp replaced.

2. Dated, geo-referenced photo documentation are required for closure. One of the photos must demonstrate an exposed and clean liner as per 19.15.29.10 NMAC.
