SUNDRY NOTICES AND REPORTS ON WELLS (DO NOT USE THIS FORM FOR PROPOSALS TO DRILL OR TO DEEPEN OR PLUG BACK TO A DIFFERENT RESERVOIR. USE "APPLICATION FOR PERMIT" (FORM C-101) FOR SUCH PROPOSALS.)		WELL API NO. 30-009-20022

**Subject: Stovall 13-1 Gas Well Completion Pit Closure Report
Terry and Pamela Stovall Partnership Lease
Curry County, New Mexico**

APPENDIX A
Photographic Log

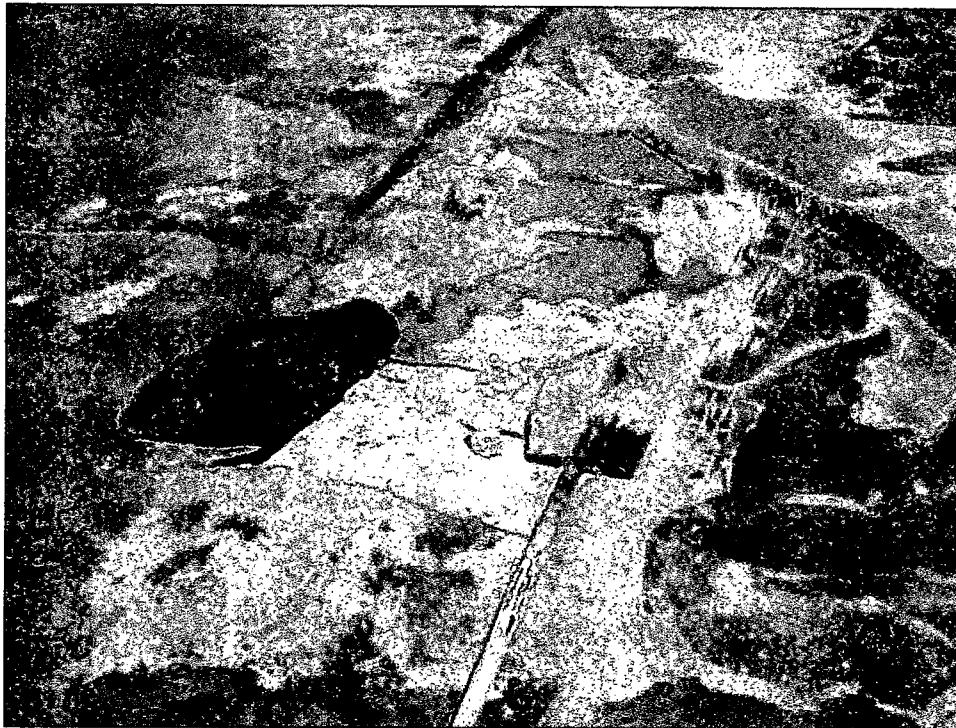
Photo 2. Sample location Stovall-82611-A (looking northwest).

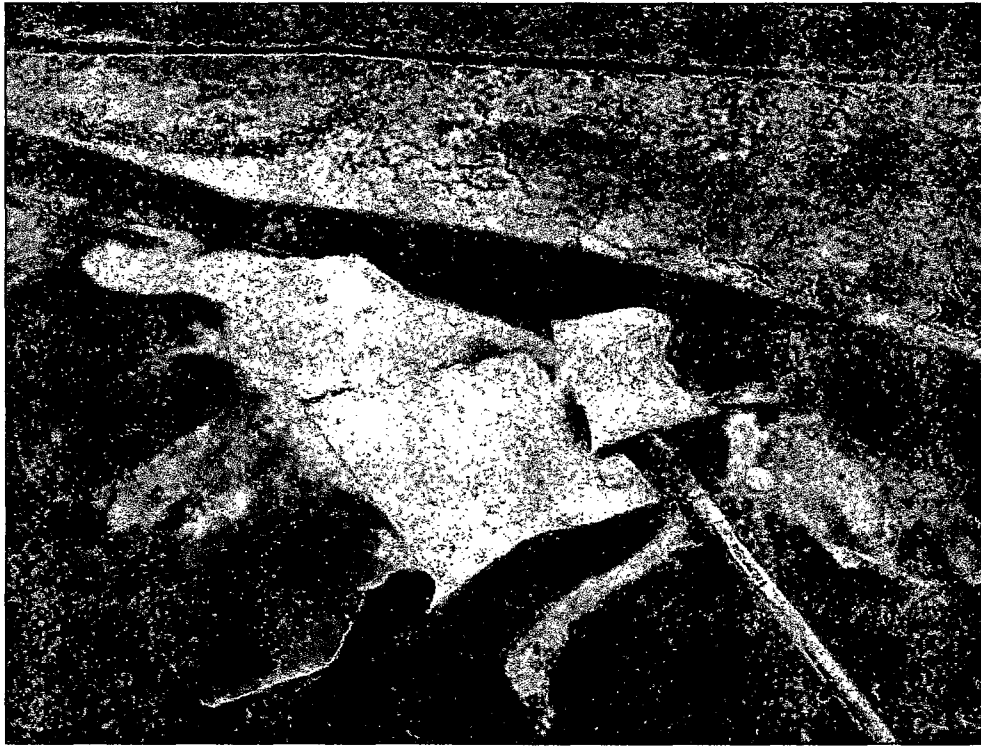
Photo 5. Sample location Stovall-82611-D (looking northeast).

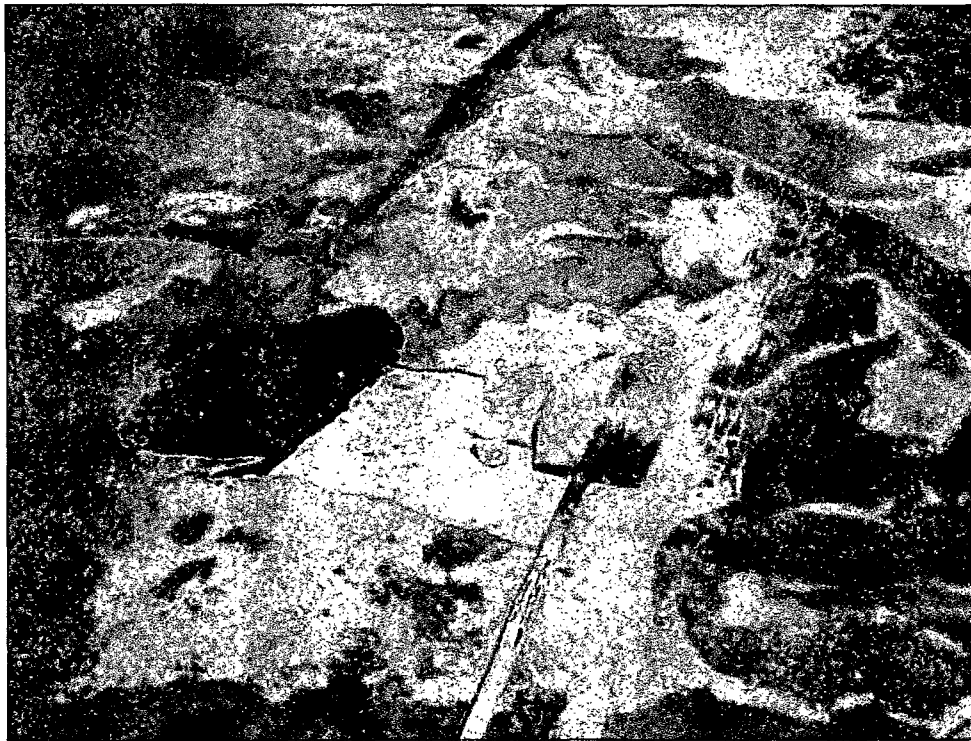
Photo 6. Sample location Stovall-82611-E (looking northwest).

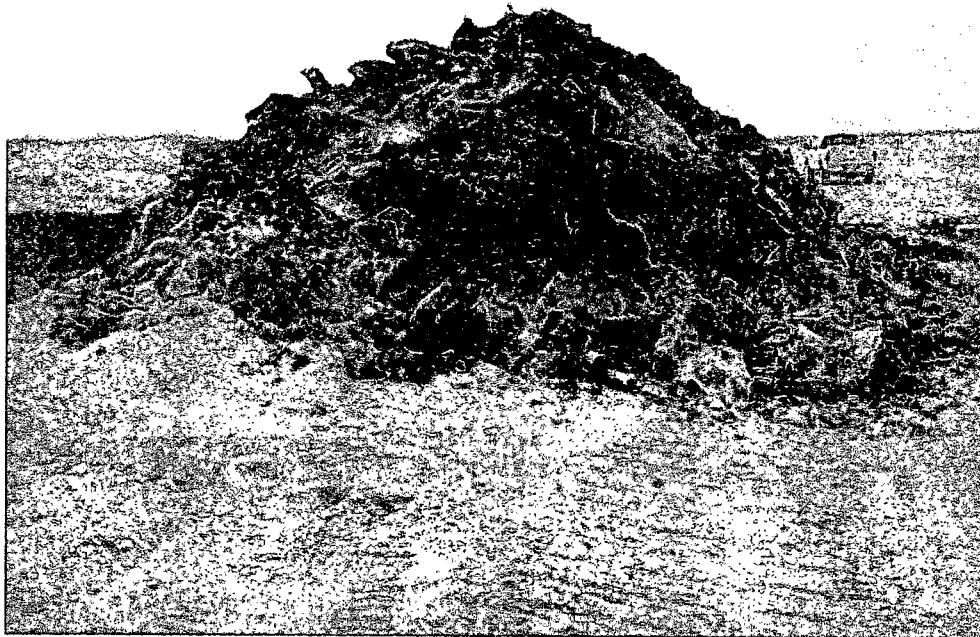
Photo 9. Liner removed and staged for transport and disposal (looking north).
