Pit, Below-Grade Tank, or
Proposed Alternative Method Permit or Closure Plan Application

1.
Operator: Chevron, USA OGRID #: _____
Address: 56 Texas Camp Road, Lovington, New Mexico 88260
Facility or well name: Central Vacuum Unit #342
API Number: 30-025-38002 OCD Permit Number: _____
U/L or Qtr/Qtr A Section 36 Township 17S Range 34E County: Lea
Center of Proposed Design: Latitude N 32.7986° Longitude W 103.5089° NAD: ☐ 1927 ☐ 1983
Surface Owner: ☐ Federal ☒ State ☐ Private ☐ Tribal Trust or Indian Allotment

CRA recommends no further action be required for the Site and requests closure of the Central Vacuum Unit #342 Pit (RP #2672). Attached to the front of this closure report is a completed and signed Form C-144.

PHOTOGRAPH LOG
Central Vacuum Unit #342
Lea County, New Mexico
Chevron Environmental Management Company

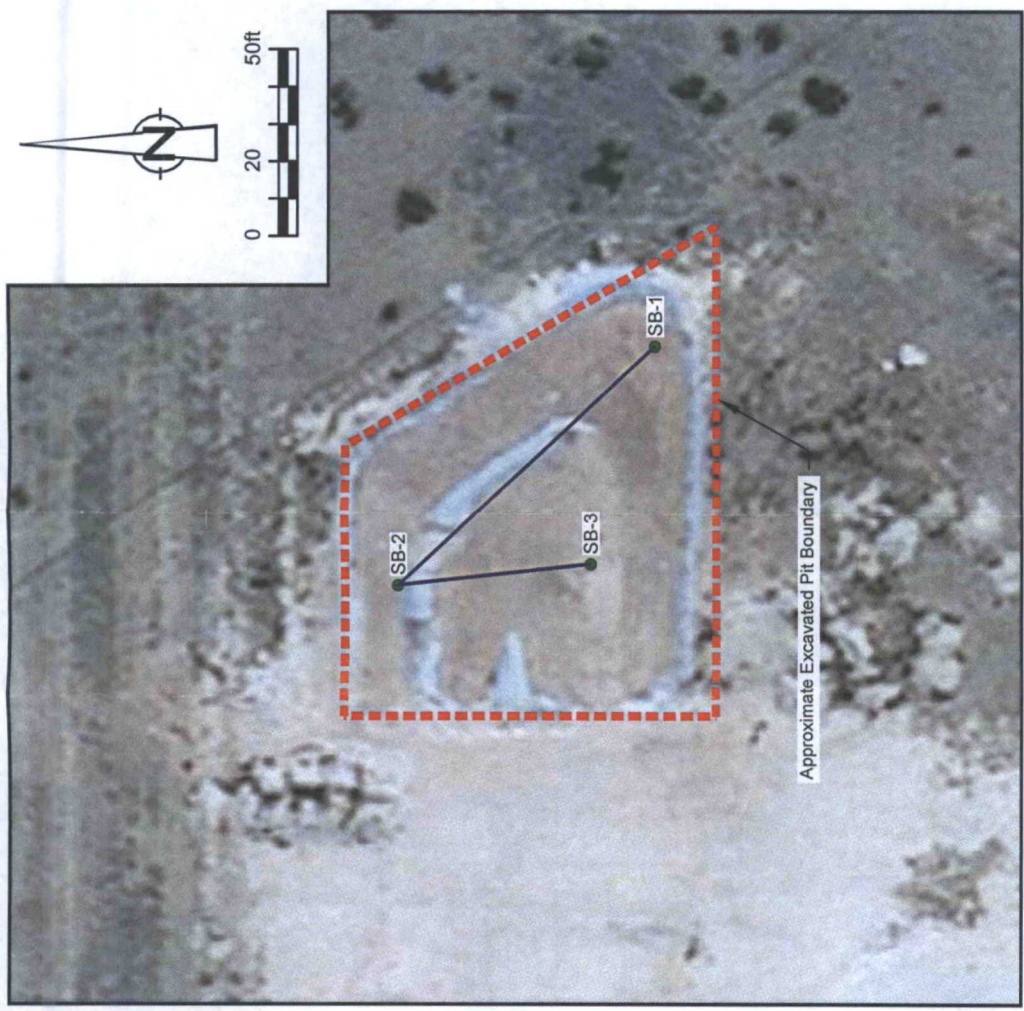
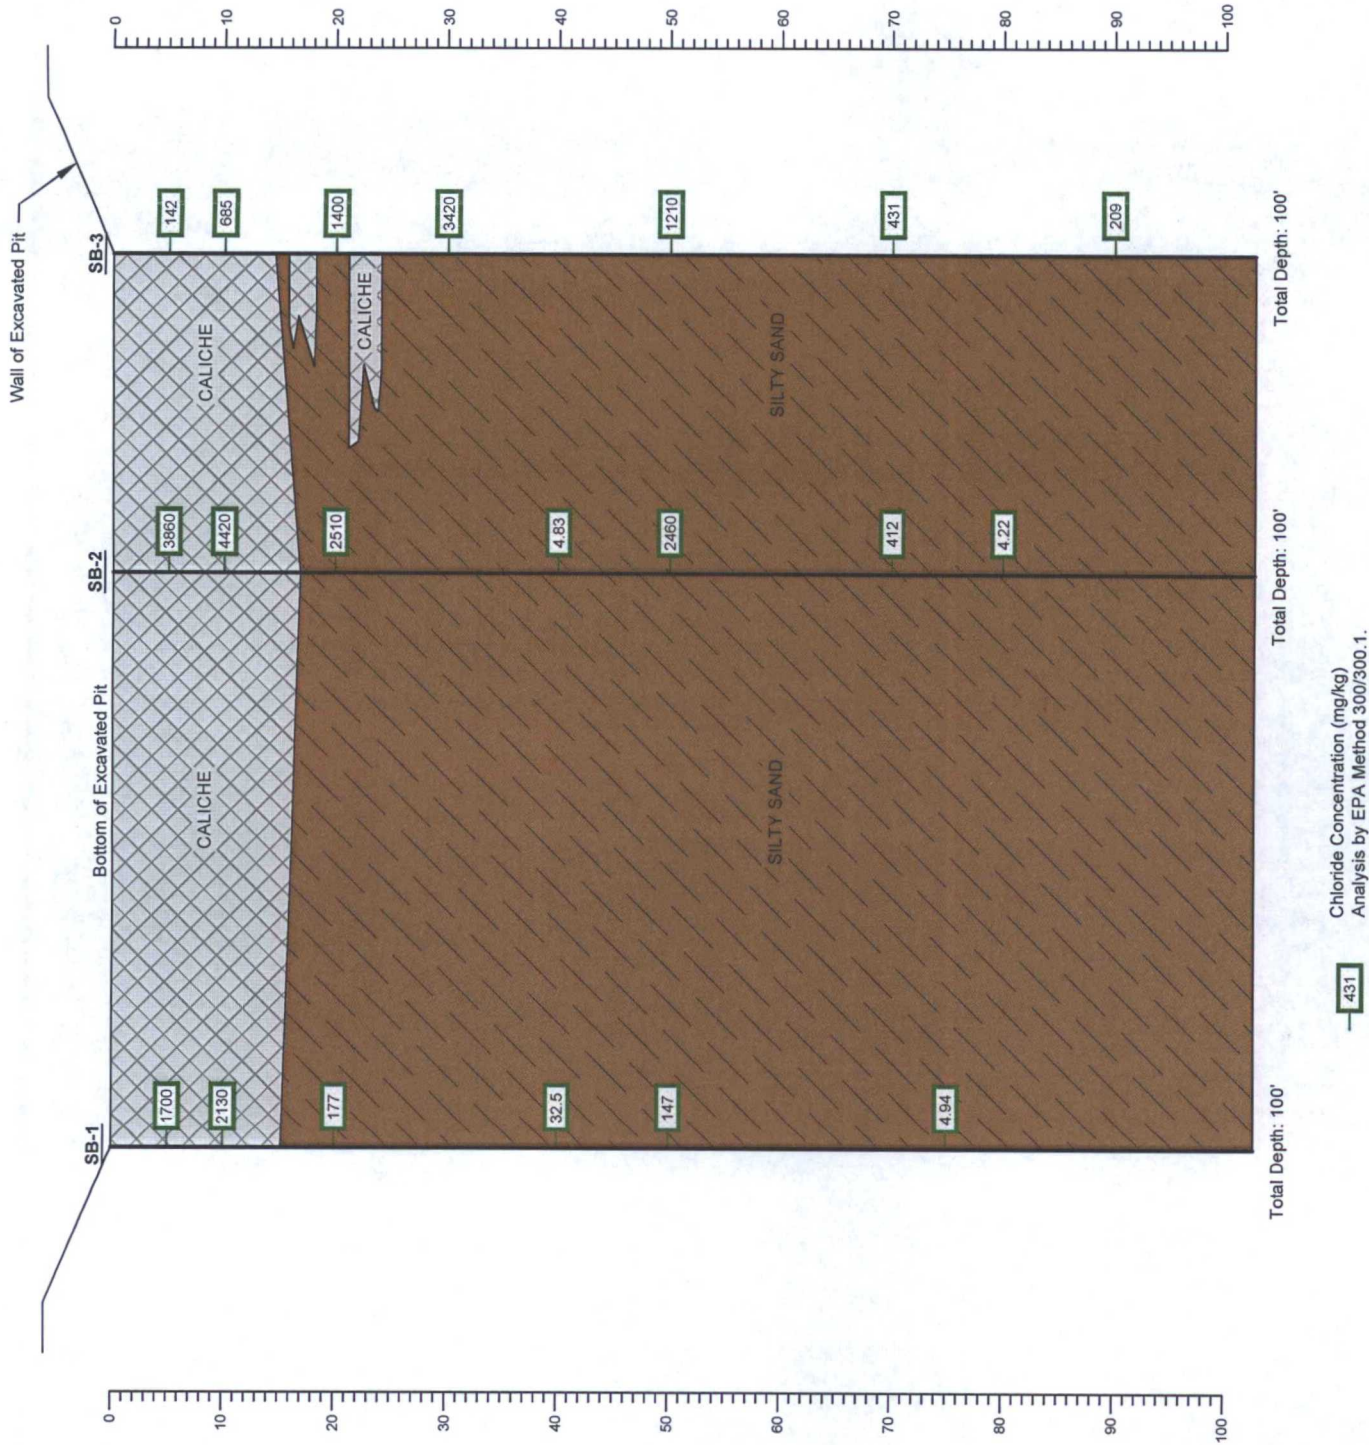
figure 2
SOIL CROSS-SECTION
CENTRAL VACUUM UNIT 342 RESERVE PIT
SECTION 36, T 17S, R 34E (RP #2672)
Chevron Environmental Management Company

1. Soil borings advanced May 6 and 7, 2013.
2. Samples evaluated using drill cuttings and split spoon sampler.
3. Boundaries between soil units are approximate.
4. Harrison & Cooper (Lubbock, Texas) drilling contractor. Six-inch borehole using Ingersol Rand 11RTH60 (2006) drill rig.
5. All borings plugged with drill cuttings and approximately 20 bags of bentonite.

- CALICHE - White, tan, dry, indurated at top of unit. Dense to very dense, increasing in silty sands toward base of unit.
- SILTY SAND - Reddish brown, tan, firm to dense, moist toward bottom of unit.

In May 2013, after discussions and approval from the NMOCD Hobbs District I office, three soil borings (SB-1, SB-2 and SB-3) were installed within the existing remedial excavation to a depth of 100 feet bgs. Soil samples were collected at 5 to 10 foot intervals in an effort to horizontally and vertically evaluate the extent of chloride impacts. All three soil borings SB-1 (75'-4.94 mg/kg), SB-2 (80'-4.22 mg/kg), and SB-3 (90'-209 mg/kg) demonstrated decreasing chloride levels with depth to well below recommended remediation and delineation levels. Analytical results are summarized in Table I. A soil cross section depicting subsurface conditions is provided in Figure 2. Certified Laboratory Reports for the 2013 soil sampling events are provided in Appendix D.

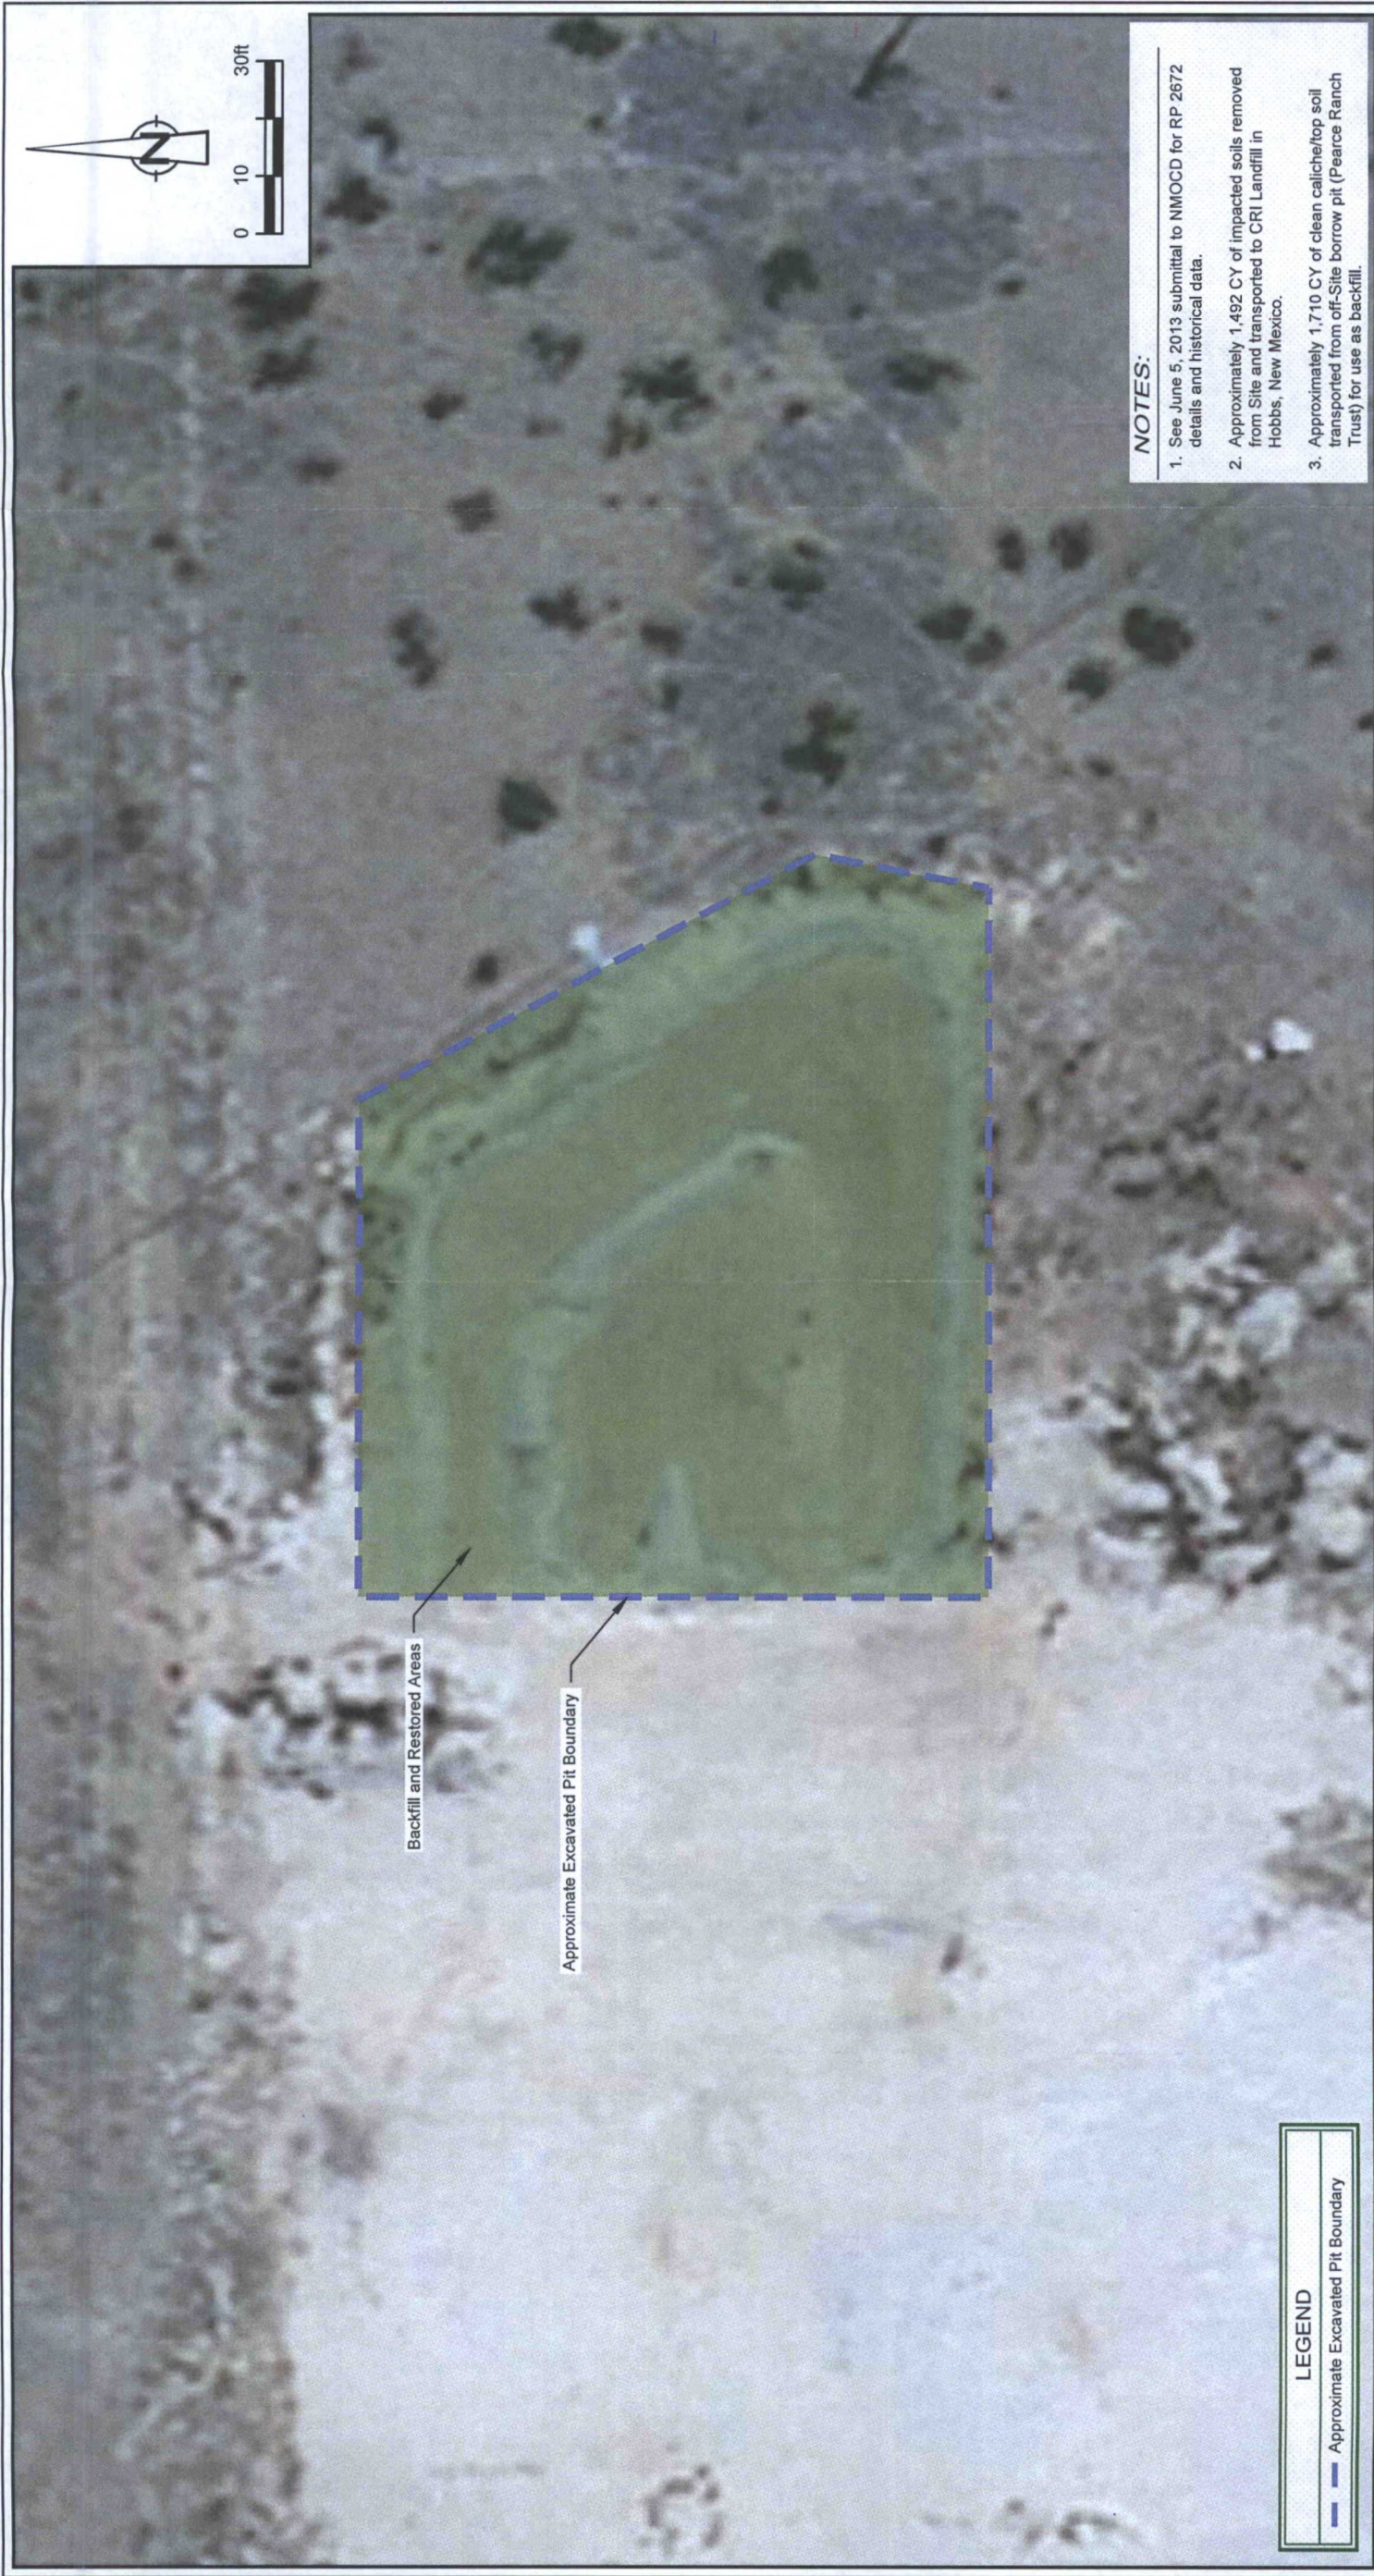
LEGEND	
	Approximate Excavated Pit Boundary

- NOTES:**
1. See June 5, 2013 submittal to NMOCD for RP 2672 details and historical data.
 2. Approximately 1,492 CY of impacted soils removed from Site and transported to CRI Landfill in Hobbs, New Mexico.
 3. Approximately 1,710 CY of clean caliche/top soil transported from off-Site borrow pit (Pearce Ranch Trust) for use as backfill.

CRA was responsible for managing waste associated with the 2013 project activities (1492 cy). Controlled Recovery, Inc. (CRI) of Hobbs, New Mexico was utilized as a disposal facility for impacted soils. The permit number for CRI is R9166. CRI is an NMOCD and Chevron-approved facility. The material was loaded into trucks provided by RWI Construction, Inc. Each truck leaving the Site was provided with a uniquely numbered non-hazardous waste manifest to accompany each load. The manifest was signed by the generator (CEMC's agent), the transporter and finally by CRI landfill's representative. Table II provides disposal volumes (in cubic yards), as well as manifest and vehicle numbers for the waste material that was transported off of the Site. Copies of the Manifests are included in Appendix E in electronic form on a CD.

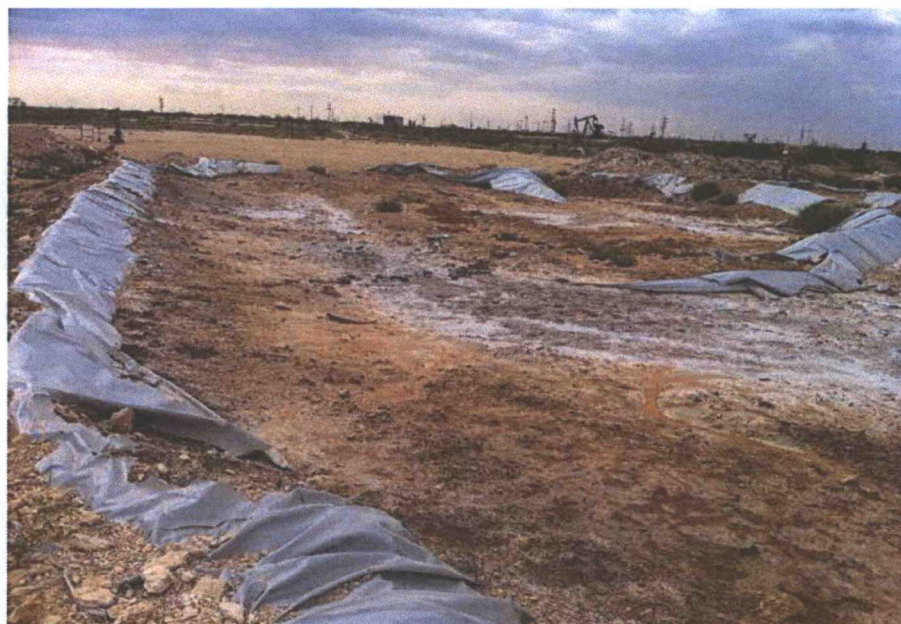
PHOTO 1: View of reserve pit facing west before any remedial work activities

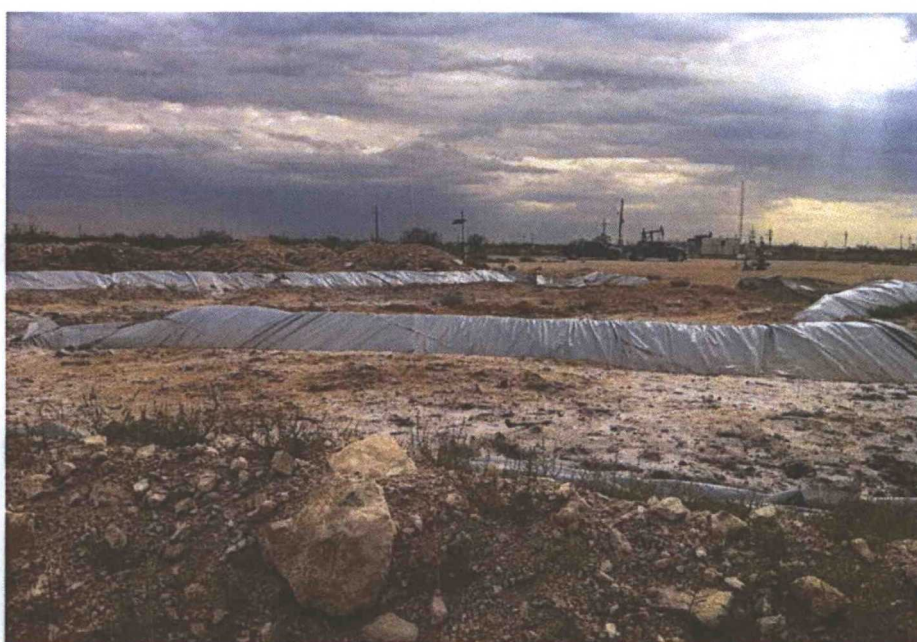
PHOTO 2: View of reserve pit facing southwest before any remedial work activities

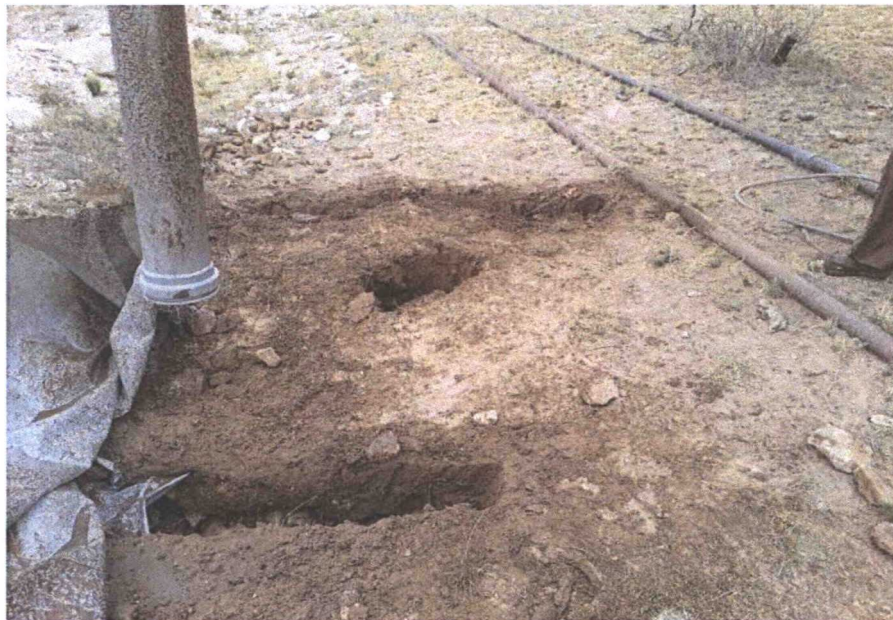
PHOTO 3: View of hydro-vac activities – April 2, 2013

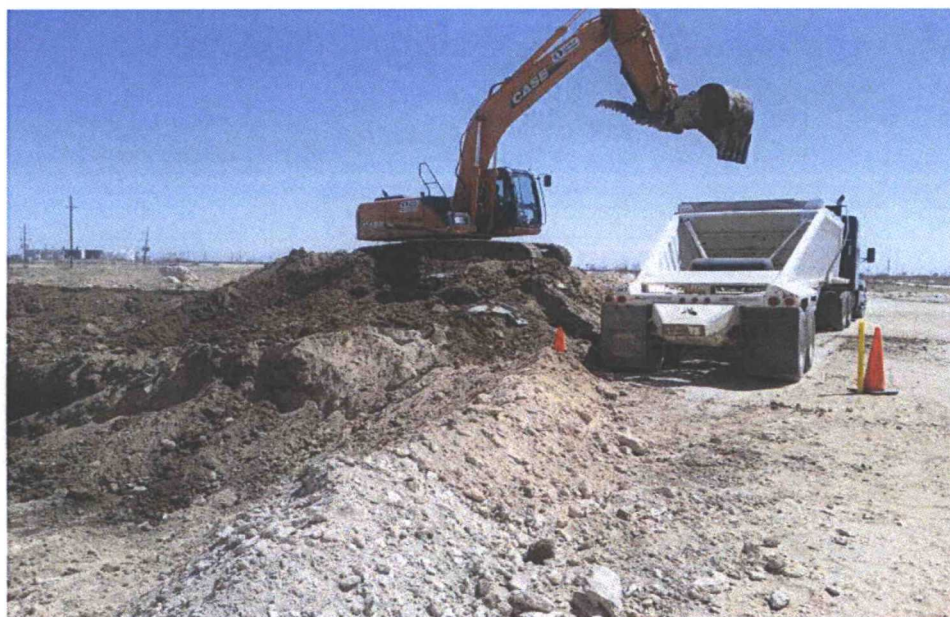
PHOTO 4: View of excavation/waste removal activities

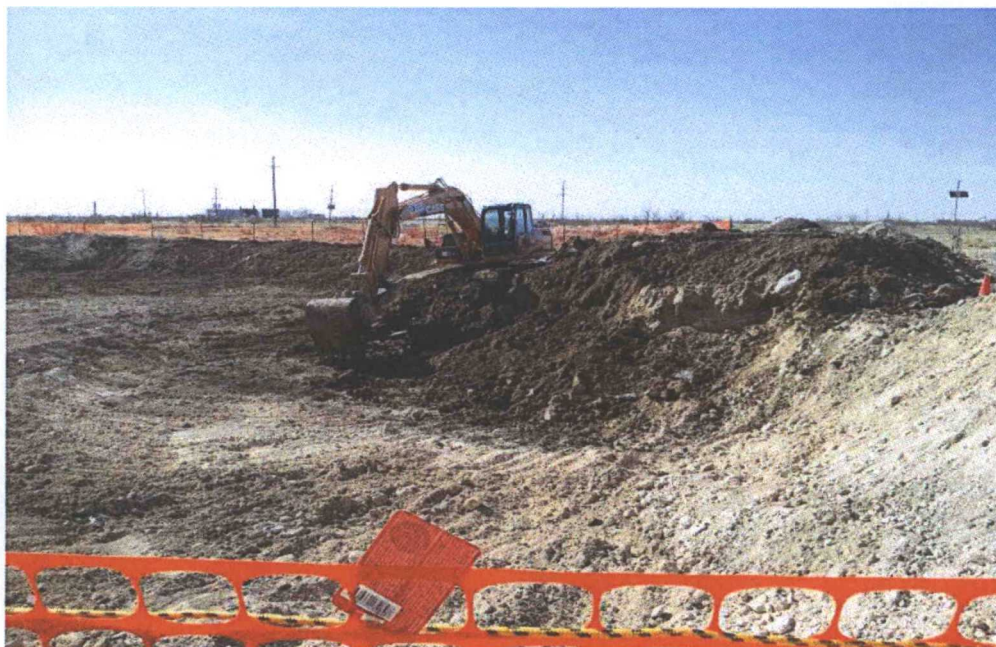
PHOTO 5: View of excavation activities

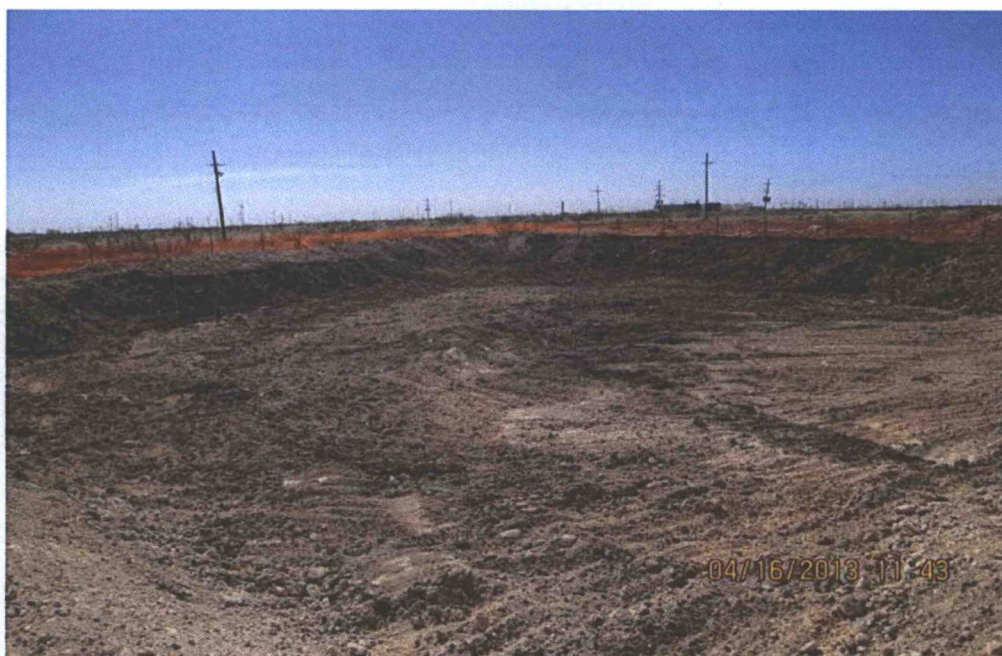
PHOTO 6: View of excavated reserve pit facing southeast

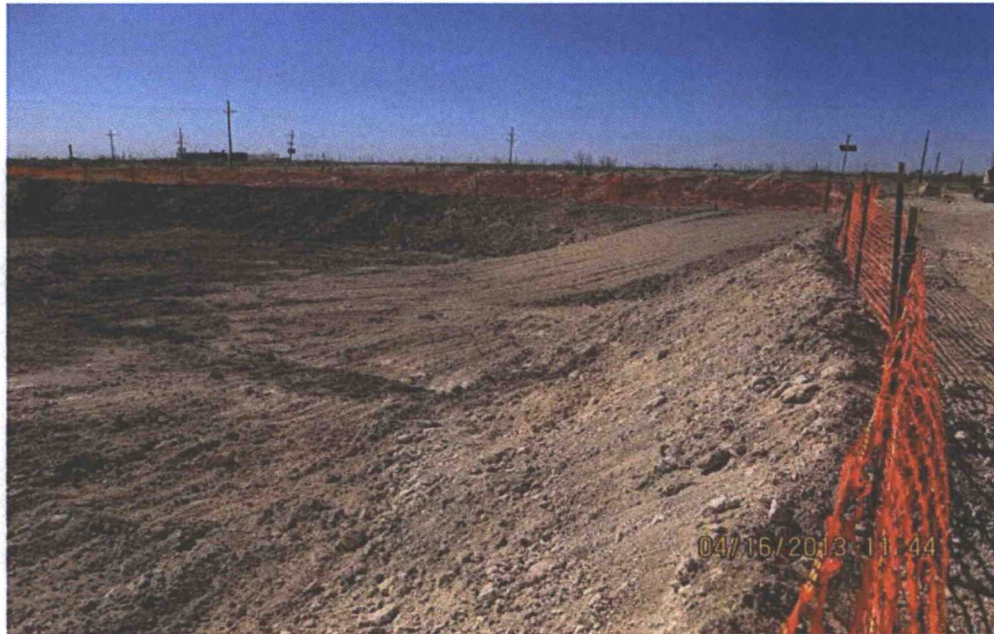
PHOTO 7: View of excavated pit and entrance ramp facing southeast

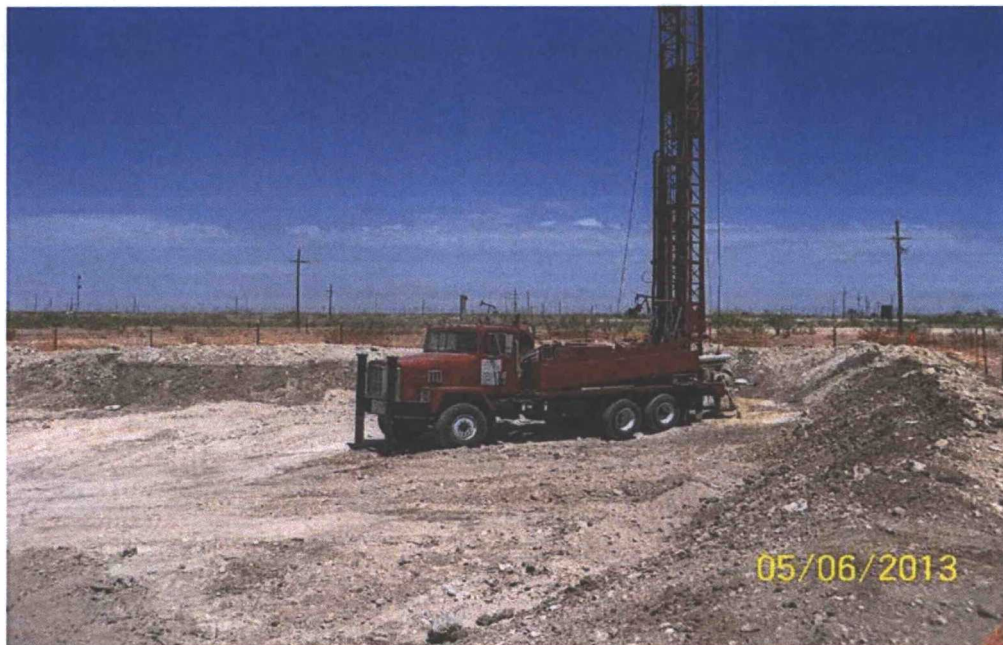
PHOTO 8: View of drill rig inside excavated reserve pit facing east

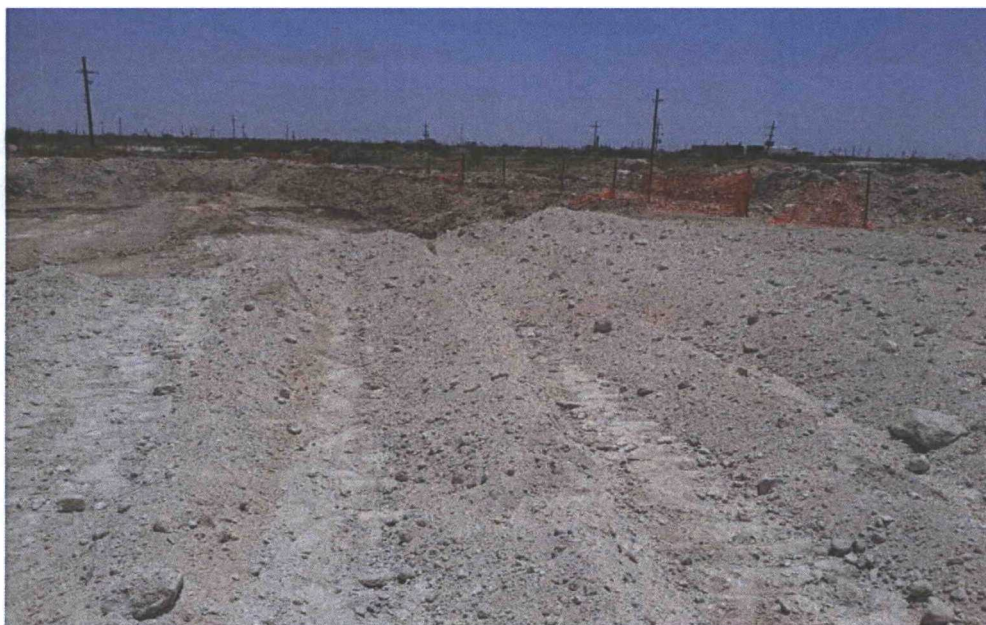
PHOTO 9: View of backfill activities facing northeast

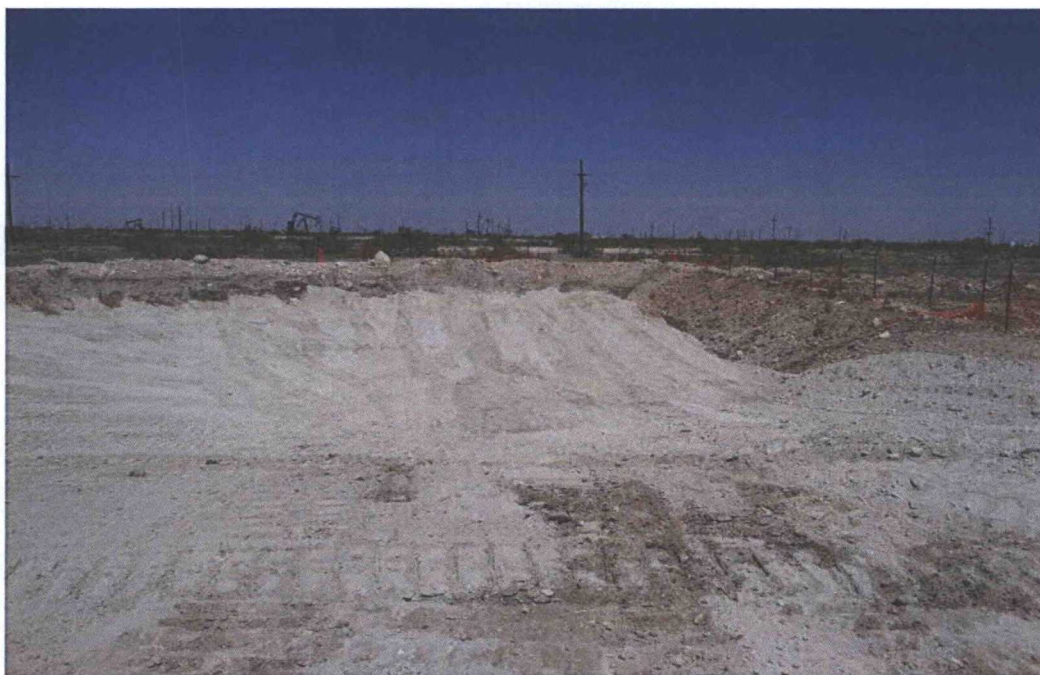
PHOTO 10: View of backfilling activities facing northeast, ready for liner material

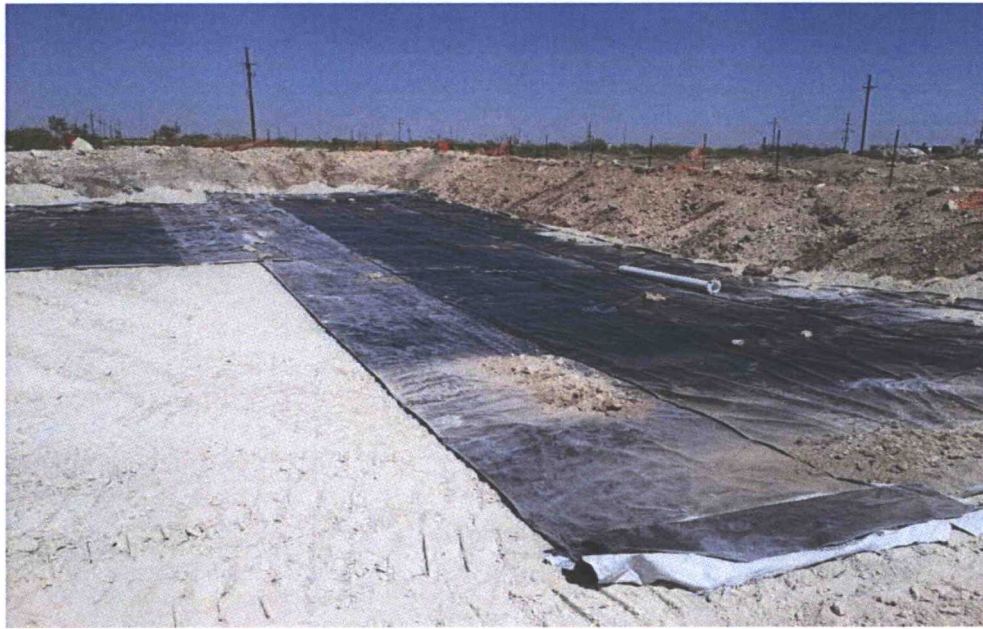
PHOTO 11: View of 20 mil poly liner installation facing northeast

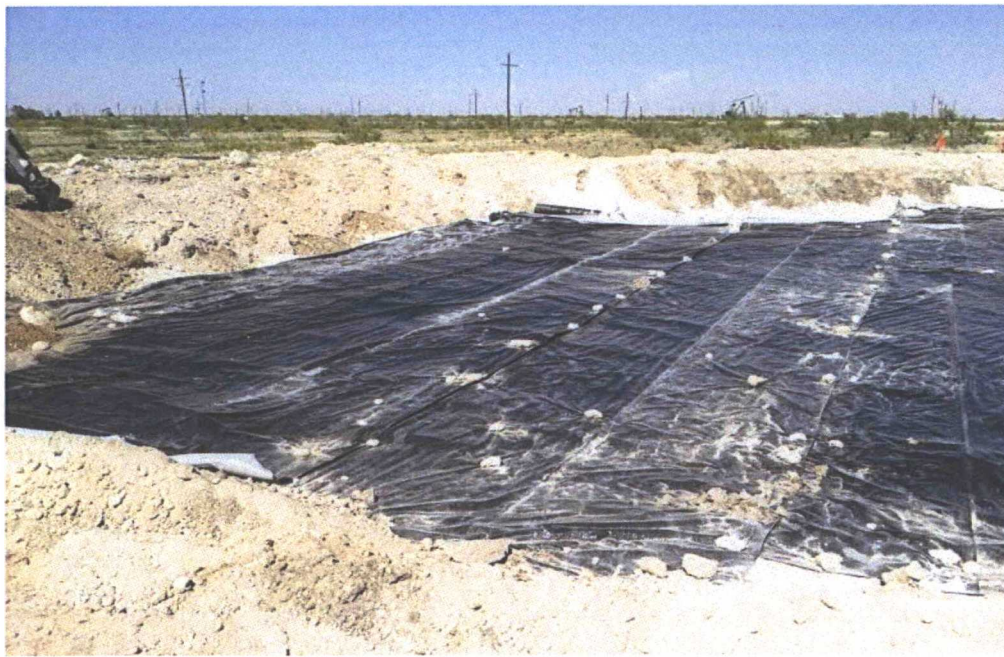
PHOTO 12: View of 20 mil poly liner installation facing northwest

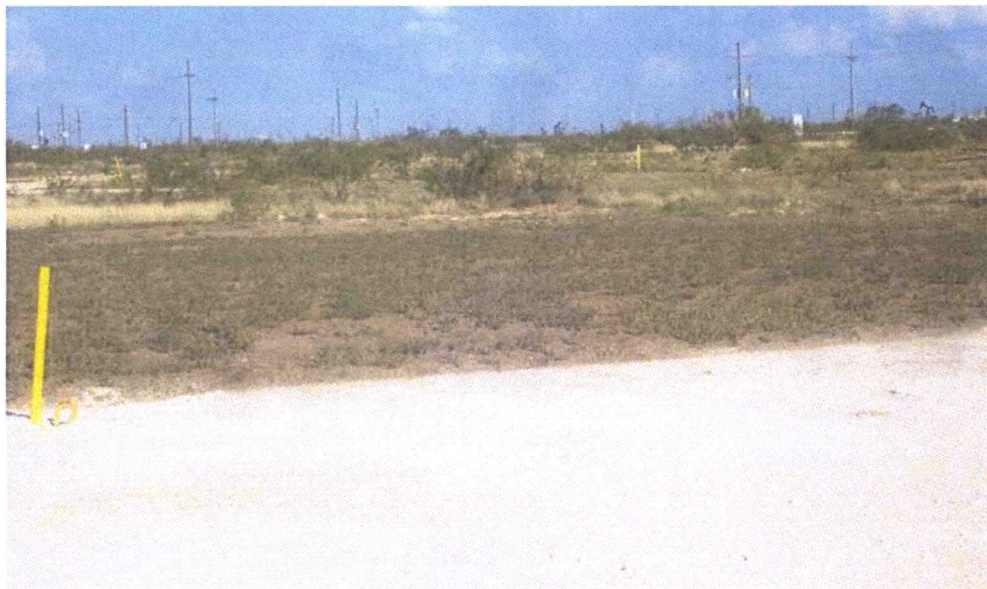
PHOTO 13: View of final grading and seeding activities completed with new vegetative growth already taking place - facing southeast.

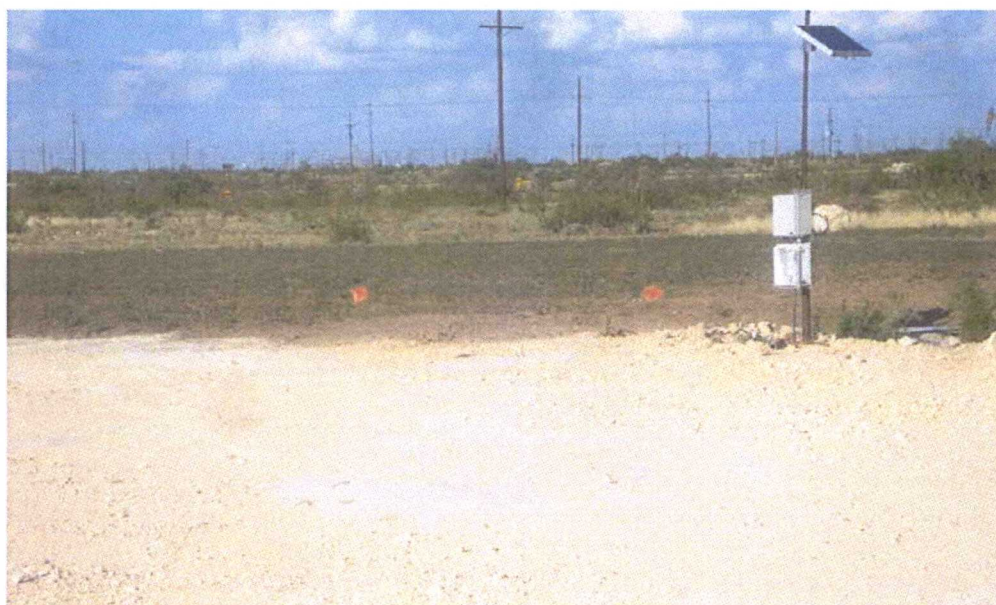
PHOTO 13: View of final grading and seeding activities completed facing northeast. Flags are representative of entrance ramp location during remedial activities for the Site.
