REMEDICATION SUMMARY & RISK-BASED SITE CLOSURE REQUEST

SOUTHERN UNION GAS SERVICES

A-7 Bettis

NMOCD Reference #1RP 1540

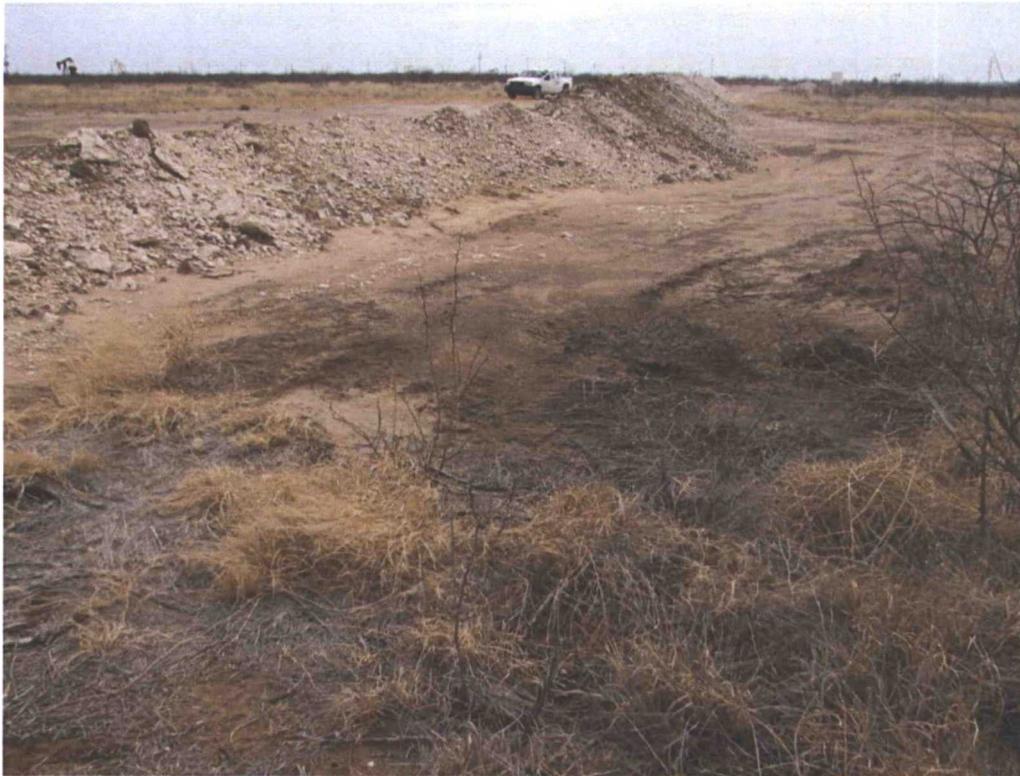
Photograph of surface staining from the initial release at the A-7 Bettis Release Site.

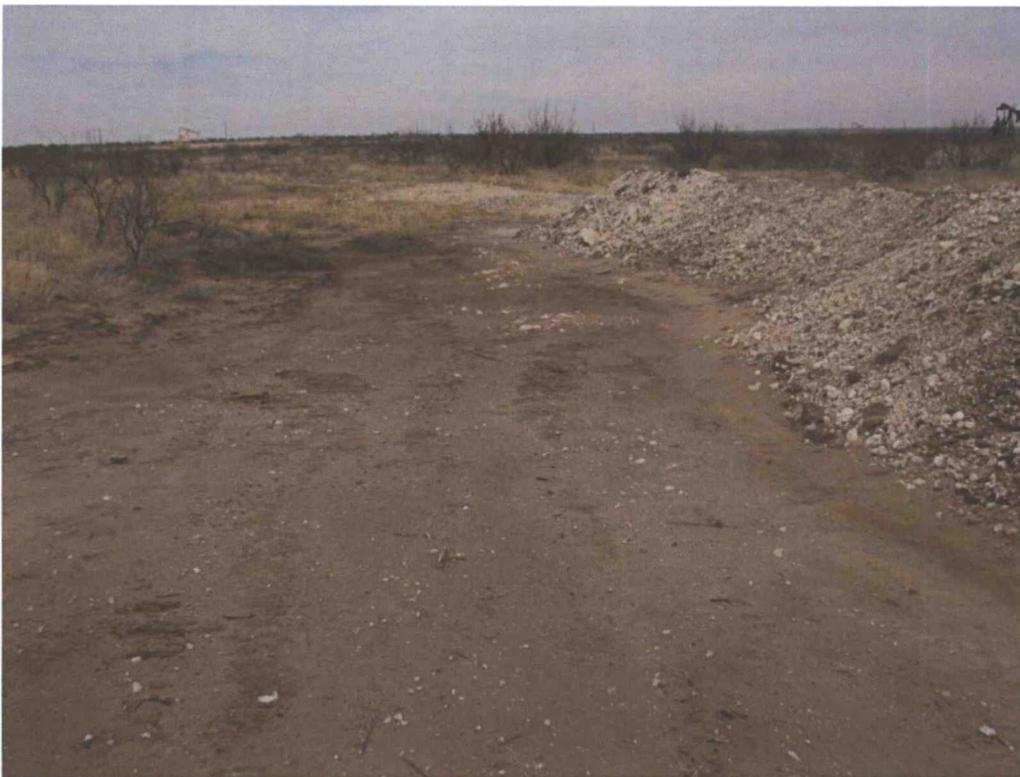
Photograph of surface staining from the initial release at the A-7 Bettis Release Site.

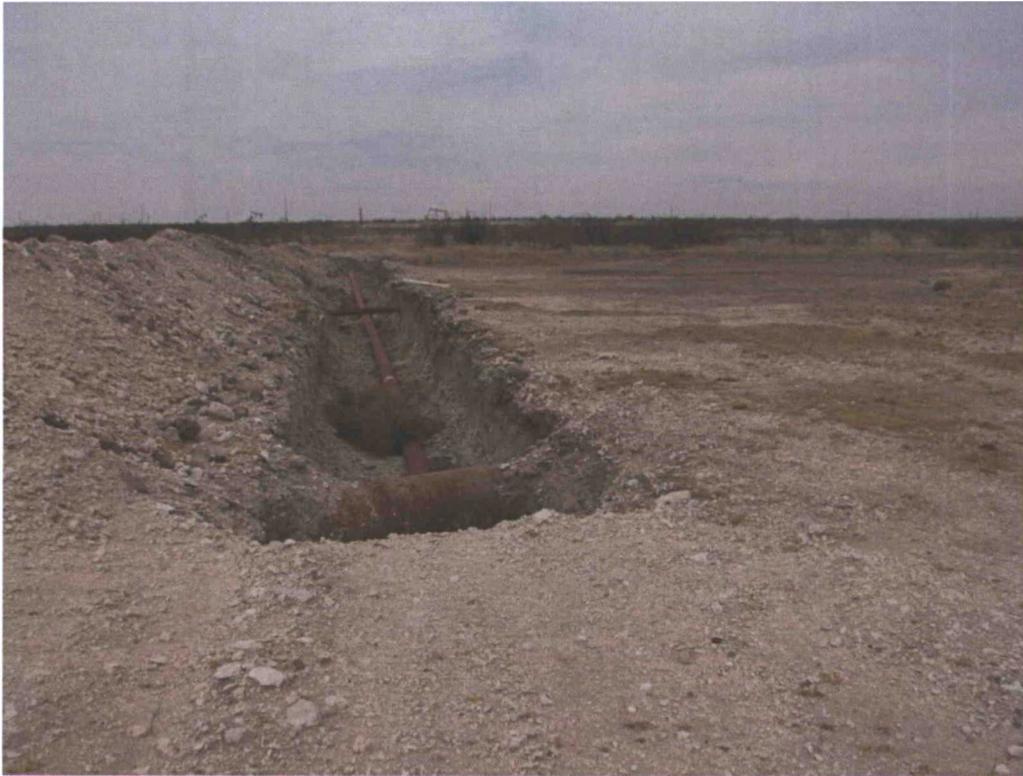
Photograph of initial excavation activities at the A-7 Bettis Release Site.

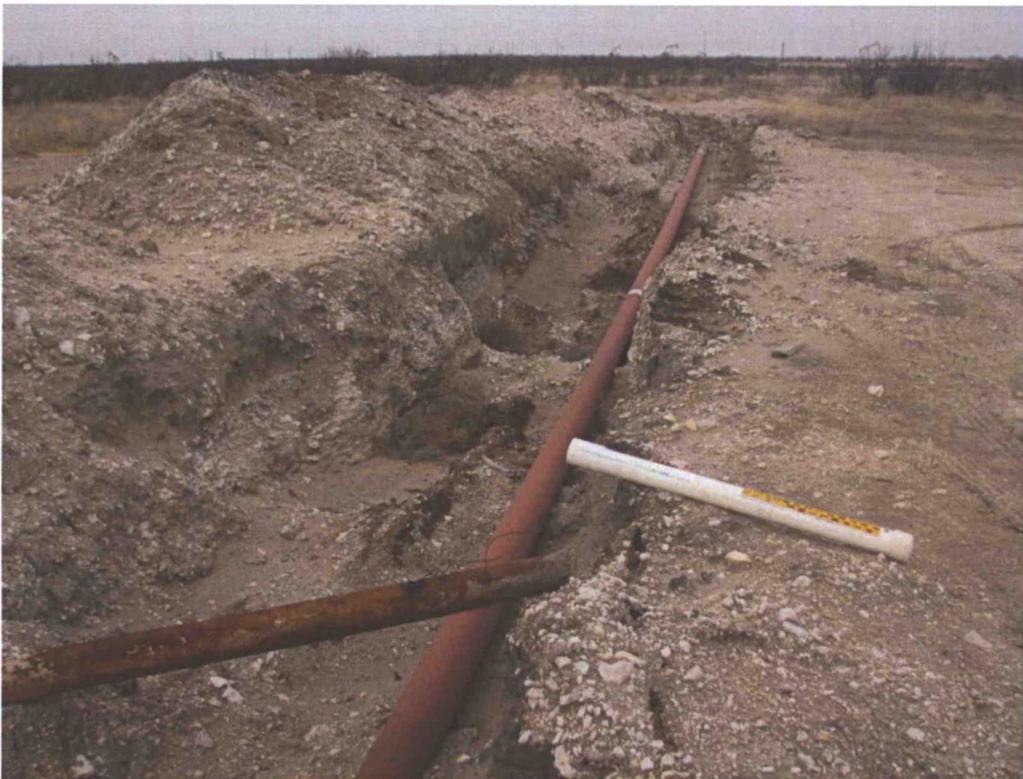
Photograph of initial excavation activities at the A-7 Bettis Release Site.

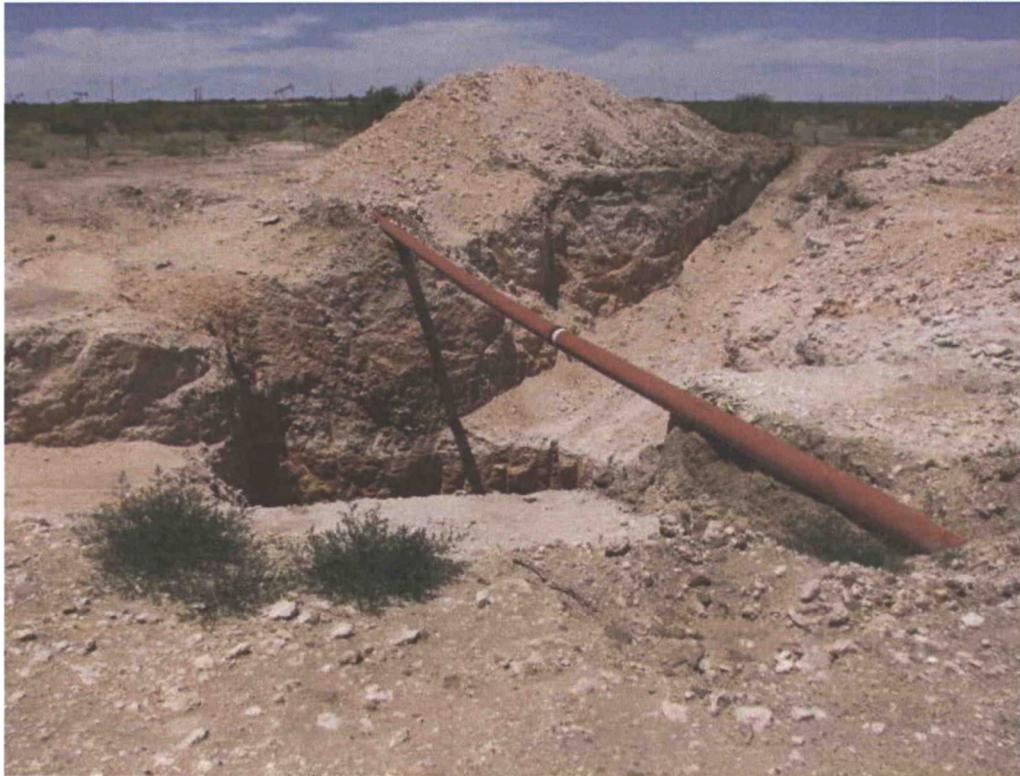
Photograph of the final excavation at the A-7 Bettis Release Site.

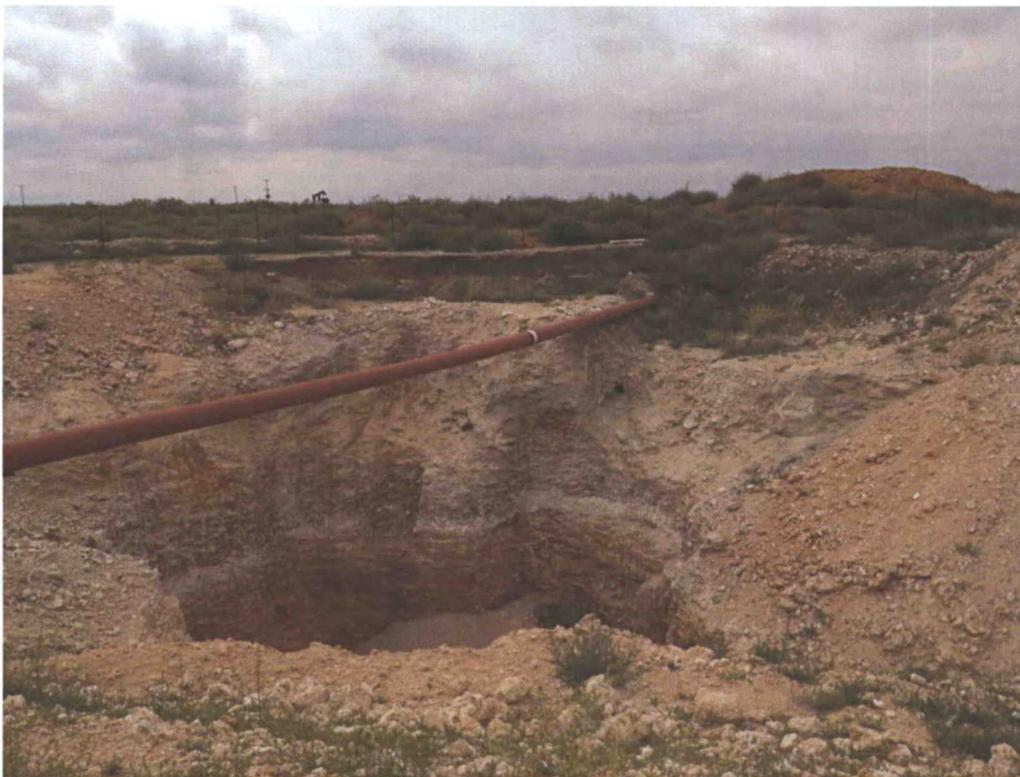
Photograph of the final excavation at the A-7 Bettis Release Site.

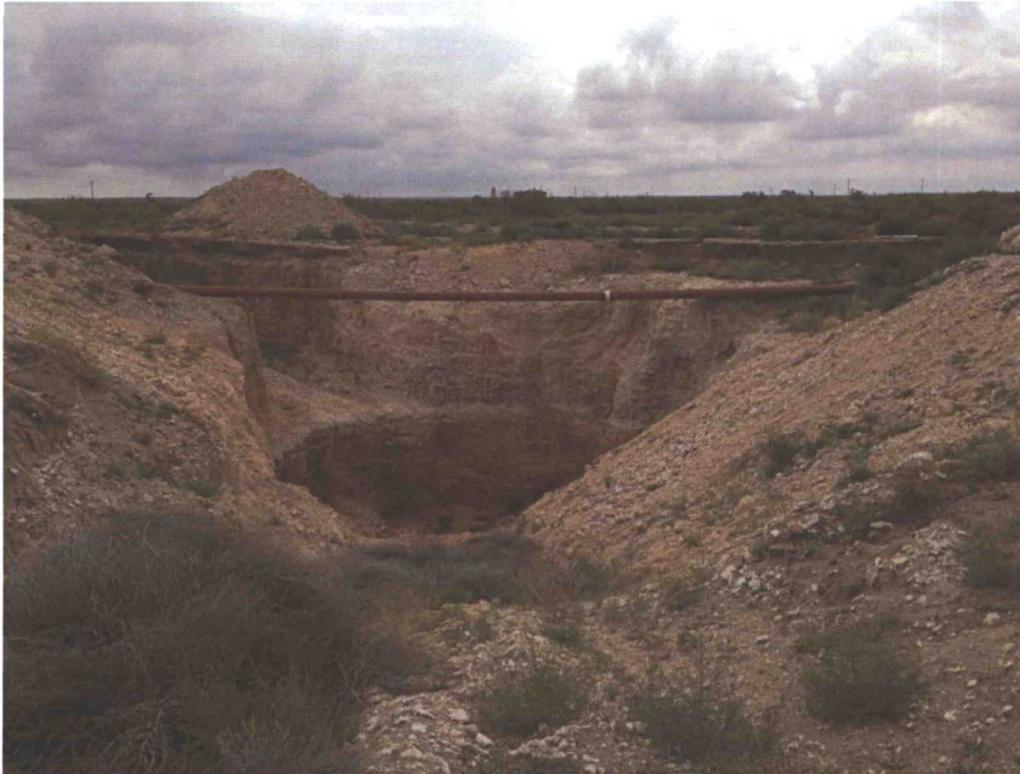
Photograph of the final excavation at the A-7 Bettis Release Site.

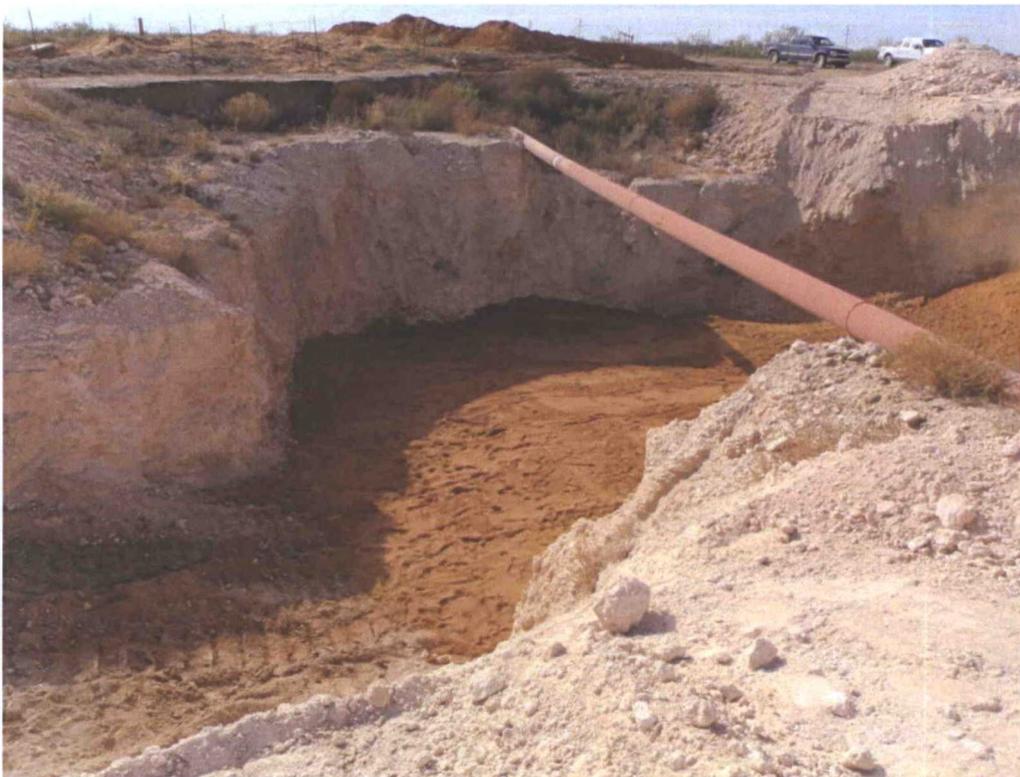
Photograph of backfilling activities and the pad sand installation at the A-7 Bettis Release Site.

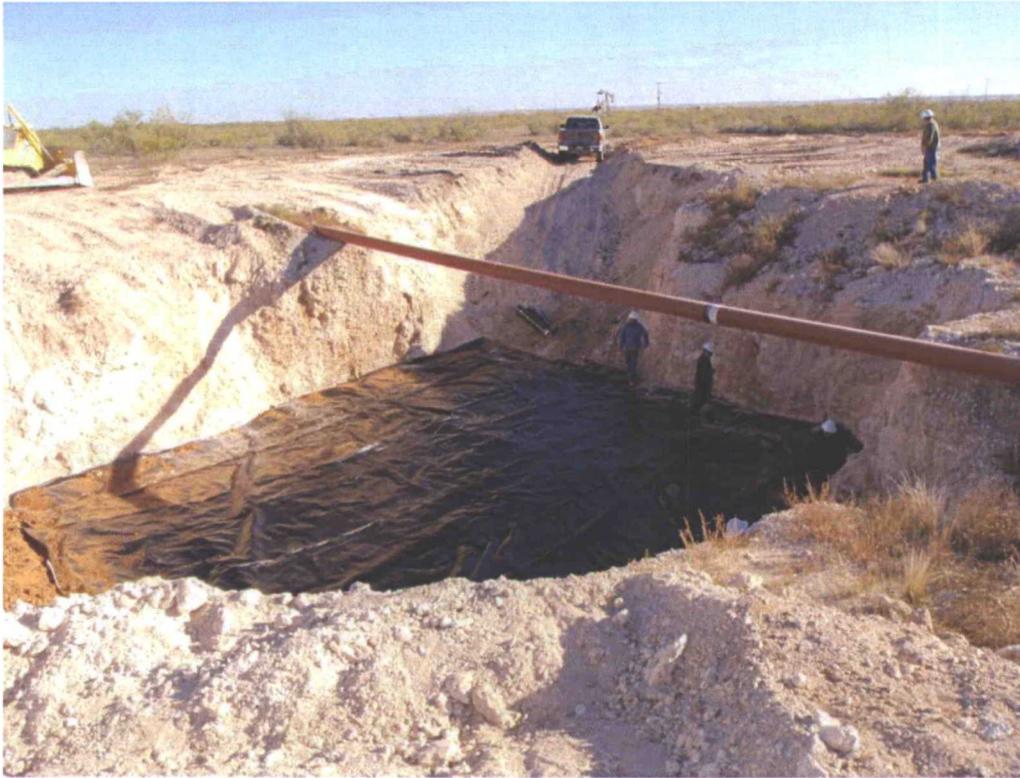
Photograph of the polyurethane liner installation at the A-7 Bettis Release Site.

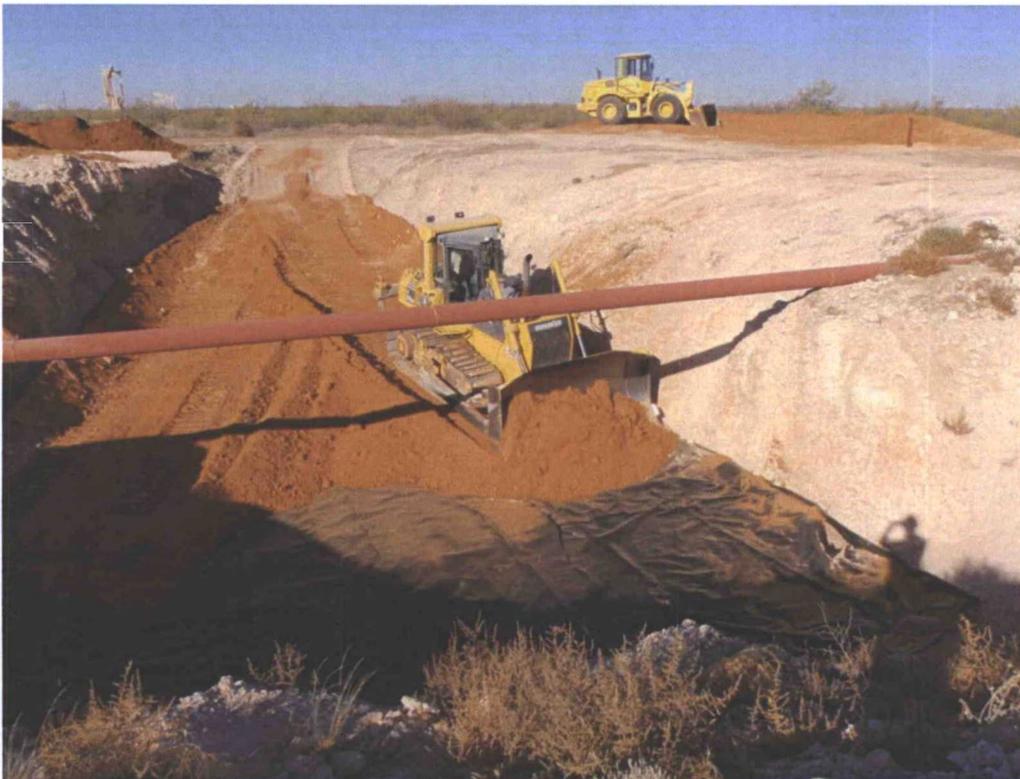
Photograph of backfilling activities and the pad sand installation at the A-7 Bettis Release Site.

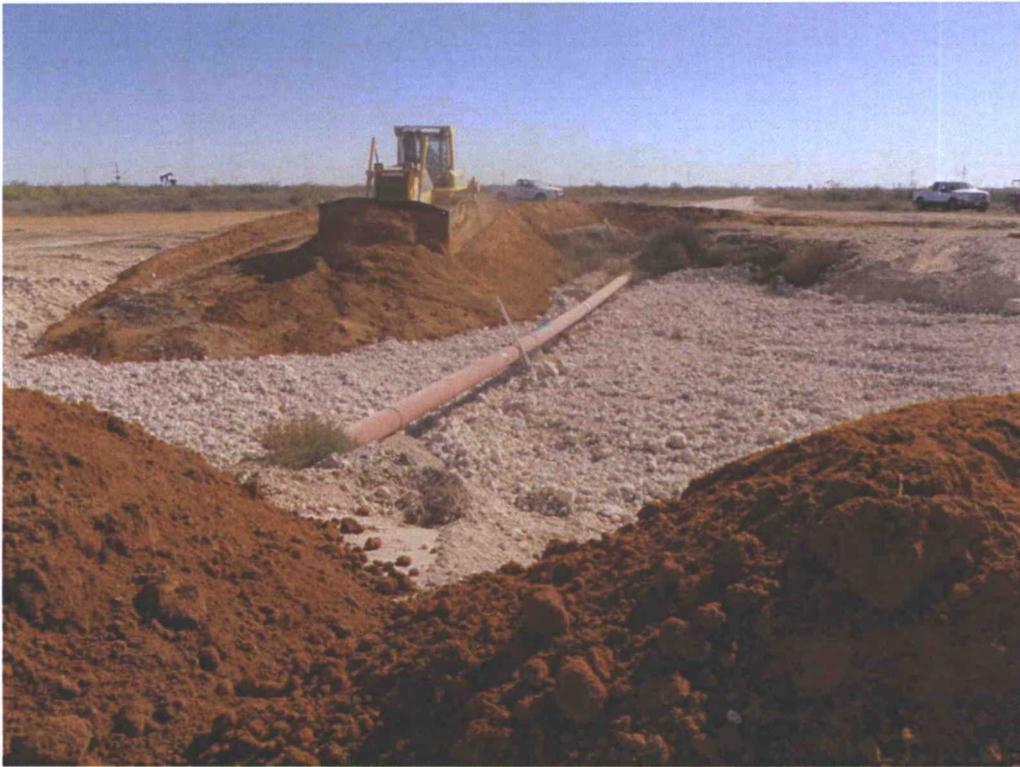
Photograph of backfilling activities at the A-7 Bettis Release Site.

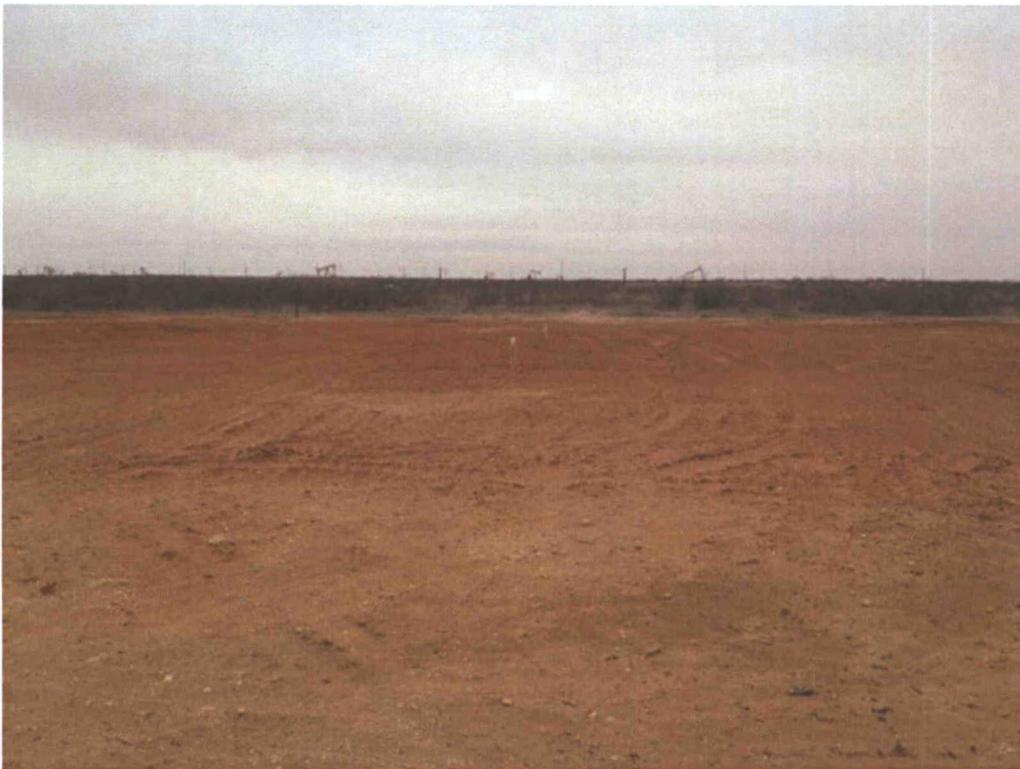
Photograph of A-7 Bettis Release Site after remediation activities.
