Pit, Below-Grade Tank, or
Proposed Alternative Method Permit or Closure Plan Application

Hilcorp Energy Company
San Juan Basin
Below Grade Tank Closure Report

Lease Name: **San Juan 328 227 Compressor**

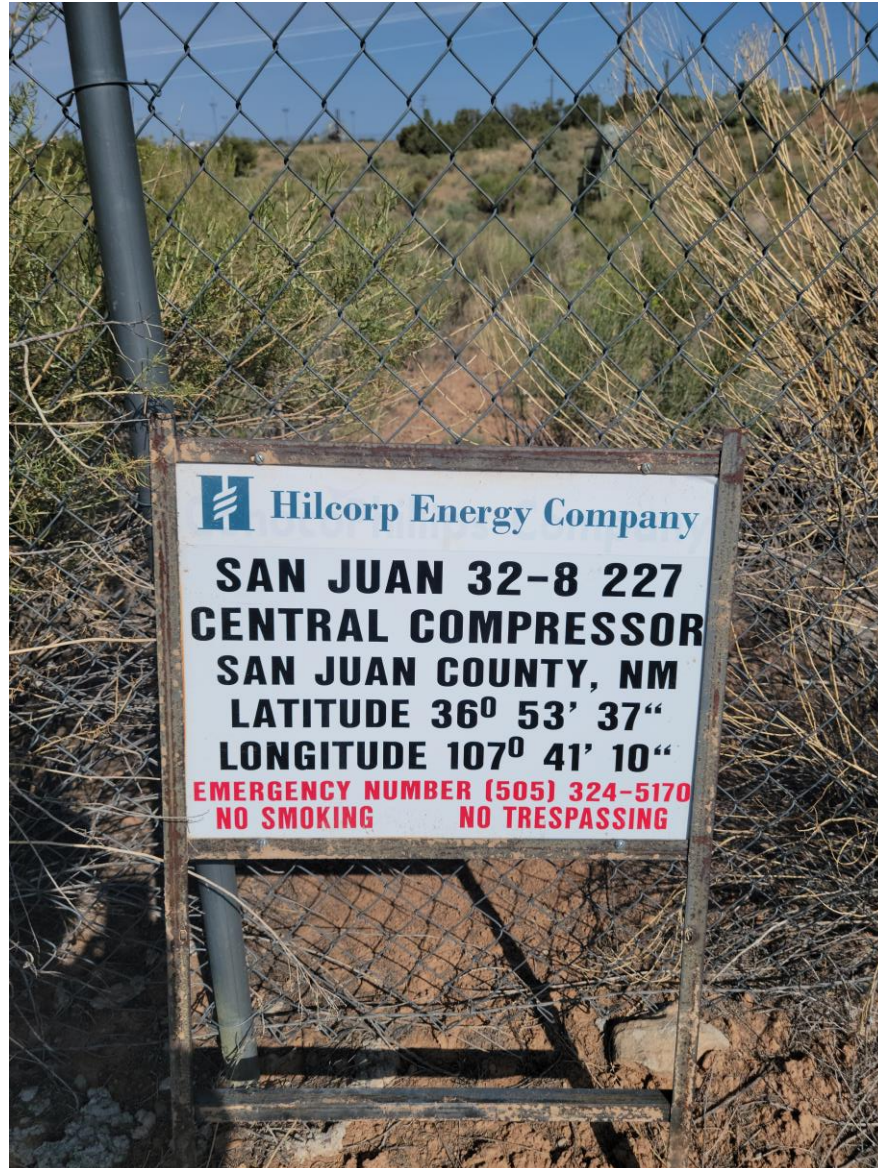
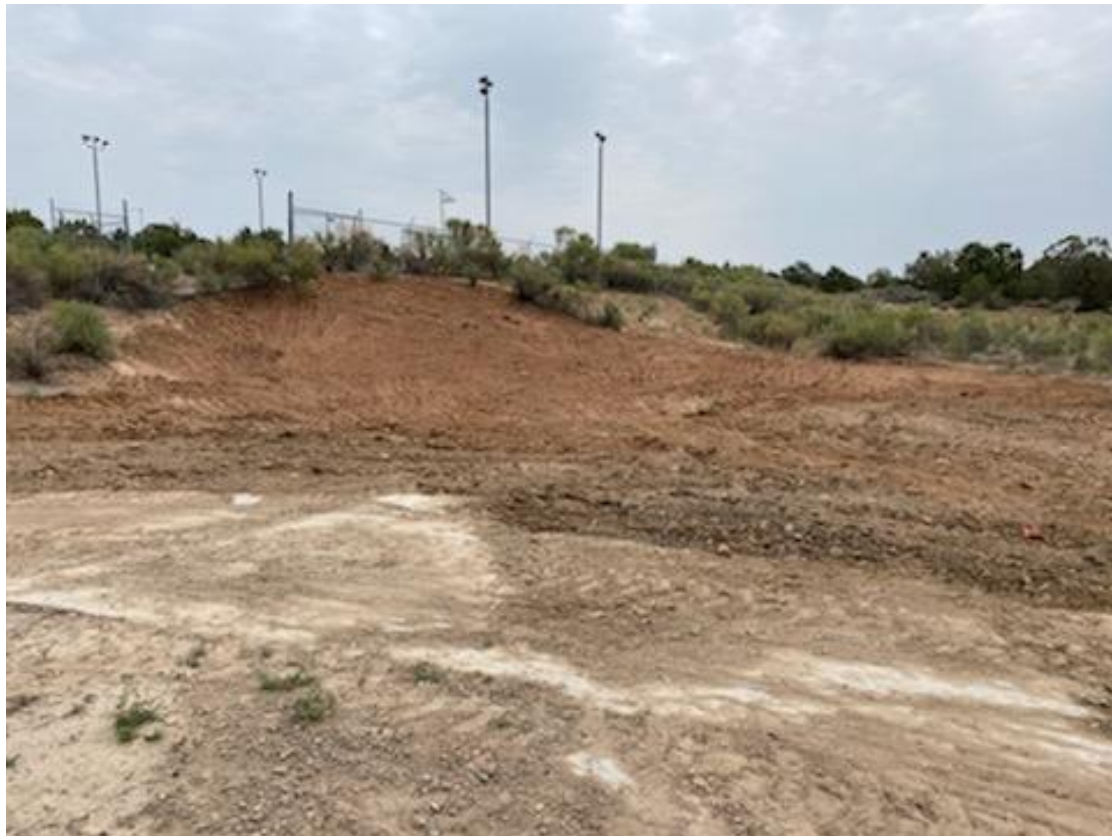
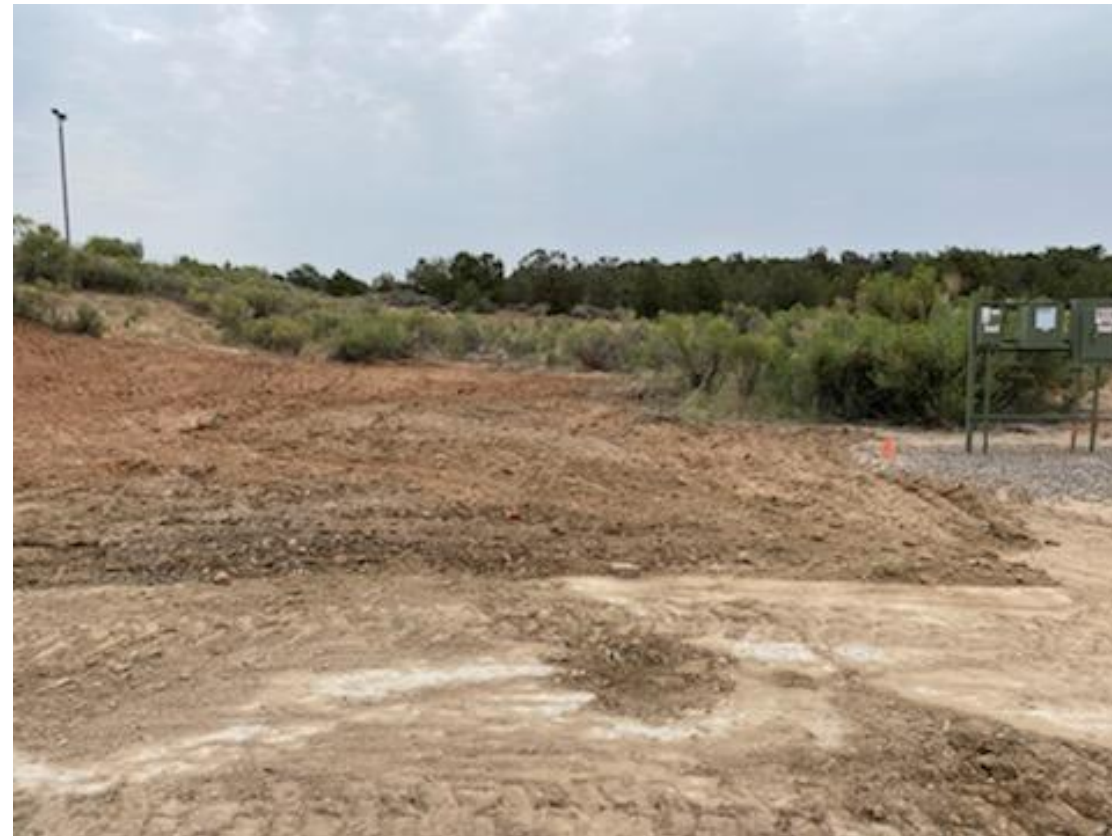
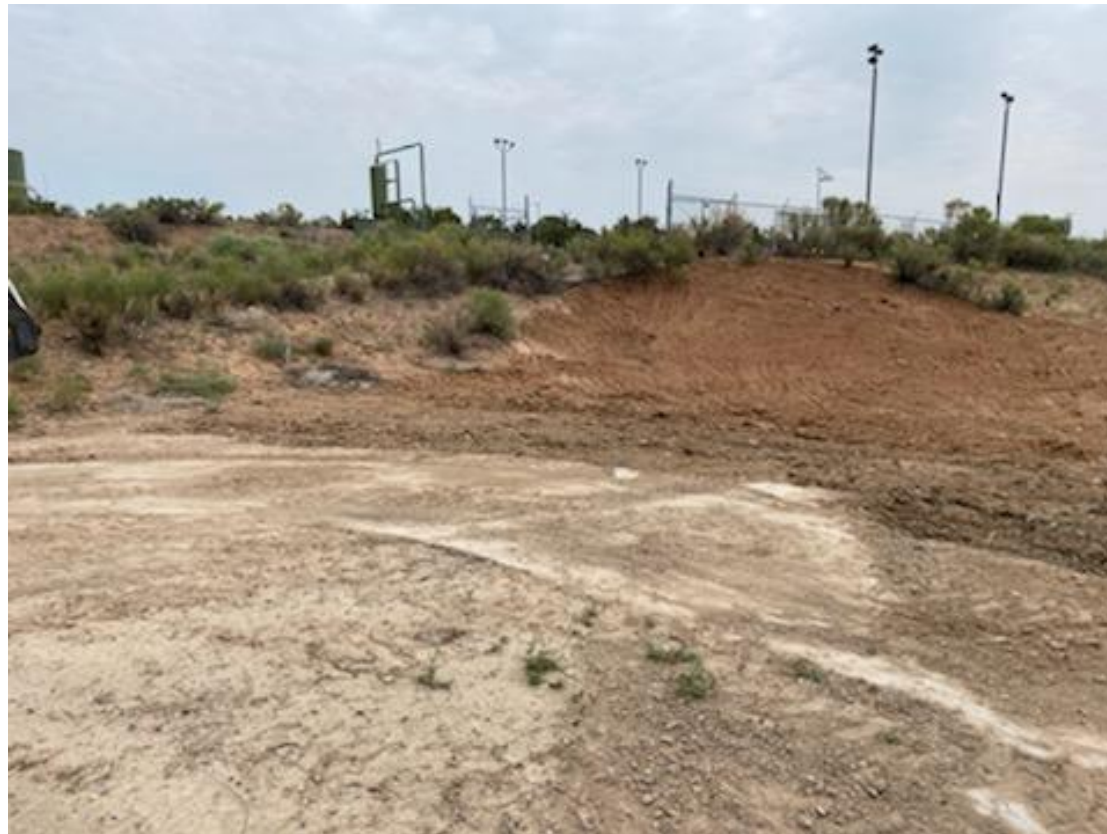
Pit Closure Pictures.

San Juan
32-8 #227
08/11/21

The below-grade tank area passed all requirements of Paragraph (4) of Subsection E of 19.15.17.13 NMAC and was backfilled with compacted, non-waste containing, earthen material.
