Pit, Below-Grade Tank, or
Proposed Alternative Method Permit or Closure Plan Application

1. Operator: Harvest Four Corners OGRID # 373888
Address: 1755 Arroyo Dr., Bloomfield, NM 87413
Facility or well name: 29-6 #2 Compressor Station (BGT 2) Facility File: fCS00000000060
API Number: OCD Permit Number:
U/L or Qtr/Qtr NW/NE (B) Section 10 Township 29N Range 6W County: Rio Arriba
Center of Proposed Design: Latitude 36.745087 Longitude -107.445901 NAD83
Surface Owner: [ ] Federal [ ] State [X] Private [ ] Tribal Trust or Indian Allotment

**RE: Below Grade Tank Closure Report (BGT 1 and BGT 2)  
San Juan 29-6 #2 Compressor Station  
Facility #fCS00000000060  
Rio Arriba County, New Mexico**

**AERIAL SITE MAP  
 BELOW GRADE TANK CLOSURE, JULY 2020**  
 HARVEST FOUR CORNERS, LLC  
 SAN JUAN 29-6 #2 COMPRESSOR STATION  
 NW¼ NE¼, SECTION 10, T29N, R6W  
 RIO ARriba COUNTY, NEW MEXICO  
 N36.745059, W107.445854

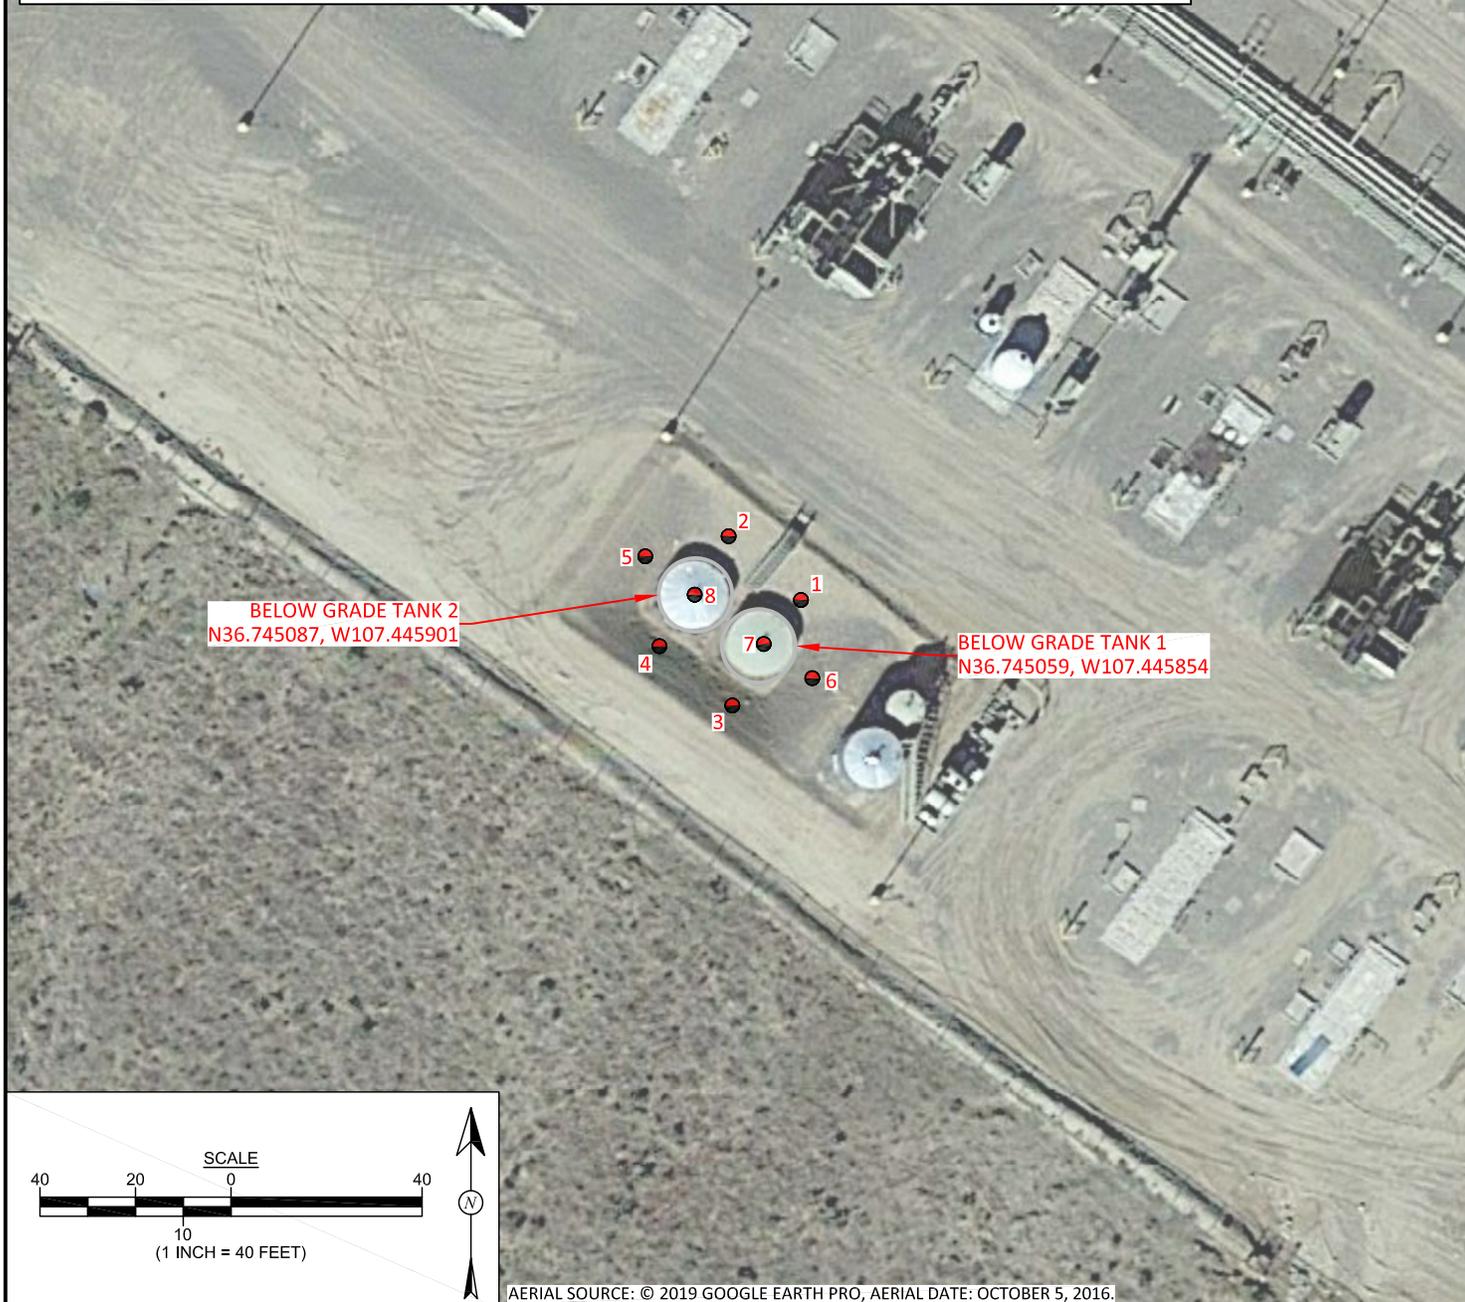
**FIGURE 2**

Laboratory analytical results are summarized in Table 1 and presented on Figure 2. The laboratory analytical report is attached.

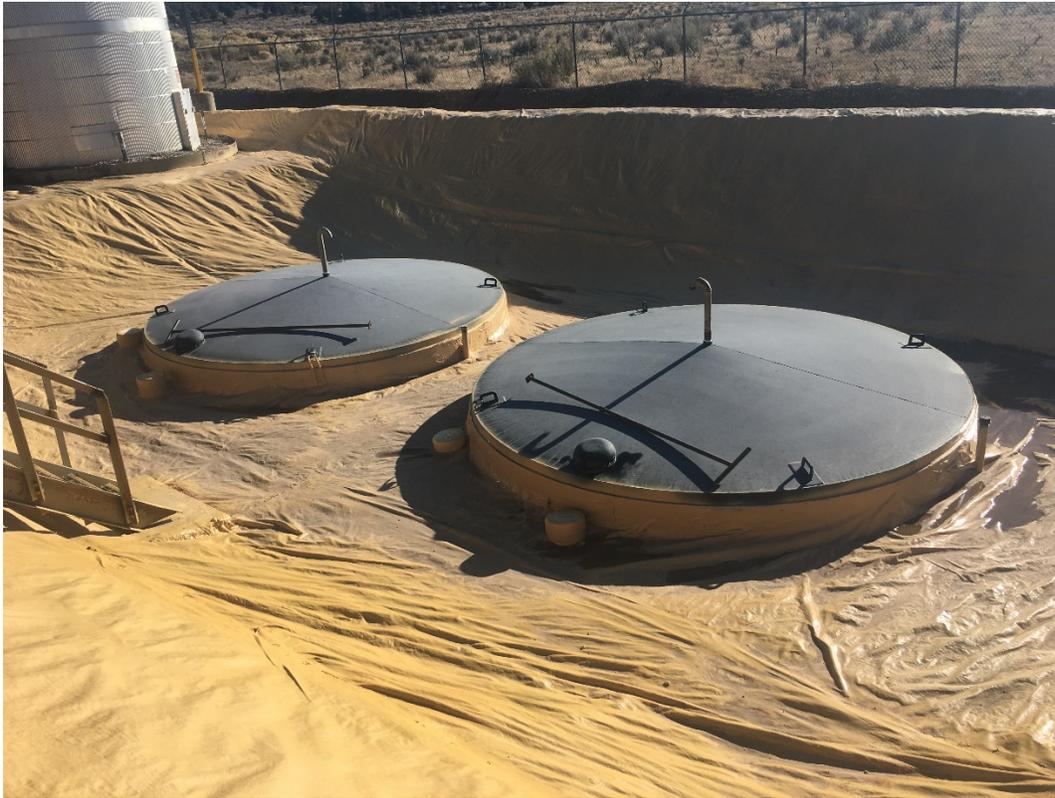
Photo 1: San Juan 29-6 #2 Compressor Station – BGT 1 on left and BGT 2 on right.

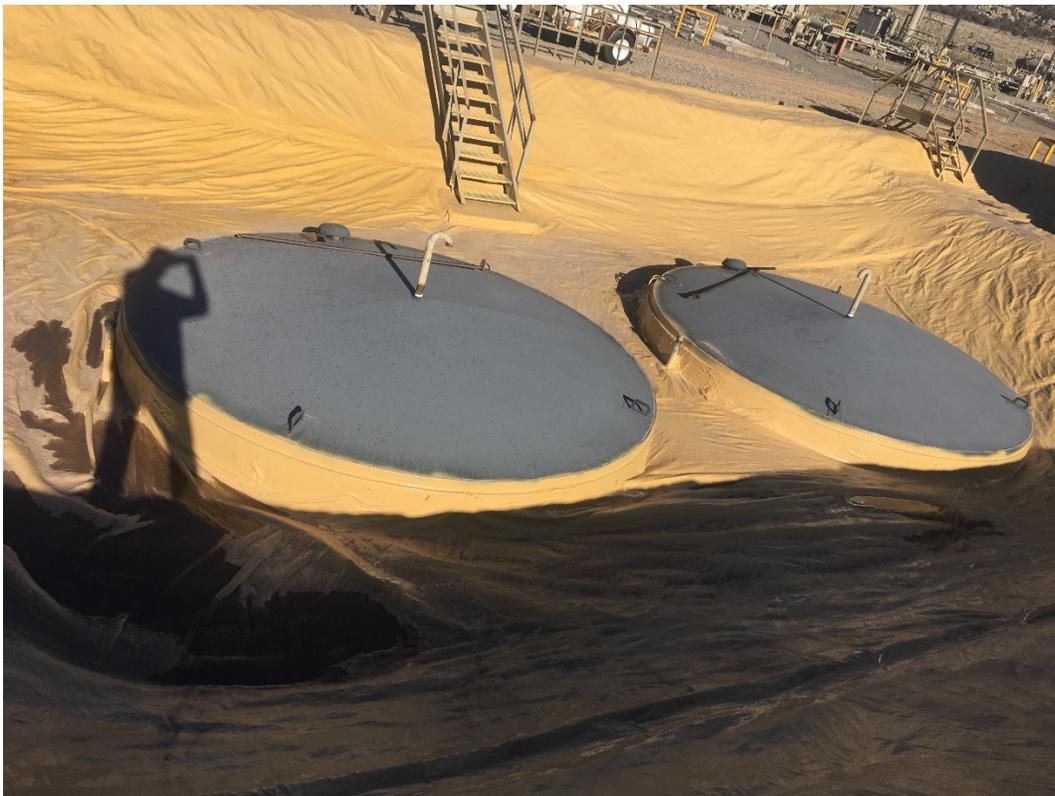
Photo 2: San Juan 29-6 #2 Compressor Station - BGT 2 on left and BGT 1 on right.
