Release Notification and Corrective Action

Name of Company	Plains Pipeline, LP	Contact	Jason Henry
Address	2530 Hwy 214 - Denver City, Tx 79323	Telephone No.	(575) 441-1099
Facility Name	14 - inch Vac to Jal BLM	Facility Type	Pipeline

## REMEDIATION SUMMARY AND SITE CLOSURE REQUEST

On April 9, 2009, Plains responded to a crude oil release occurring on the 14-Inch Vac to Jal pipeline. The release site is located on and adjacent to a caliche lease road, remediation of the release required the closure and diversion of traffic from the road. The release occurred during purging activities on the inactive pipeline and was initially deemed a non-reportable release of three (3) to four (4) barrels. The visible surface stain measured approximately thirty (30) feet in width and fifty (50) feet in length. In the course of excavation and delineation activities, Plains representatives revised the estimated volume of the release. On May 13, 2009, Plains submitted a Form C-141 to the NMOCD Hobbs District Office, indicating eighteen (18) barrels of crude oil was released, with no recovery.

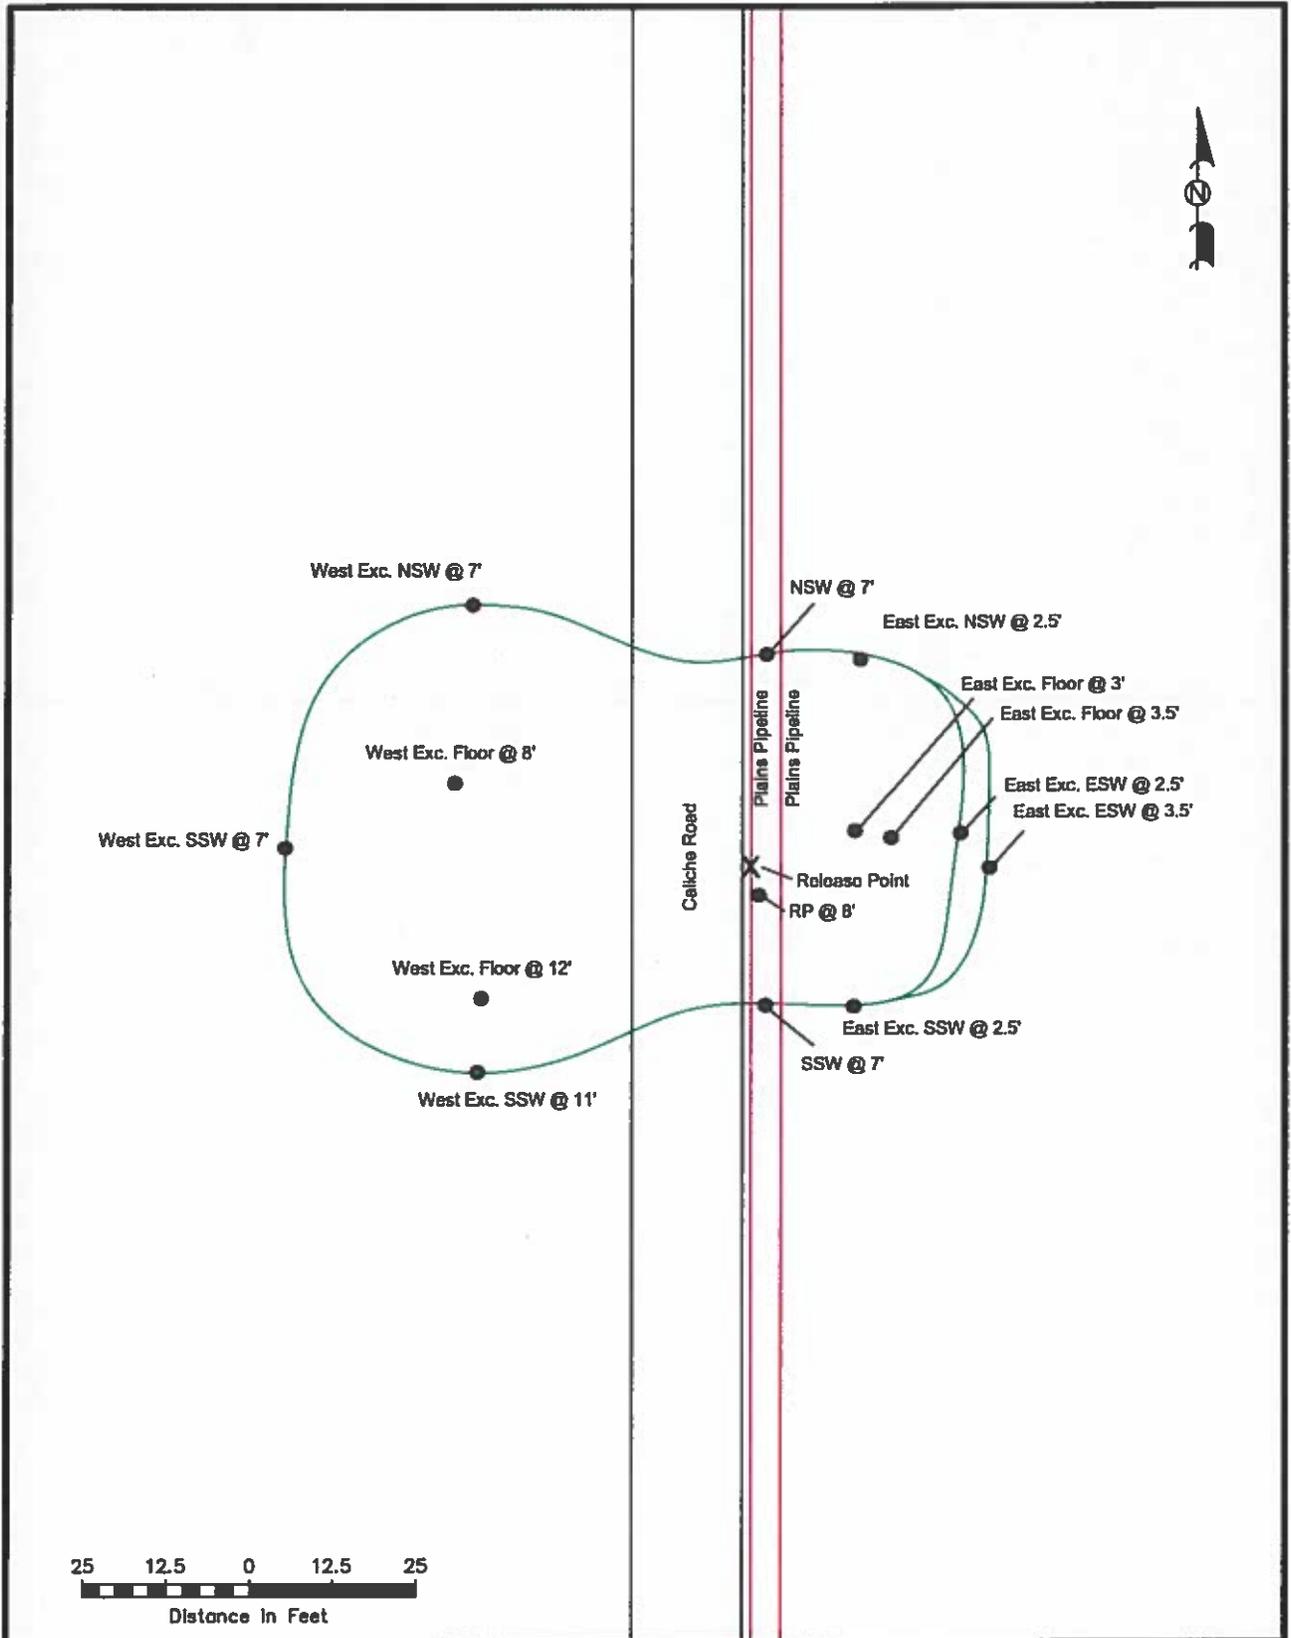
**Figure 2**  
 Site and Sample  
 Location Map  
 Plains Pipeline, L.P.  
 14-Inch Vac to Jal - BLM  
 SRS # 2009-093  
 Lea County, NM  
 1RP - 2182

**LEGEND:**  
 — Excavation Extent  
 ● Sample Location  
 — Pipelines

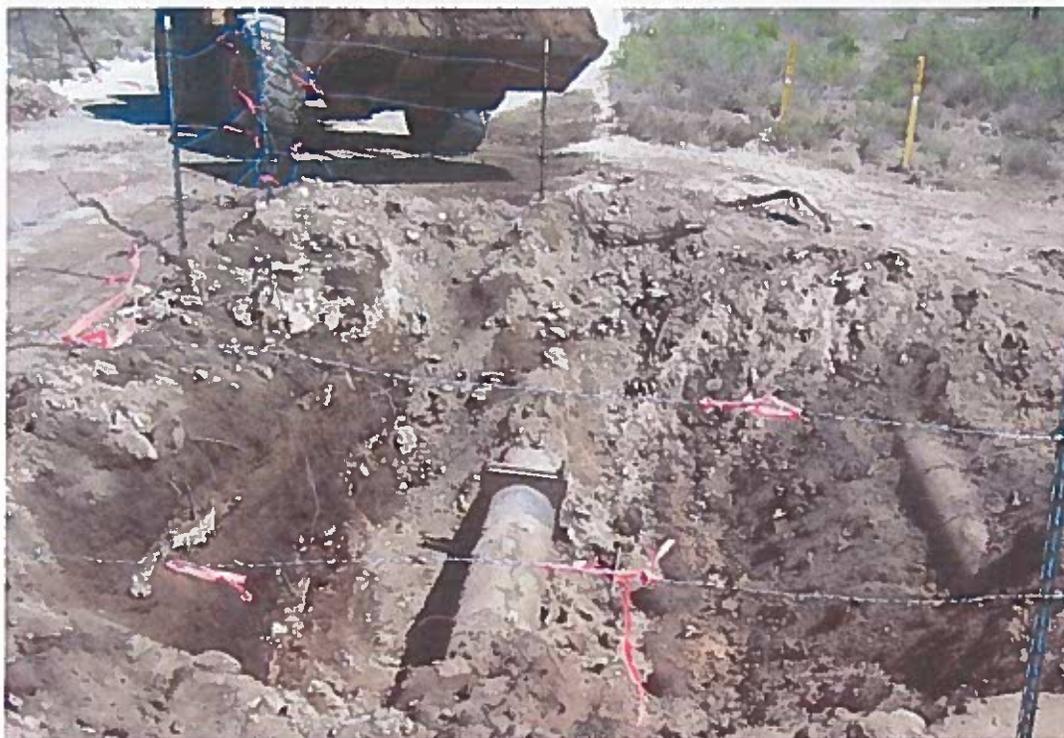
Release Point of 14-Inch Vac to Jal – BLM Release Site

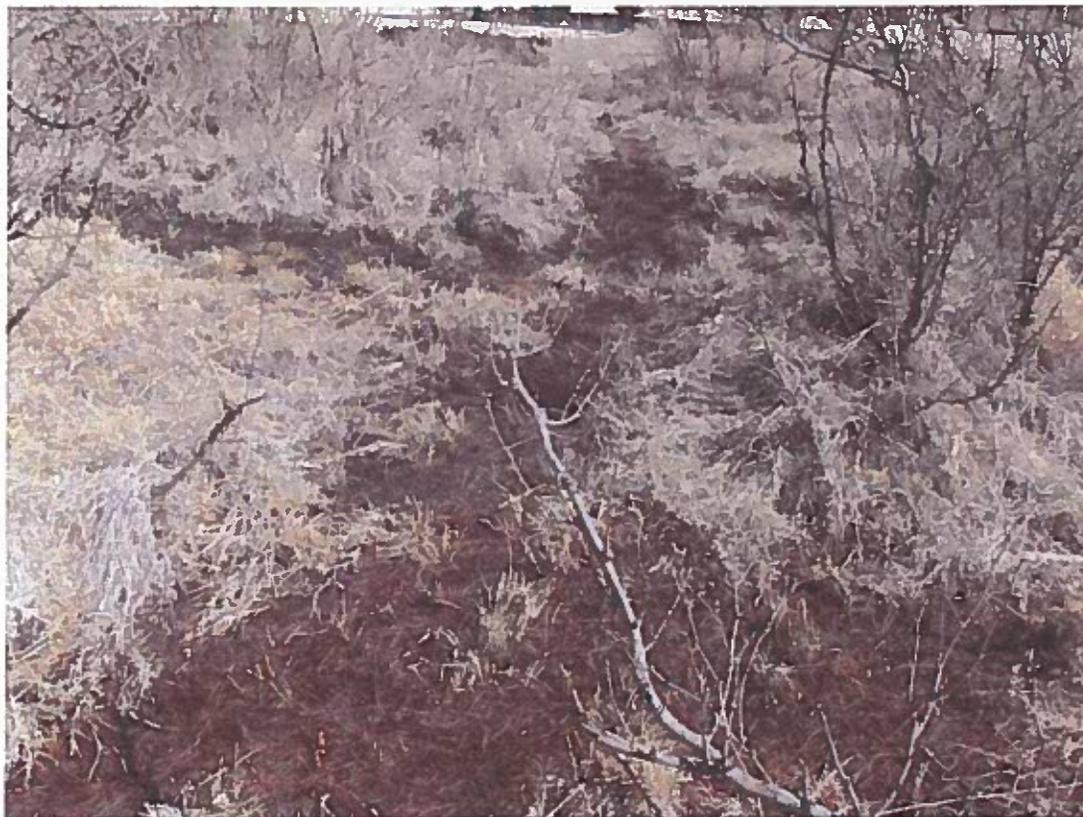
14-Inch Vac to Jal – BLM Initial Response

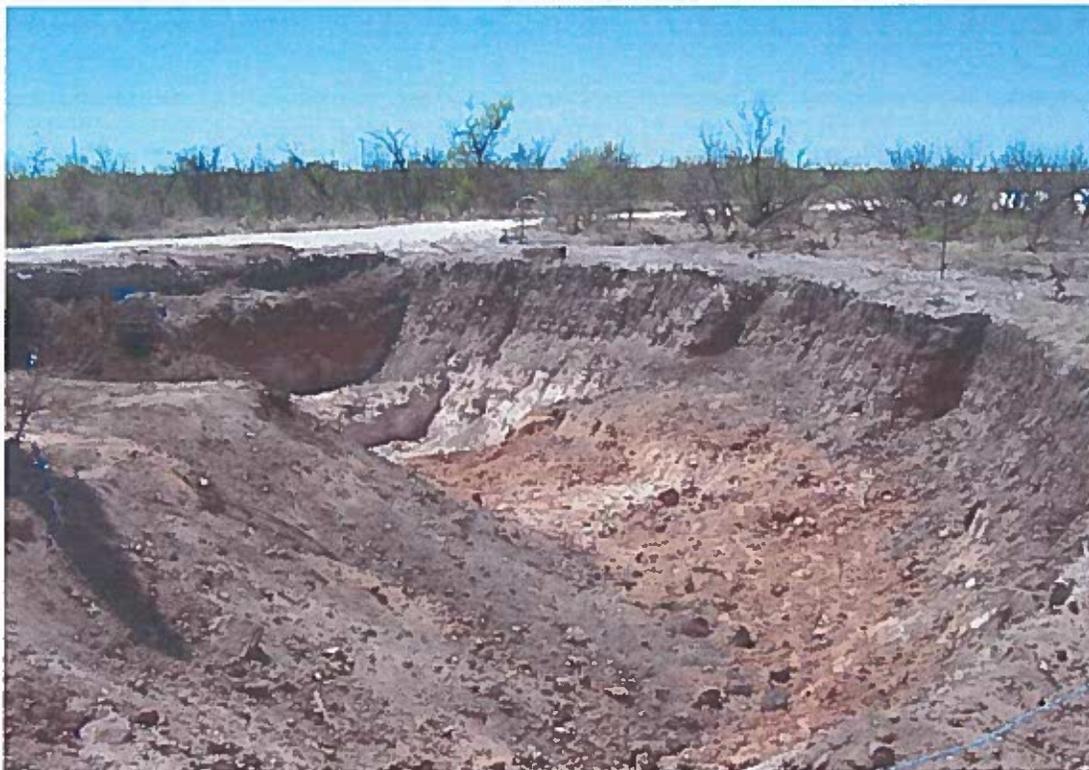
14-Inch Vac to Jal – BLM Release Excavation, looking southeast

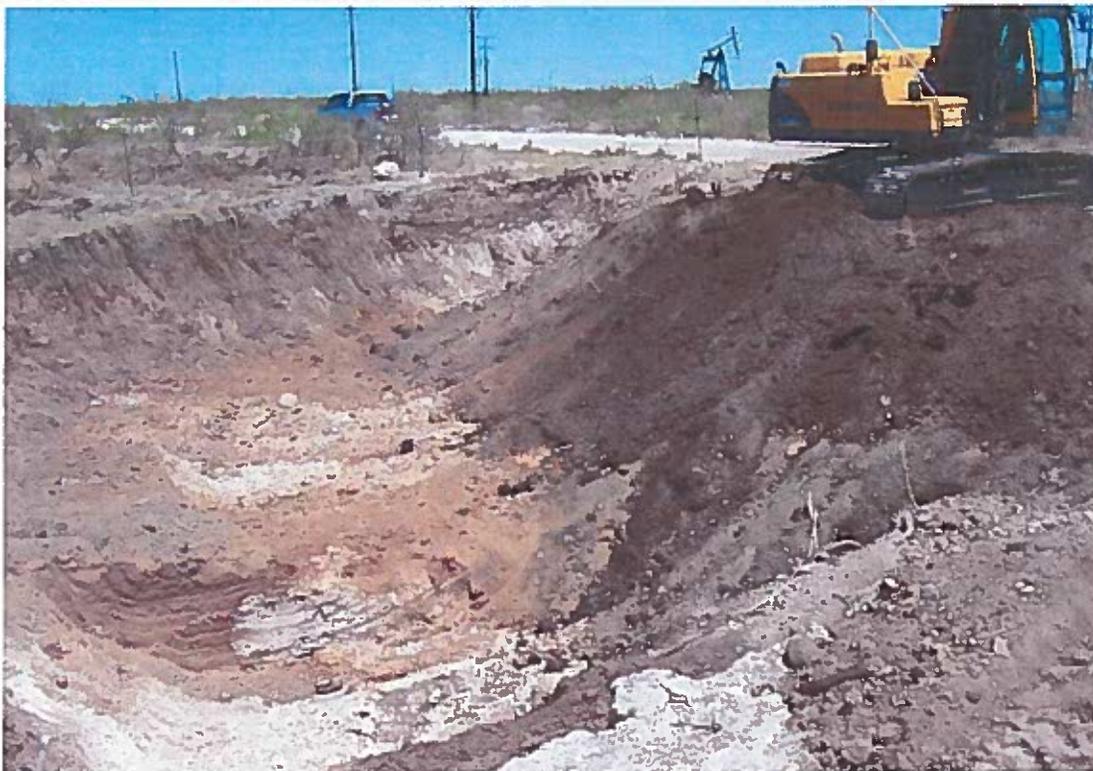
14-Inch Vac to Jal – BLM Release Excavation, looking northeast

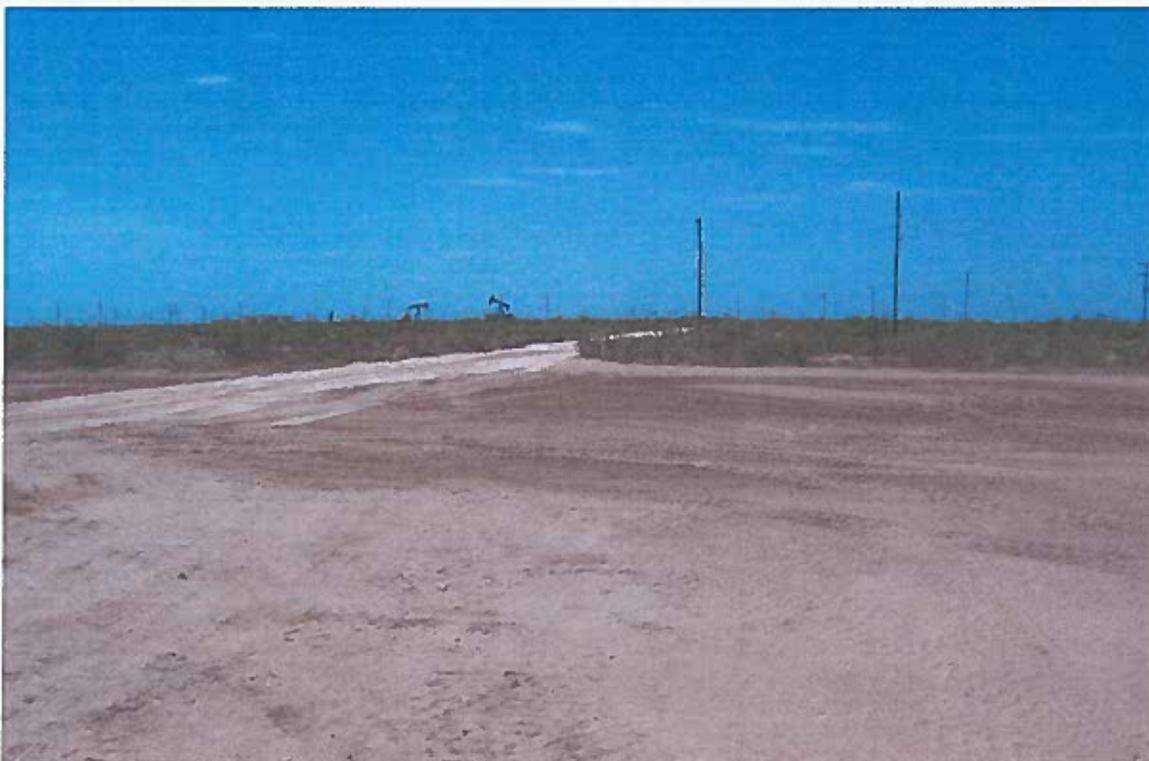
14-Inch Vac to Jal – BLM Release Remediation Completed, looking North

backfill activities, the soil was contoured to fit the surrounding topography and non-impacted caliche was purchased from an off-site source. The caliche lease road was replaced and reopened, and any areas disturbed by remediation activities will be reseeded to BLM specifications.

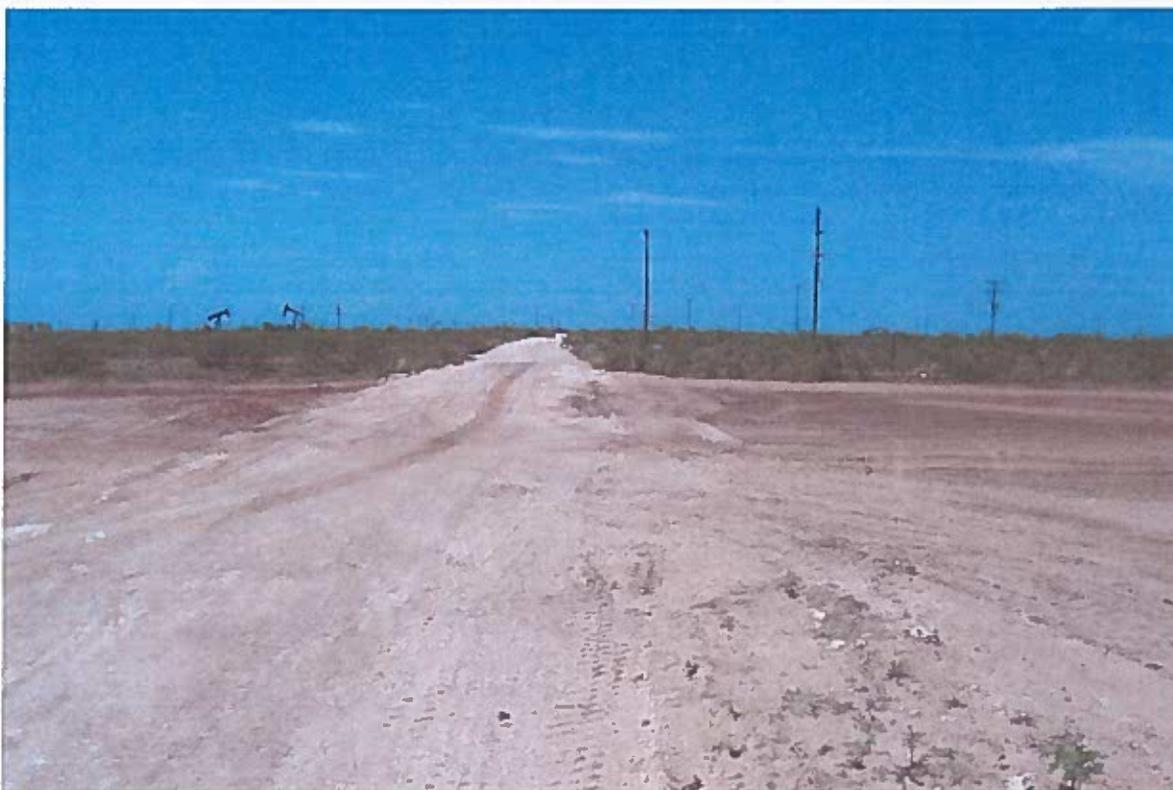
14-Inch Vac to Jal – BLM Release Remediation Completed, looking North
