Pit, Below-Grade Tank, or
Proposed Alternative Method Permit or Closure Plan Application

FACILITY ID
[fCS1912236570]
Trench 3

1. Operator: LOGOS Operating, LLC OGRID #: 289408
Address: 2010 Afton Place, Farmington NM 87401
Facility or well name: Section 25 Burial Trench #3 / Drying Pad
API Number: See attached for API#'s OCD Permit Number: fCS1912236570
U/L or Qtr/Qtr D Section 25 Township 31N Range 6W County: Rio Arriba
Center of Proposed Design: Latitude 36.874940 Longitude -107.419135 NAD83
Surface Owner: [X] Federal [ ] State [ ] Private [ ] Tribal Trust or Indian Allotment

### Section 25 Recycling Containment/Burial Trench #3 – Final Photos

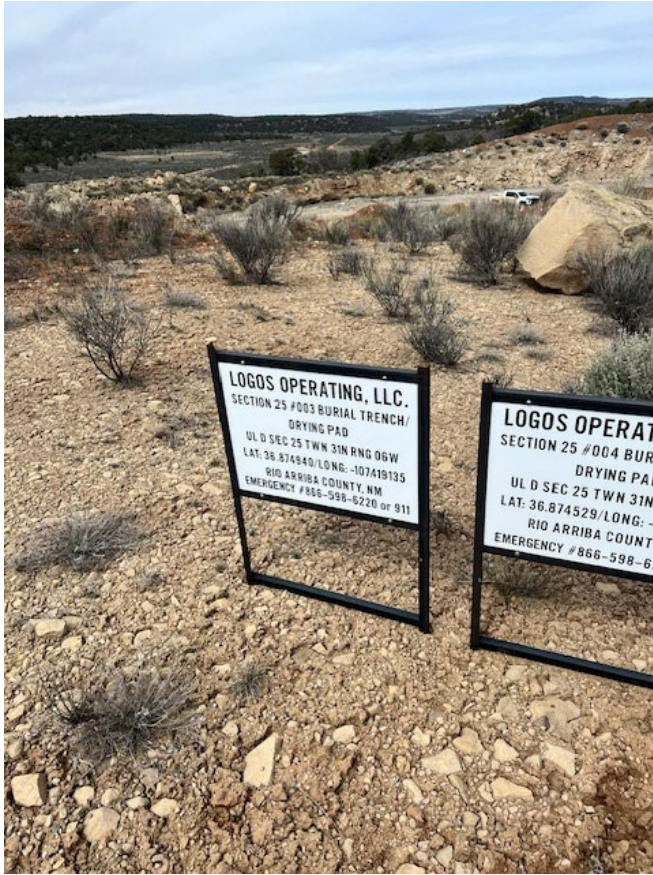
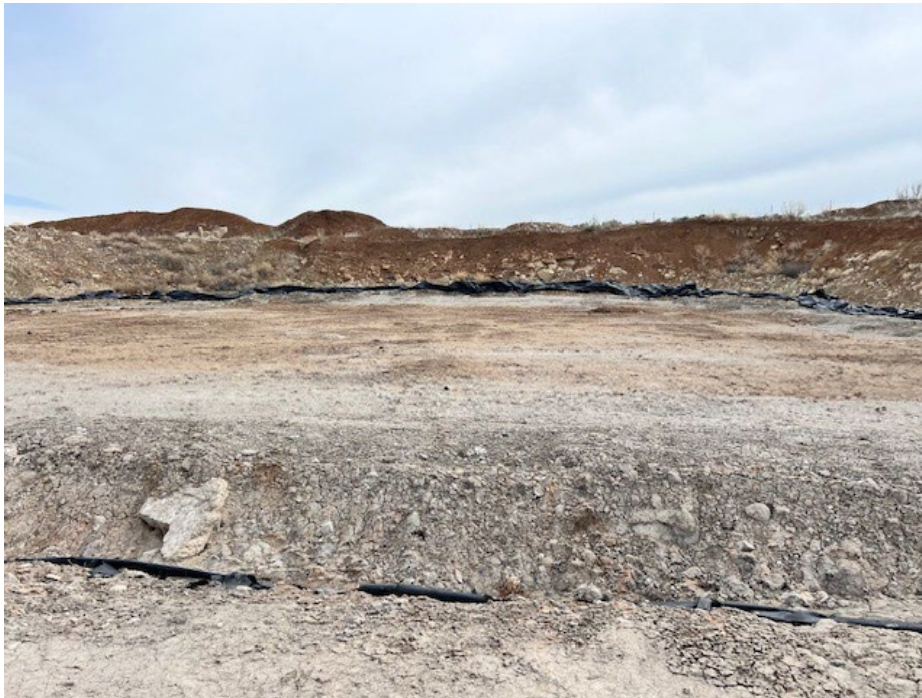
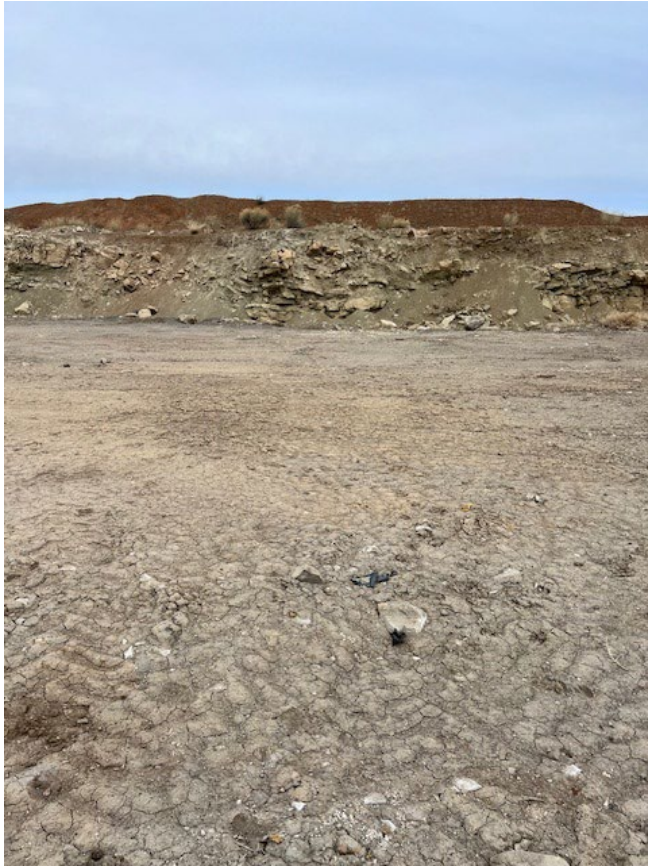
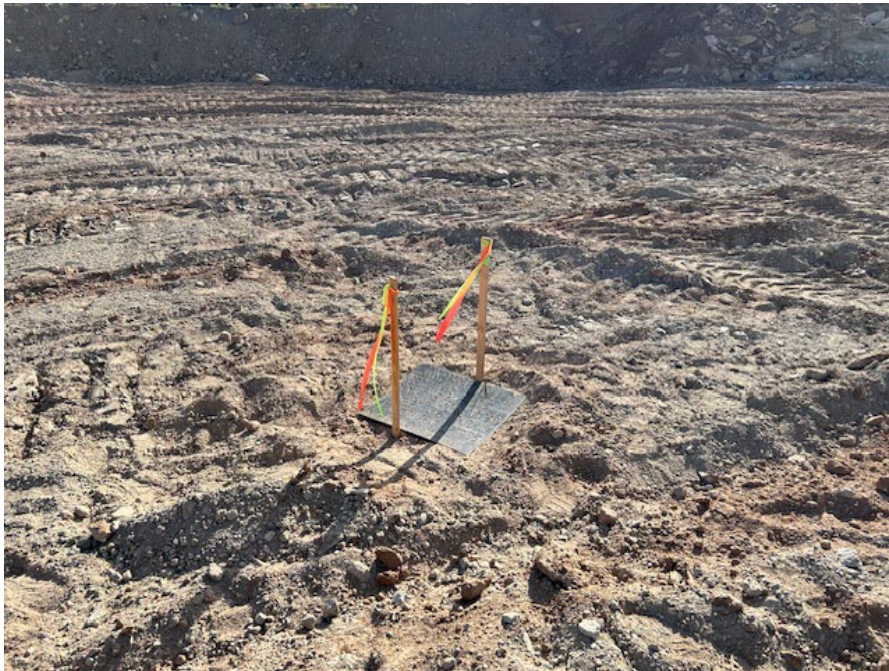
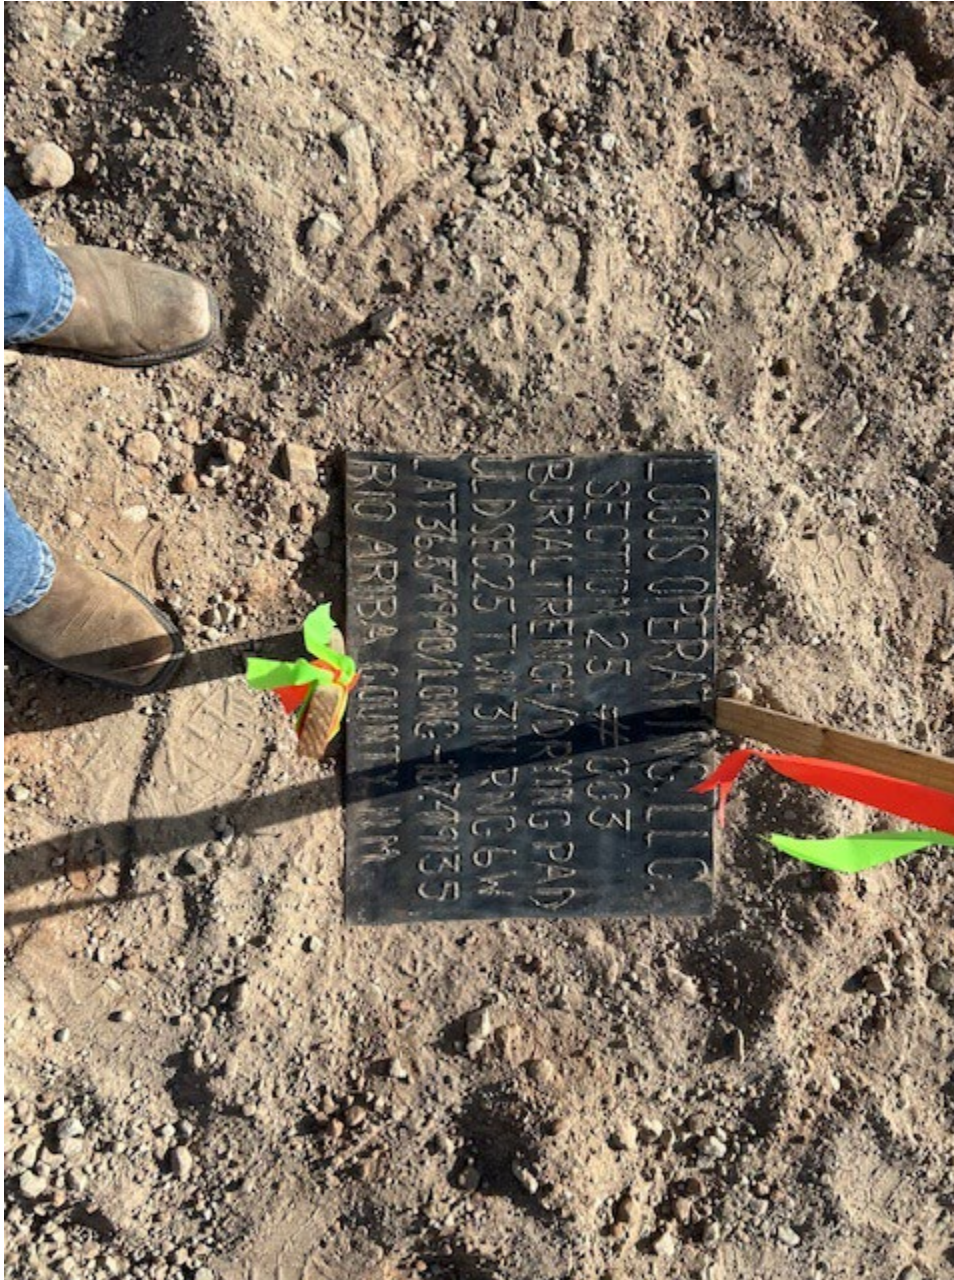
- **Upon completion of solidification and testing, the burial trench area was backfilled with non-waste earthen material compacted to native conditions. A minimum of four feet of cover was achieved and the cover included one foot of suitable material to establish vegetation at the site.**

- **LOGOS covered the trench and the drying pad to match fit, shape, line form and texture of the surrounding area. Re-shaping included drainage control, to prevent ponding and erosion. Natural drainages were unimpeded and BMPs were used to aid in the soil stabilization. Will complete final closing of the area at final reclamation quarry. This area is in use for future drilling projects. Upon final reclamation LOGOS will contour the location to approximately match previous topography per the conditions of approvals (COA)s within the APD and the direction offered by the BLM inspector.**
