May 1, 2020

Vertex Project #: 20E-00141-046

Spill Closure Report: Malachite 22 Fed 1H
Unit D, Section 22, Township 19 South, Range 33 East
County: Lea
API: 30-025-40318
Tracking Number: NRM2005651912

Prepared For: Devon Energy Production Company
6488 Seven Rivers Highway
Artesia, New Mexico 88210

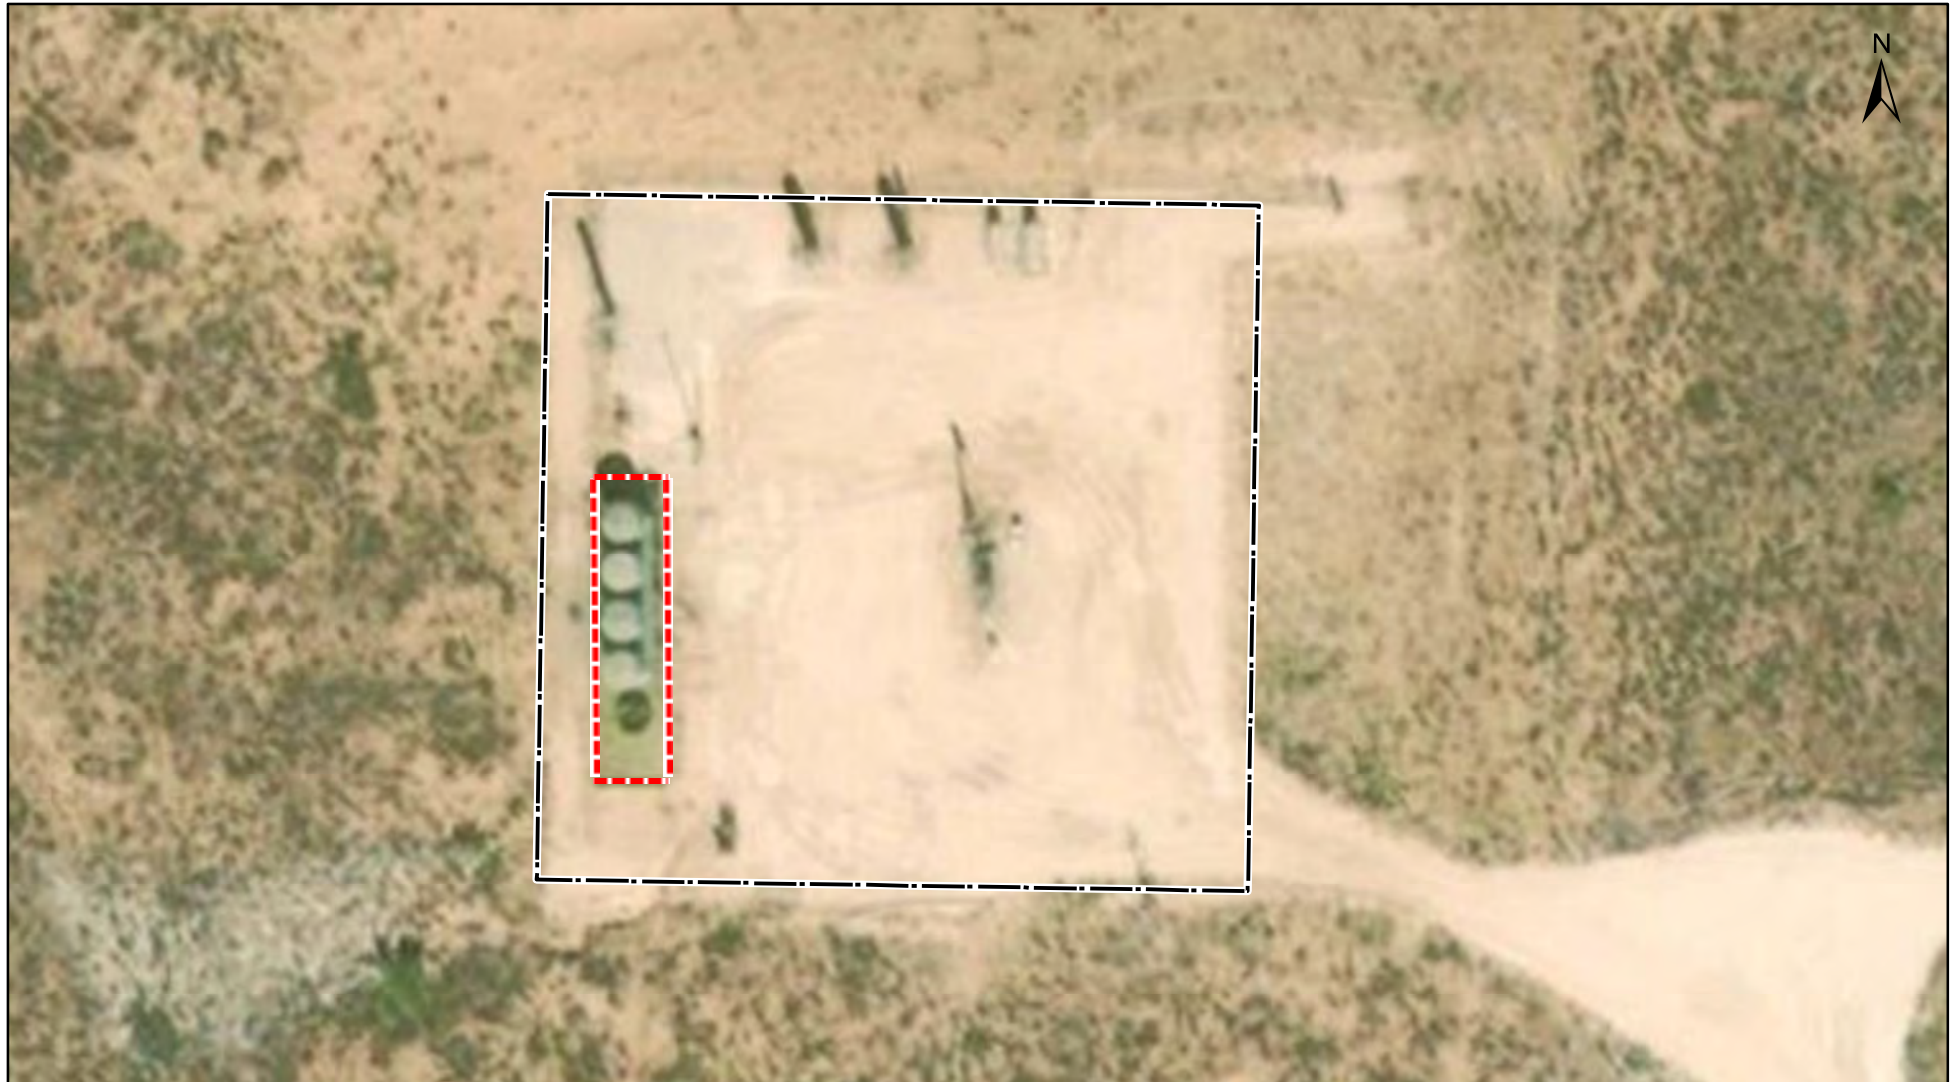
DRAWN: NM	FIGURE: 1
APPROVED: JC	
DATE: JAN 22/20

SPILL AREA

Site Schematic
Malachite 22 Fed 1H

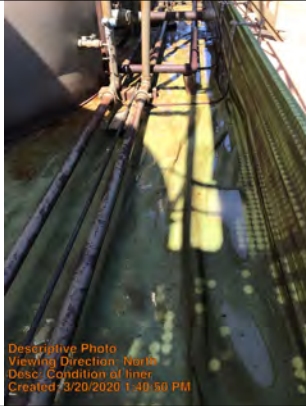
Descriptive Photo
Viewing Direction: North
Desc: Condition of liner
Created: 3/20/2020 1:40:59 PM

Condition of liner

Vertex recommends no additional remediation action to address the release at Malachite. The secondary containment liner appeared to be intact and had the ability to contain the release in question, as shown in the inspection photographs included with the DFR (Attachment 5). There are no anticipated risks to human, ecological or hydrological receptors associated with the release site.

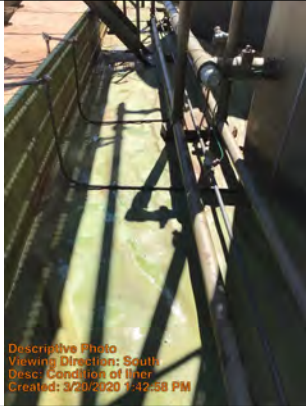
Descriptive Photo
Viewing Direction: South
Desc: Condition of liner
Created: 3/20/2020 1:42:58 PM

Condition of liner

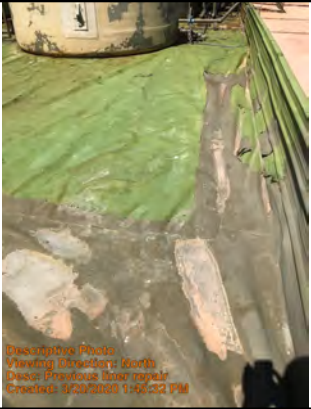
<p>Viewing Direction: North</p>

<p><small>Descriptive Photo Viewing Direction: North Desc: Previous liner repair Created: 3/20/2020 1:47:32 PM</small></p> <p>Previous liner repair</p>	<p>Viewing Direction: West</p>

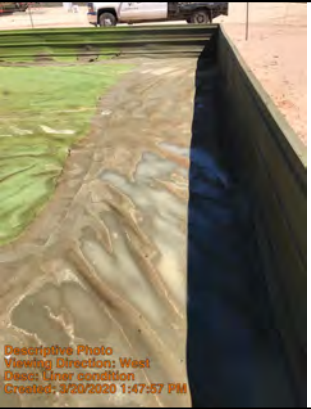
<p><small>Descriptive Photo Viewing Direction: West Desc: Liner condition Created: 3/20/2020 1:47:57 PM</small></p> <p>Liner condition</p>
<p>Viewing Direction: North</p>

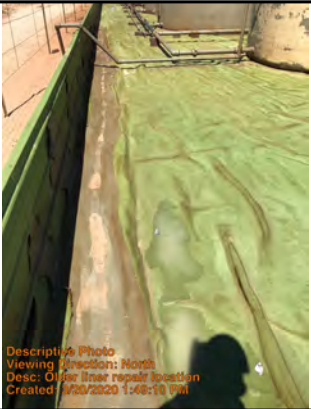
<p><small>Descriptive Photo Viewing Direction: North Desc: Older liner repair location Created: 3/20/2020 1:48:18 PM</small></p> <p>Older liner repair location</p>	<p>Viewing Direction: West</p>

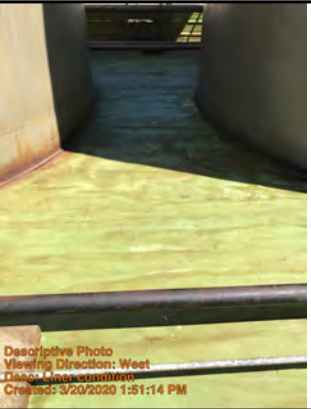
<p><small>Descriptive Photo Viewing Direction: West Desc: Liner condition Created: 3/20/2020 1:51:14 PM</small></p> <p>Liner condition</p>

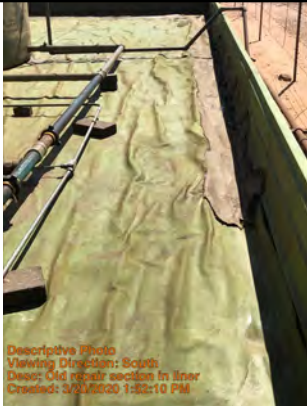
<p>Viewing Direction: South</p>

<p><small>Descriptive Photo Viewing Direction: South Desc: Old repair section in liner Created: 3/20/2020 1:52:10 PM</small></p> <p>Old repair section in liner</p>	<p>Viewing Direction: North</p>

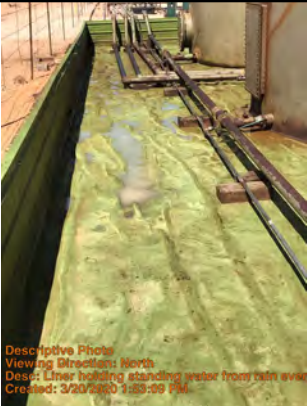
<p><small>Descriptive Photo Viewing Direction: North Desc: Liner holding standing water from rain event Created: 3/20/2020 1:53:09 PM</small></p> <p>Liner holding standing water from rain event</p>
<p>Viewing Direction: South</p>

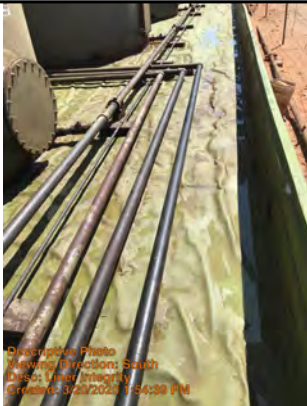
<p><small>Descriptive Photo Viewing Direction: South Desc: Liner integrity Created: 3/20/2020 1:54:39 PM</small></p> <p>Liner integrity</p>	<p>Viewing Direction: East</p>

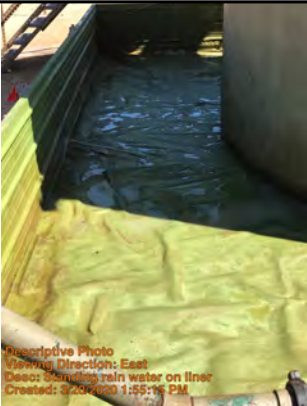
<p><small>Descriptive Photo Viewing Direction: East Desc: Standing rain water on liner Created: 3/20/2020 1:55:16 PM</small></p> <p>Standing rain water on liner</p>

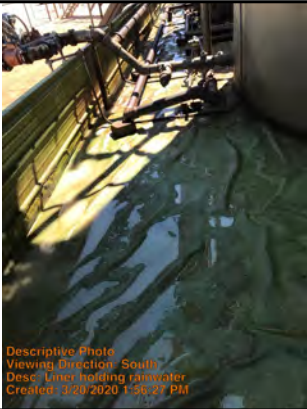
<p>Descriptive Photo Viewing Direction: South Desc: Liner holding rainwater Created: 3/20/2020 1:58:27 PM</p>

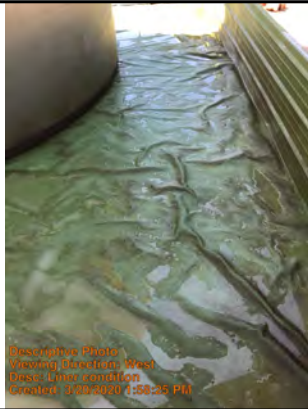
<p>Descriptive Photo Viewing Direction: West Desc: Liner condition Created: 3/20/2020 1:58:35 PM</p>
Liner holding rainwater	Liner condition
