303 Veterans Airpark Lane Midland, TX 79705

Remediation Plan

Re: Eugene Wood Lease
Case # NRM2024530079

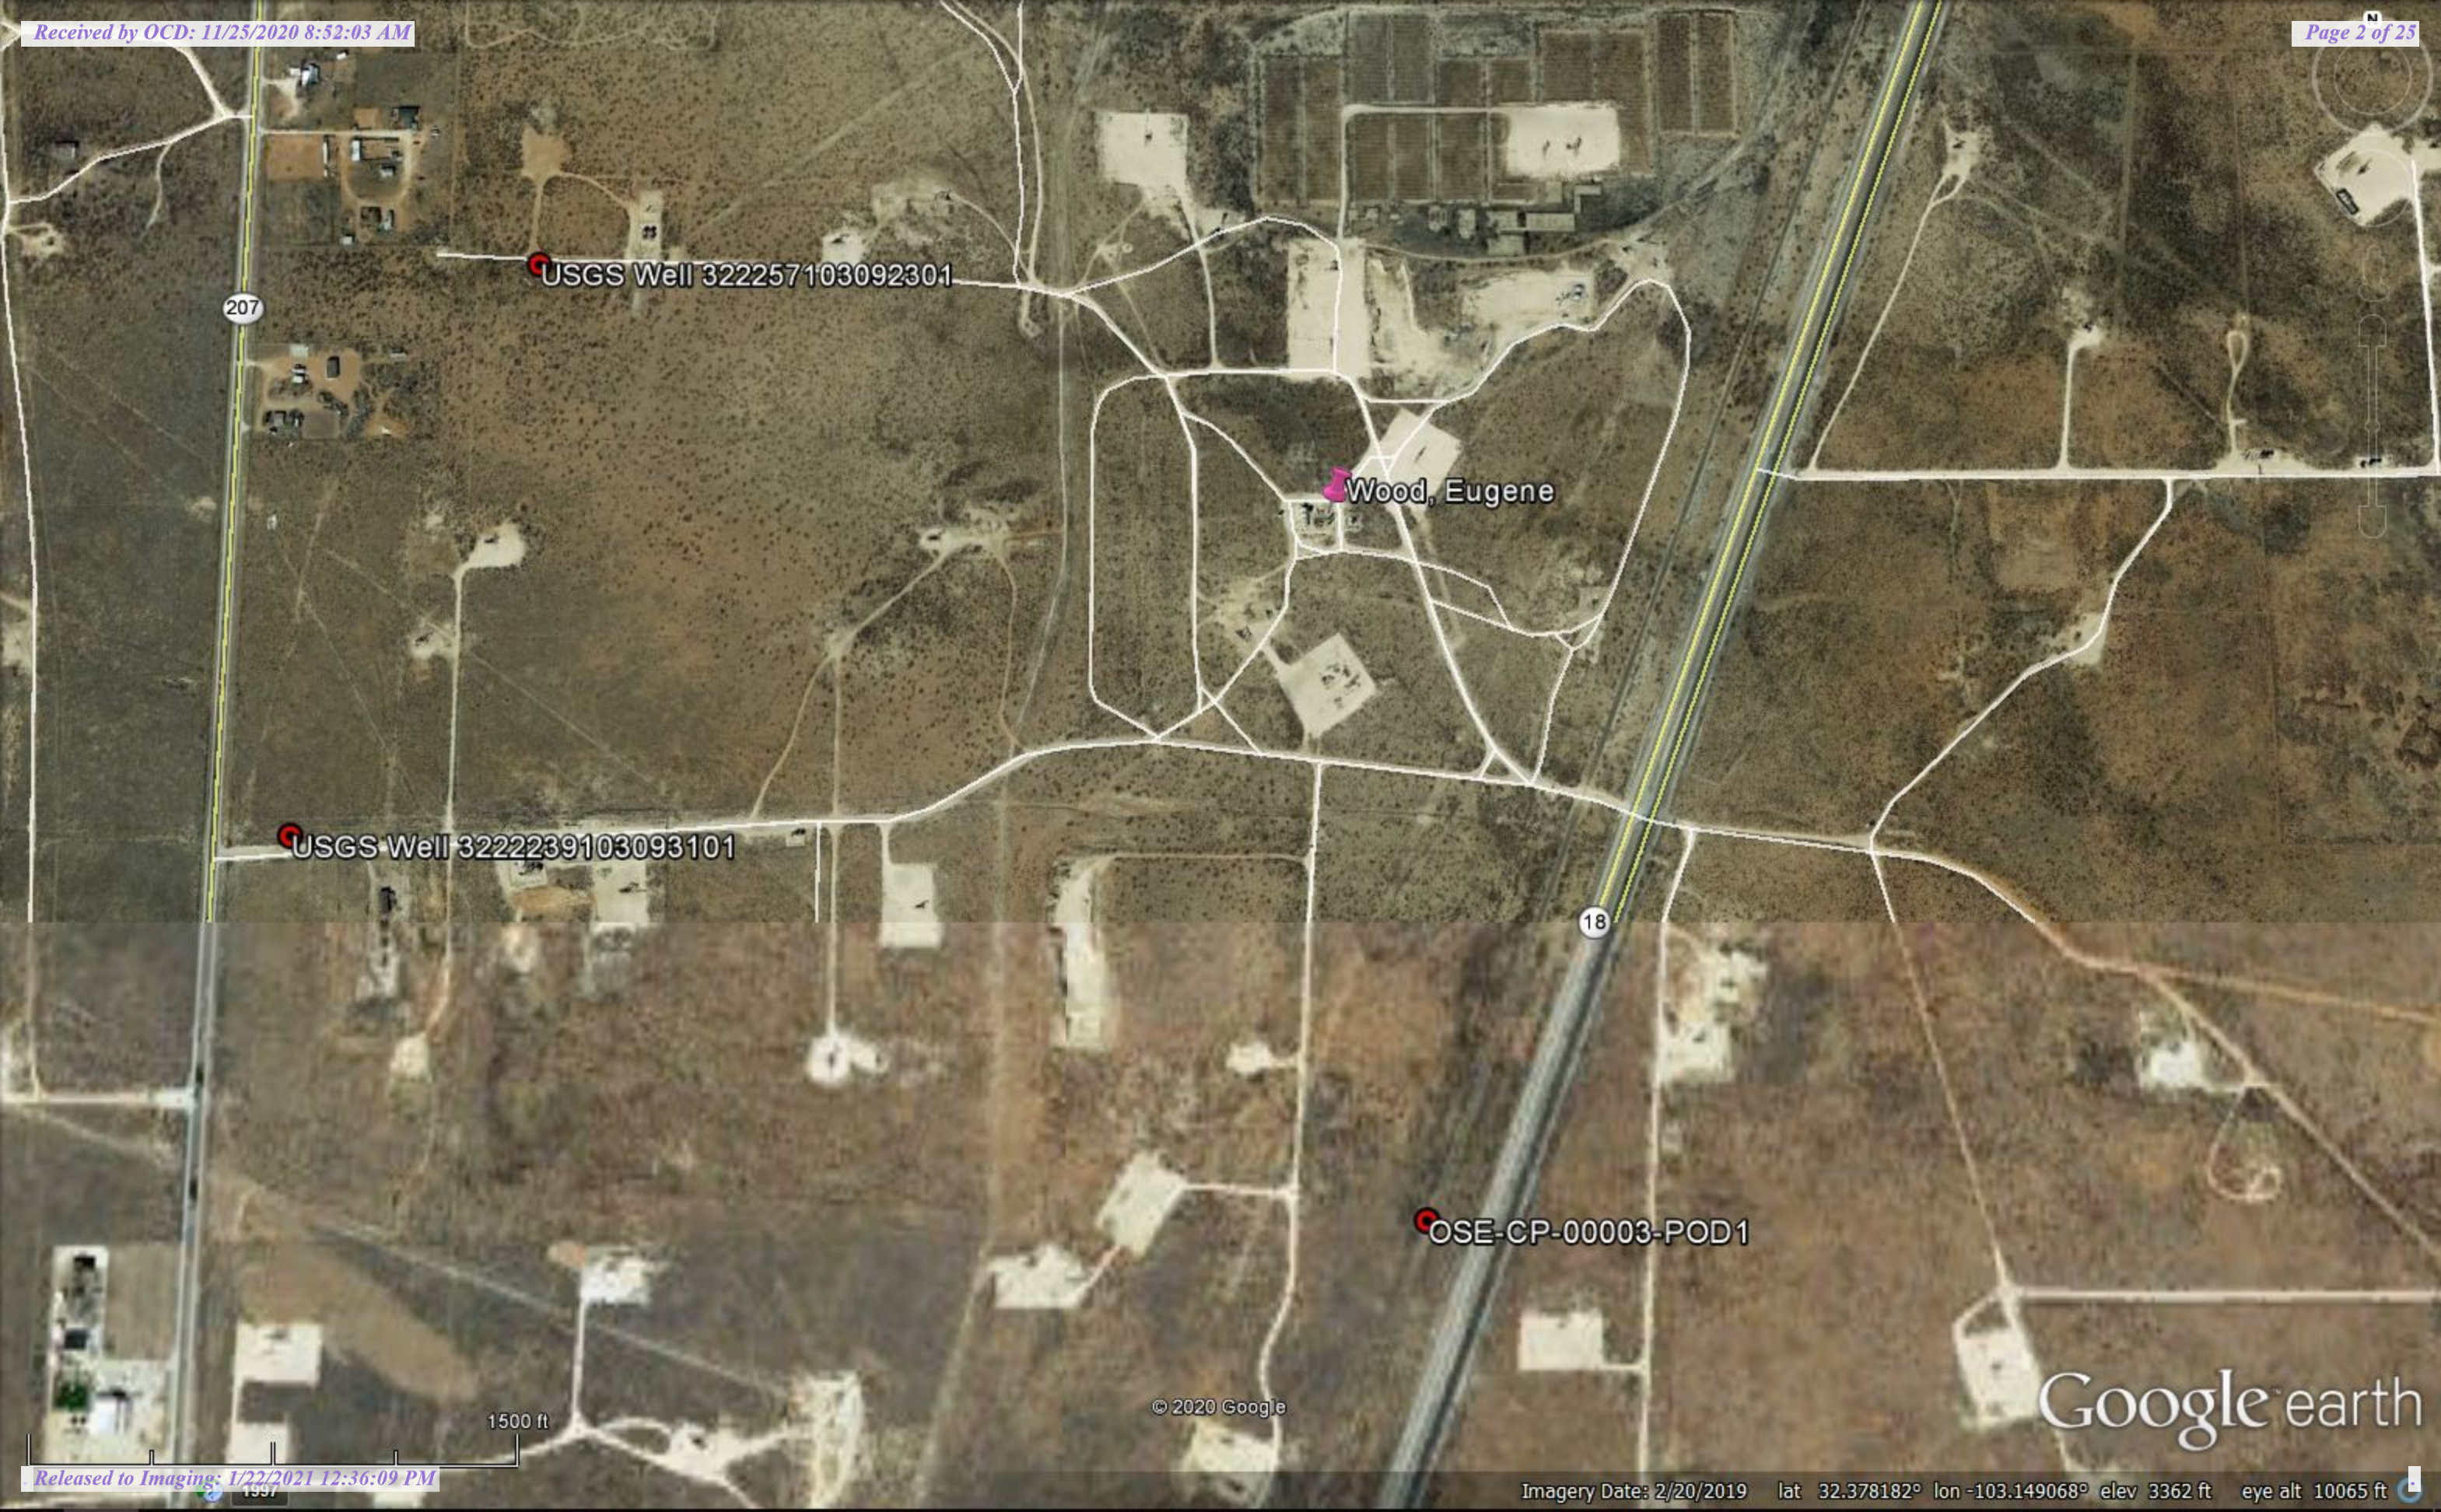
USGS Well 322257103092301

Wood, Eugene

USGS Well 3222239103093101

OSE-CP-00003-POD1

1500 ft

On 08/25/2020 a release occurred due to a failed phase arrestor. The release (GPS: 32.38021, -103.14785) is located south of Eunice, NM in unit letter G section 22 township 22S range 37E. A groundwater survey was conducted utilizing the NMOSE and USGS wells of record. The 3 nearest wells of record suggest groundwater is greater than 50 feet with the shallowest well 75 feet to groundwater.

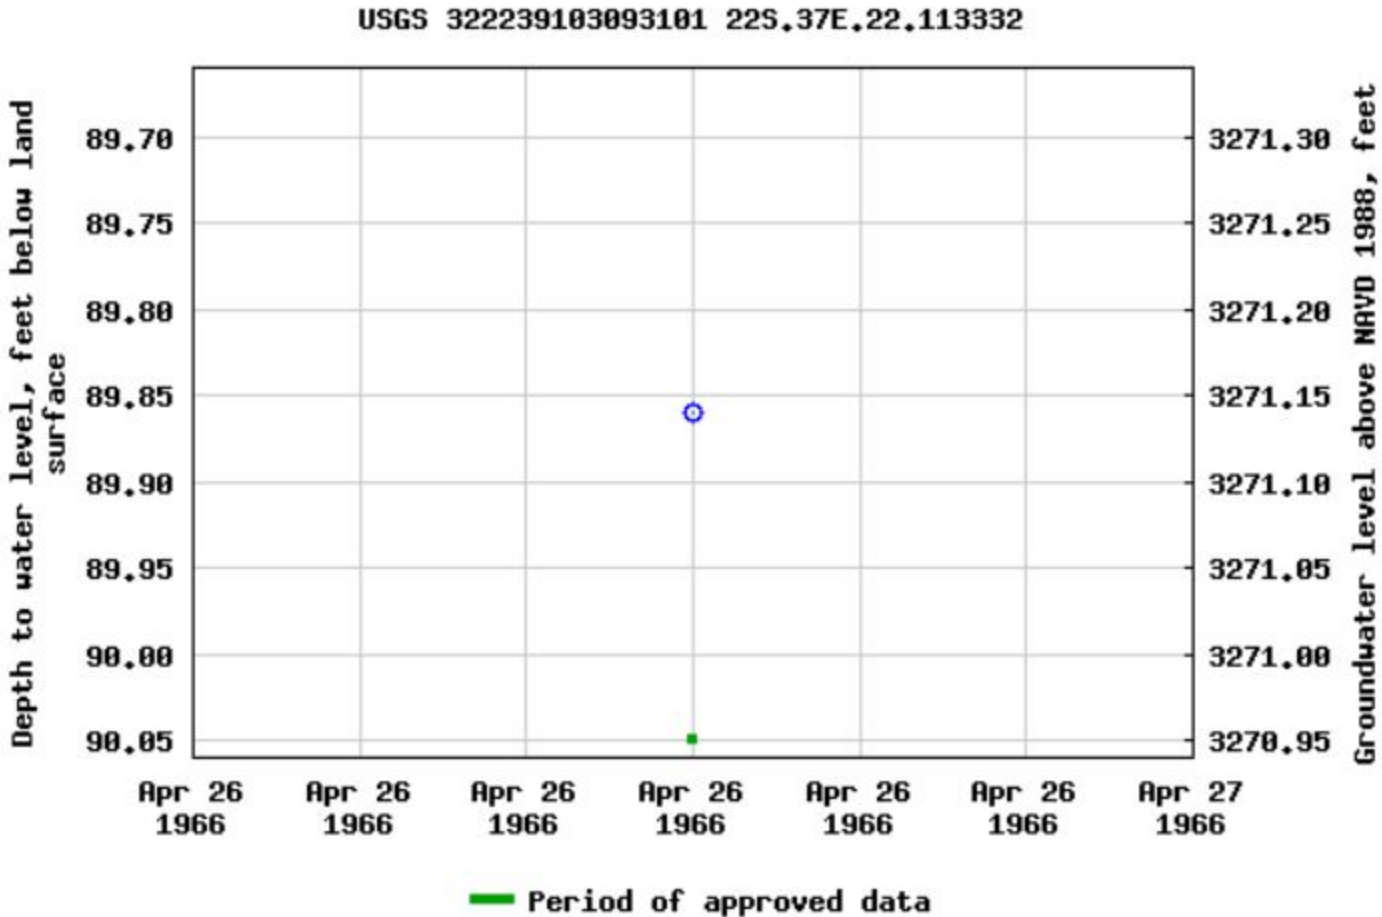
USGS 322239103093101 22S.37E.22.113332

Lea County, New Mexico
Hydrologic Unit Code 13070007
Latitude 32°22'39", Longitude 103°09'31" NAD27
Land-surface elevation 3,361 feet above NAVD88
The depth of the well is 150 feet below land surface.
This well is completed in the Alluvium, Bolson Deposits and Other Surface Deposits (110AVMB) local aquifer.

Breaks in the plot represent a gap of at least one year between field measurements.
[Download a presentation-quality graph](#)

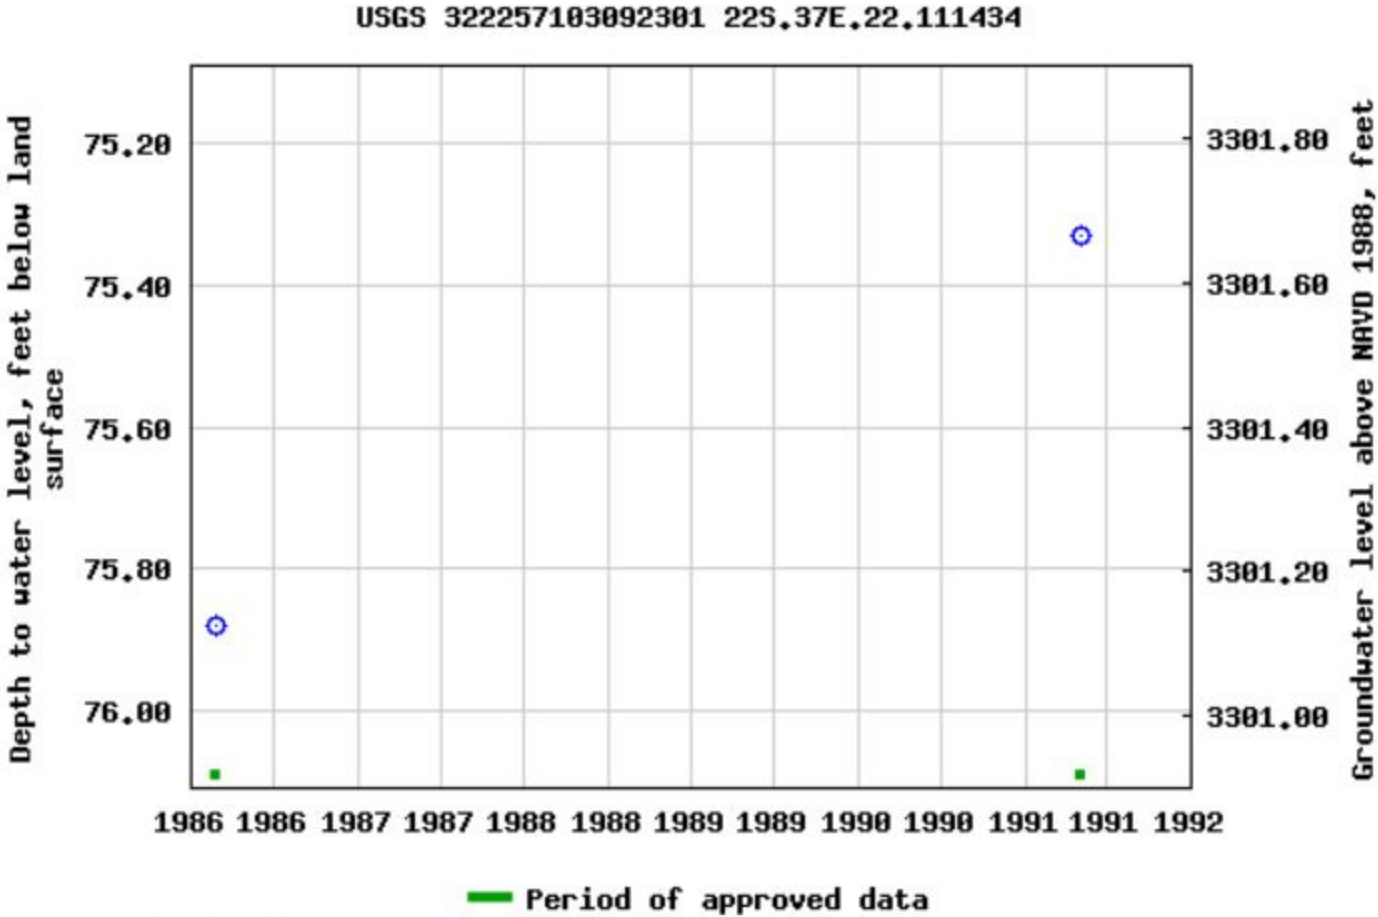
USGS 322257103092301 22S.37E.22.111434

Lea County, New Mexico
Hydrologic Unit Code 13070007
Latitude 32°22'57", Longitude 103°09'23" NAD27
Land-surface elevation 3,377 feet above NAVD88
The depth of the well is 320 feet below land surface.
This well is completed in the Chinle Formation (231CHNL) local aquifer.

Breaks in the plot represent a gap of at least one year between field measurements.

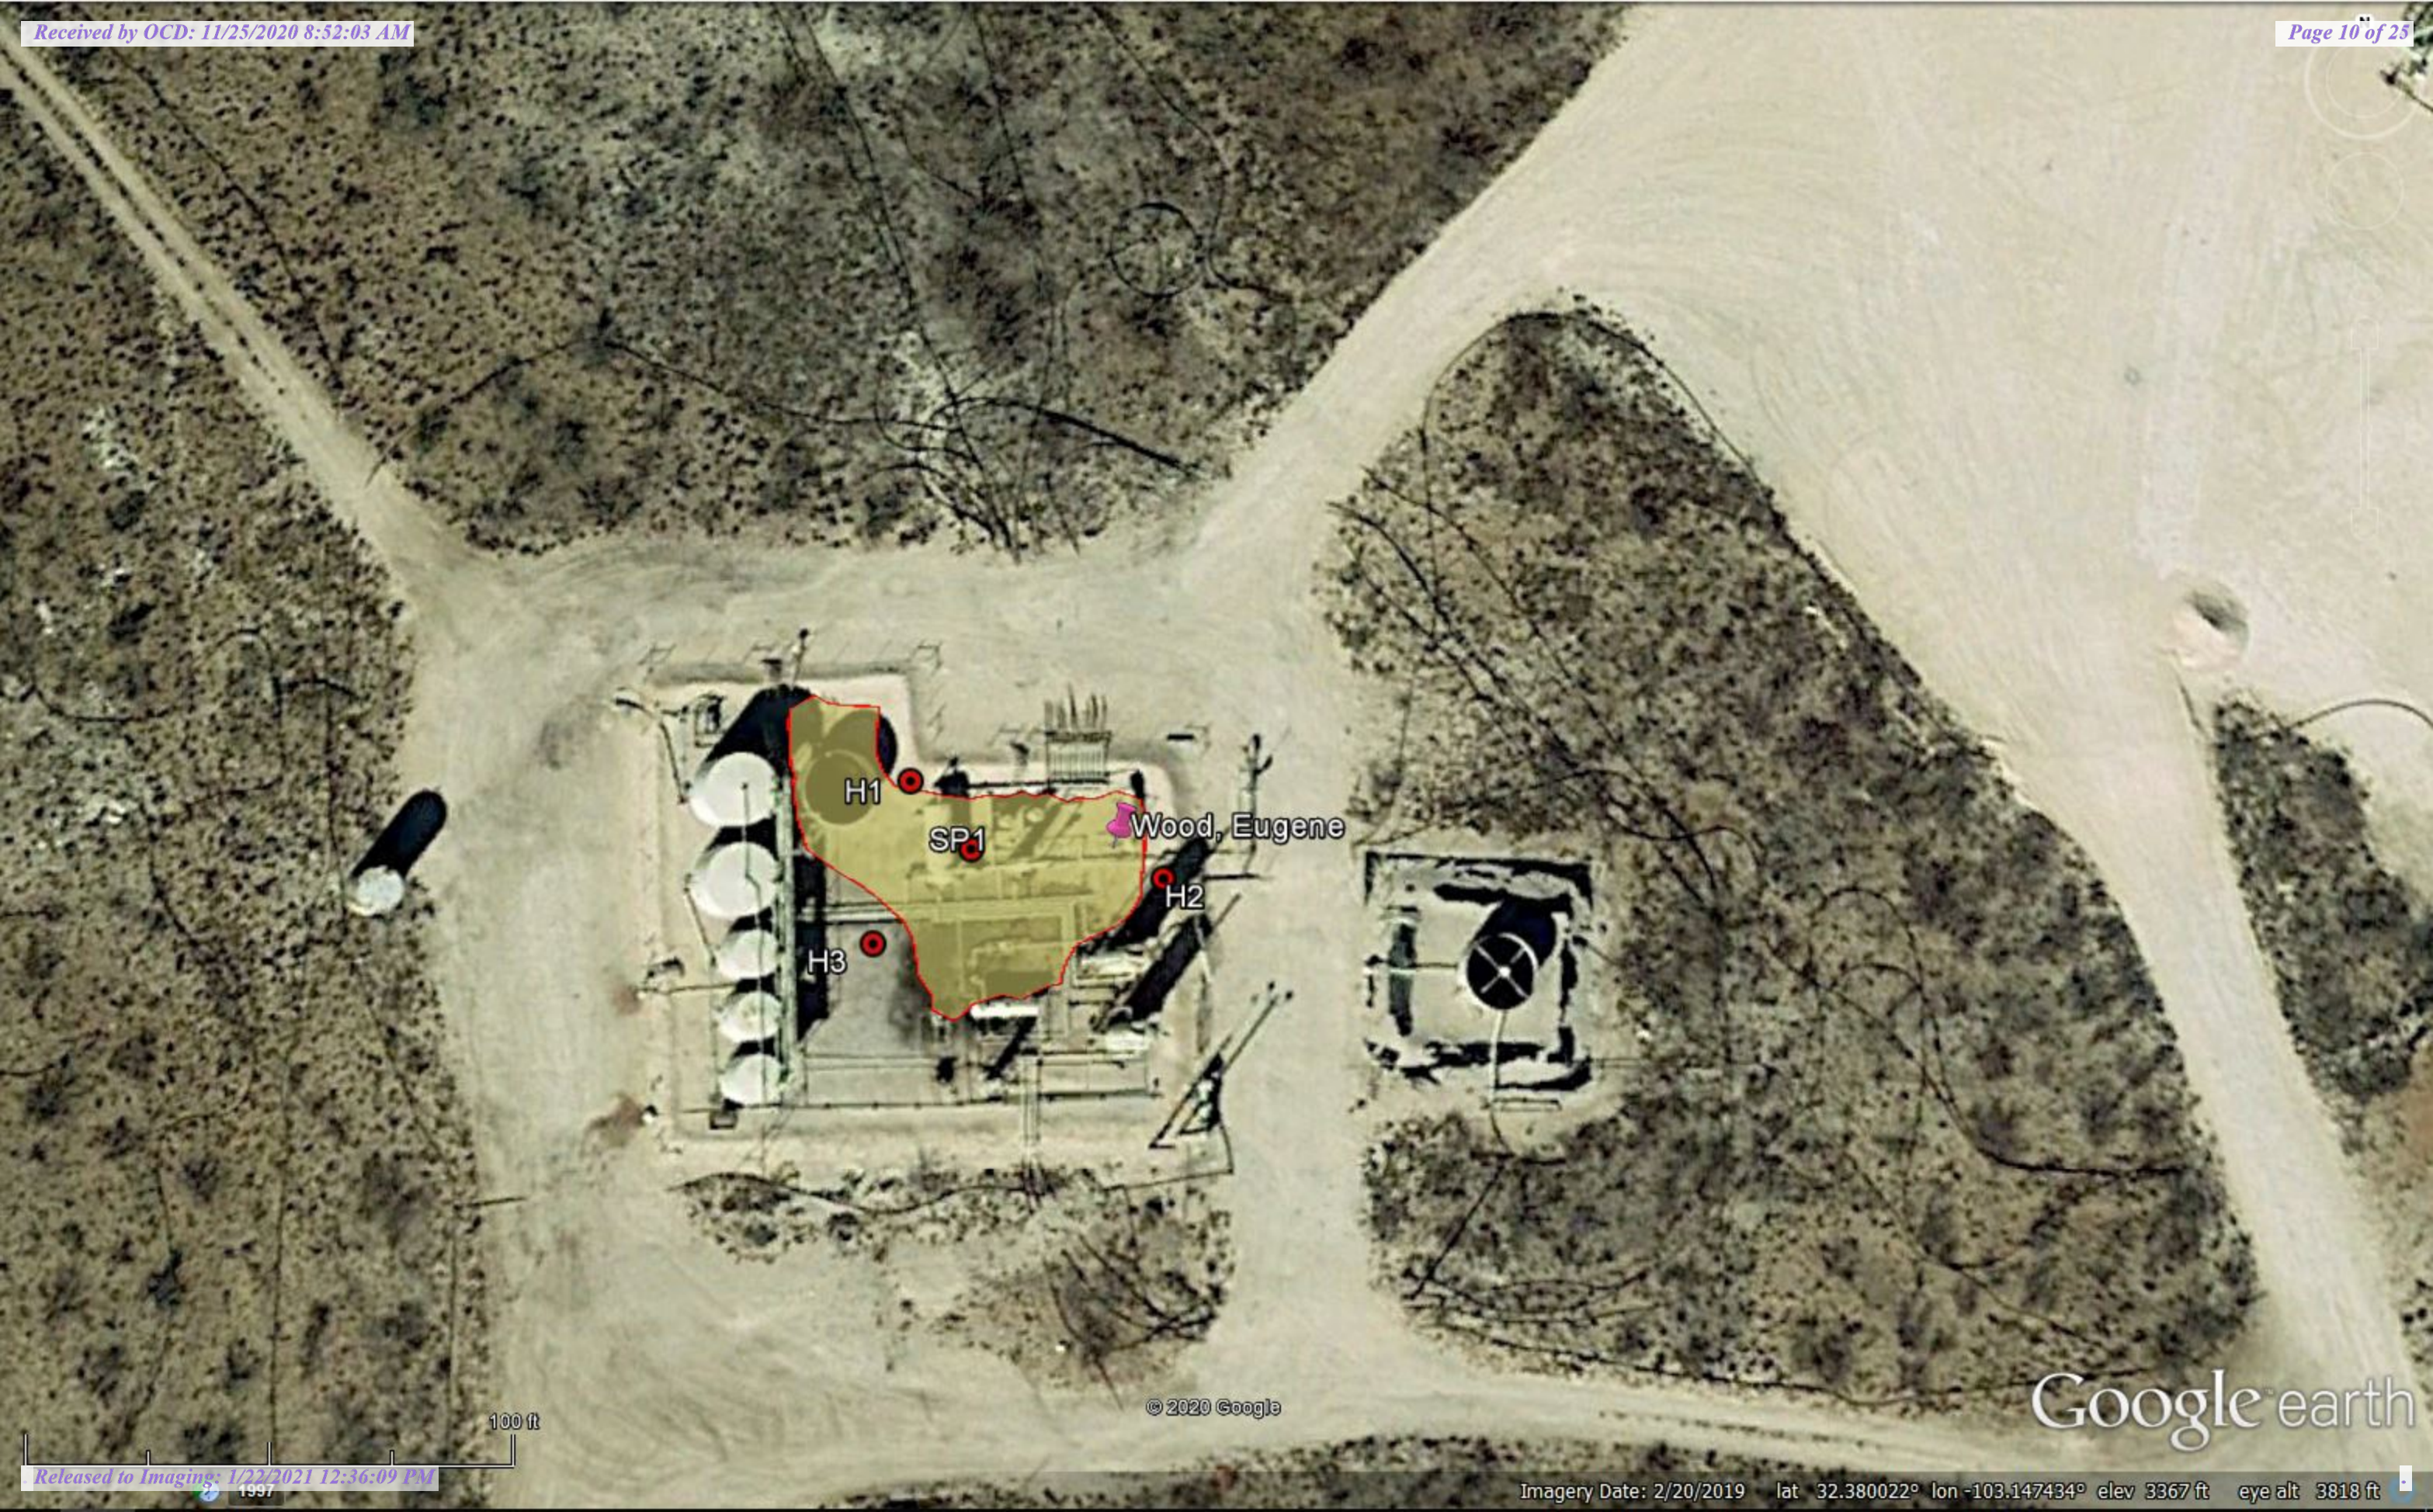
NEDU Injection Line
