Release Notification

CLOSURE REPORT

**Lateral 6A-29 Pipeline Release
SE ¼, S28 T27N R9W
San Juan County, New Mexico**

November 26, 2019
Ensolum Project No. 05A1226069

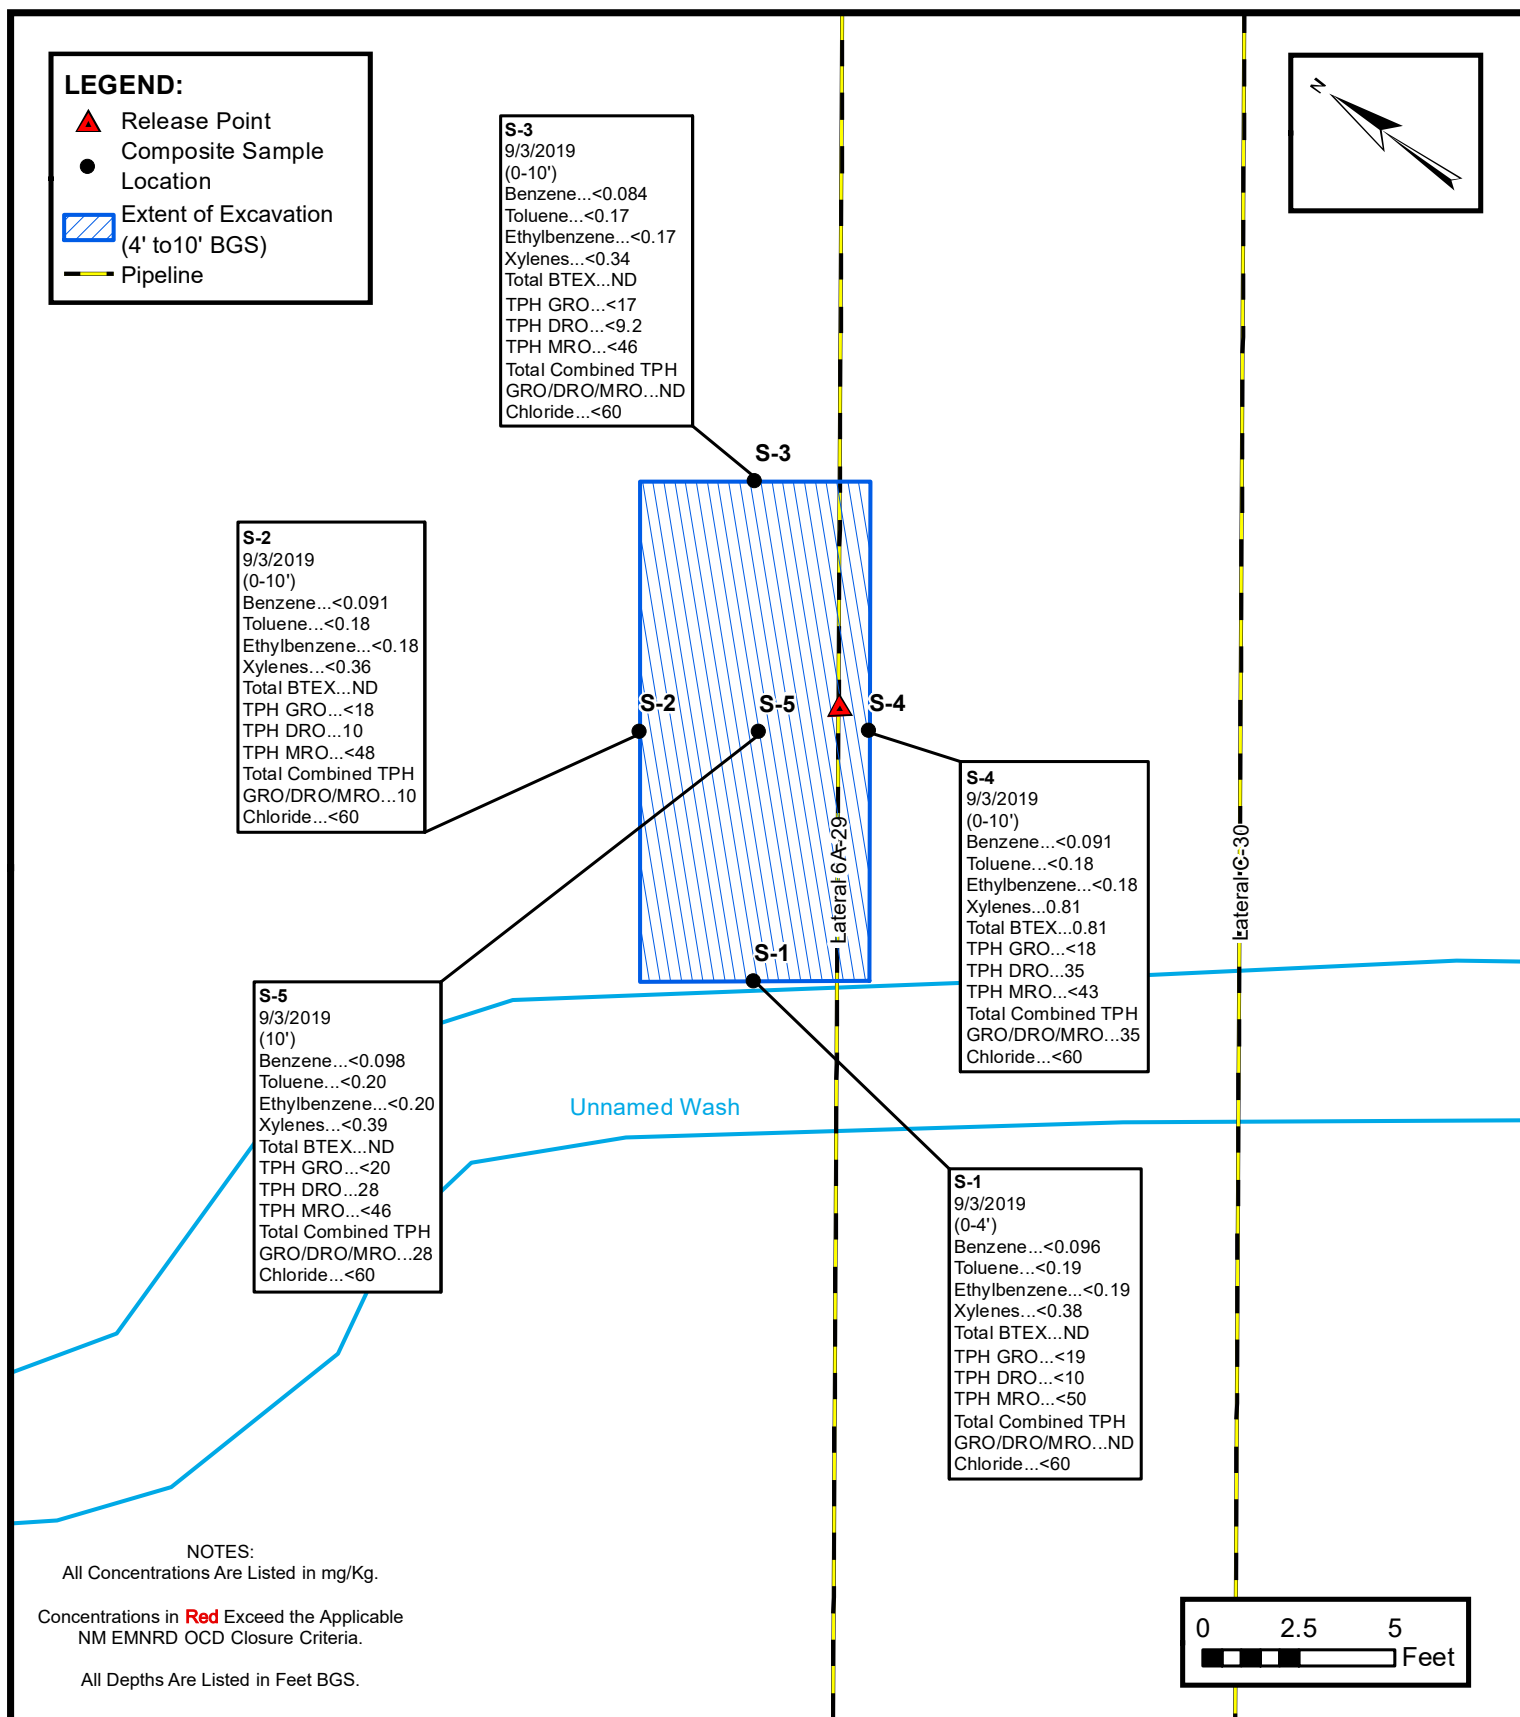
FIGURE
3

The final excavation measured approximately 13 feet long and six (6) feet wide at the maximum extents. The maximum depth of the excavation measured approximately 10 feet bgs.

Figure 3 is a map that identifies approximate soil sample locations and depicts the approximate dimensions of the excavation with respect to the pipeline (**Appendix A**). Photographic documentation of the field activities is included in **Appendix B**.

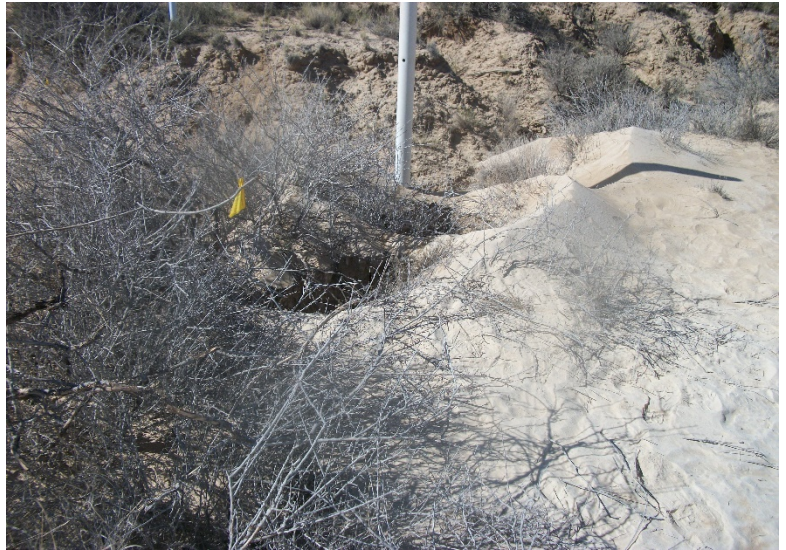
**Photograph 1**

Photograph Description: View of release area.

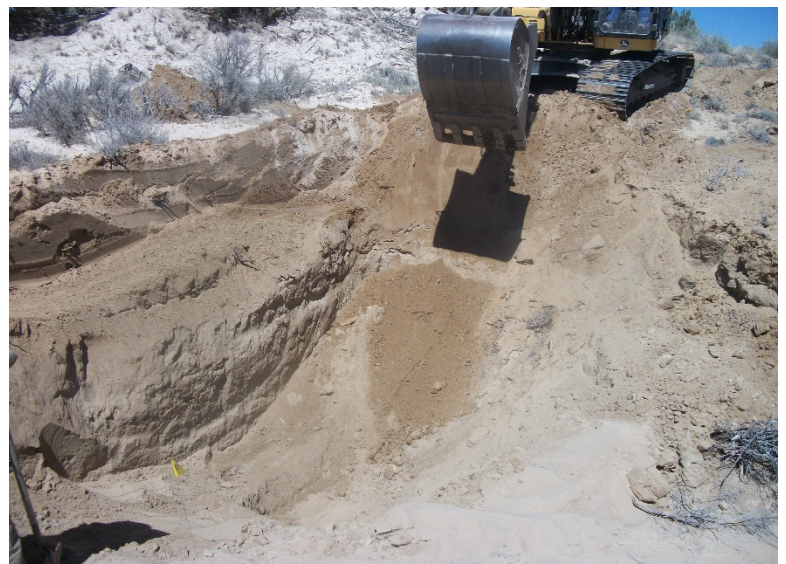
**Photograph 2**

Photograph Description: View of in-process excavation activities.

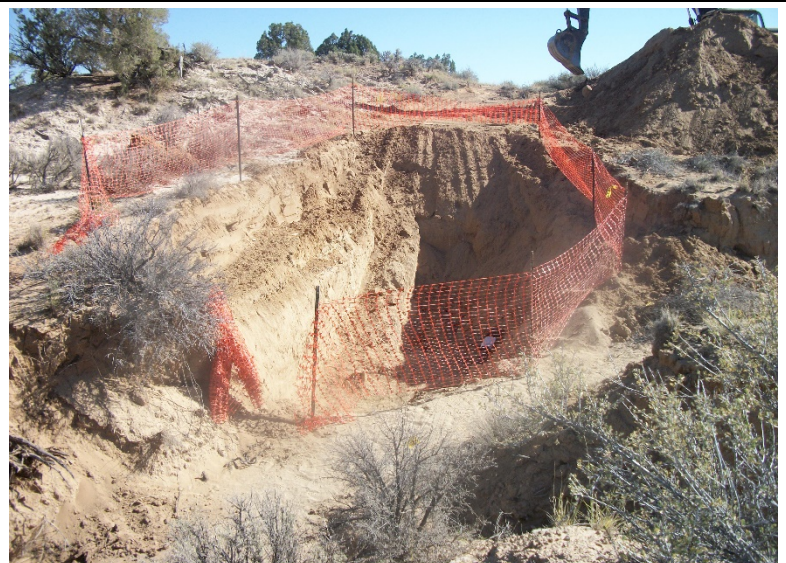
**Photograph 3**

Photograph Description: View of the final excavation.

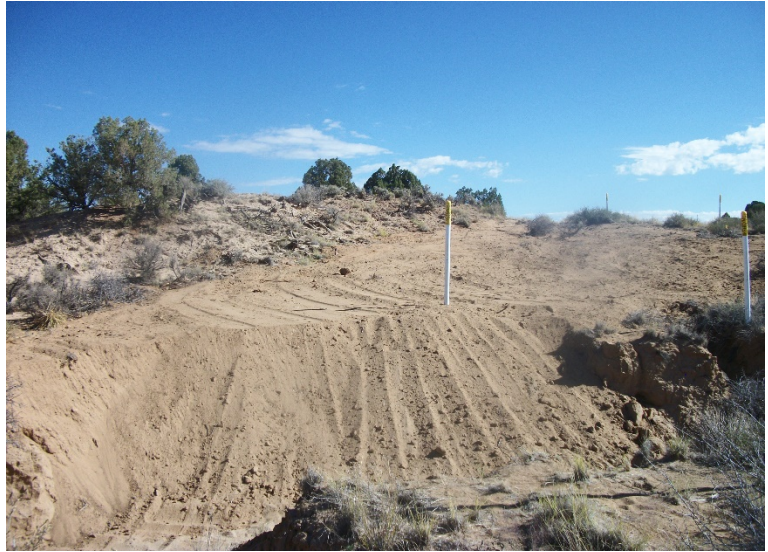
Photograph 4

Photograph Description: View of the final excavation after initial restoration.

The excavation was backfilled with laboratory-confirmed, unaffected stockpiled soils, and then contoured to surrounding grade.
