## Release Notification

Site Name: WBDU 144H	Site Type: Well
Date Release Discovered: 09/30/2020	API # 30-025-40429

## **Remediation Plan**

Re: WBDU 144H  
Case #NRM2028760472

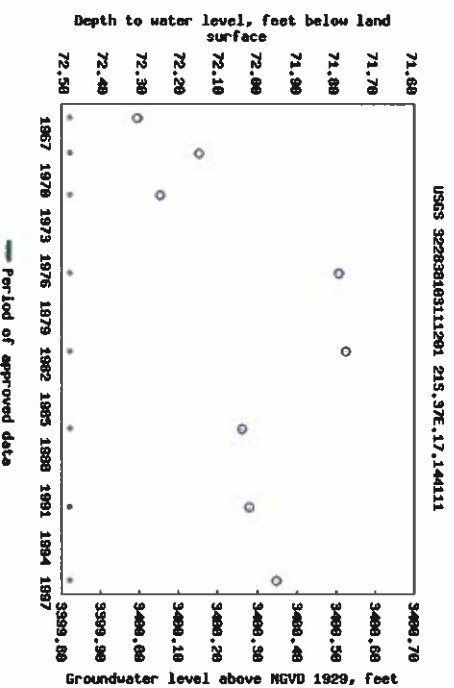
**USGS 32283810311201 21S.37E.17.144111**

Lea County, New Mexico  
Hydrologic Unit Code 13070007  
Latitude 32°28'50", Longitude 103°11'14" NAD27  
Land-surface elevation 3,472.30 feet above NGVD29  
The depth of the well is 96 feet below land surface.  
This well is completed in the Alluvium, Bolson Deposits and Other Surface Deposits (110AVMB) local aquifer.

Breaks in the plot represent a gap of at least one year between field measurements

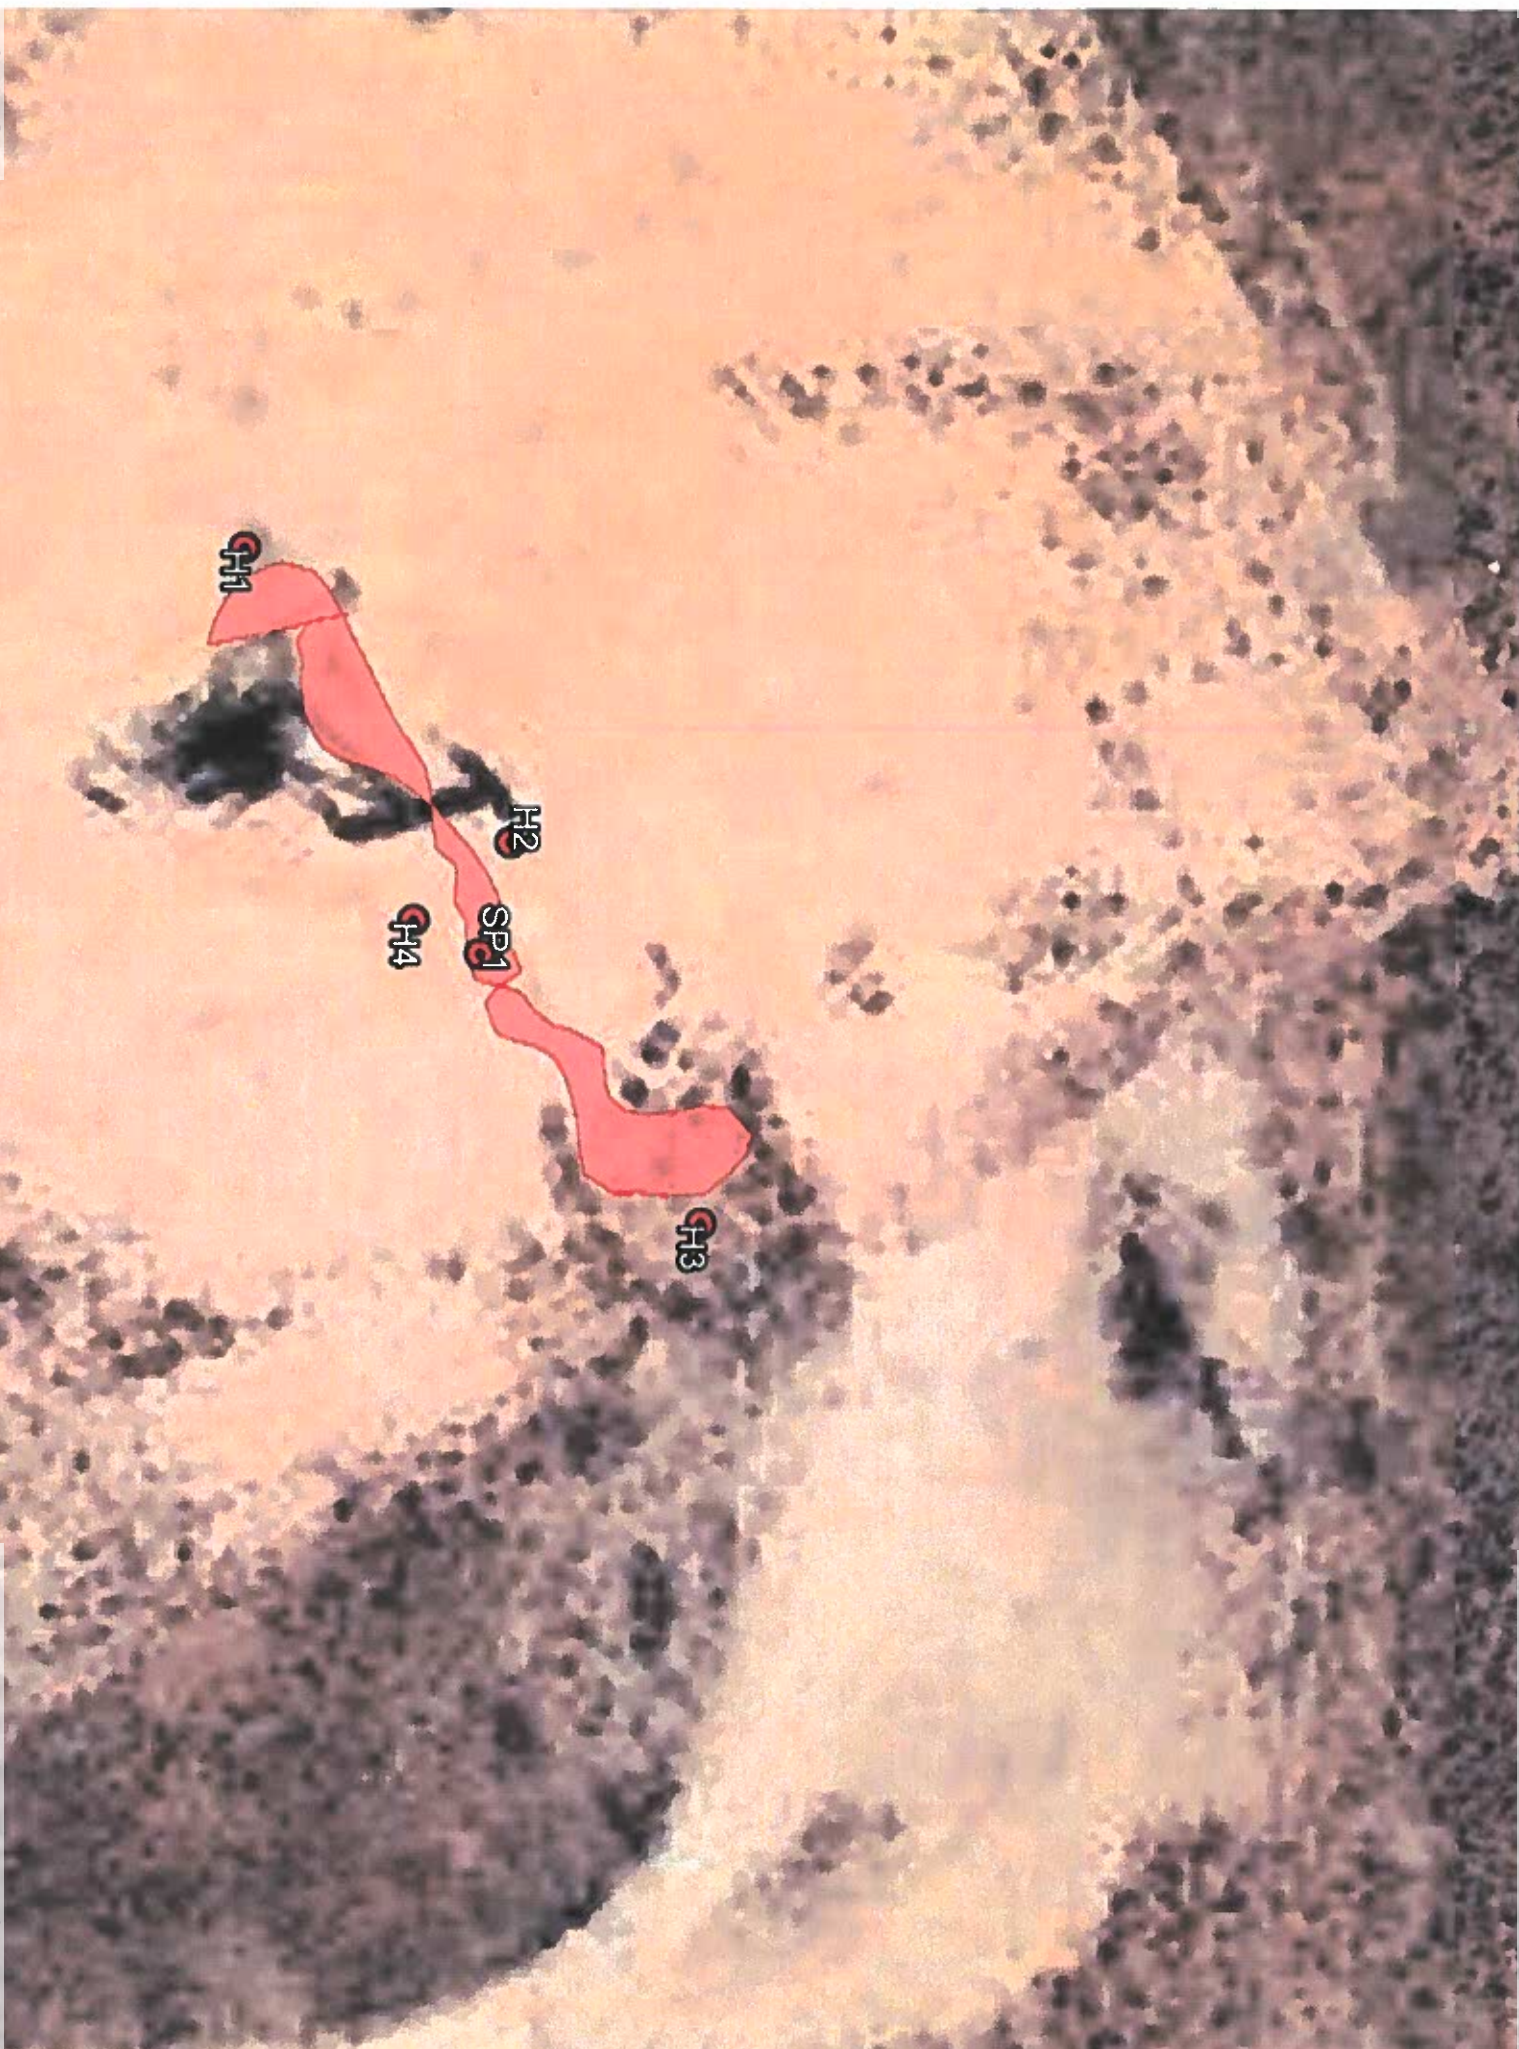
## Delineation Samples

Sample Date	Sample ID	Depth	Chloride Field	Chloride Lab	Benzene	Toulene	Ethylbenzene	Total Xylenes	Total BTEX	GRO	DRO	EXT DRO	GPS Coordinates
12/10/2020	SP 1	S	10,286	14,000	<0.050	0.421	0.467	1.53	2.41	10	890	205	32.484055 -103.183244
12/10/2020		1'	2,230	960	<0.050	<0.050	<0.050	<0.150	<0.300	<10.0	17.6	<10.0	
Horizontal Samples													
12/10/20020	H1	S	227	64	<0.050	<0.050	<0.050	<0.150	<0.300	<10.0	59.7	12.6	32.483942 -103.183470
12/28/2020	H2	S	145	16.0	<0.050	<0.050	<0.050	<0.150	<0.300	<10.0	<10.0	<10.0	32.484070 -103.183306
12/10/2020	H3	S	145	<16.0	<0.050	<0.050	<0.050	<0.150	<0.300	<10.0	<10.0	<10.0	32.484159 -103.183094
12/28/2020	H4	S	150	<16.0	<0.050	<0.050	<0.050	<0.150	<0.300	<10.0	<10.0	<10.0	32.484028 -103.183264
