Vertex Project #: 20E-00141-008

Spill Closure Report: Maldives 15 CTB 1
Unit D, Section 15, Township 23 South, Range 31 East
County: Eddy
Tracking Numbers: NAB1904257393

Prepared For: Devon Energy Production Company
6488 Seven Rivers Highway
Artesia, New Mexico 88210

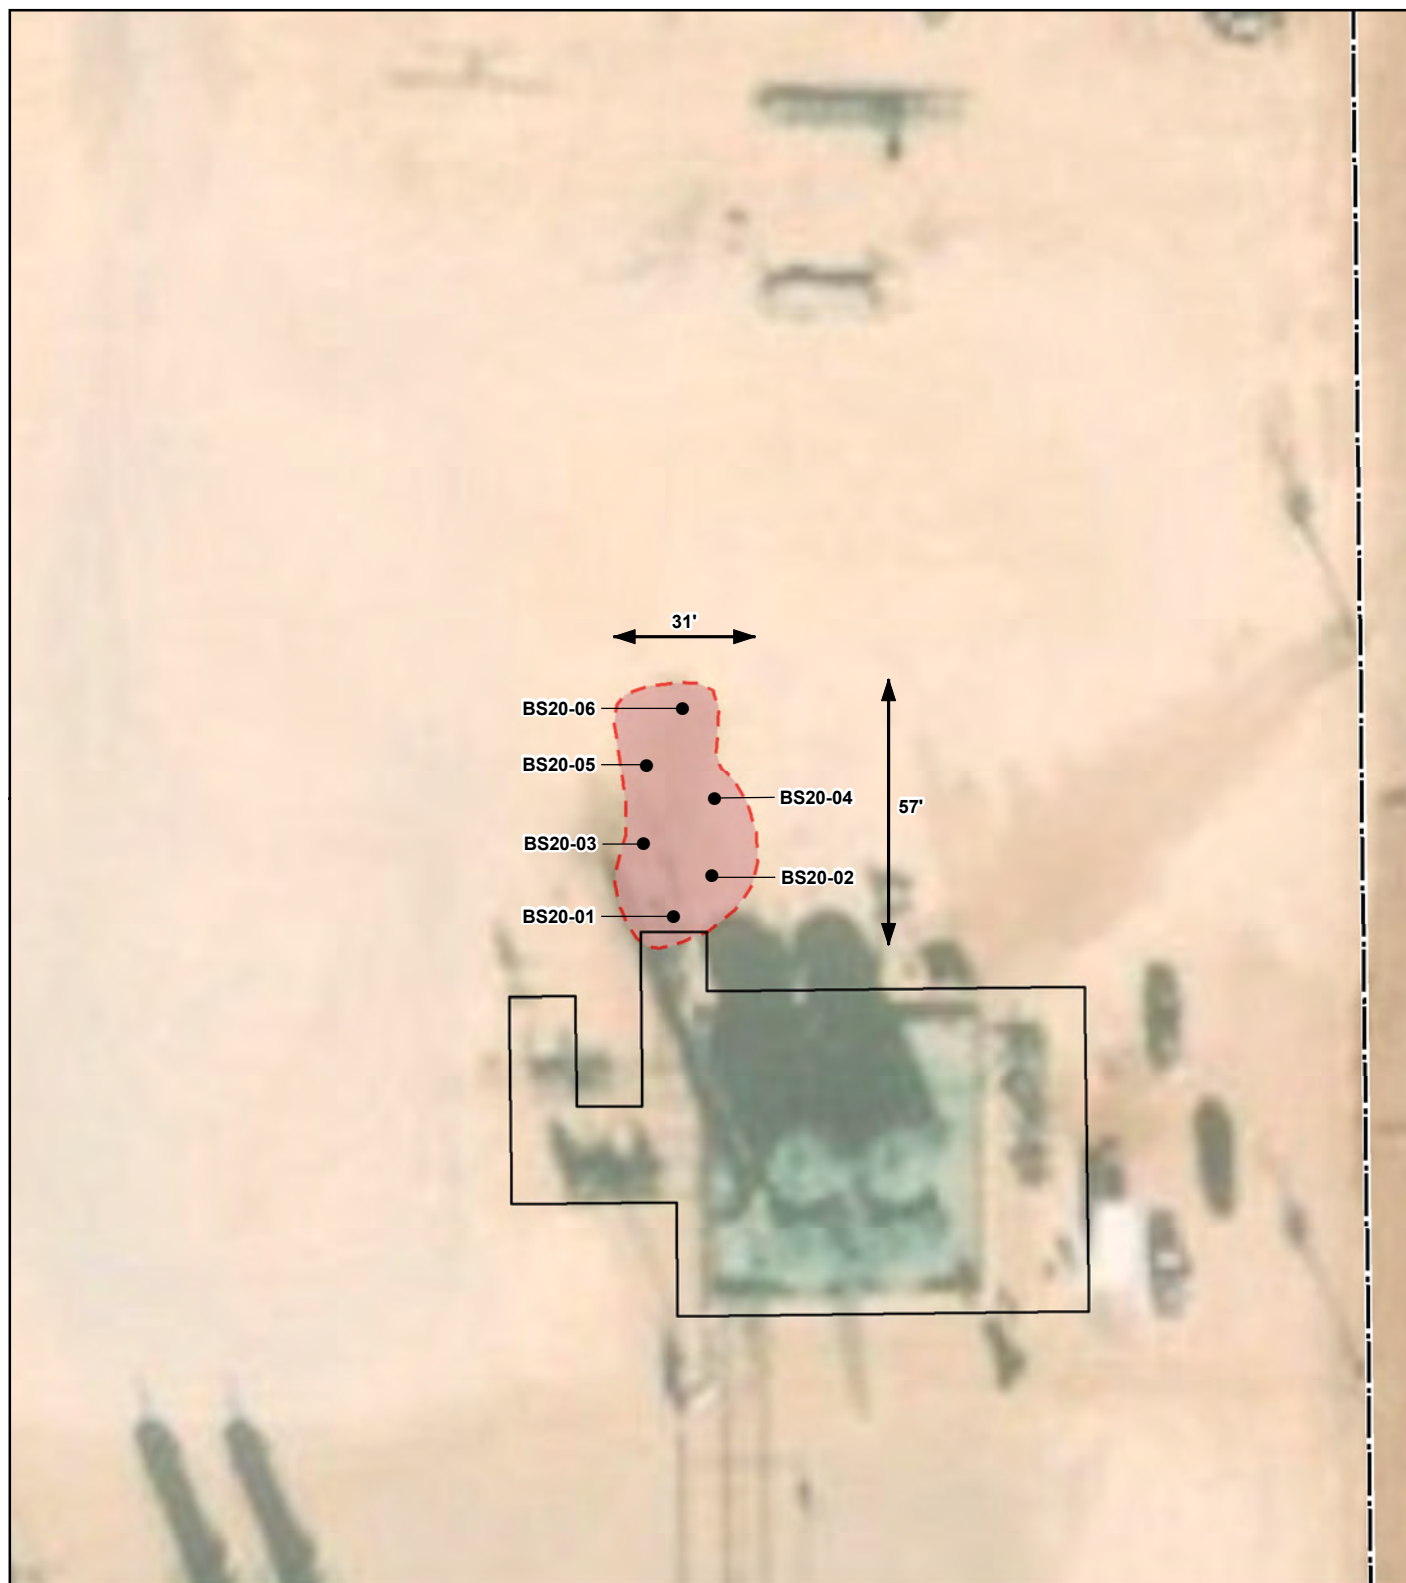
- Base Sample
- Approximate Lease Boundary
- Production Equipment
- Spill (~ 1,378 sq.ft.)

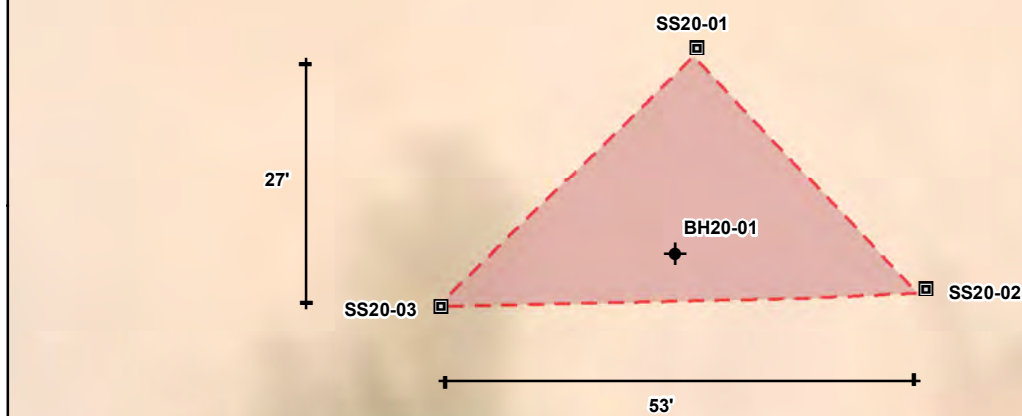
- ◆ Borehole
- Soil Sample
- ▭ Approximate Additional Characterization Extent (695 sq. ft.)

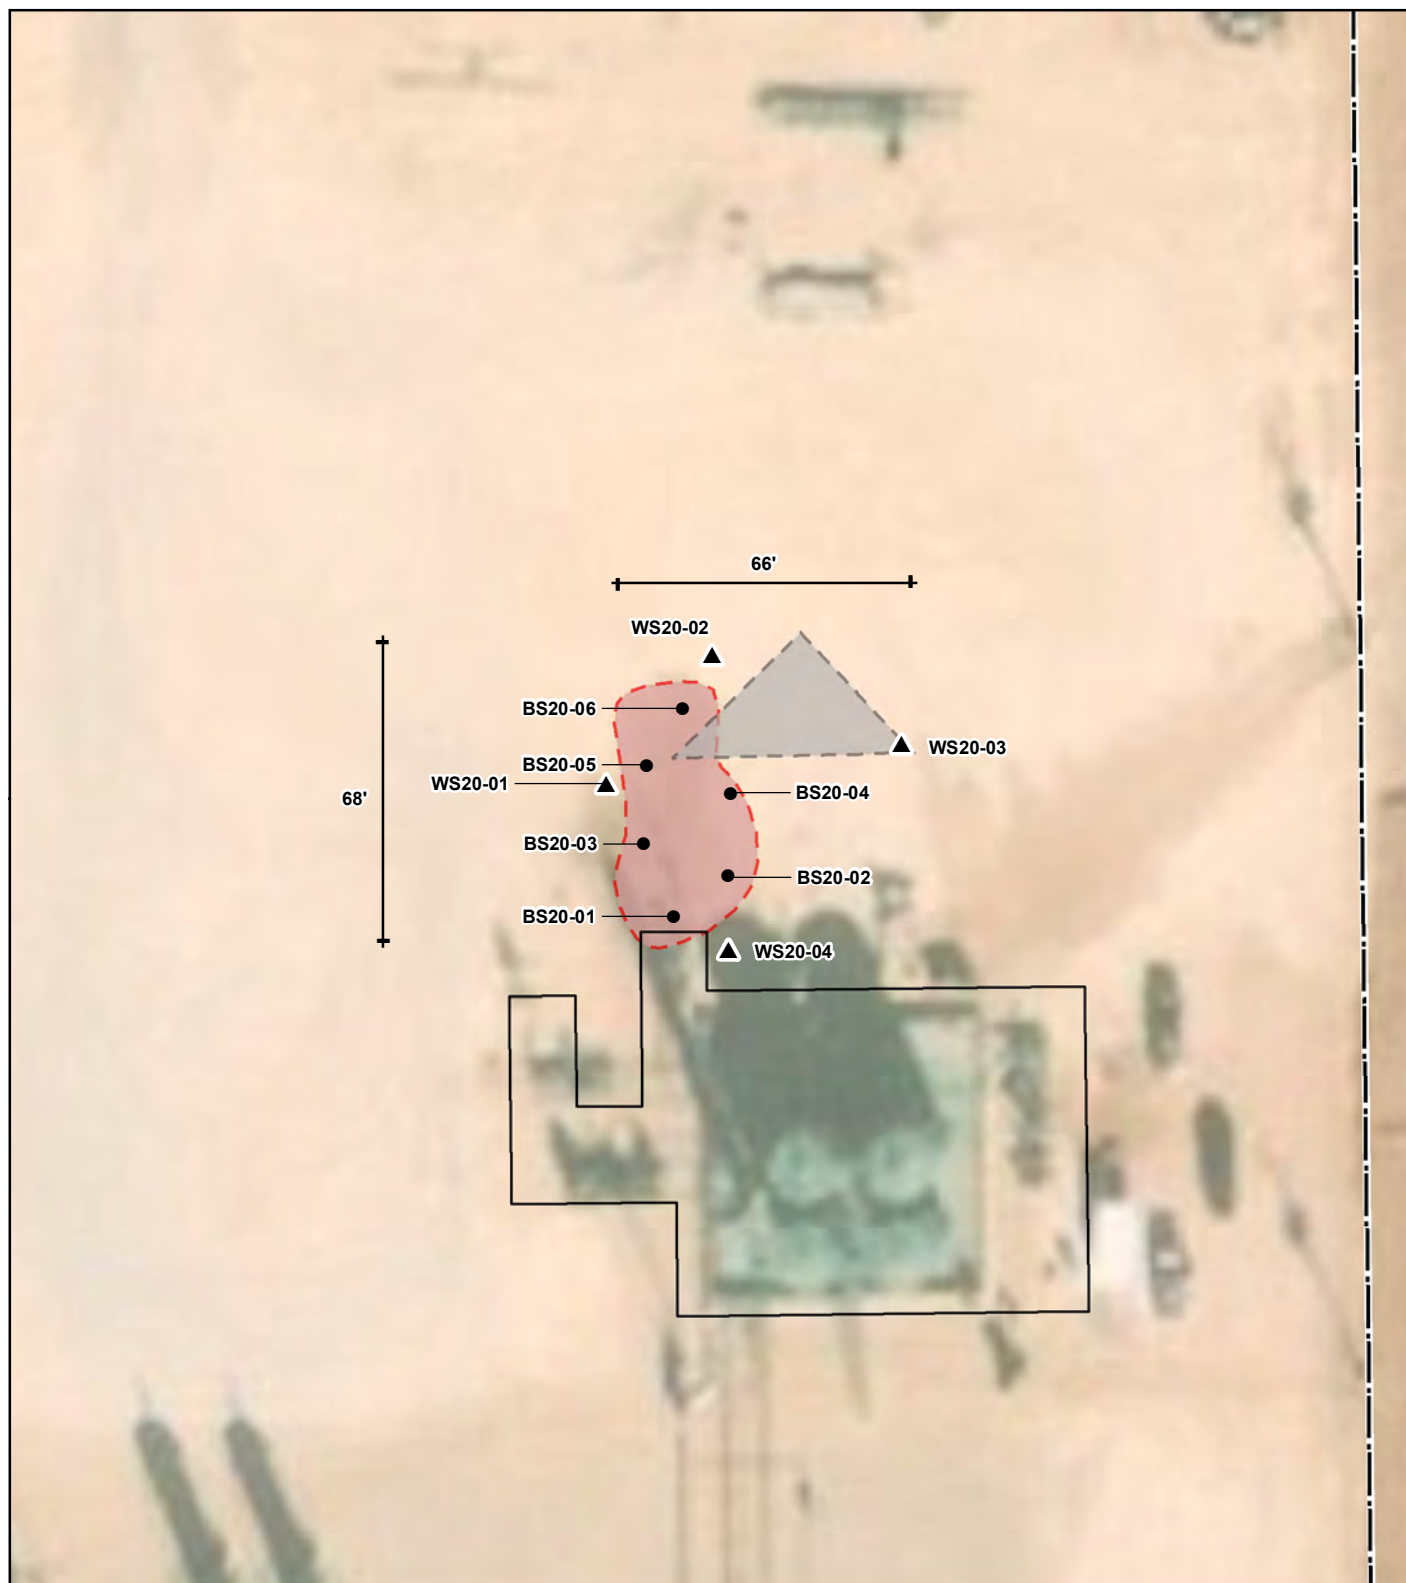
- ▲ Wall Sample
- Base Sample
- Approximate Lease Boundary
- Production Equipment
- Original Spill Extent (~ 1,378 sq.ft.; Total Combined Extent 2,011 sq. ft.)
- Additional Spill Characterization

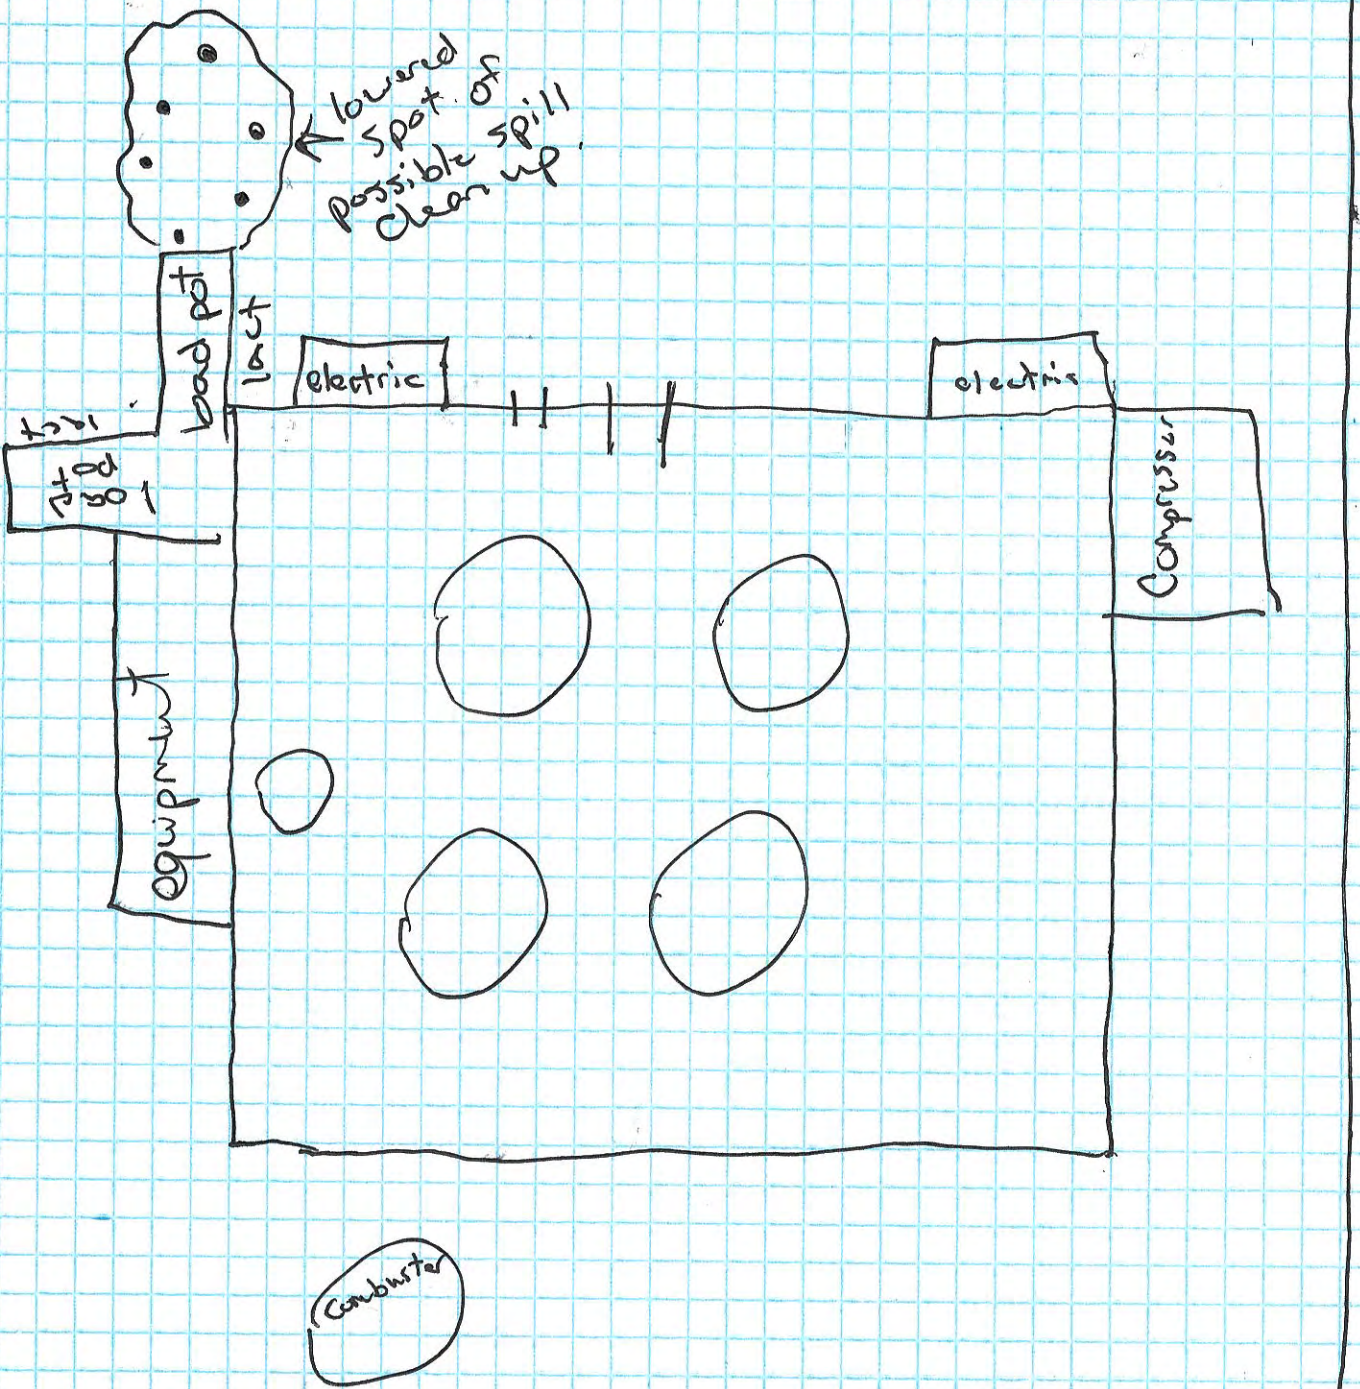
1/24 Maldives Devon

Liner integrity looks very uniform. No signs of tears, wear points, or weathering.

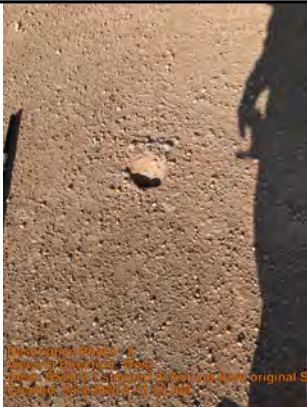
<p>Photograph taken by Viewing Direction: West Date: 12/7/2020 Created: 12/7/2020 11:27 AM</p>
SS20-03	SS20-2.1 stepped (6') out from original SS20-2

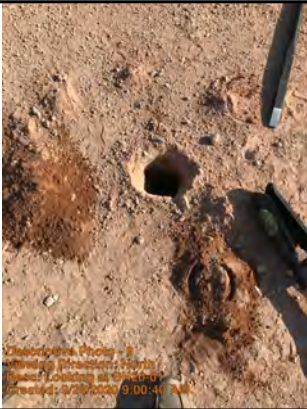
<p>Metadata Photo - 2 Viewing Direction: North Date: Looking at BH20-01 Created: 9/24/2020 9:00:40 AM</p>
Looking at BH20-01

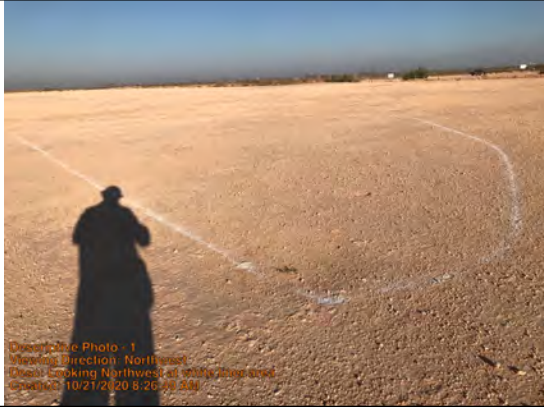
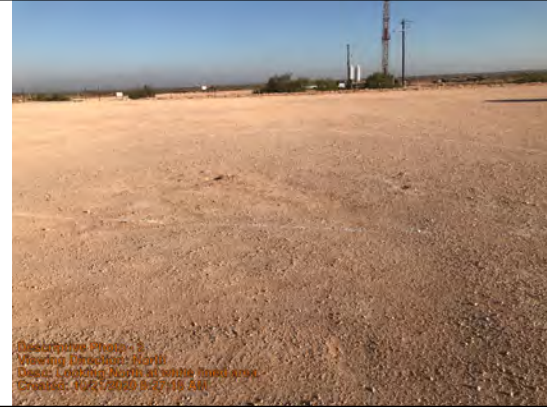
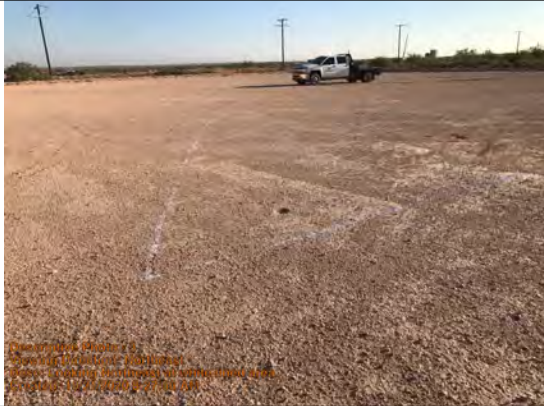
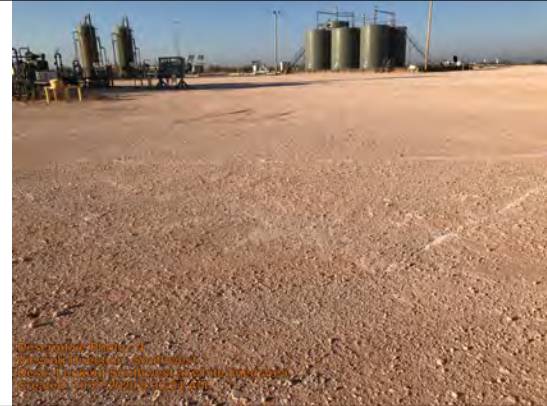
Looking Northwest at white liner area

Looking North at white lined area.

Looking Northeast at white lined area.

Looking Southwest at white lined area.

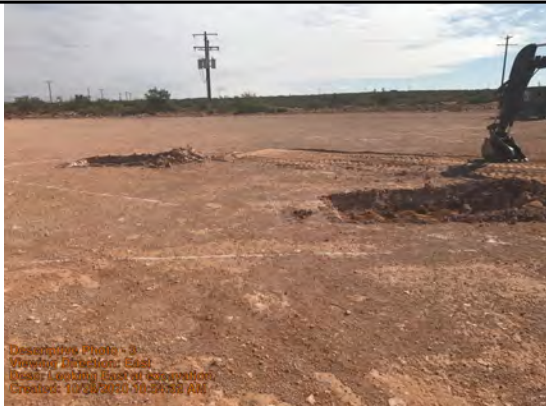
Descriptive Photo - 3
Viewing Direction: East
Date: Looking East at excavation
Created: 10/28/2020 2:10:10 PM

Looking East at excavation.
