**Re: Site Delineation Summary, and Proposed Remediation Plan and Deferral Request**  
**Tulk VV State #002**  
**API No. 30-025-28437**  
**GPS: Latitude 33.07348 Longitude -103.71678**  
**UL "N", Sec. 11, T14S, R33E**  
**Lea County, NM**  
**NMOCD Ref. No. NRM20112853960**

Tasman Geosciences, LLC (Tasman), on behalf of Foundation Energy Management, LLC (Foundation), has prepared this Site Delineation Summary, and Proposed Remediation Plan and Deferral Request for the Release Site known as the Tulk VV State #002. Details of the release are summarized below:

**Figure 1 – Site Characterization Map**

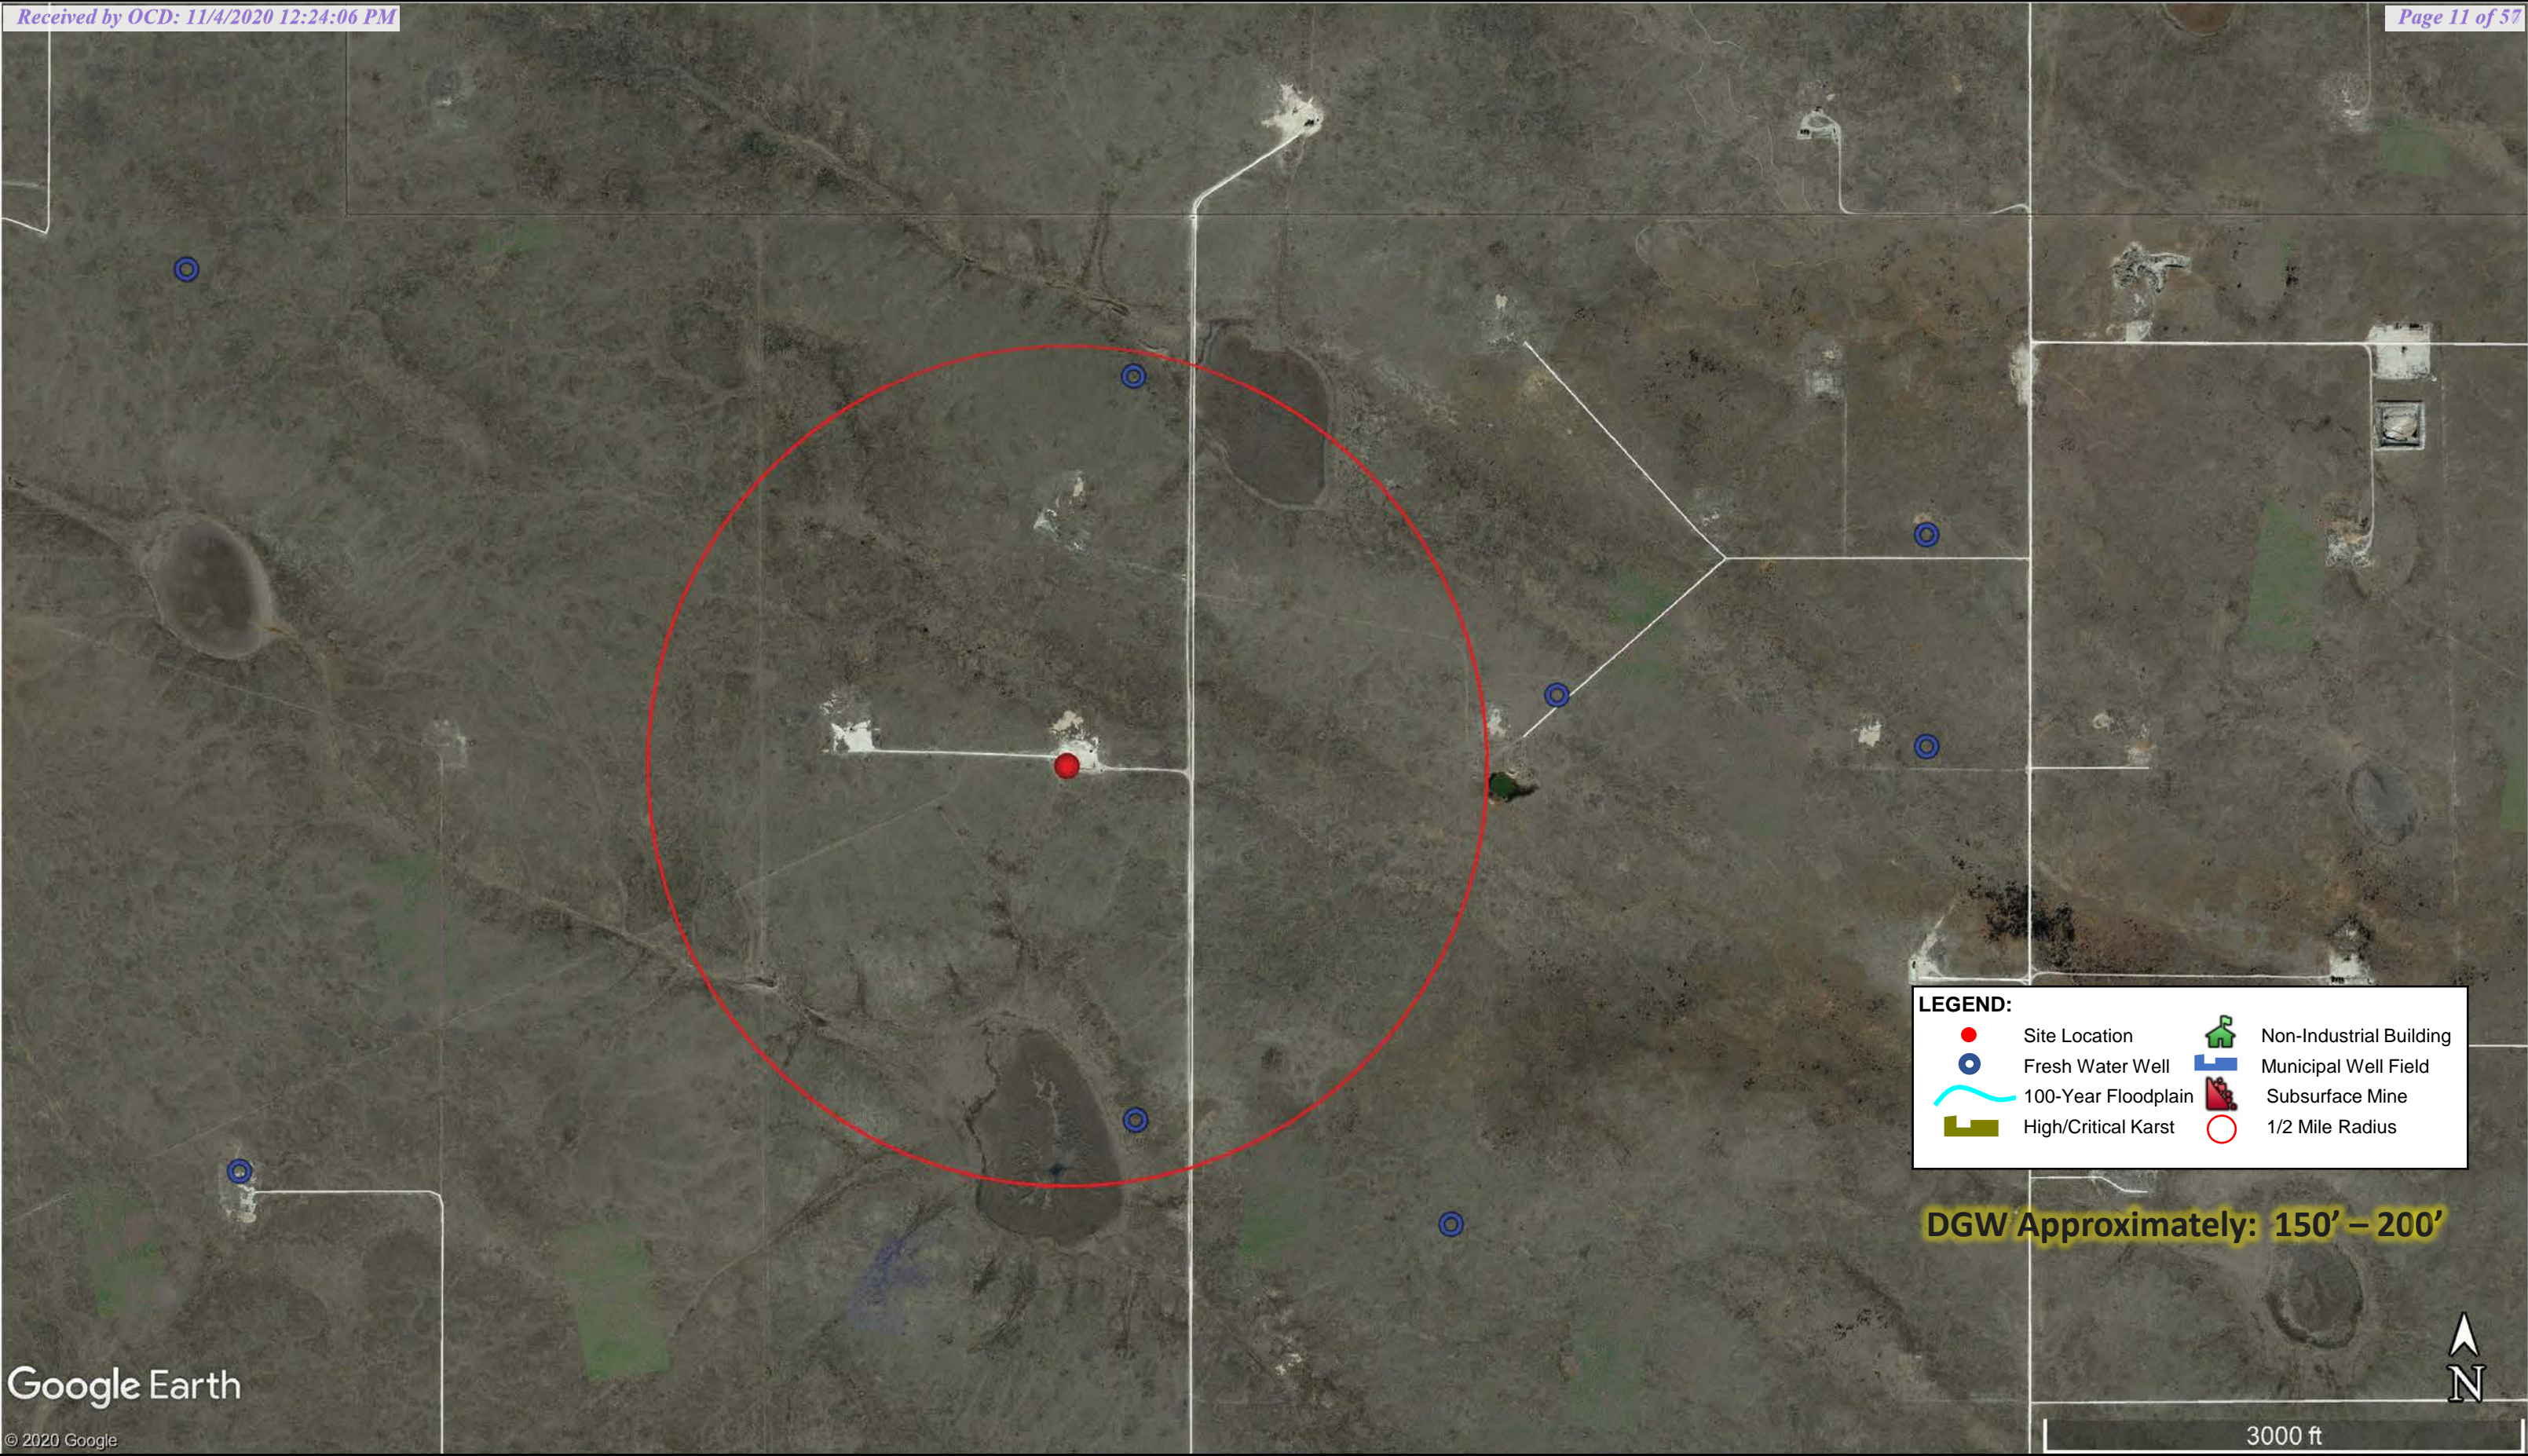
A Site Characteristics Map (Figure 1) is provided as Attachment #1. General Site Photographs are provided as Attachment #8. A copy of the Initial Release Notification and Corrective Action (NMOCD Form C-141) is provided as Attachment #9.

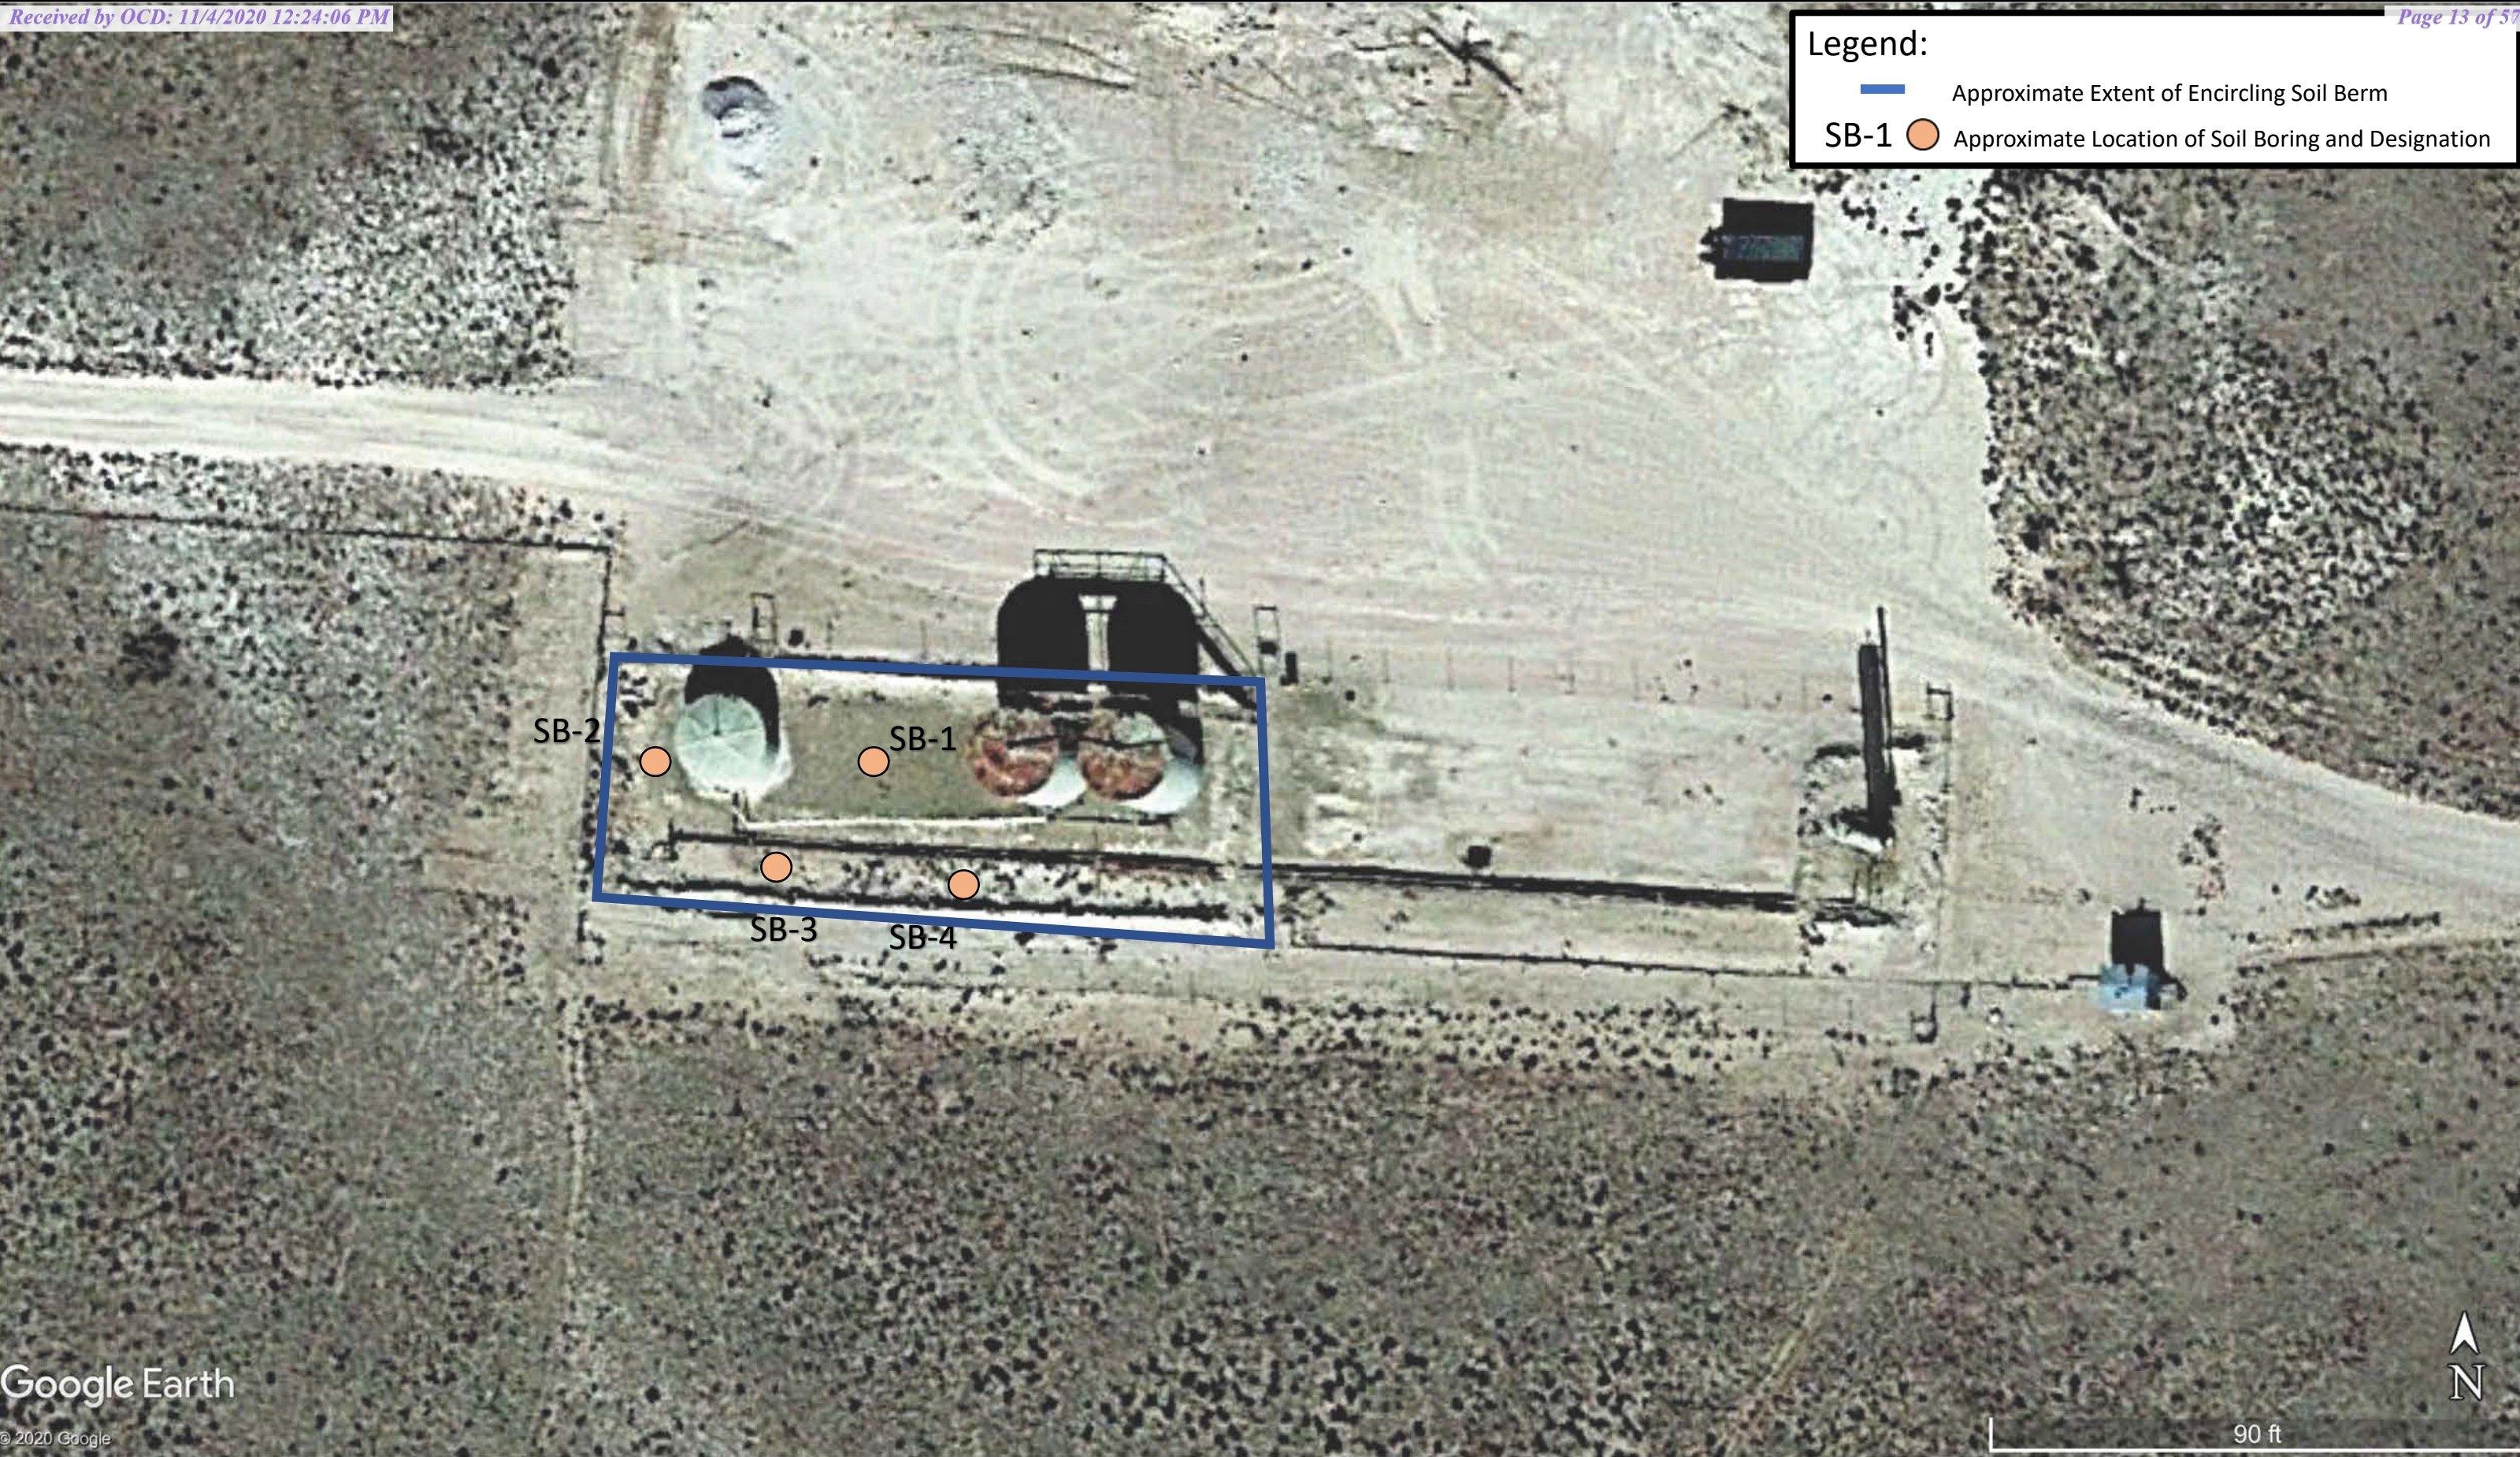
Representative soil samples (including "Surface", 5 feet, 10 feet, and 15 feet [SB-3 and SB-4 only]) were collected from each investigative boring and submitted to a commercial laboratory for analysis of chlorides; total petroleum hydrocarbon (TPH); and benzene, toluene, ethylbenzene and xylenes (BTEX) concentrations. Select soil samples were placed on hold at the commercial laboratory and only analyzed if requested by Foundation. Laboratory analytical results indicated chlorides concentrations were below the NMOCD Closure Criteria in the analyzed soil samples with the exception of SB-3 @ Surface and SB-4 @ Surface, which exhibited concentrations of 43,200 and 28,800 mg/kg, respectively. Analytical results for TPH and BTEX were below laboratory reporting limits and NMOCD Closure Criteria for all the soil samples analyzed. A table (Table 3) summarizing laboratory analytical results from soil samples collected from investigative borings and analyzed by the laboratory is provided as Attachment #6. Laboratory analytical reports are provided as Attachment #7.
