SMA #5E29133, BG61

**RE: LINER INSPECTION REPORT
CHILES 28-21 STATE COM 2H (NRM2025334934)**

Souder, Miller & Associates (SMA) is pleased to submit this letter report on behalf of Devon Energy Production (Devon) summarizing the liner inspection that occurred due to the Chiles 28-21 State Com #002H release. The site is located in Unit Letter O, Section 28, T21S, R34E (N32.443404 /W-103.473873) Lea County, New Mexico, on State land.

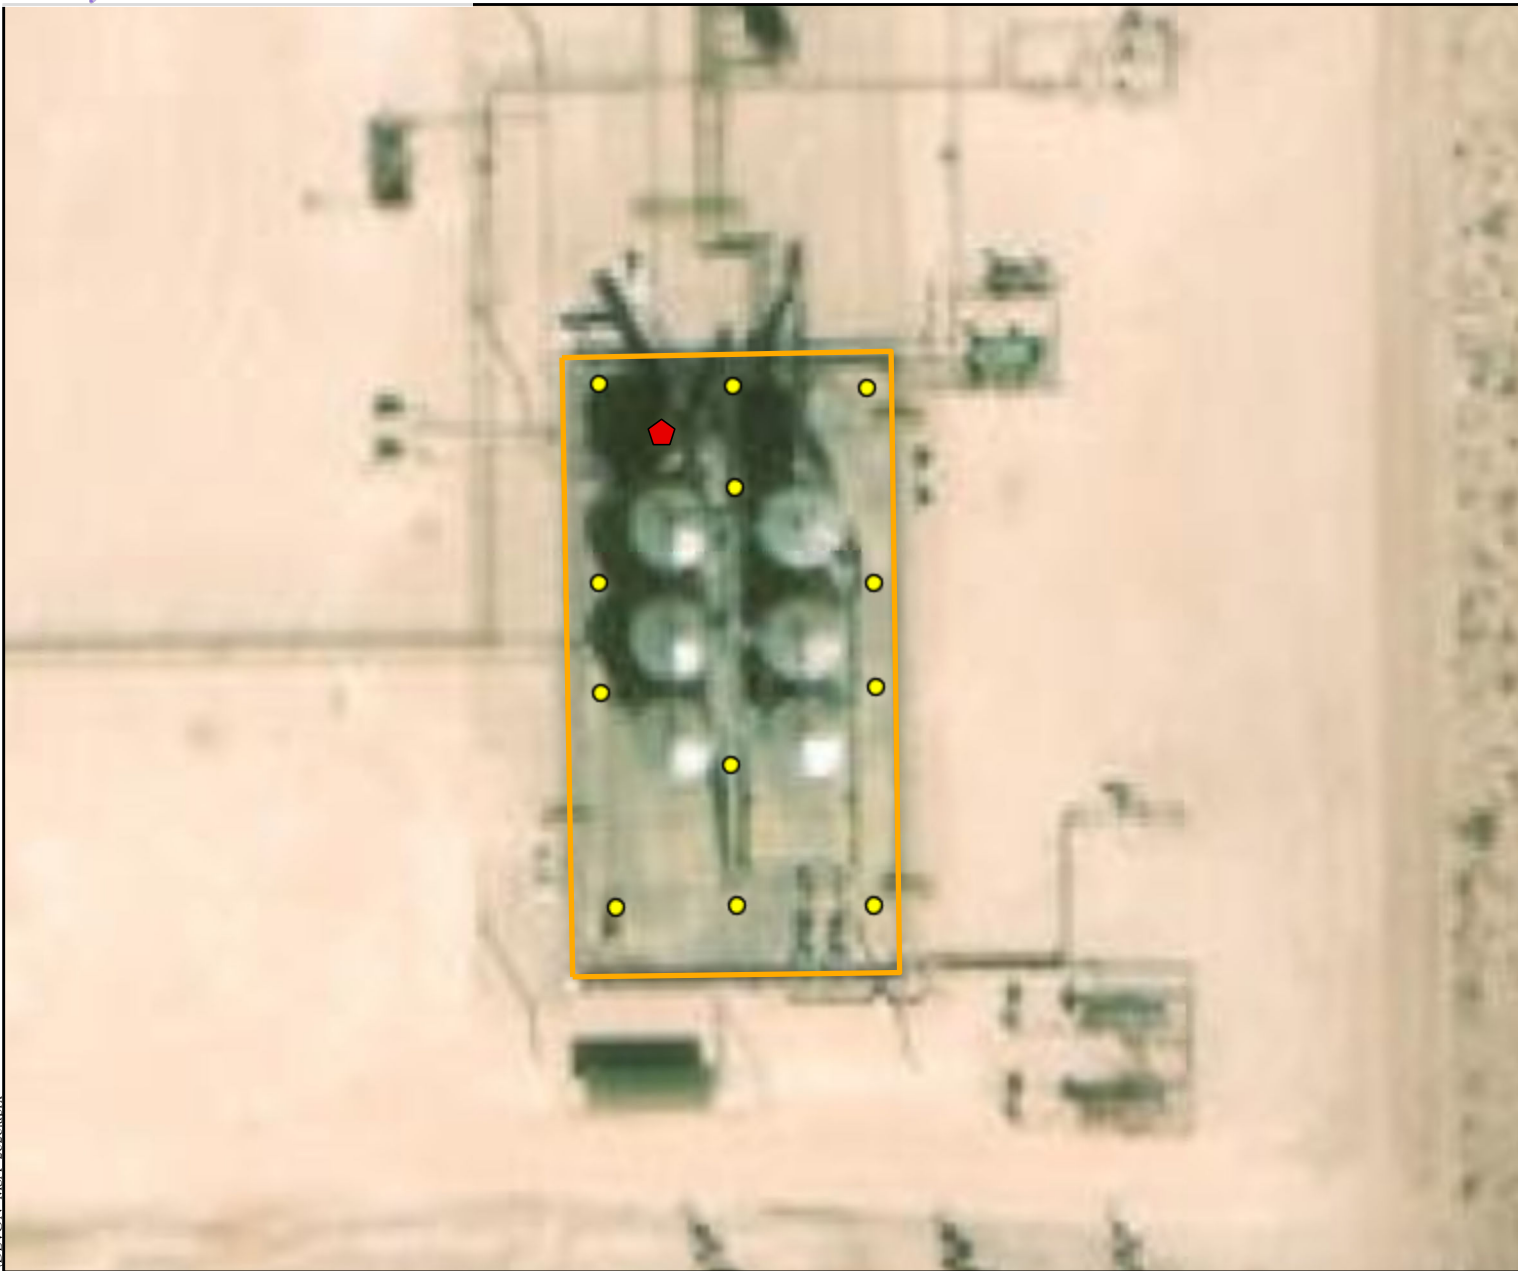
Figure 3

Site and Sample Location Map
Chiles 28-21 State Com 2H - Devon Energy
UL: O S: 28 T: 21S R:34E, Lea County, New Mexico

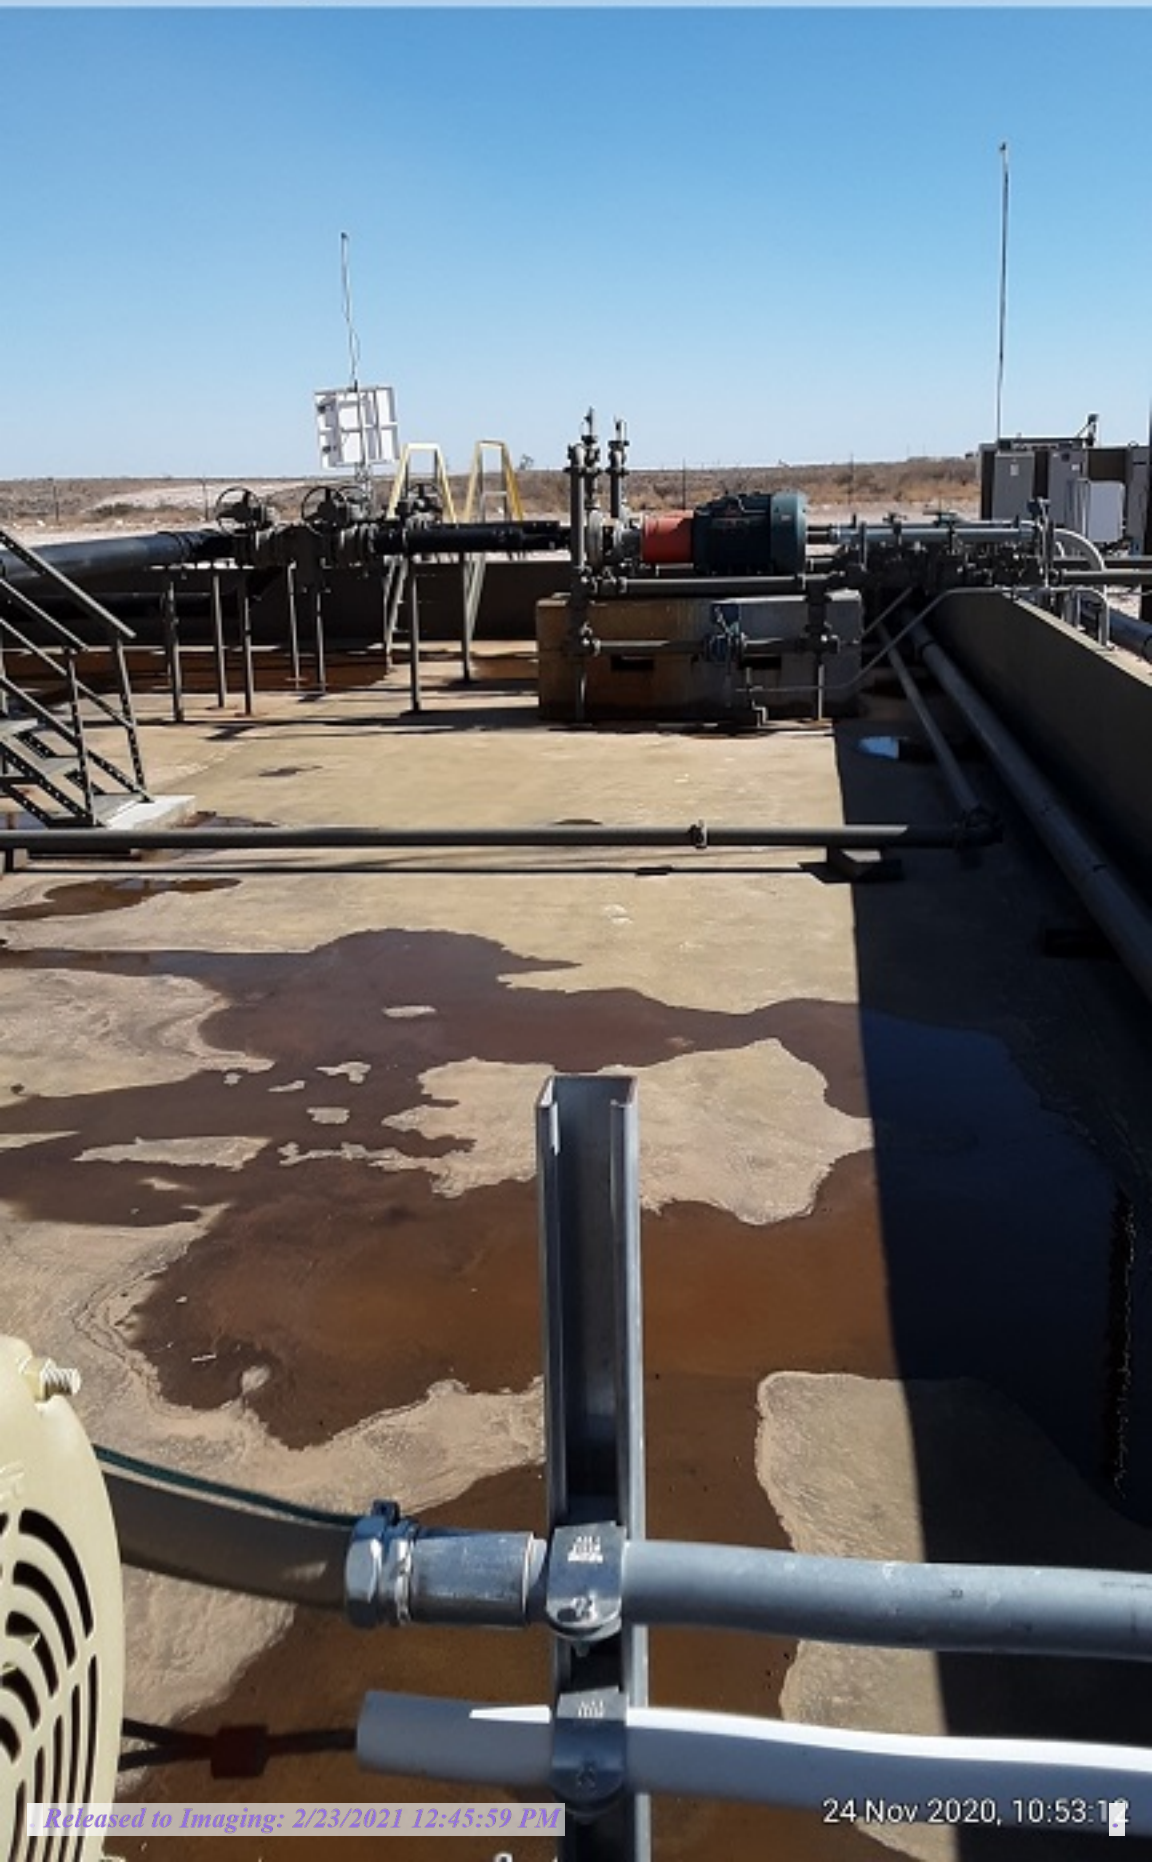
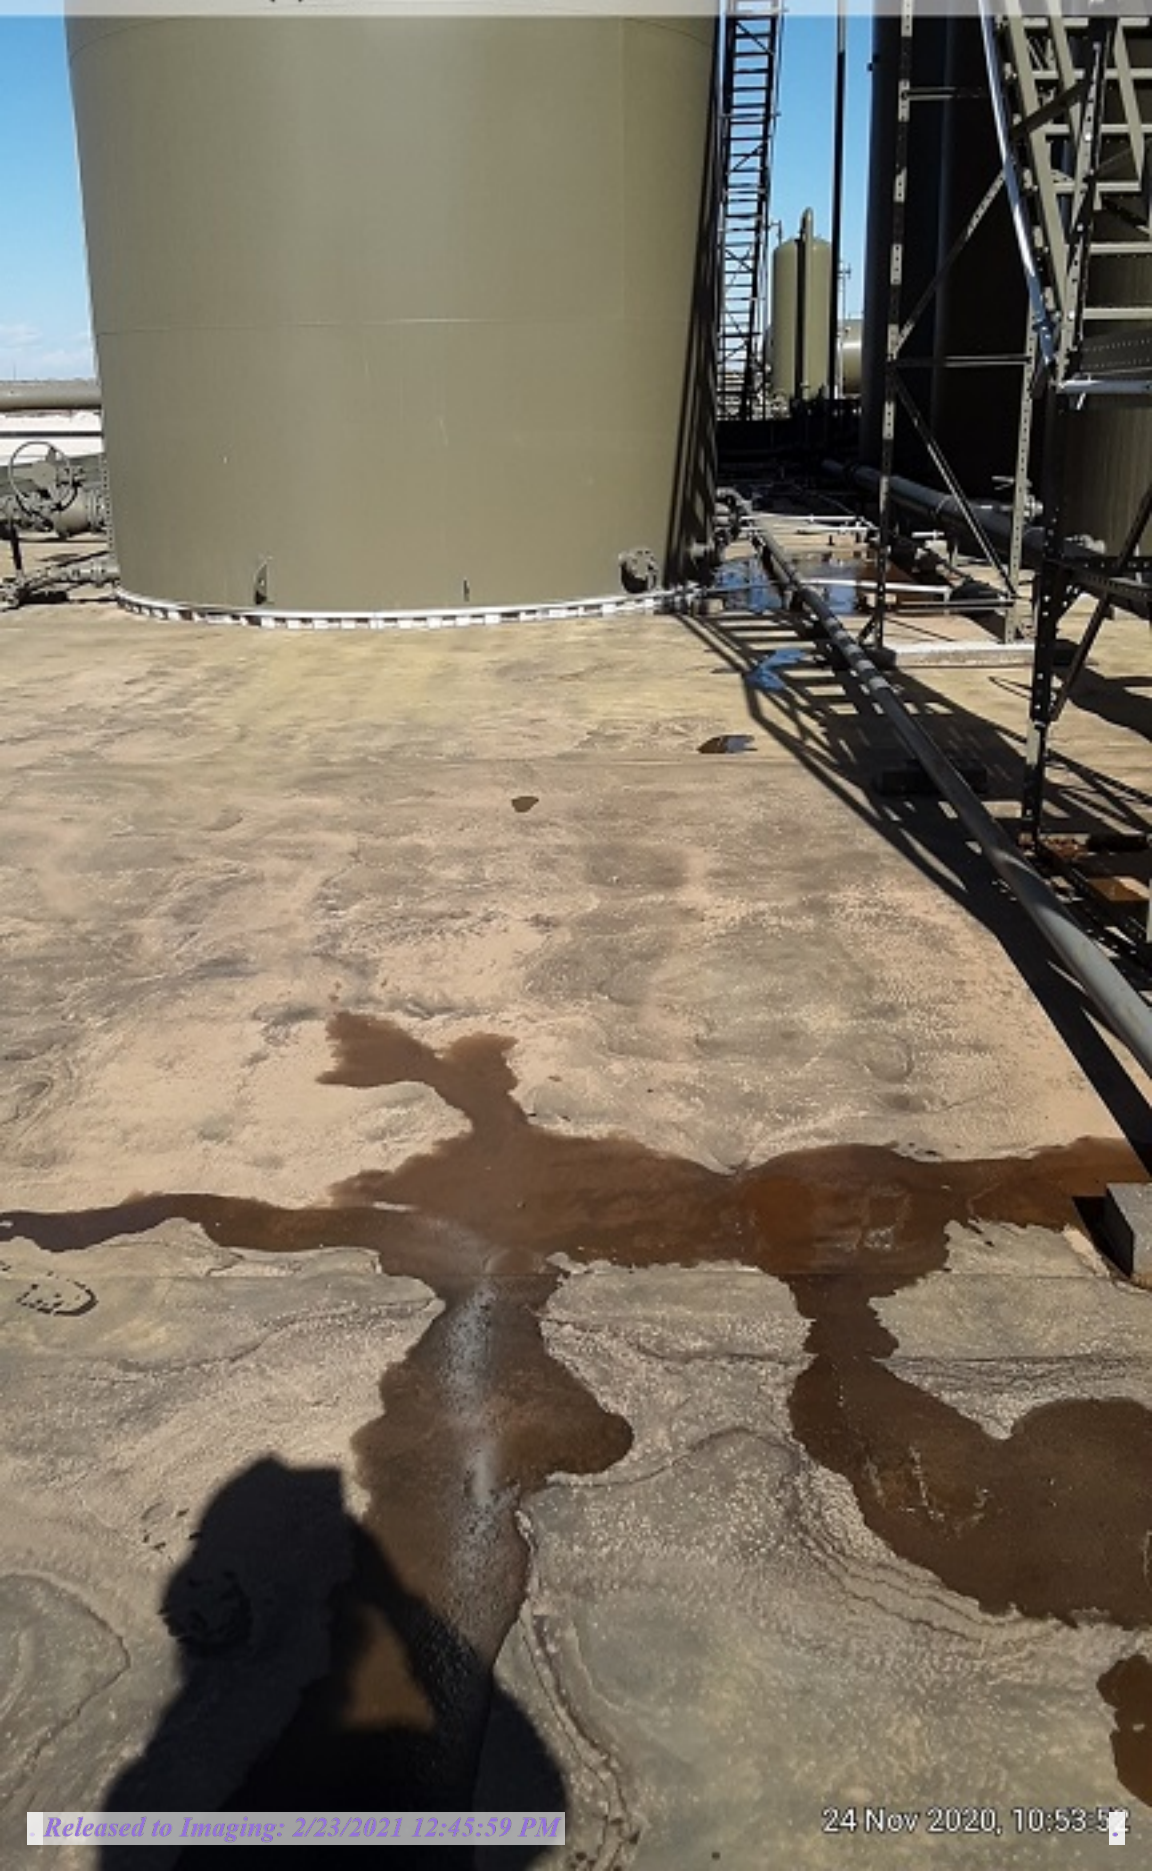
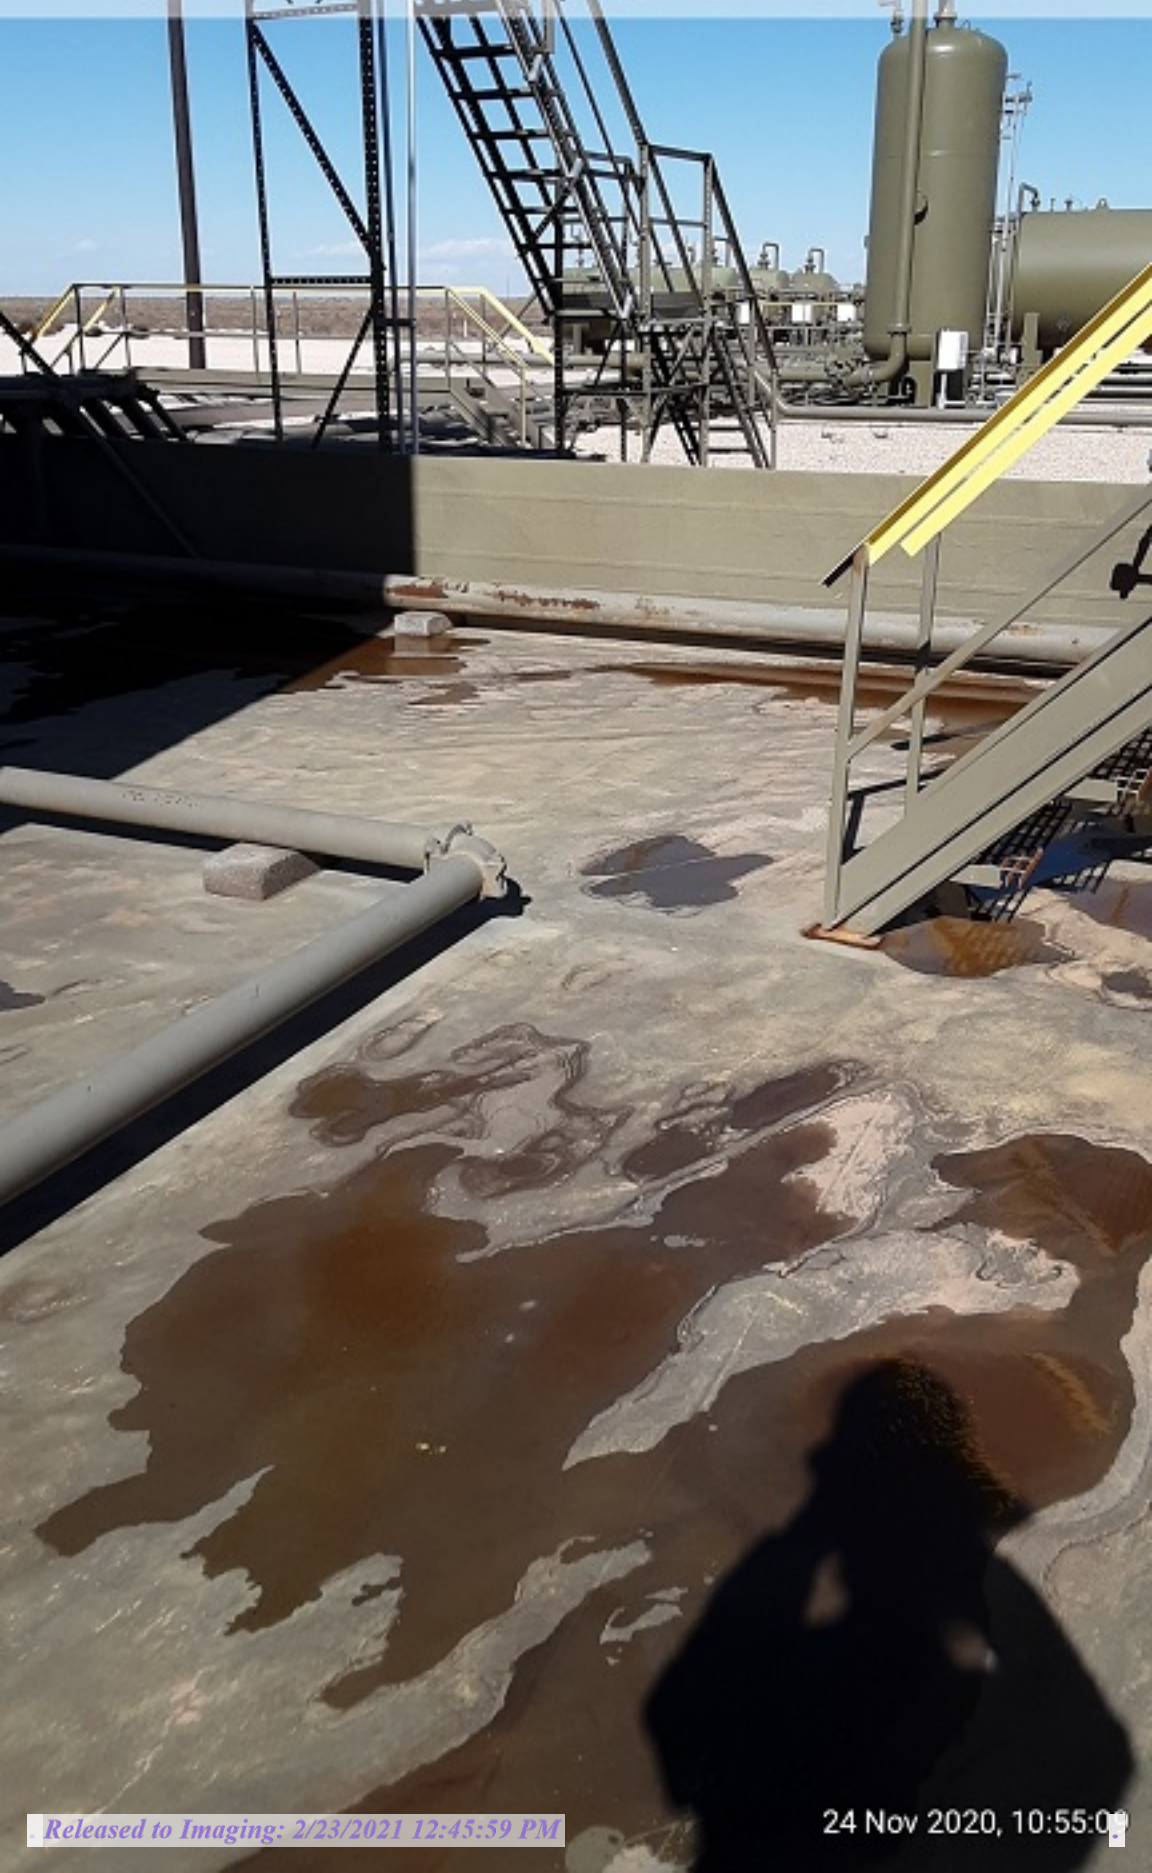
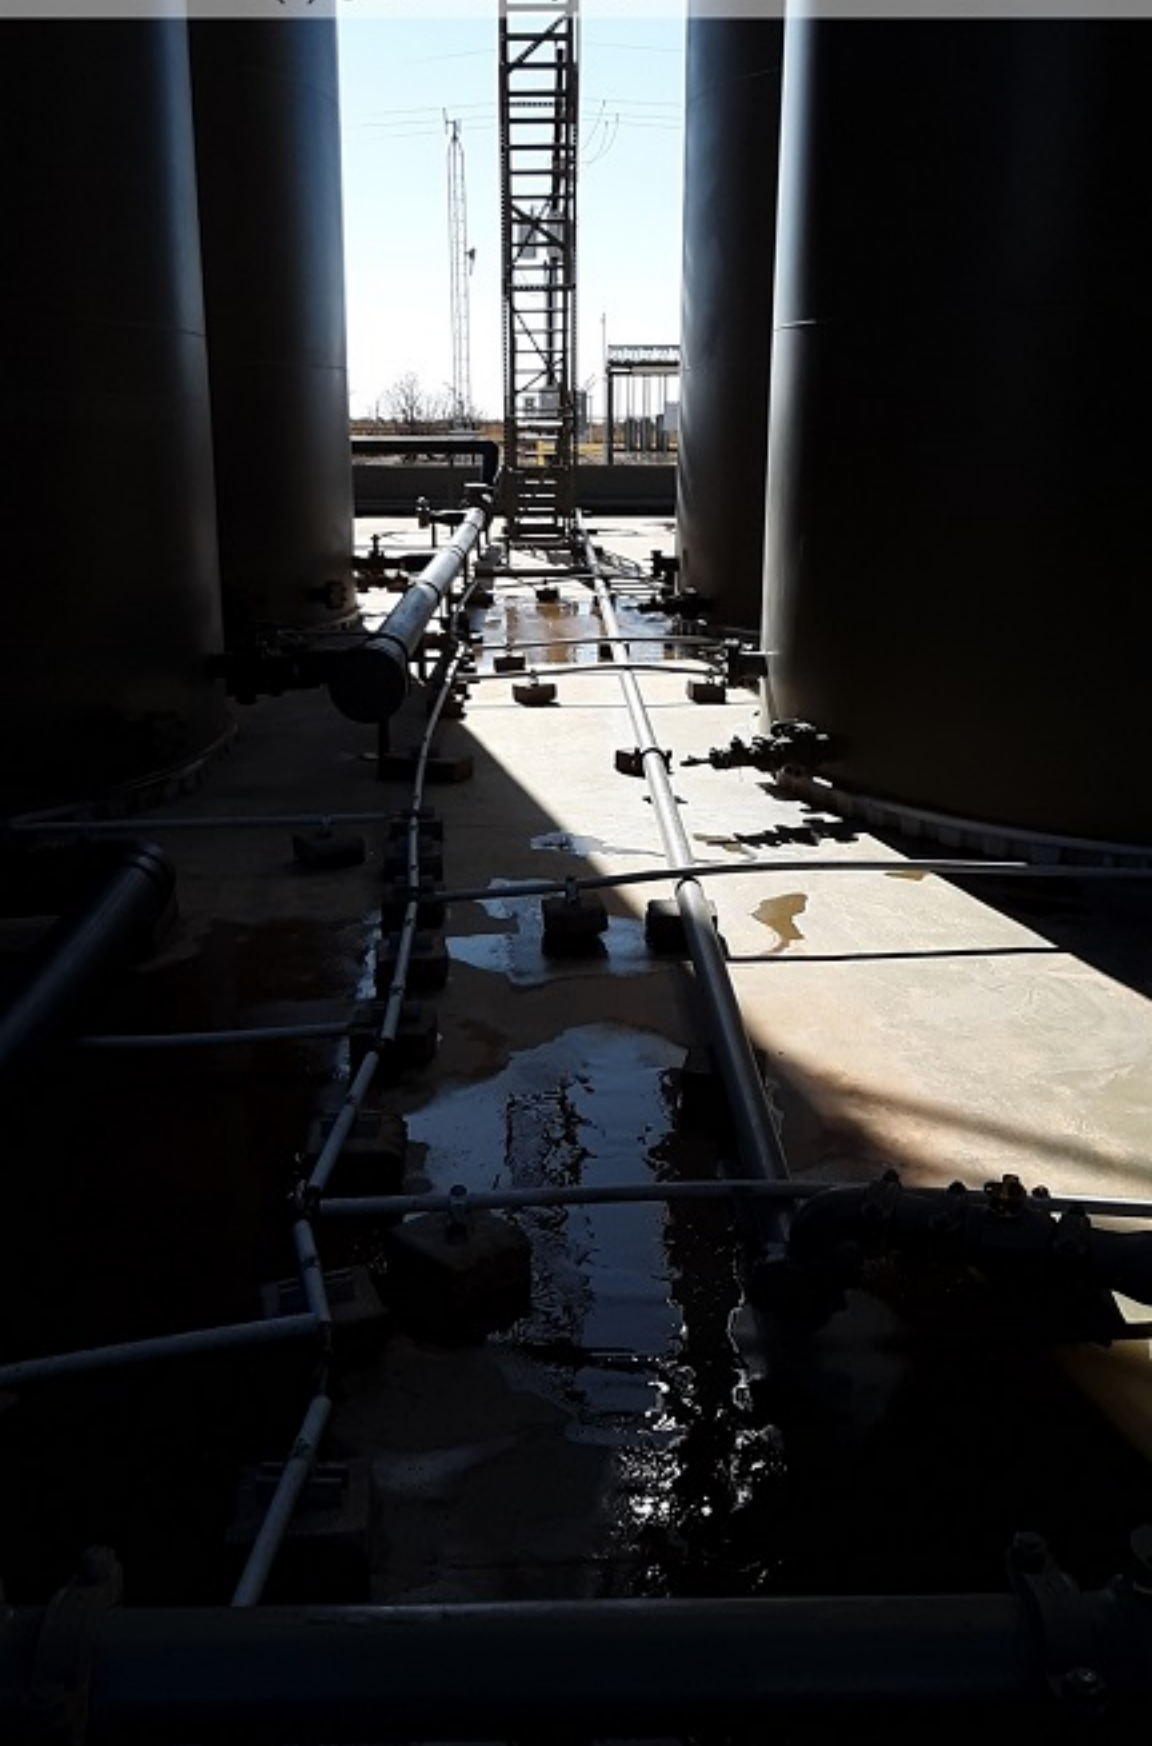
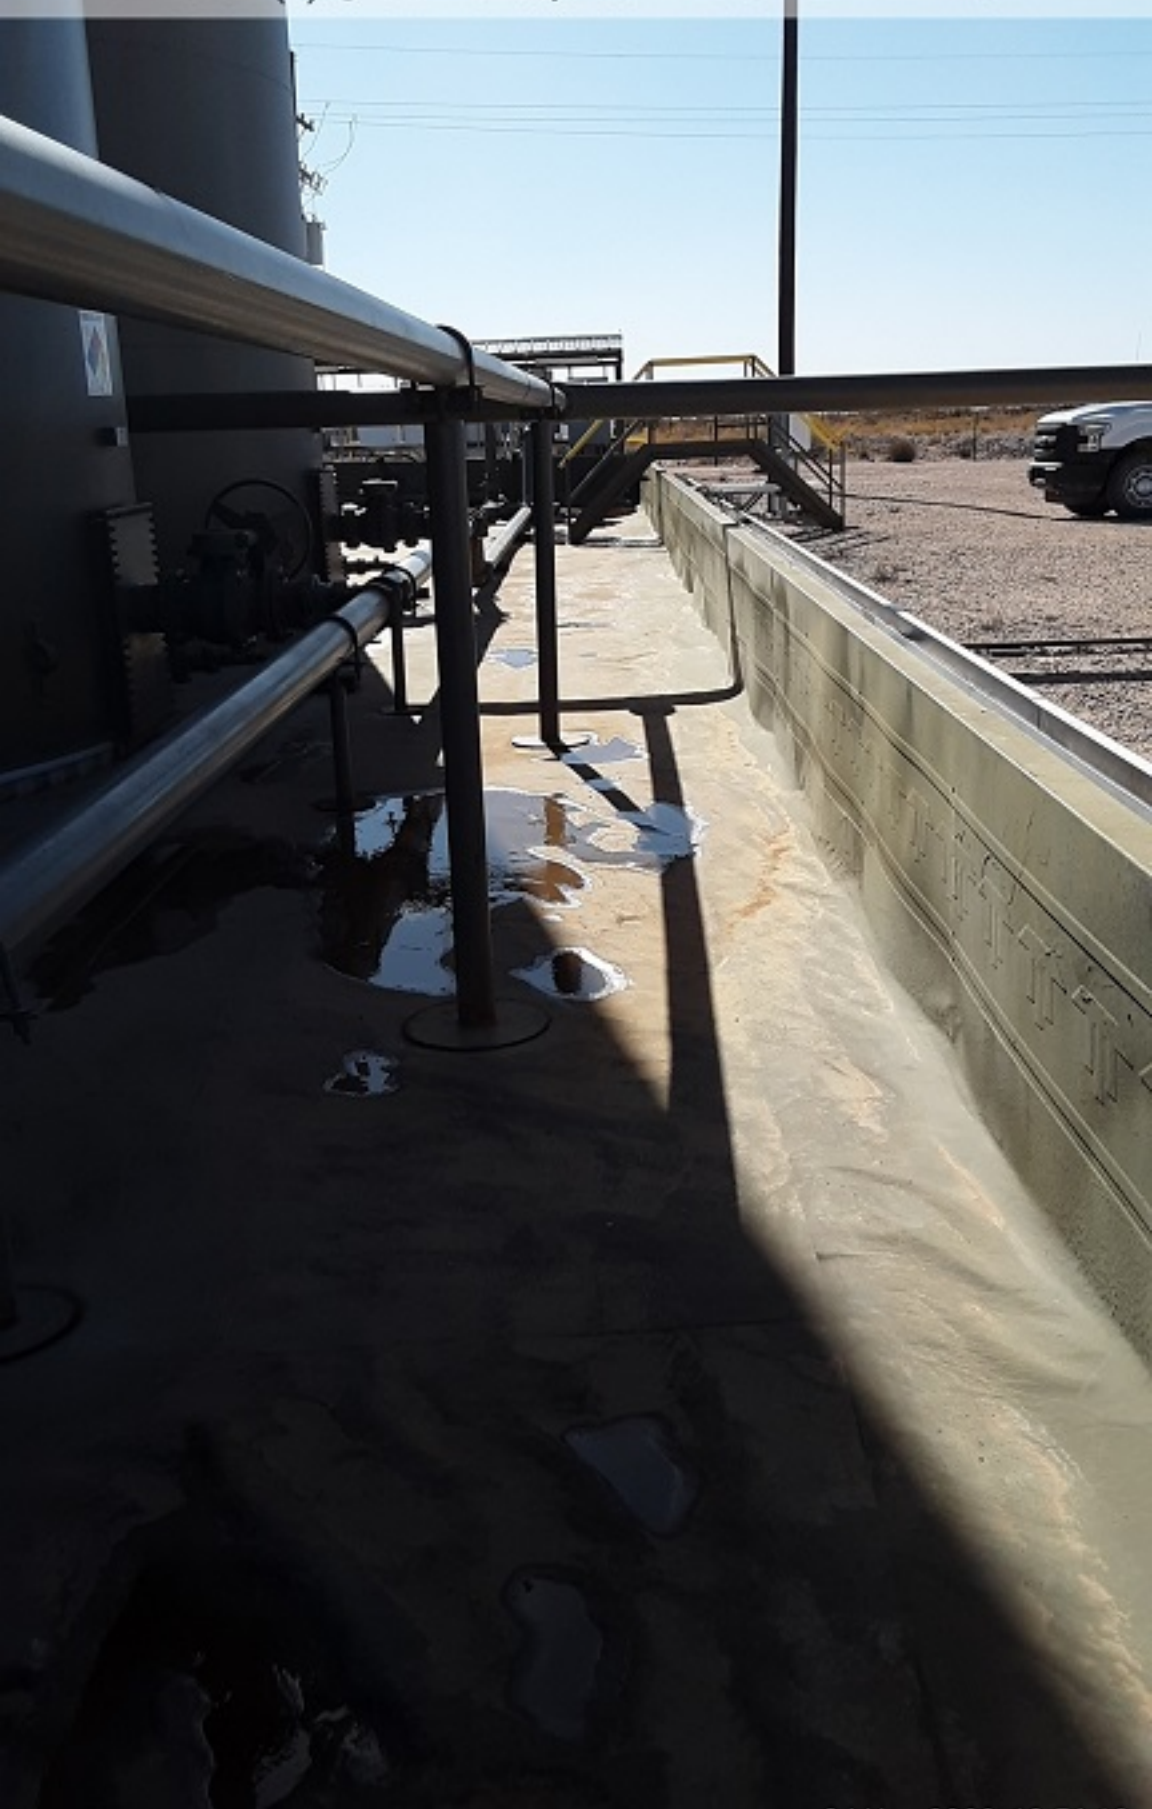
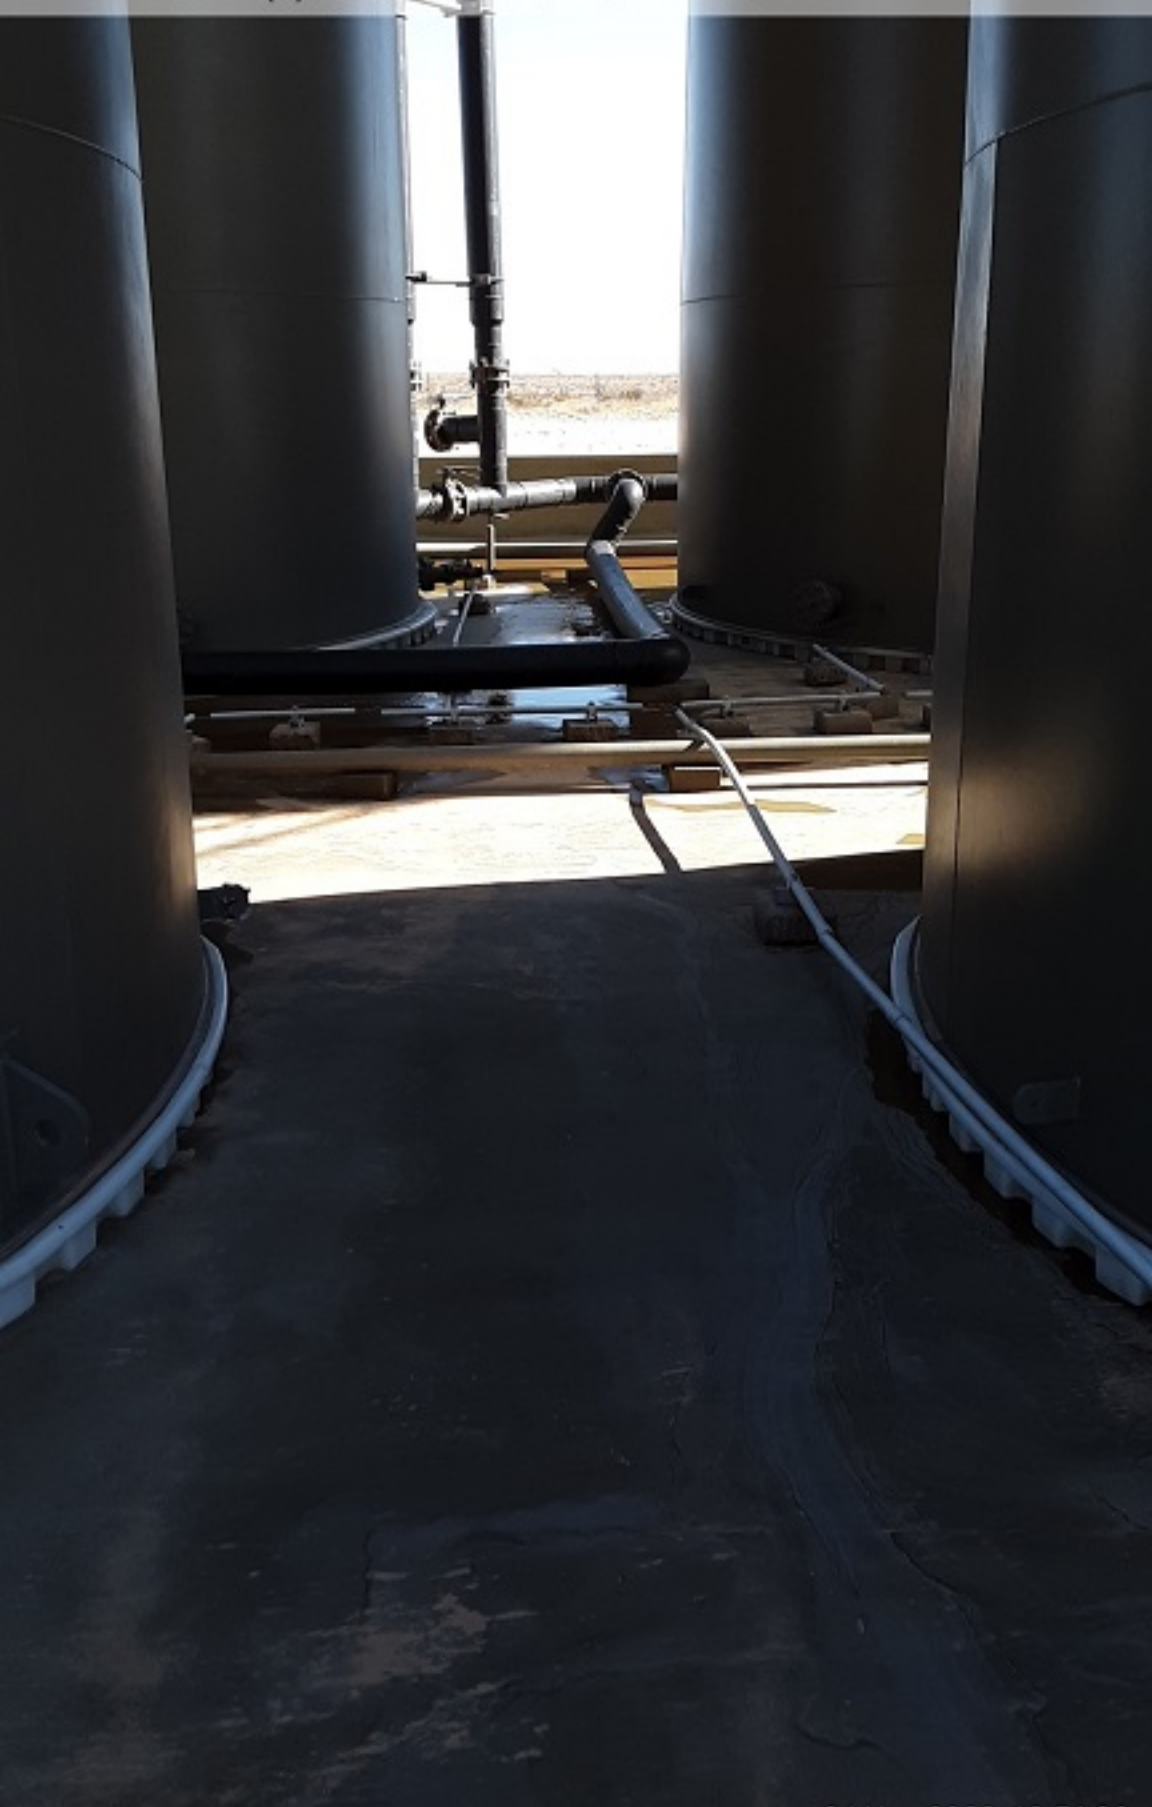
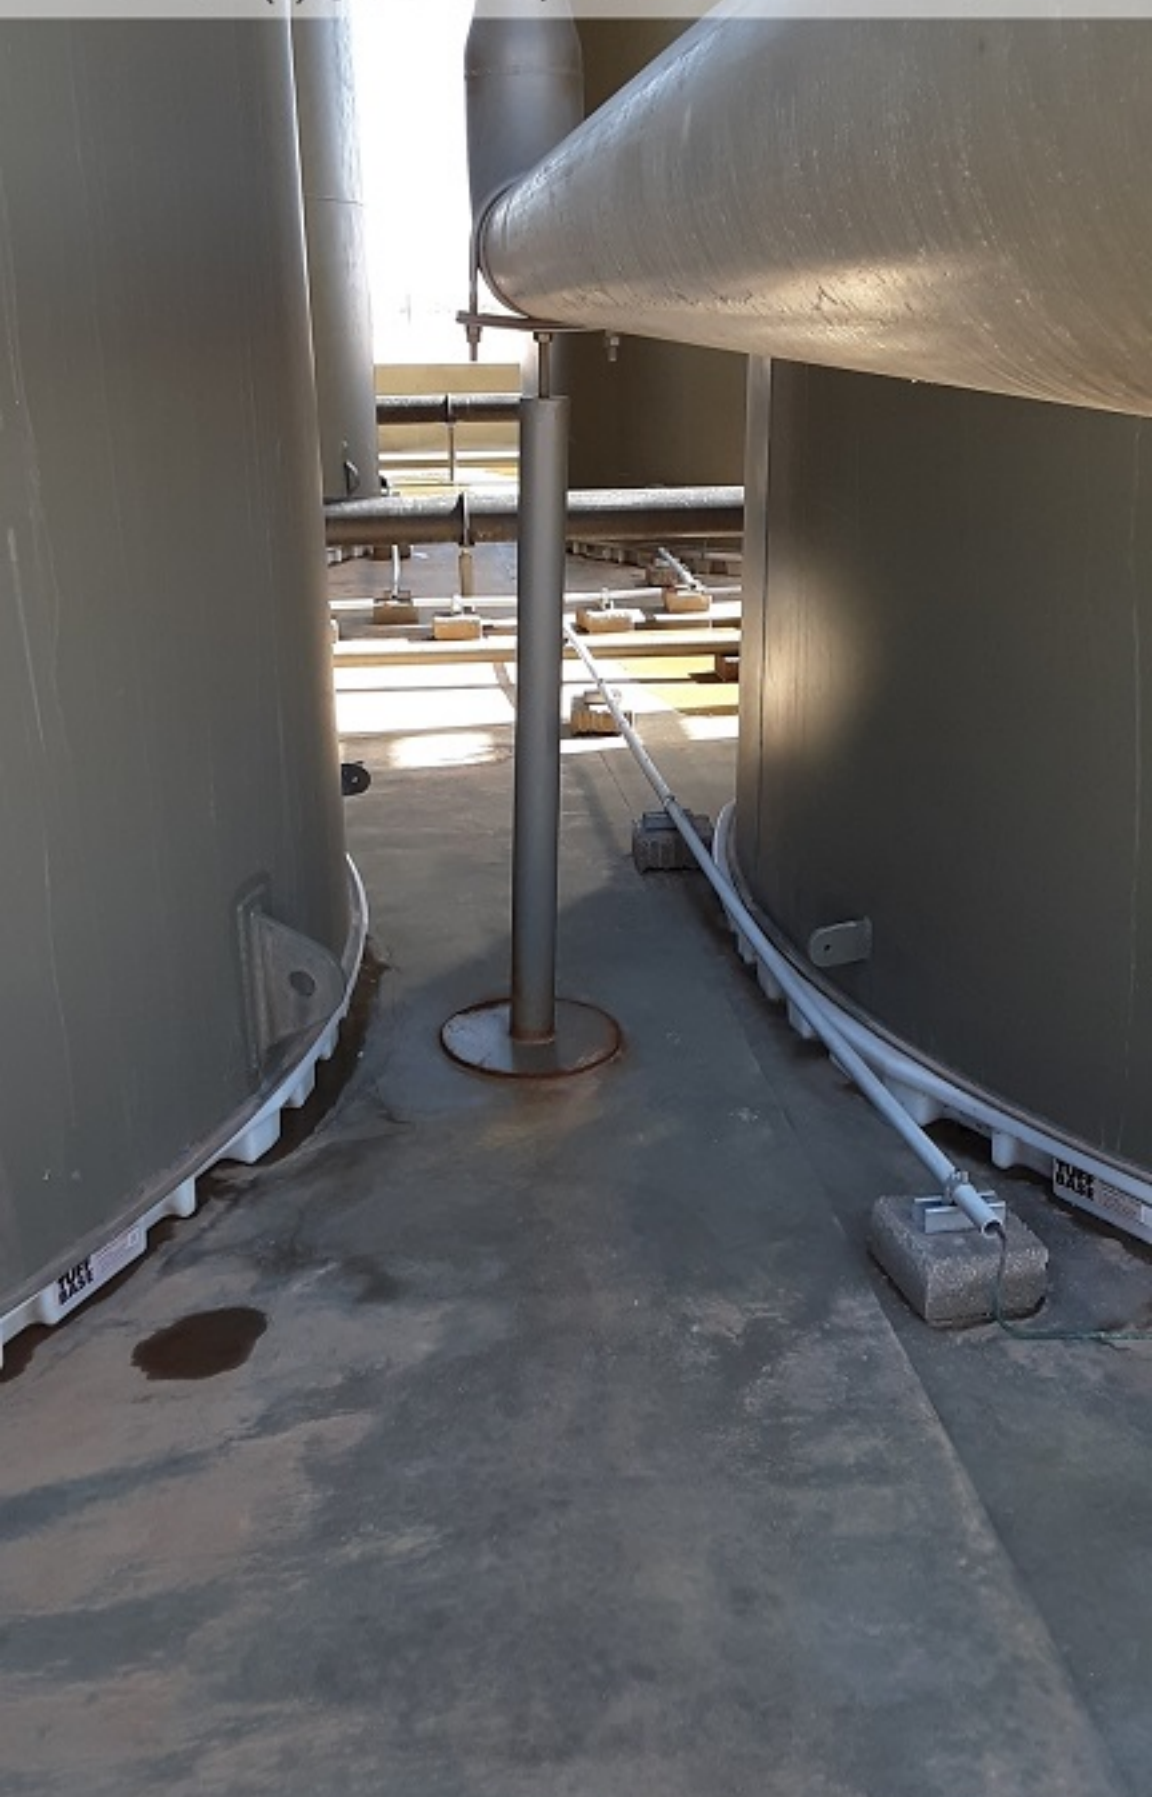
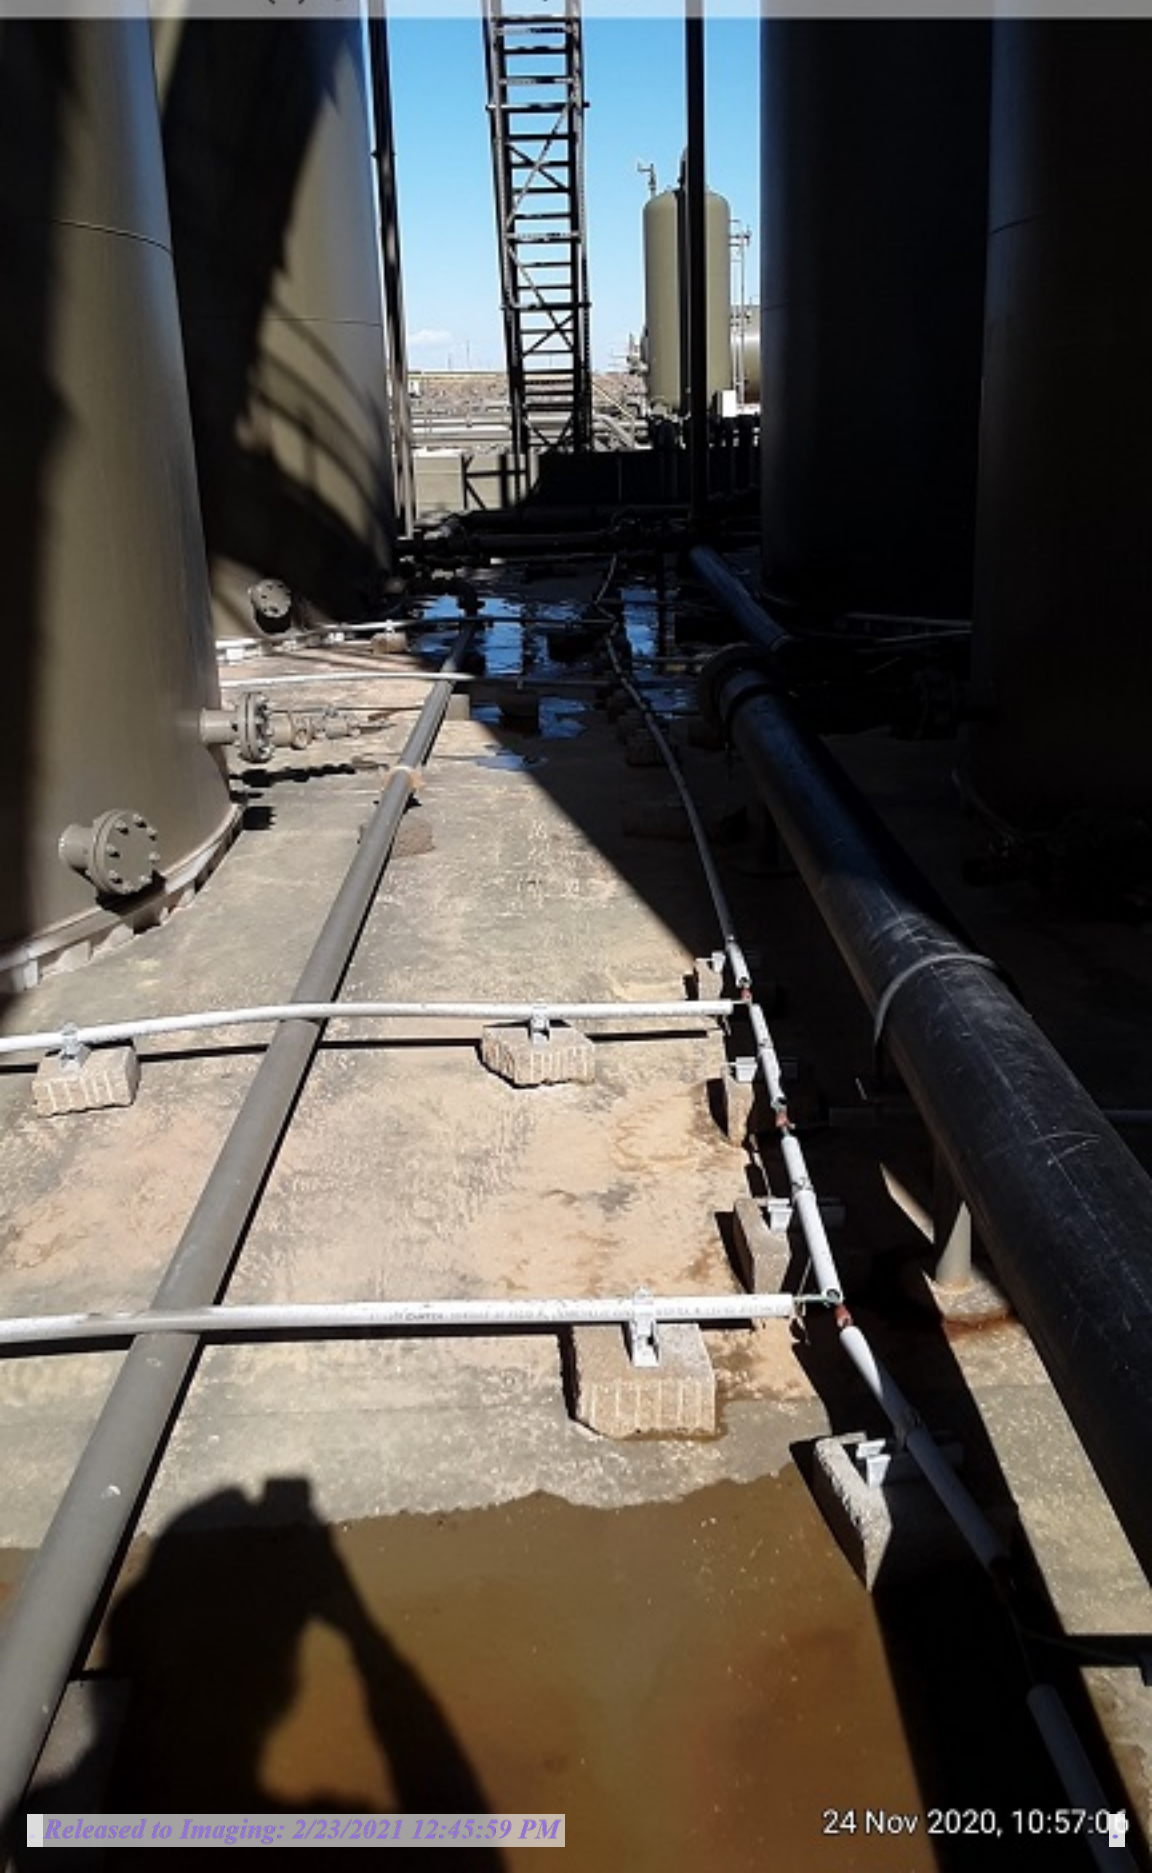
At the request of Devon, SMA conducted a liner integrity inspection per requirements of 19.15.29.11.A(5)(a) NMAC. NMOCD was notified on November 20, 2020 that the liner inspection was to occur, and the inspection was conducted on November 24, 2020. After a thorough visual inspection of the liner within the tank battery containment, the liner appeared to be intact and had the ability to contain the leak in question. The location where the release occurred was identified, and SMA verified

that the release did not occur outside of the lined containment. A photo log of the inspection is included in Appendix A.

Additional Comments:Water Was Present due to recent rain shower.**SMA INSPECTOR SIGNATURE****CLIENT REPRESENTATIVE**Date: 11/24/20

- Arrived at Scheduled time of 10:30 am.
 - Will wait 20 minutes for NMOC before beginning inspection.
- Examined POR to see if release was fully contained.
 - Release did stay in containment.
- Searched Containment for any tears or Potential Compromises.
 - No indication of liner failures were found during inspection of Secondary Containment
 - Liner remained intact
 - Water was present due to recent rainstorm
- Took photos of containment with Solocator app.
- Mapped Containment
- Left Site.

SMA recommends no further action and requests the closure of NRM2025334934.
