Release Notification

CLOSURE REPORT

Lateral 2B-27/Huerfano #74 Pipeline Release
SW ¼, S19 T27N R10W
San Juan County, New Mexico

February 20, 2020
Updated May 20, 2020
Ensolum Project No. 05A1226072

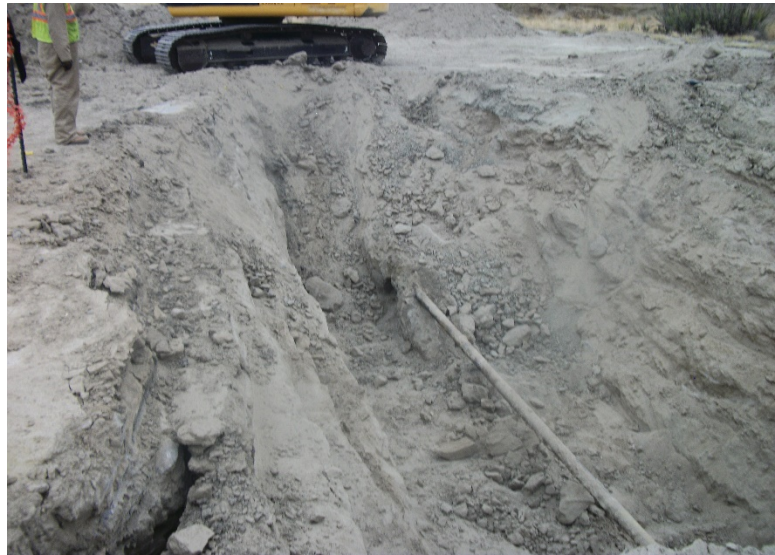
**Photograph 1**

Photograph Description: View of in-process excavation activities.

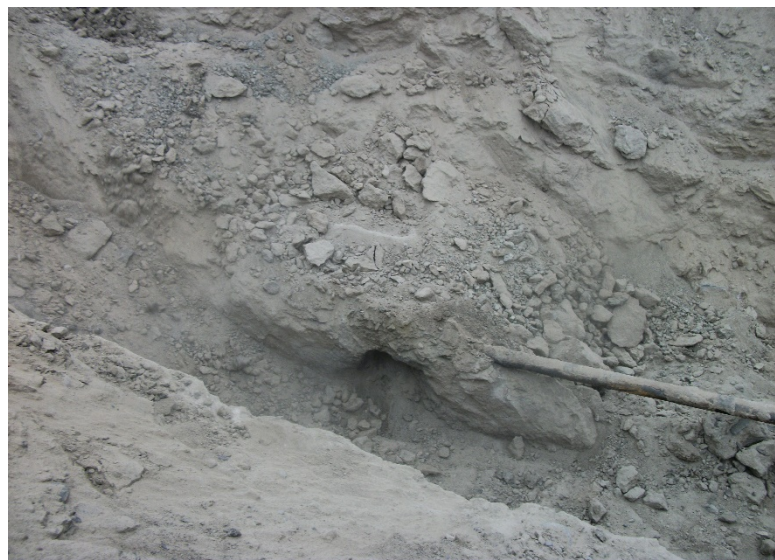
**Photograph 2**

Photograph Description: View of in-process excavation activities.

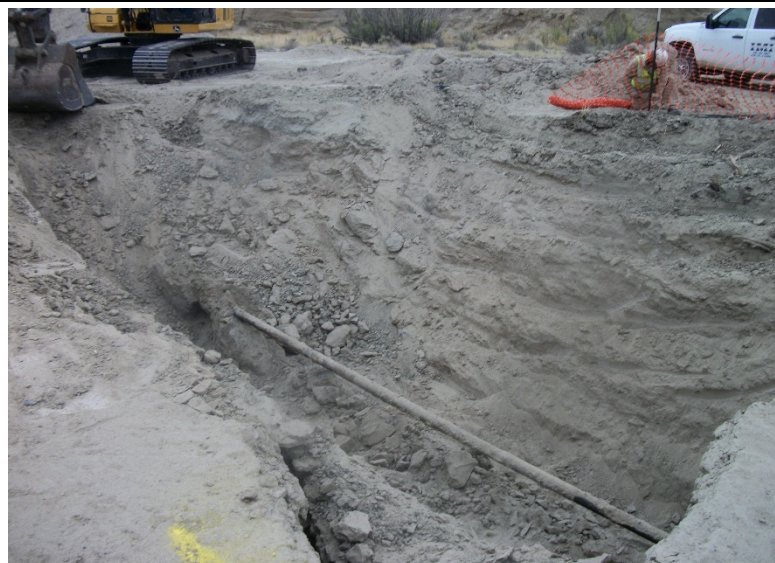
**Photograph 3**

Photograph Description: View of in-process excavation activities.

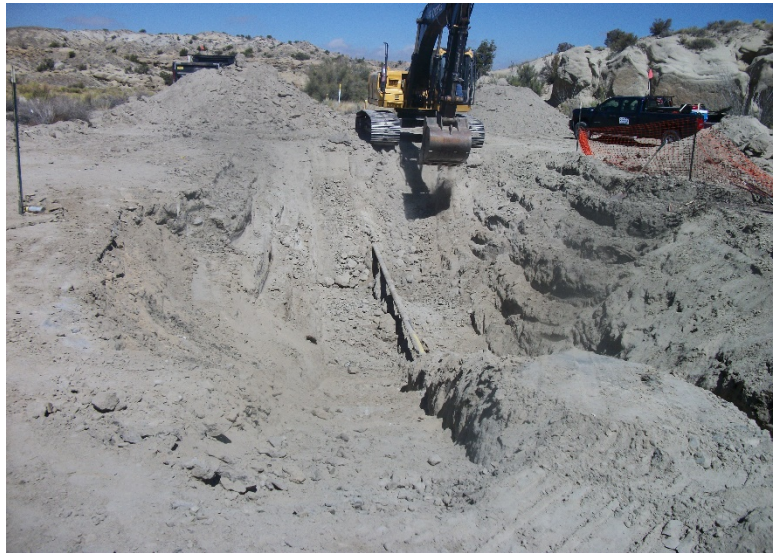
**Photograph 4**

Photograph Description: View of in-process excavation activities.

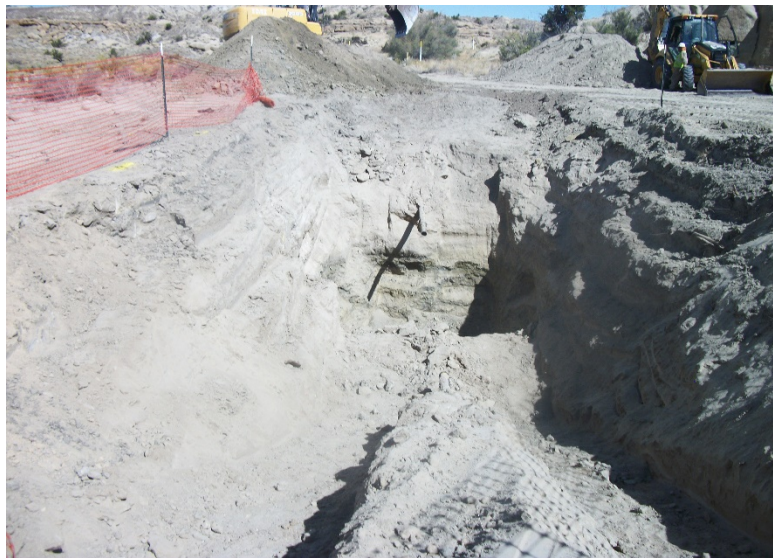
**Photograph 5**

Photograph Description: View of in-process excavation activities.

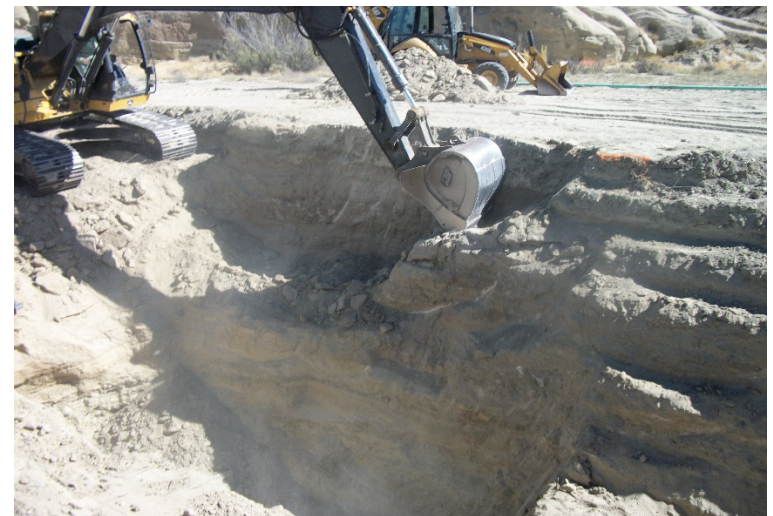
**Photograph 6**

Photograph Description: View of in-process excavation activities.

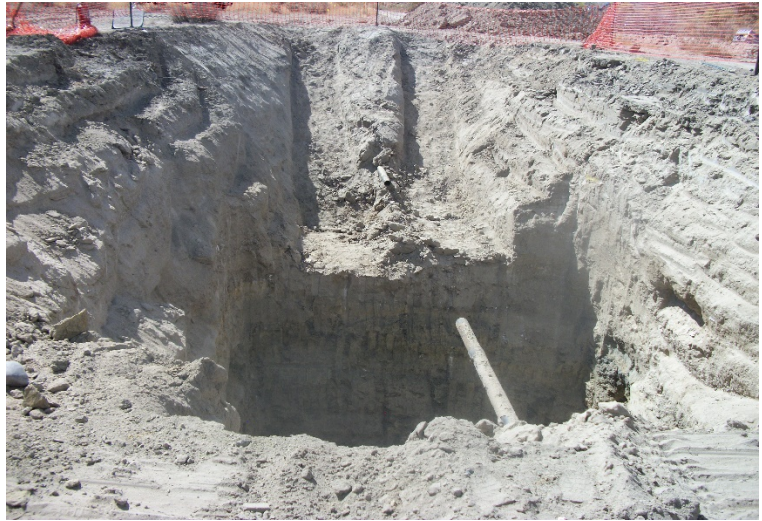
**Photograph 7**

The final excavation measured approximately 37 feet long and 16 feet wide at the maximum extents. The maximum depth of the excavation measured approximately 19 feet below grade surface (bgs).

Photograph Description: View of the final excavation.

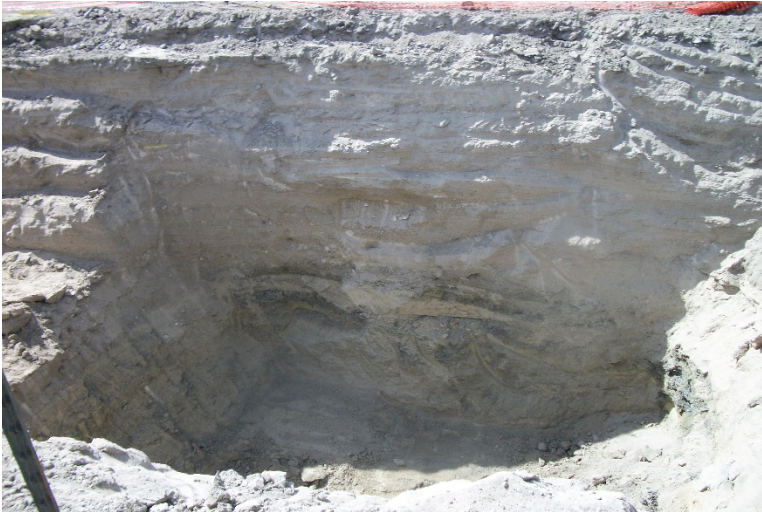
**Photograph 8**

Photograph Description: View of the final excavation.

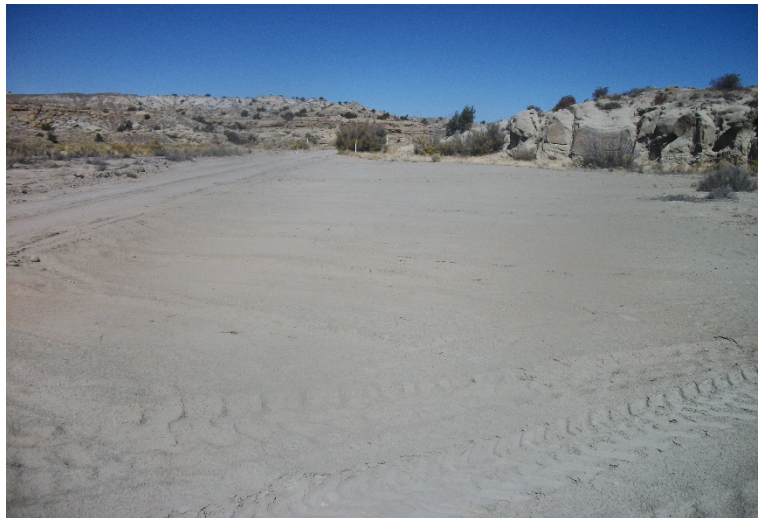
**Photograph 9**

Photograph Description: View of the final excavation after initial restoration.

The excavation was backfilled with a combination of imported fill and segregated, laboratory-confirmed, unaffected stockpiled soils, and was then contoured to the surrounding grade. Enterprise will re-seed the Site with a BLM Farmington Field Office approved seeding mixture.
