## Release Notification

Site Name Rustler Bluff SWD	Site Type SWD Facility
Date Release Discovered 02/03/2020	API# (if applicable)

**RE: Closure Request Addendum  
Rustler Bluff SWD  
Incident Number NRM2004956954  
Eddy County, New Mexico**

**Table 1**  
**Soil Analytical Results**  
**RUSTLER BLUFF SWD**  
**INCIDENT NUMBER NRM2004956954**  
**Eddy County, New Mexico**

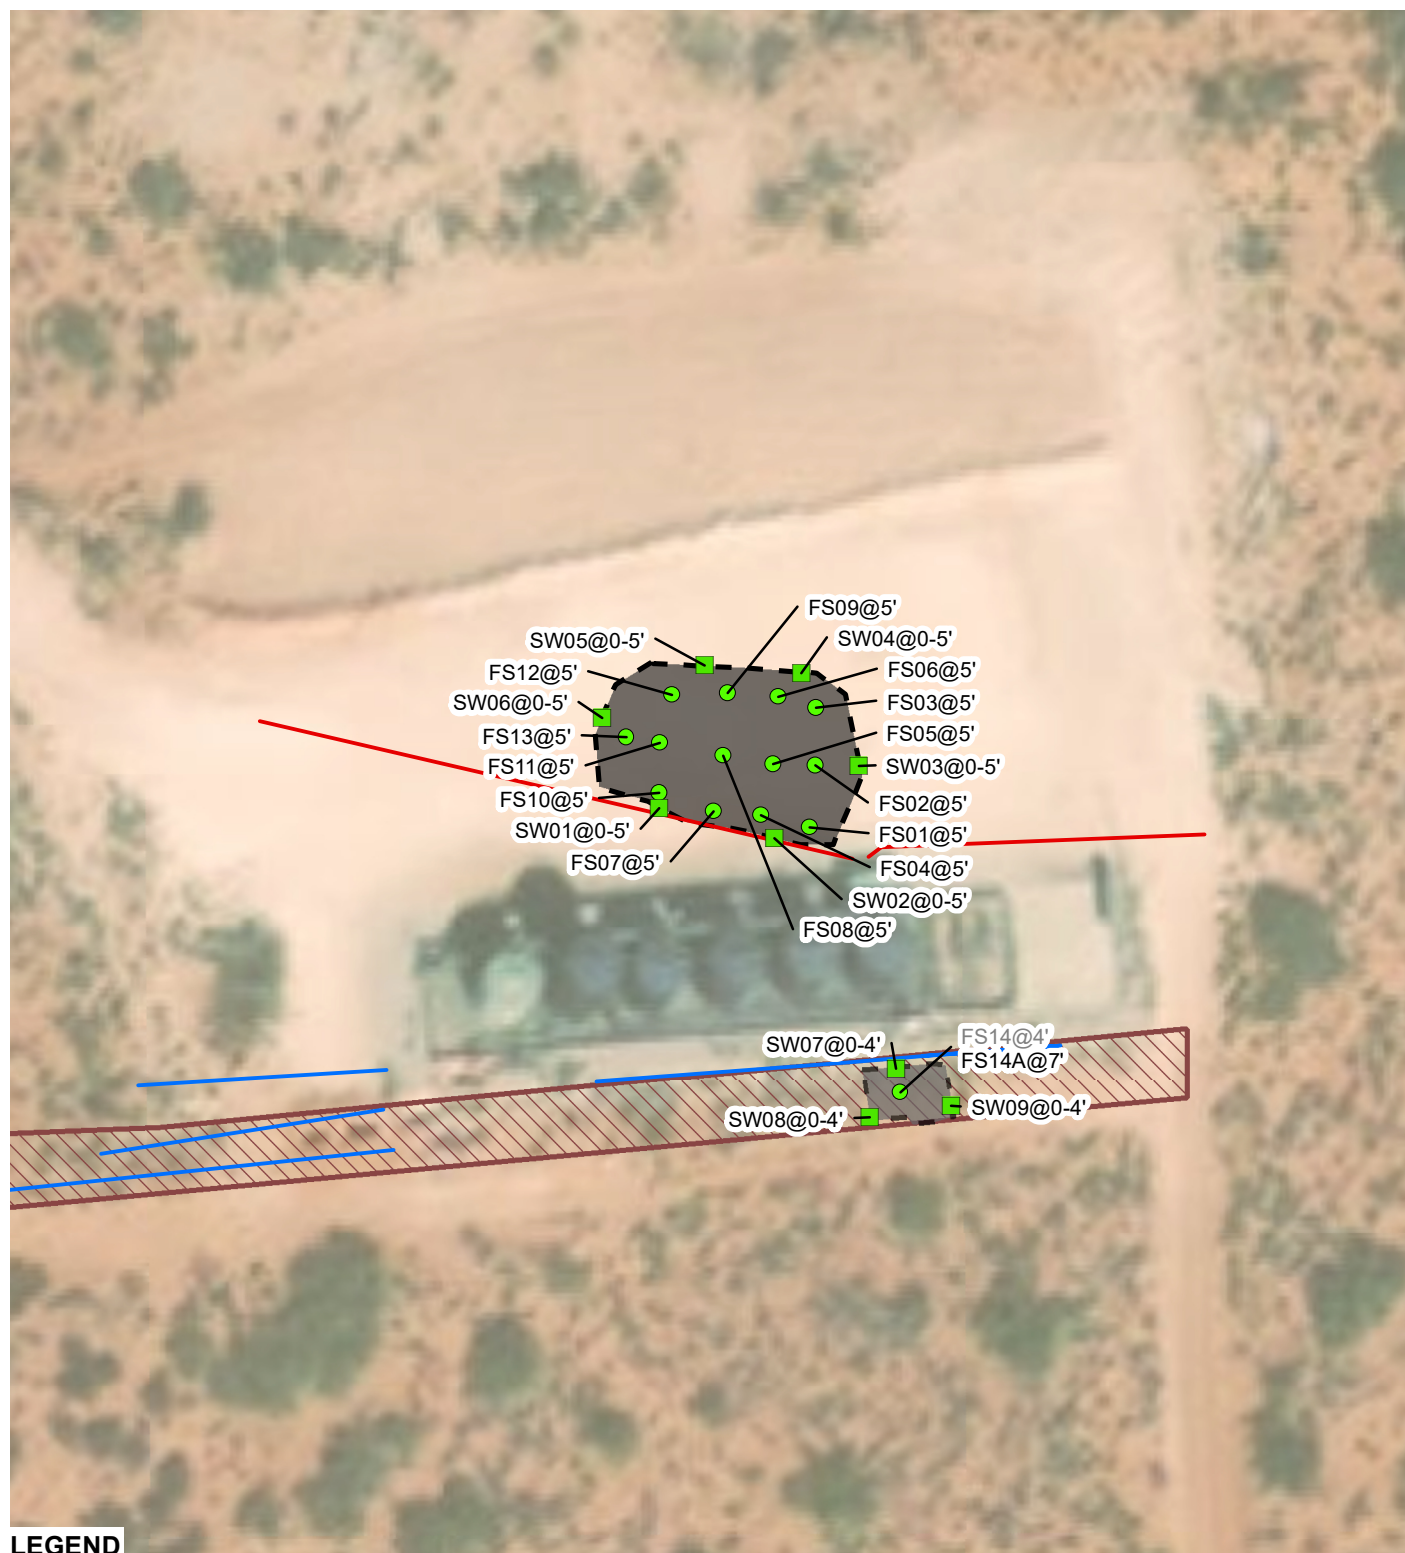
**FIGURE 1**  
 EXCAVATION SOIL SAMPLE LOCATIONS  
 RUSTLER BLUFF SWD  
 UNIT M SEC 2 T25S R30E  
 EDDY COUNTY, NEW MEXICO  
 XTO ENERGY, INC.

The excavation extents and excavation soil sample locations are depicted on Figure 1. Photographic documentation was conducted during excavation activities and photos are included in Attachment 1.

To address the denial, WSP oversaw additional excavation activities on December 22, 2020 to remove additional soil from the floor of the excavation in the area around floor sample FS14. To direct excavation activities, WSP screened soil for volatile aromatic hydrocarbons and chloride utilizing a photo-ionization detector (PID) and Hach® chloride QuanTab® test strips, respectively. The excavation was completed to a depth of 7 feet bgs. Upon completion of excavation activities, 5-point composite sample FS14A was collected from the floor of the excavation from a depth of 7 feet bgs.

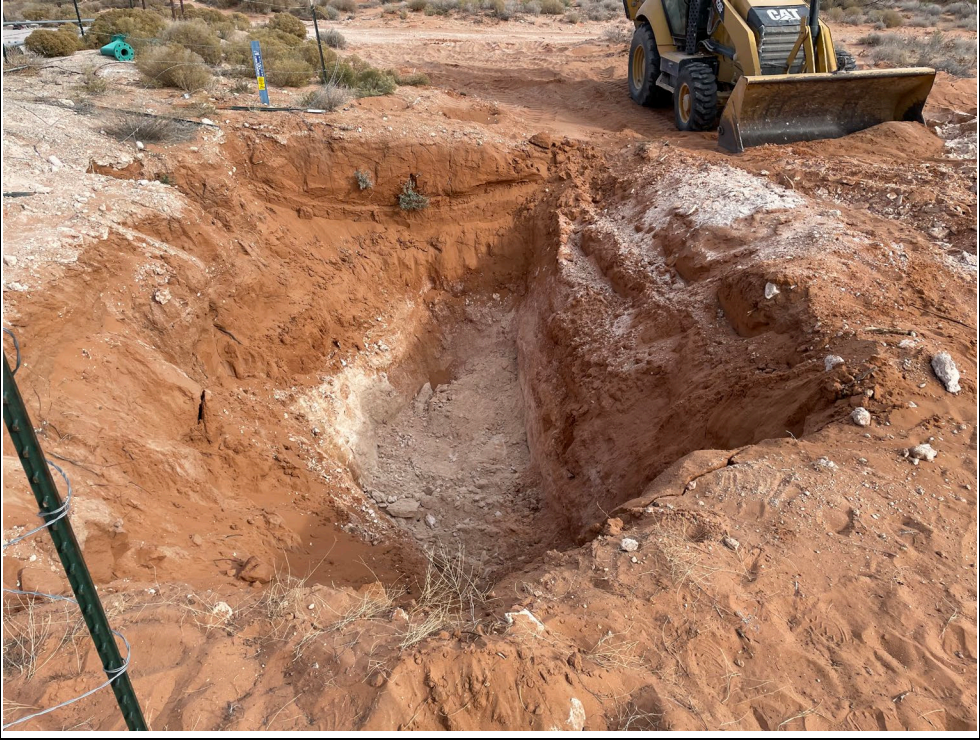
<b>Photo No.</b>	<b>Date</b>	
1	December 22, 2020	
Eastern view of excavation.

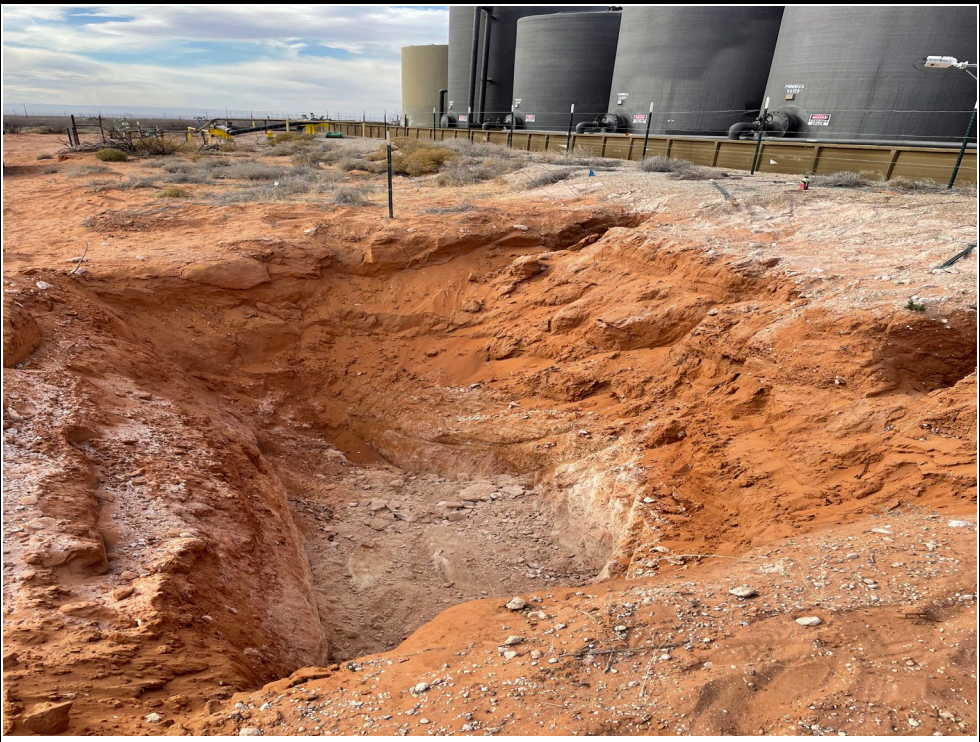
<b>Photo No.</b>	<b>Date</b>	
2	December 22, 2020	
Western view of excavation.
