## **Lateral 2C-60 Pipeline Release Closure Report**

Unit Letter C, Section 13, Township 24 North, Range 3 West  
Rio Arriba County, New Mexico

July 28, 2020

# **Enterprise Field Services, LLC Lateral 2C-60 Pipeline Release Closure Report**

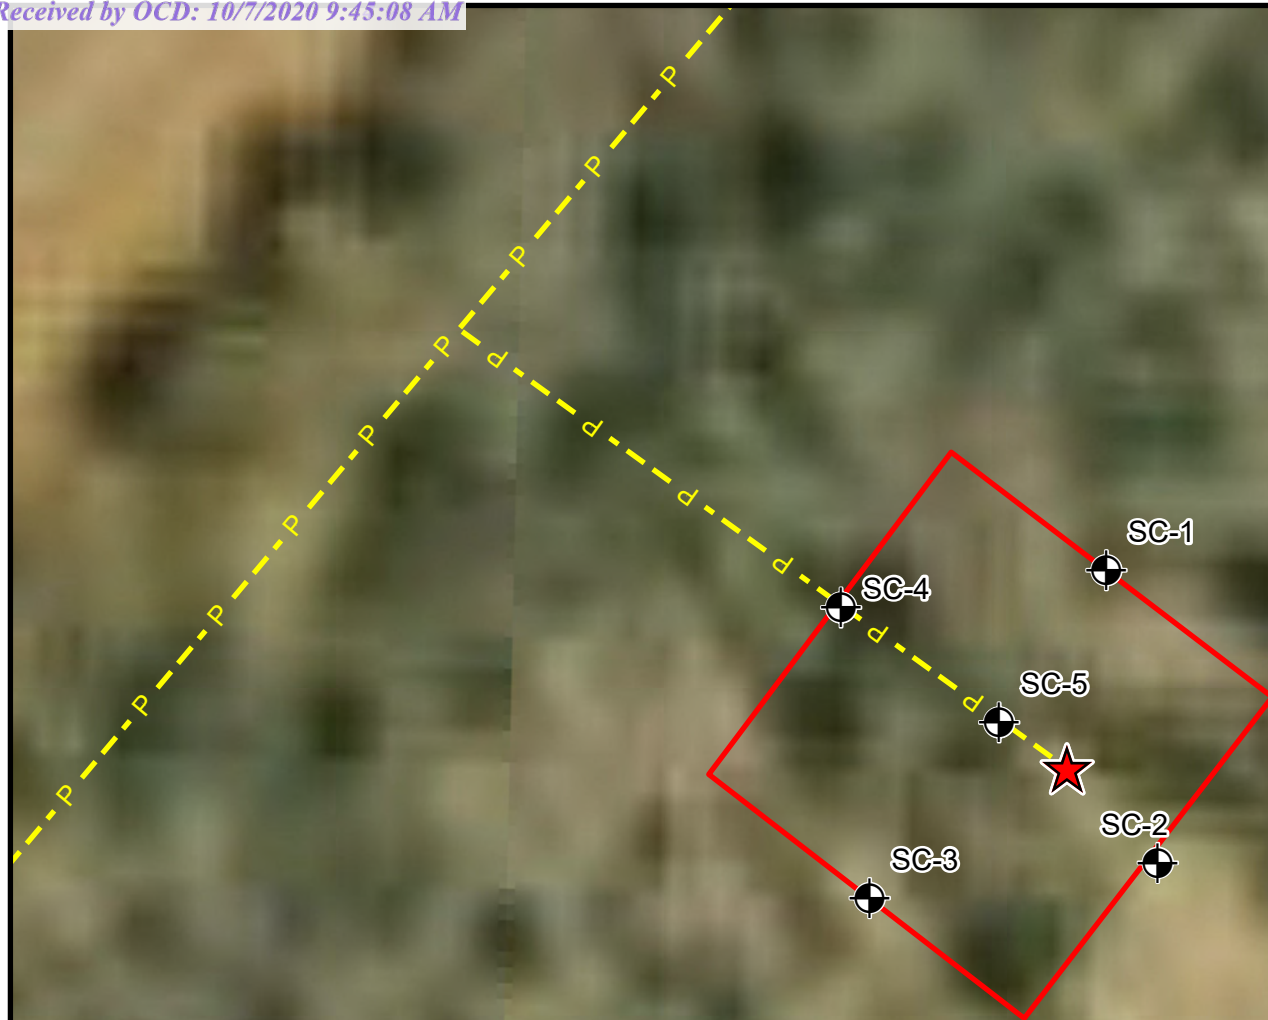
**Figure 3**  
**Sample Location Map**  
Lateral 2C-60

A depiction of the excavation with sample locations is included as Figure 3. A copy of the executed C-138 Solid Waste Acceptance Form is included in Appendix B. A photograph log is included in Appendix C. A copy of regulatory correspondence is included in Appendix D.

Rule collected confirmation excavation soil samples (SC-1 through SC-5) from the sidewalls and base of the excavation. Each confirmation soil sample is a representative composite comprised of five equivalent aliquots of soil collected from the sampled area. Additionally, two composite samples (SP-1 and SP-2) were collected from stockpiles of overburden material removed from the excavation walk-out. Excavation confirmation sample locations are shown on Figure 3.

On March 4, 2020, Enterprise initiated remediation activities at the location. O.F.T. Construction, Inc. provided heavy equipment operation and repair support. Rule Engineering, LLC (Rule) personnel provided excavation guidance and collected confirmation samples from the resultant excavation. The final repair excavation was measured approximately 20 feet by 20 feet by 10 feet in depth. Approximately 231 cubic yards of soil and 35 barrels of hydrovac cuttings were transported to the Envirotech Landfarm near Bloomfield, New Mexico for disposal/remediation. The repair excavation was backfilled with clean, imported material and laboratory confirmed stockpiled overburden.

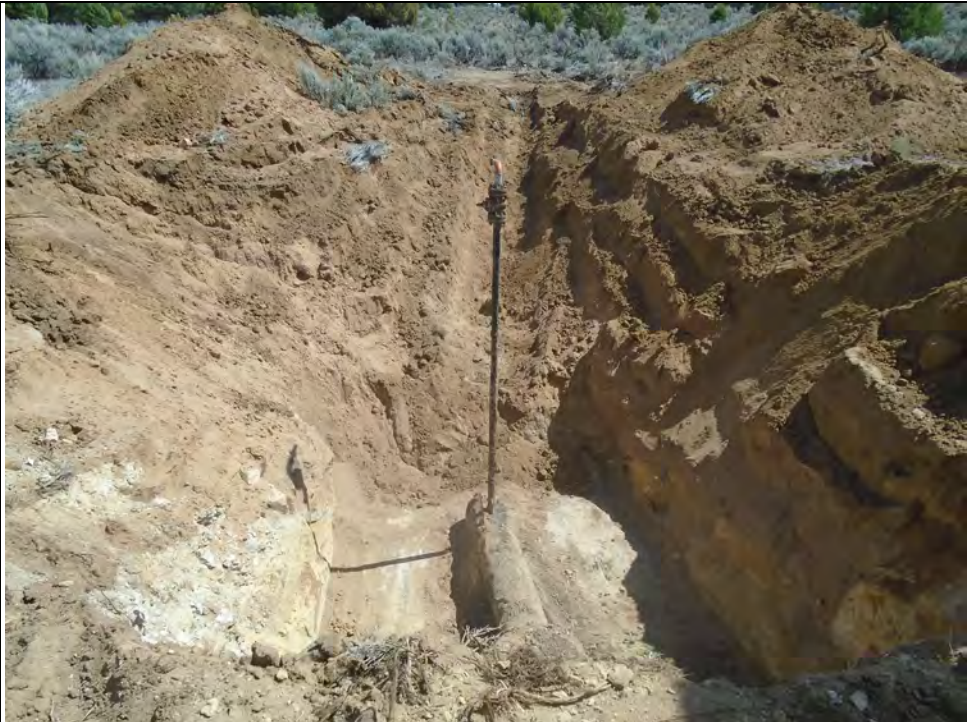
Photograph #1

Client: Enterprise	
Site Name:  Lateral 2C-60 Pipeline Release	
Date Photo Taken: April 2, 2020	
Release Location: N36.314778, W107.108354  C-13-24N-3W Rio Arriba County, NM	
Photo Taken by: Heather Woods	Description: Facing southeast, view of the final excavation extents.

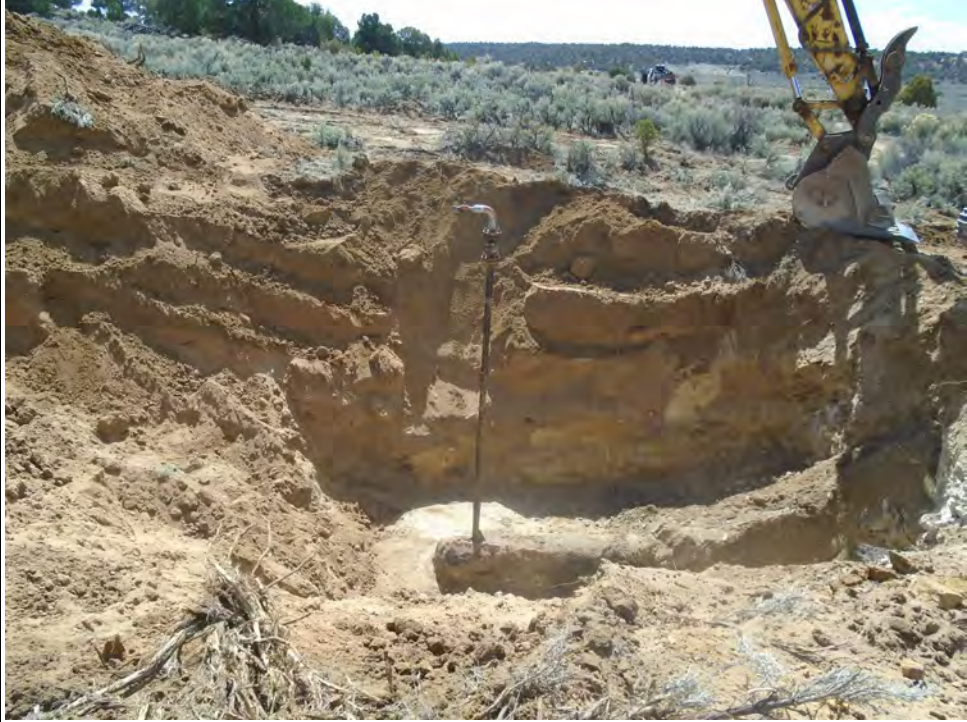
Photograph #2

Client: Enterprise	
Site Name:  Lateral 2C-60 Pipeline Release	
Date Photo Taken: April 2, 2020	
Release Location: N36.314778, W107.108354  C-13-24N-3W Rio Arriba County, NM	
Photo Taken by: Heather Woods	Description: Facing southwest, view of the final excavation extents.

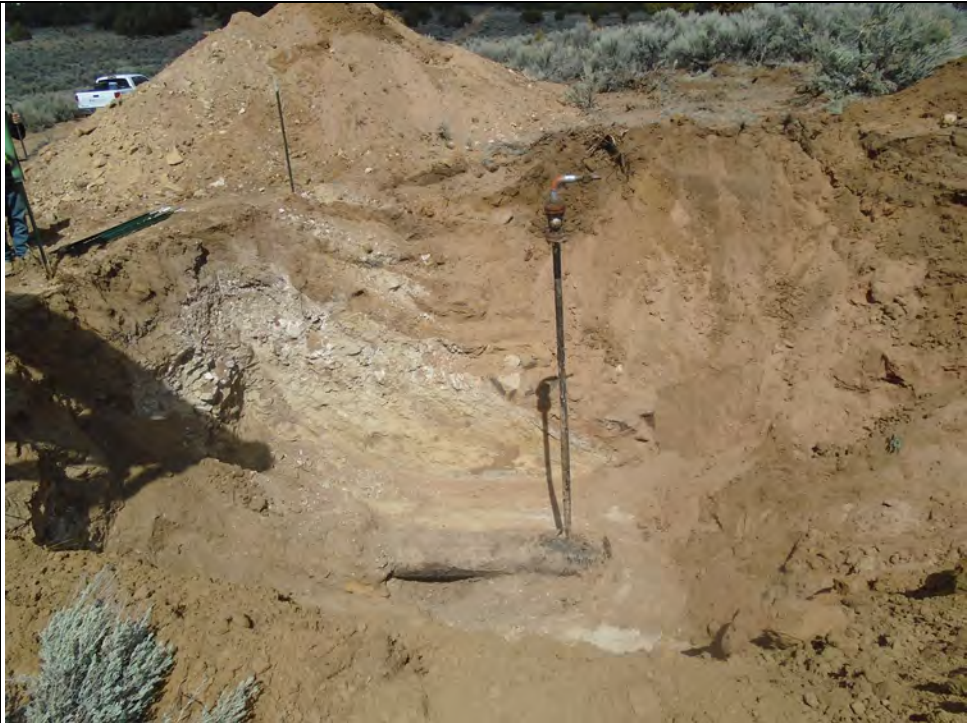
Photograph #3

Client: Enterprise	
Site Name:  Lateral 2C-60 Pipeline Release	
Date Photo Taken: April 2, 2020	
Release Location: N36.314778, W107.108354  C-13-24N-3W Rio Arriba County, NM	
Photo Taken by: Heather Woods	Description: Facing northeast, view of the final excavation extents.

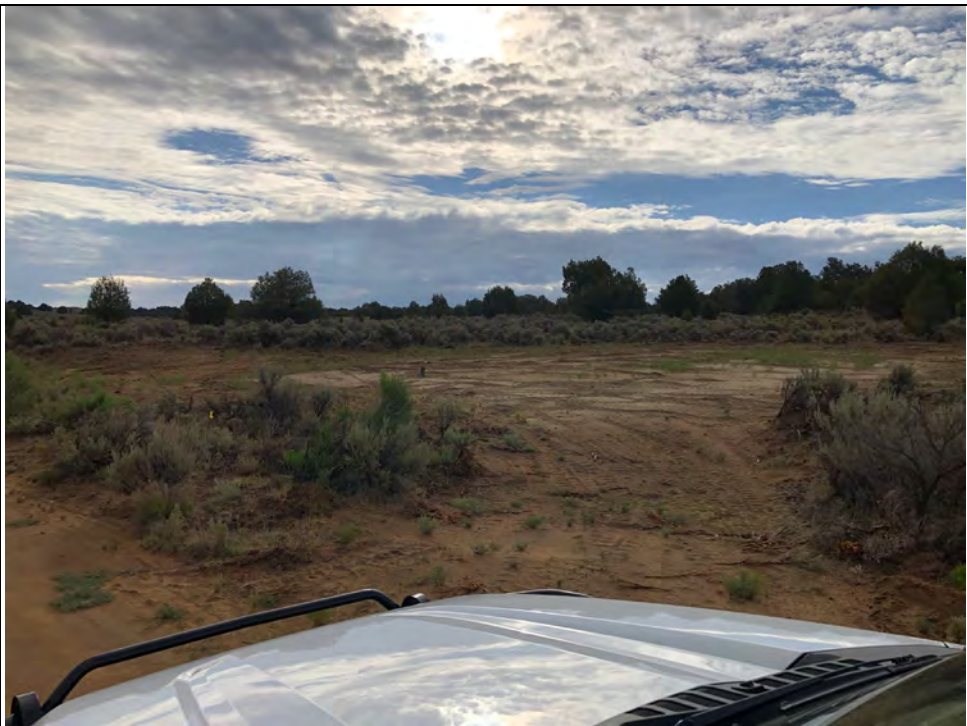
Photograph #4

Client: Enterprise	
Site Name:  Lateral 2C-60 Pipeline Release	
Date Photo Taken: July 23, 2020	
Release Location: N36.314778, W107.108354  C-13-24N-3W Rio Arriba County, NM	
Photo Taken by: Mason Hawkins	Description: Facing east, view of the reclaimed release area.

The excavation was backfilled with clean, imported material and laboratory confirmed stockpiled overburden. The area was contoured as near as possible to original grade and re-seeding will be performed as requested by the private landowner.
