Release Notification

Re: RDX Federal 21 #022H Release Closure Request (NRM2033924296)

This report summarizes the secondary containment inspection activities at the RDX Federal 21 #022H well pad (Site). The topographic map of the Site is provided as Figure 01. On November 23, 2020, a produced water transfer pump seized causing 18 barrels (bbls) of produced water and 2 bbls oil to be released inside the lined secondary containment. No fluids were observed outside the containment and all fluids were recovered using a water truck.

Well Location: RDX Federal 21 #022H

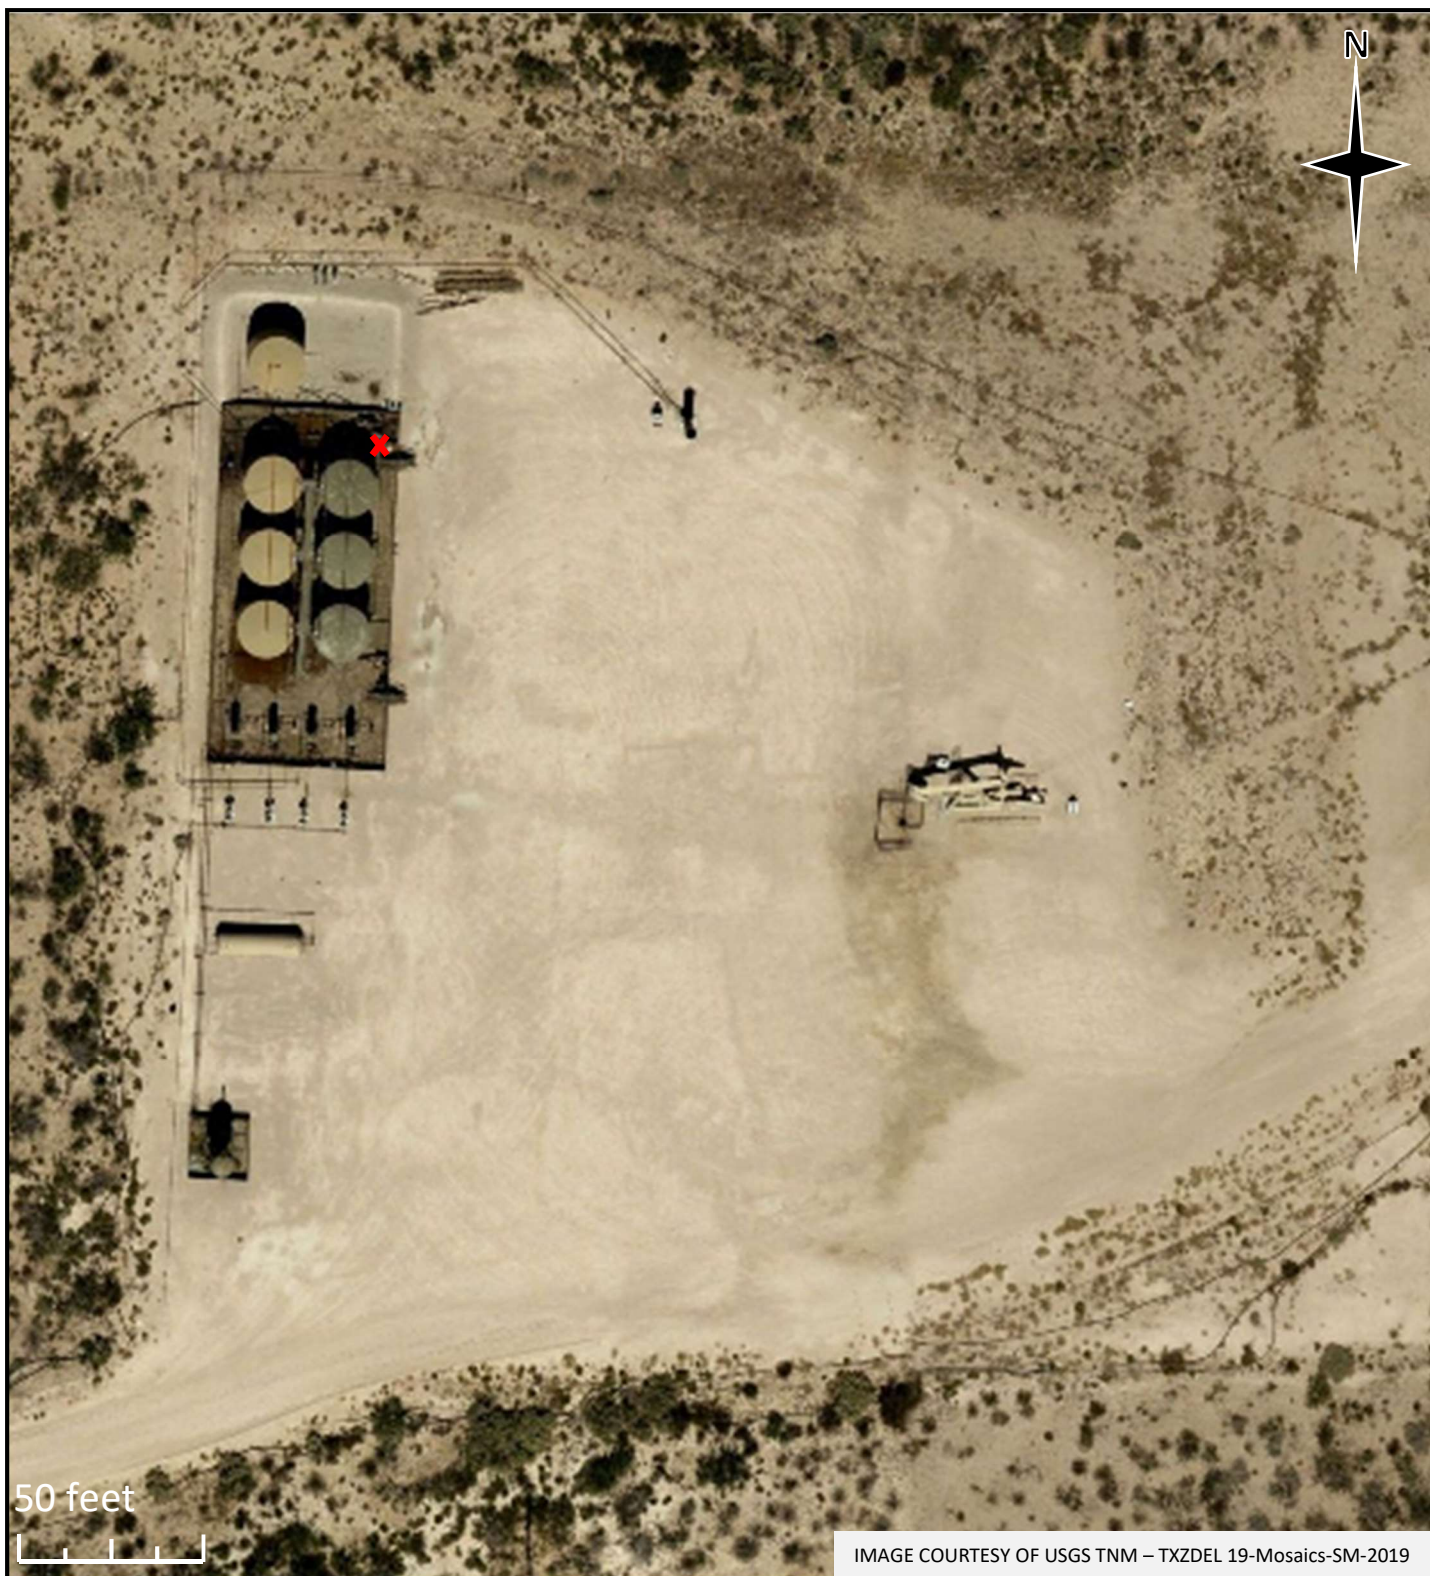
Figure 02
RDX Federal 21 #022H
30-015-40561
Permian Basin, Eddy County, NM
32.0307906, -103.8897924

The secondary liner containment was washed on December 04, 2020. The area of interest is located on Figure 02. Notification of liner inspection was scheduled with the NMOCD on

✖ Point of Release
