**Re: Site Remediation and Closure Report
Diamond PWU 22 #6H
API No. 30-015-41008
GPS: Latitude 32.647459 Longitude -104.070351
UL "E", Sec. 22, T19S, R29E
Eddy County, NM
NMOCD Ref. No. NRM2029540644**

Pima Environmental Services, LLC (Pima) has been contracted by Devon Energy Production Company (Devon) to perform a spill assessment and remediation activities for an oil release that occurred at the Diamond PWU 22 #6H (Diamond). The initial C-141 was submitted on October 19th, 2020 (Appendix C). This incident was assigned Incident ID NRM2029540644, by the New Mexico Oil Conservation Division (NMOCD).

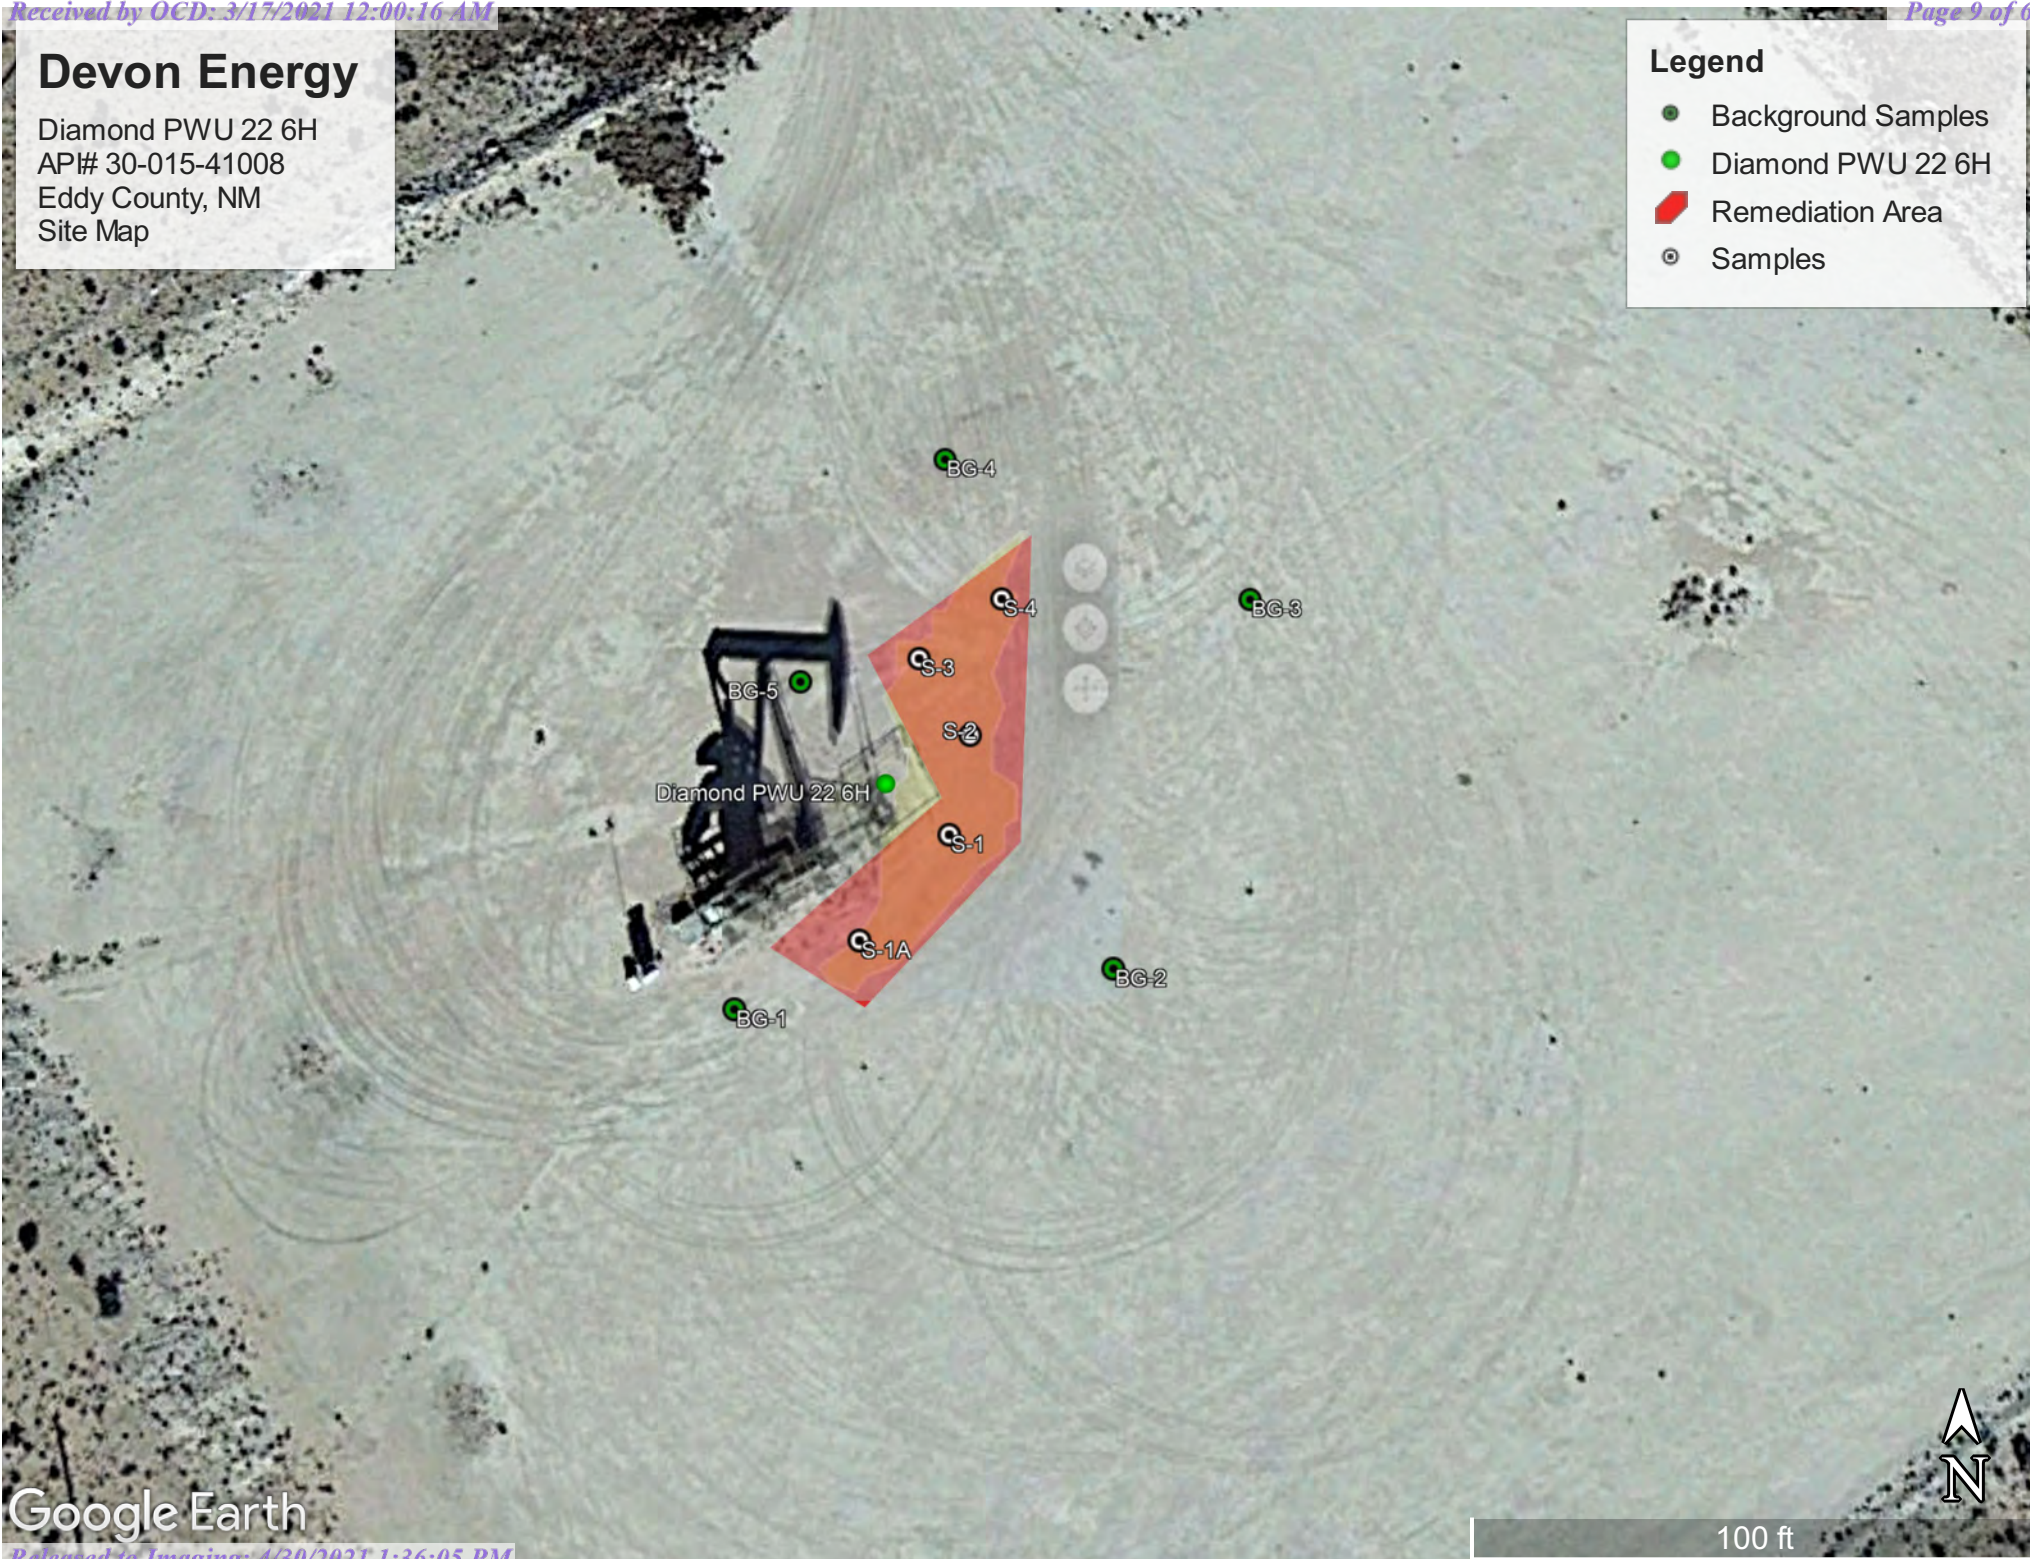
4-Site Map

On October 6th, 2020, Pima Environmental conducted a site assessment and obtained soil samples to get a more in-depth picture of the horizontal extent of the contamination. Laboratory results of this sampling event can be found in the following data table.

On February 17th, 2021, Pima mobilized personnel and equipment to conduct remedial activities based on our most recent assessment. An initial area of approximately 1,800 square feet was marked off running east and south of the wellhead and excavated to a depth of 2' BGS. Bottom and sidewall composite samples were obtained to ensure that the vertical and horizontal extents of the contamination had been removed. Each composite sample was representative of no more than 200 square feet. A map of sample locations can be found in Figure 5. The laboratory results of this sampling event can be found in the following data table.

Diamond PWU 22 6H
API# 30-015-41008
Eddy County, NM
Site Map

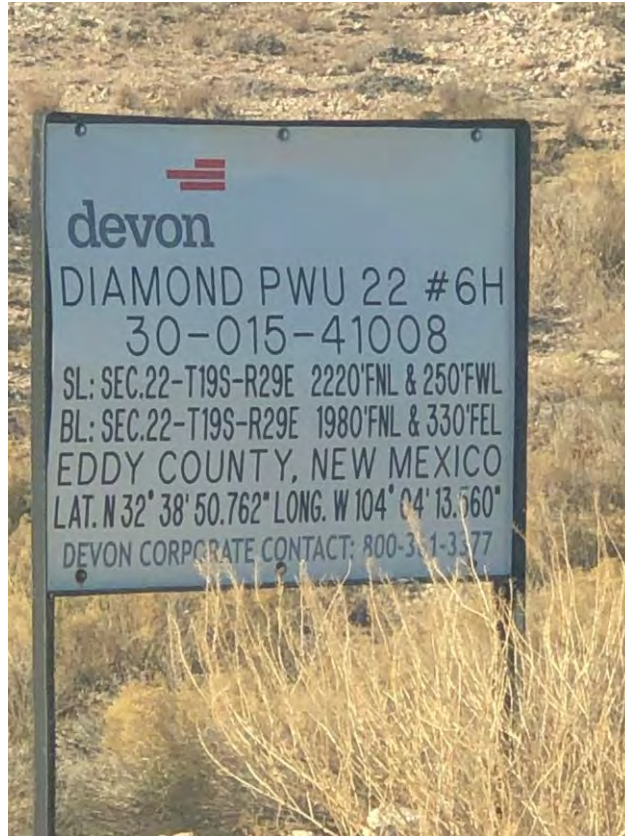
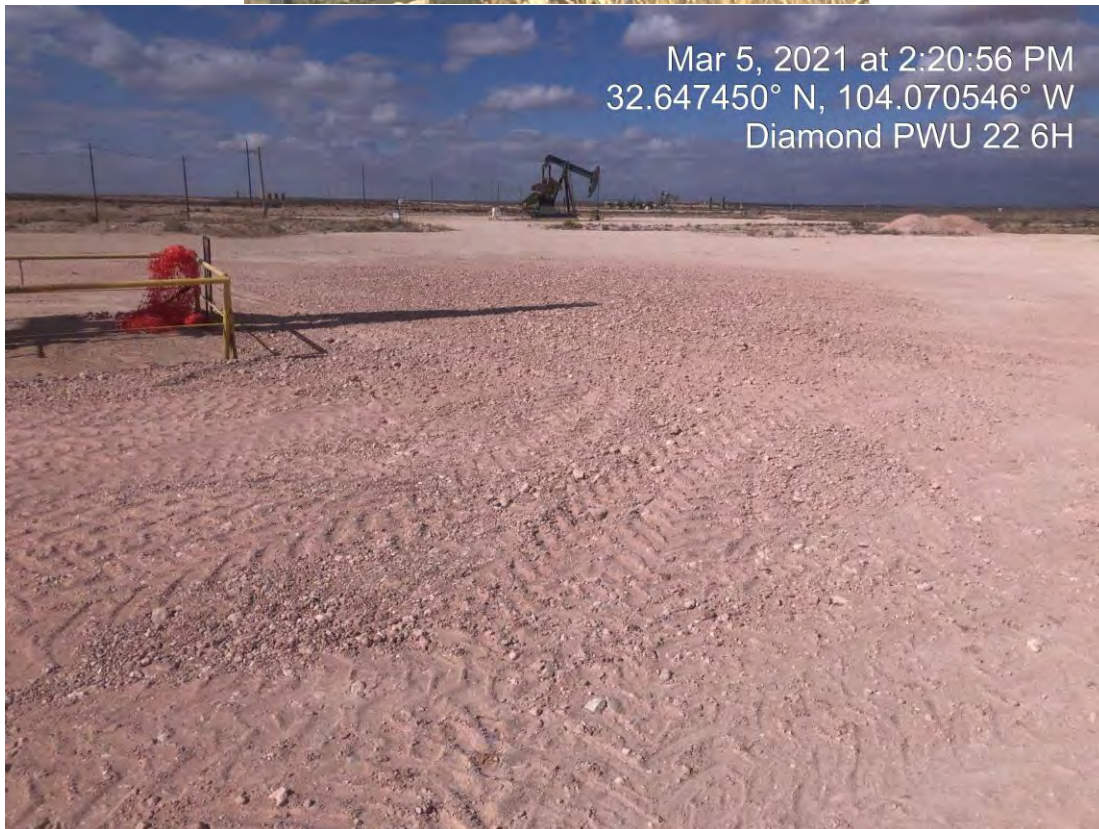
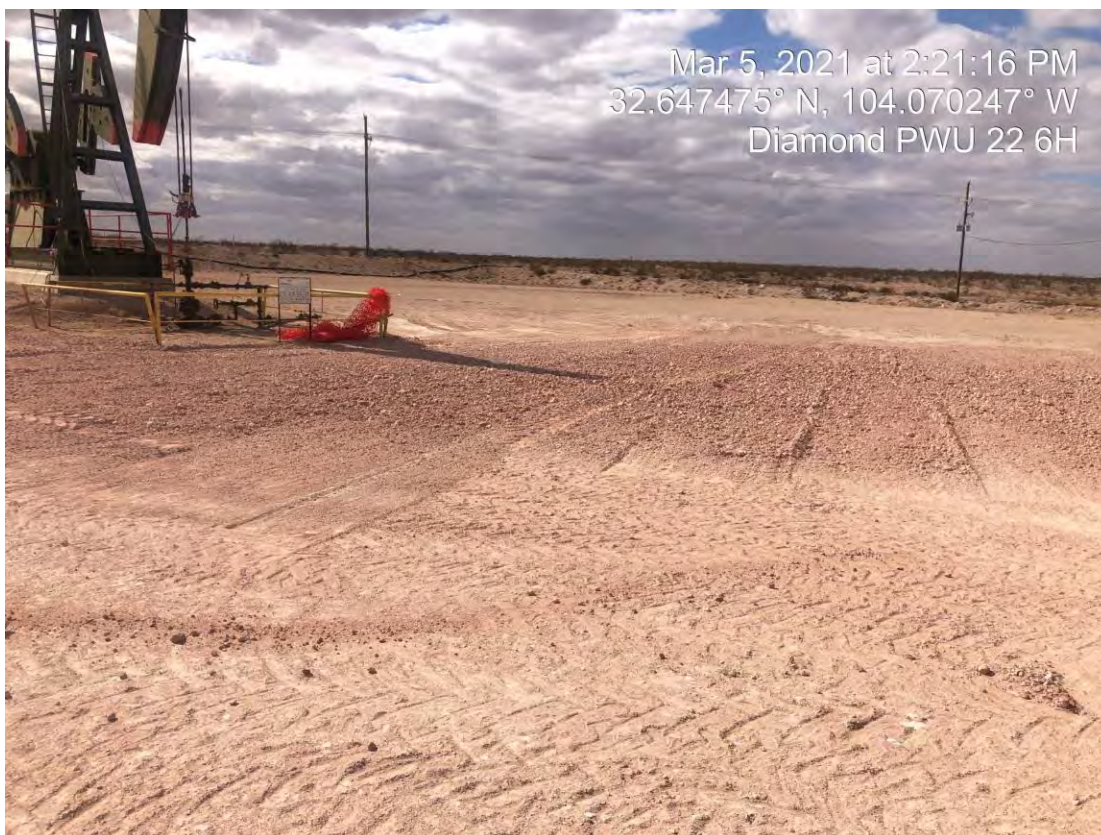
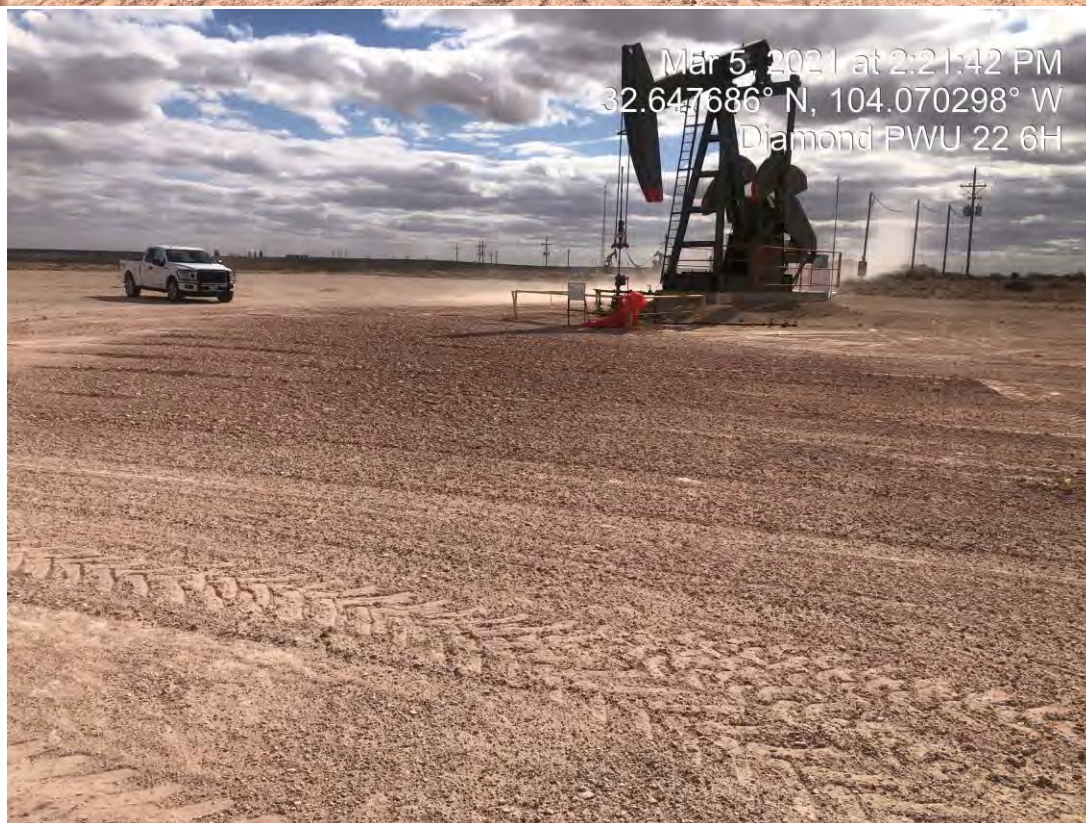
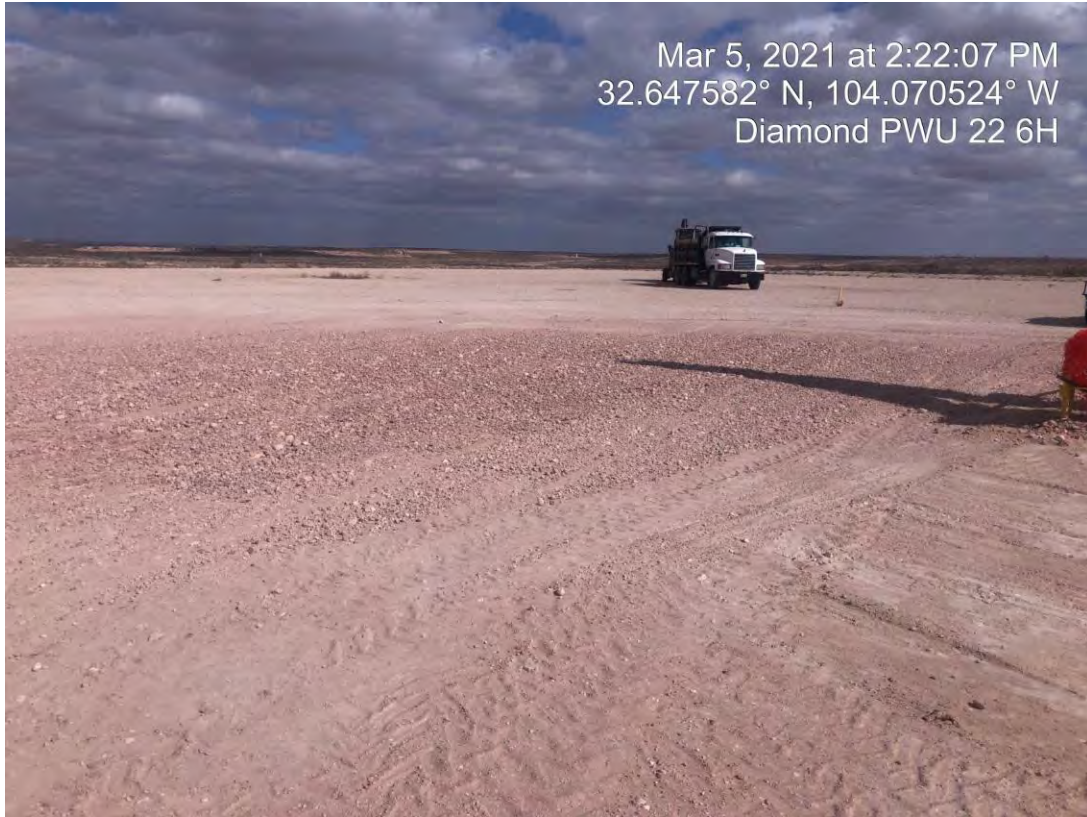
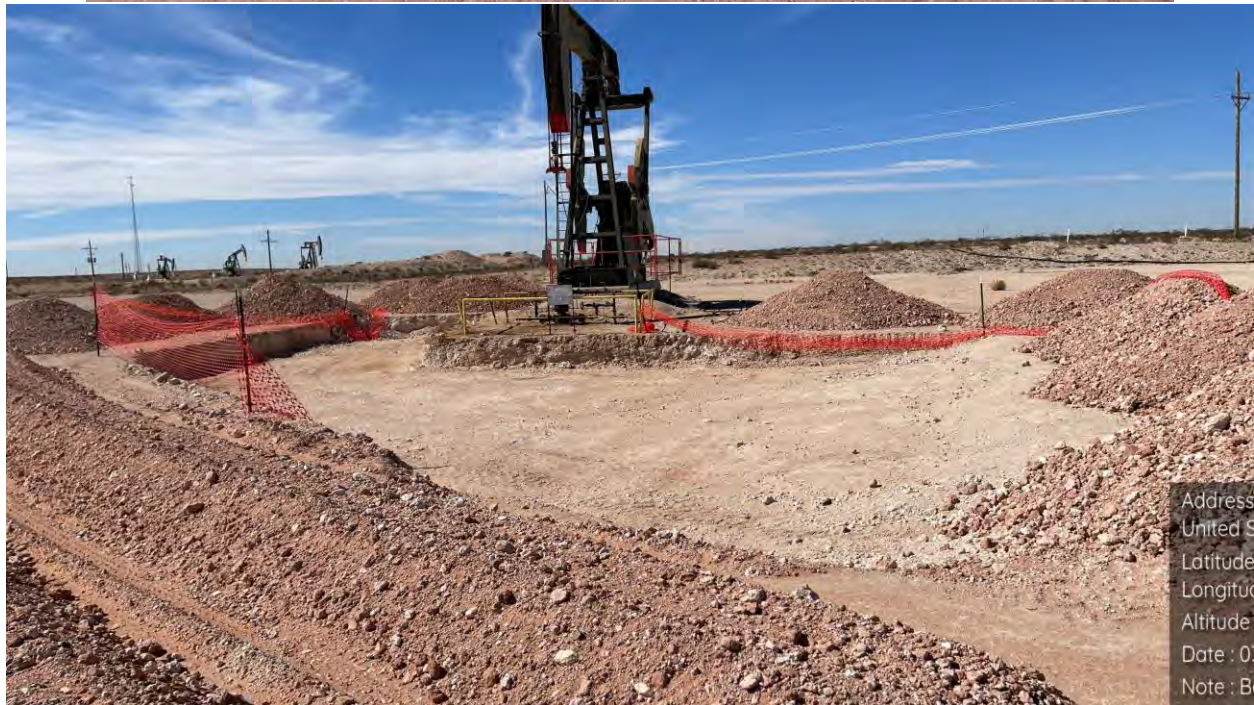
Photographic Documentation

The contaminated material was transported to Lea Land, an NMOCD approved disposal site. The excavation was then backfilled with clean like material, machine compacted and contoured to match the surrounding terrain. See Appendix D for photographic documentation.
