**MAPLE STATE #1 BATTERY
REMEDiation CLOSURE REPORT**

**API NO. 30-015-33167
UNIT LETTER D, SECTION 30, TOWNSHIP 17S, RANGE 28E
RELEASE DATE: 1/23/20
INCIDENT NO. NCE2003555083
EDDY COUNTY, NEW MEXICO**

RE: Maple State #1 Battery
Date of Release: 1/23/20
API No. 30-015-33167
U/L D, Section 30, Township 17S and Range 28E
Eddy County, New Mexico

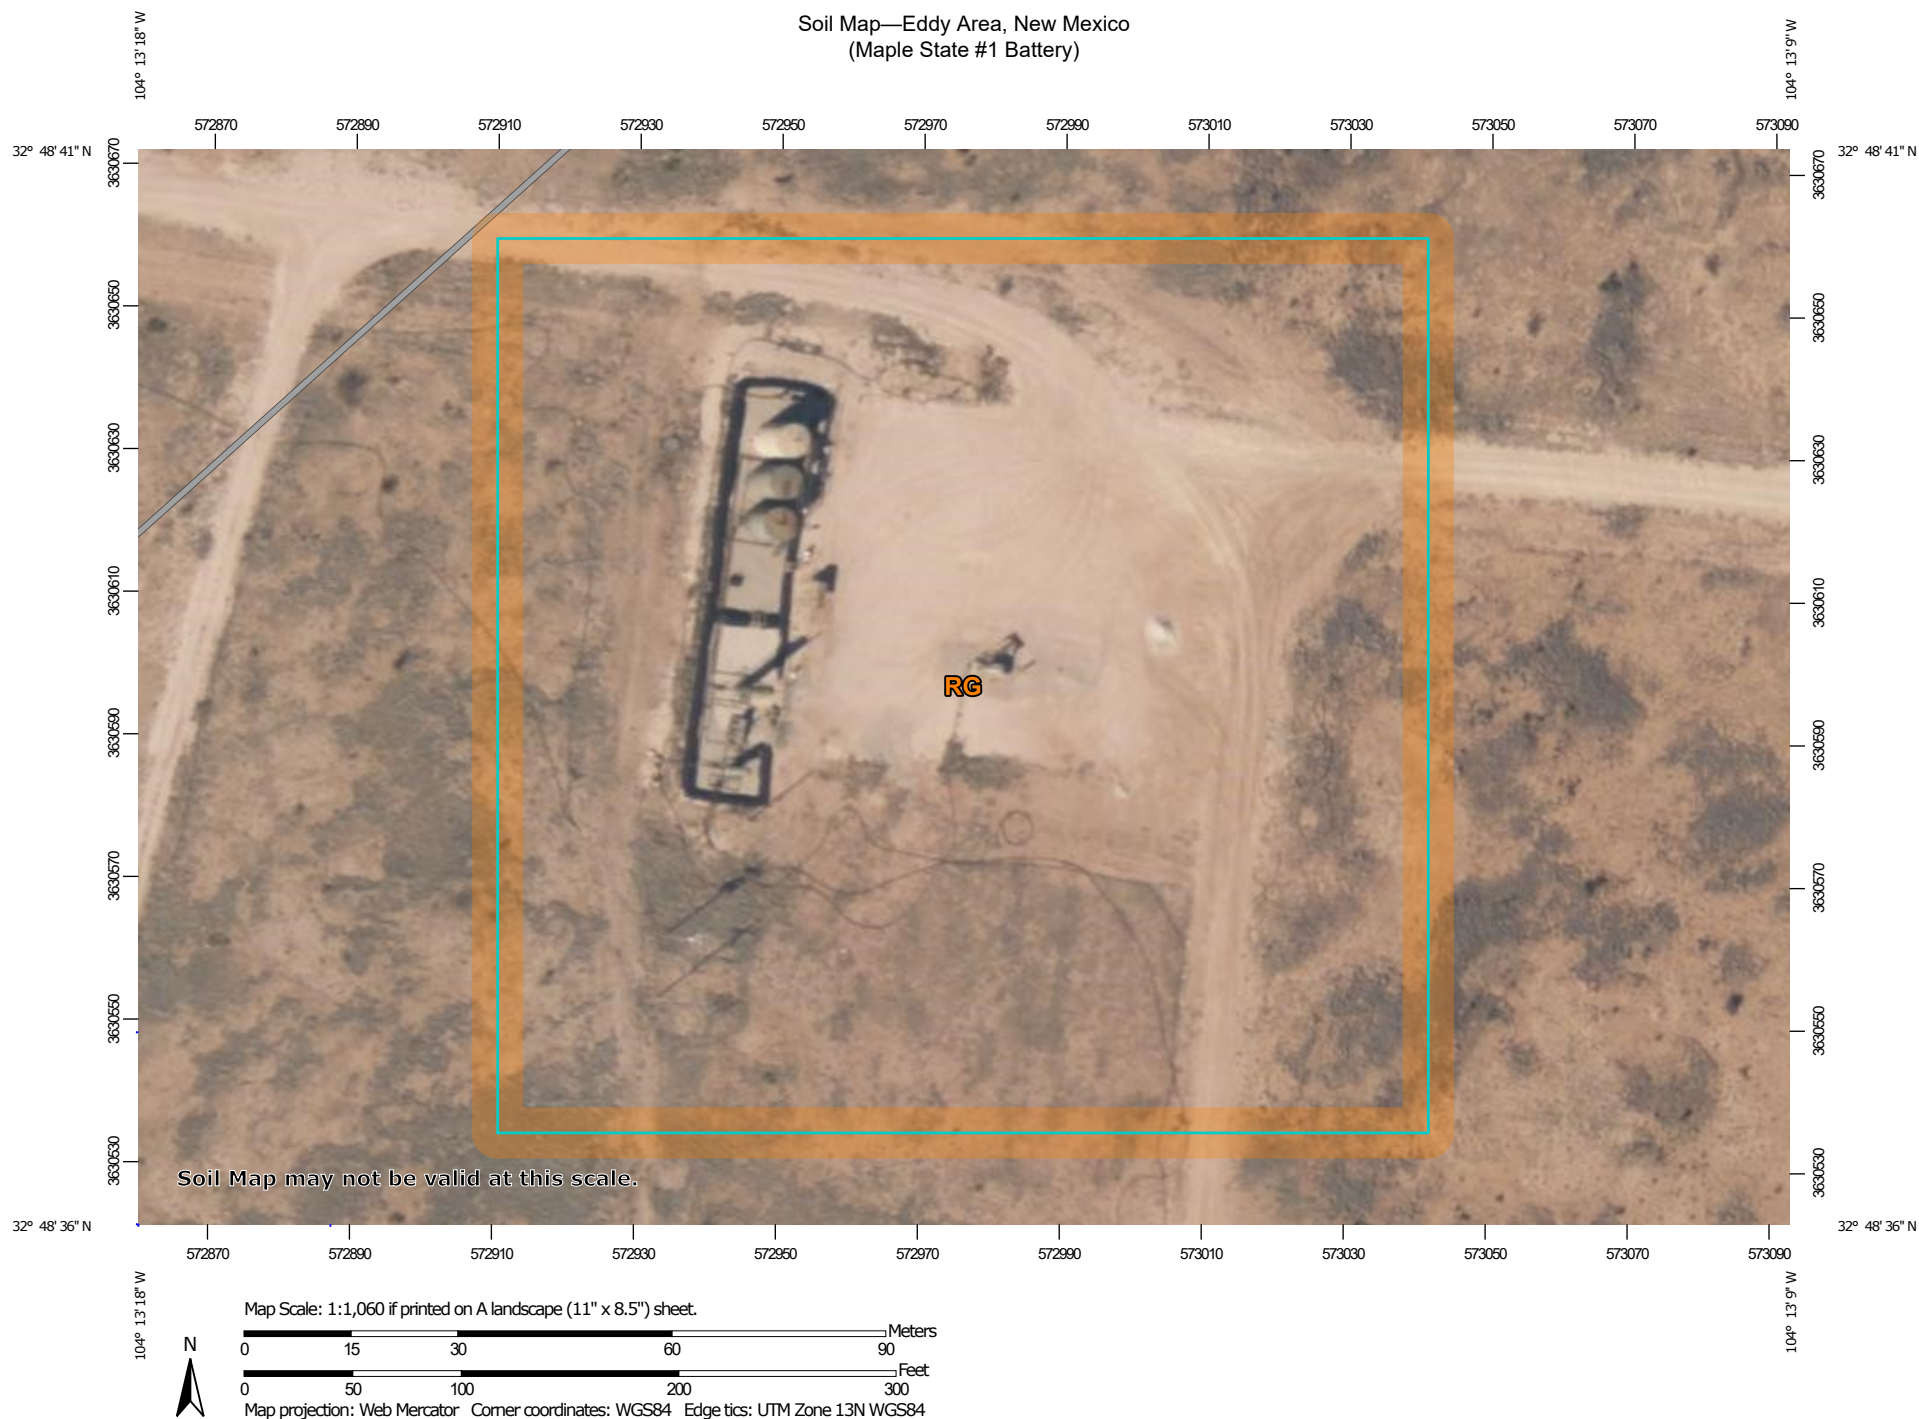
Soil Map—Eddy Area, New Mexico (Maple State #1 Battery)

The surrounding landscape is associated with the Reeves-Gypsum Land Complex, with 0 to 9 percent slopes. Elevation average around 3538 feet. The soil map and data are attached herein.

Map Unit Symbol	Map Unit Name	Acres in AOI	Percent of AOI
RG	Reeves-Gypsum land complex, 0 to 3 percent slopes	4.1	100.0%
Totals for Area of Interest		4.1	100.0%

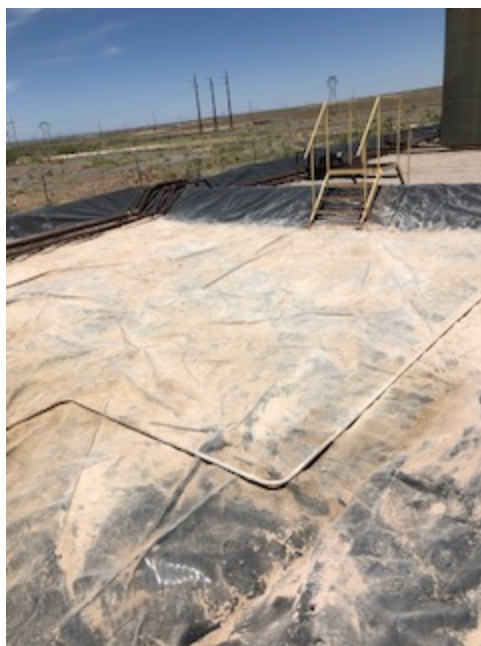
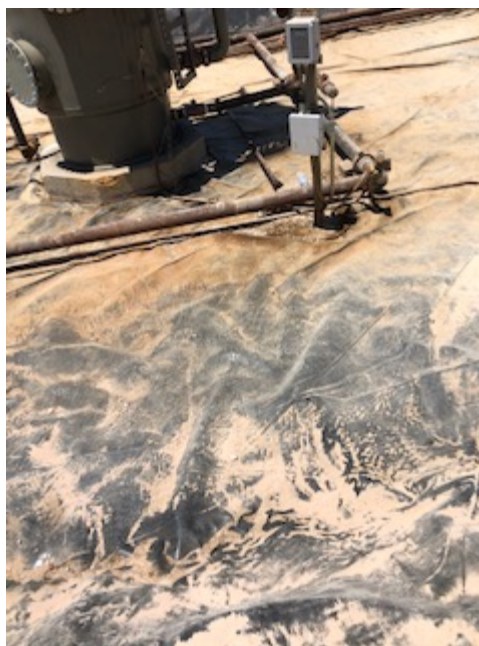
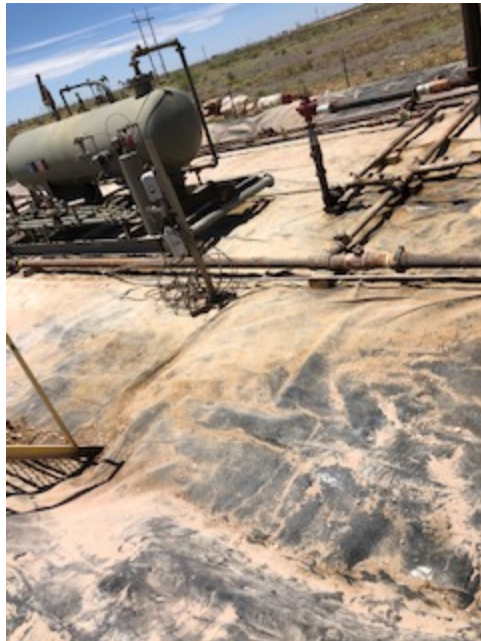
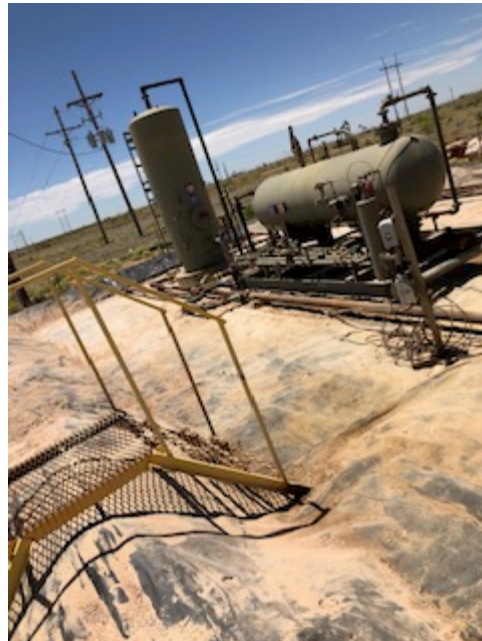
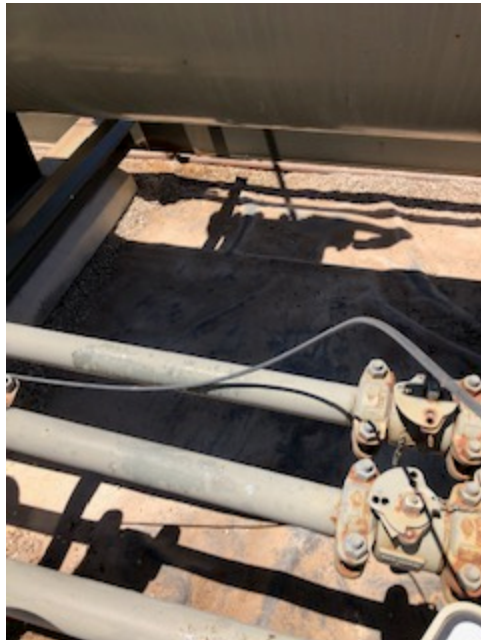
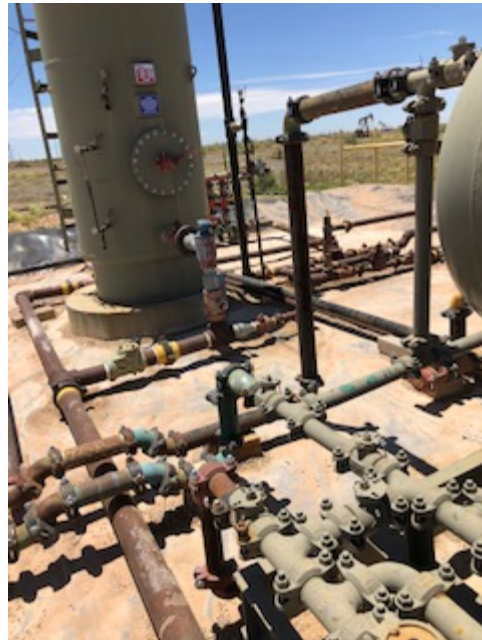
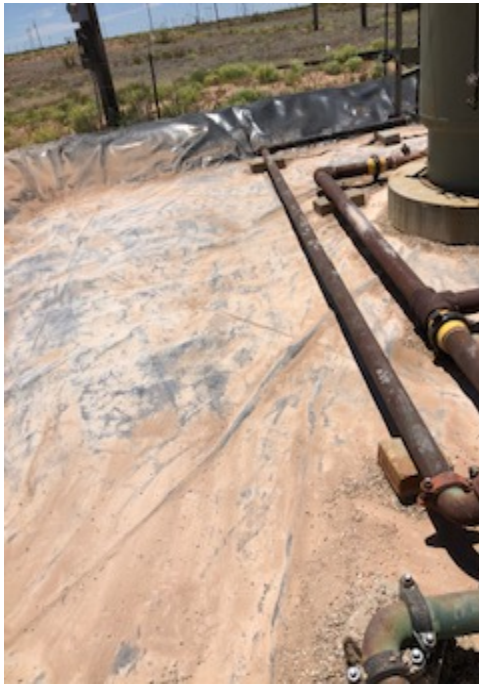
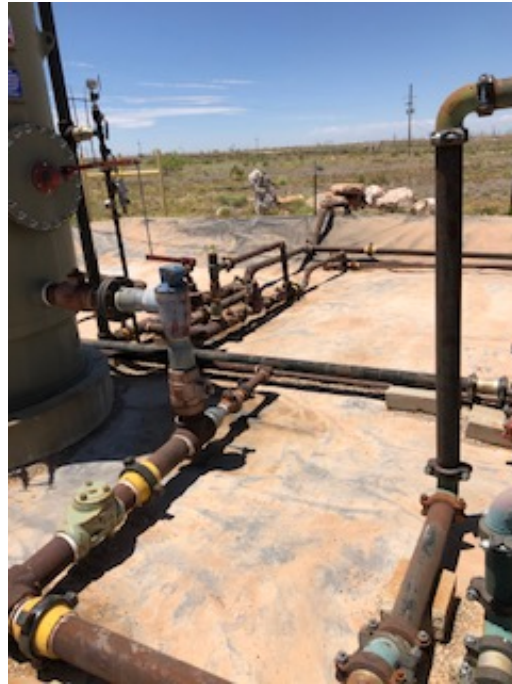
**MAPLE STATE #1 BATTERY
LINER PHOTOS**

ESS visited the site to photograph and visually inspect the liner. The liner is clear of any holes, punctures and or rips. No samples were taken under the liner due to liner not being compromised at this time.

Hungry Horse, LLC on or before June 1st of 2020, removed all of the impacted soil from on-top of the polyurethane liner and hauled the impacted material to Lea Landfill for Disposal. A total of 12.6 tons or 46.66 cubic yards of impacted soil was hand excavated, loaded into a dump truck and hauled to disposal. The liner was then washed and inspected for holes, punctures and rips. No issues were found. We do not have an email notification for the liner inspection request.

ESS recommends no additional actions are needed to address the release at the Maple State. There are no anticipated risks to human, ecological or hydrological receptors associated with the release site.
