**Re: Remediation Summary and Closure Report**  
**Natural Gas Gathering Line #11117 Leak Location 3**  
**GPS: Latitude 32.297579 Longitude -104.255423**  
**UL "P", Sec. 14, T23S, R26E**  
**Eddy County, New Mexico**  
**NMOCD Ref. No. NRM2016955206**

Tasman Geosciences (Tasman), on behalf of DCP Operating Company, LP (DCP), has prepared this Remediation Summary and Closure Report for the condensate and natural gas Release Site known as the Natural Gas Gathering Line #11117 Leak Location 3. Details of the release are summarized below:

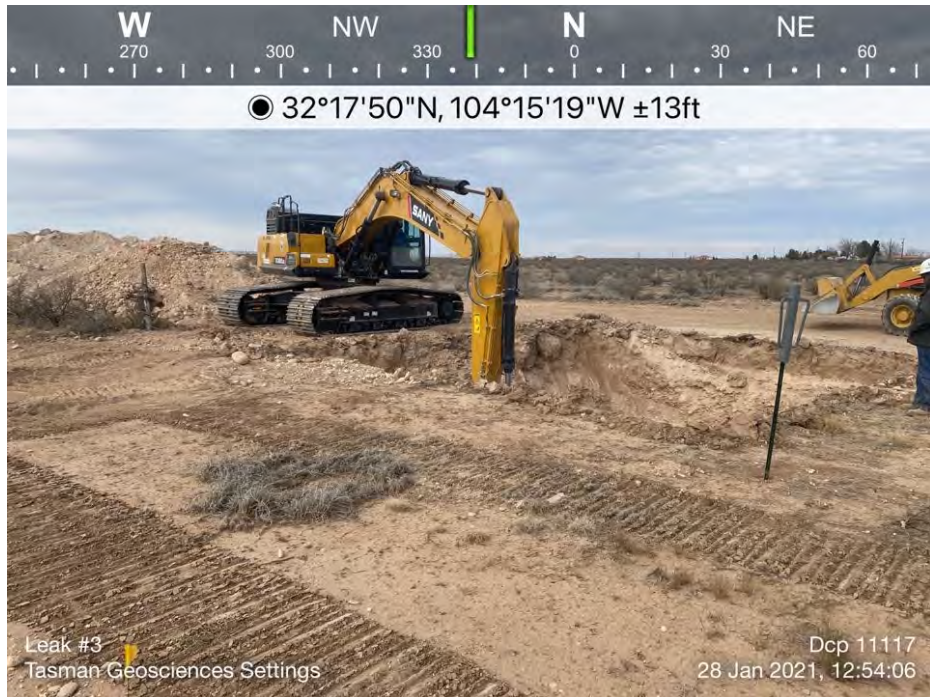
Excavating Release

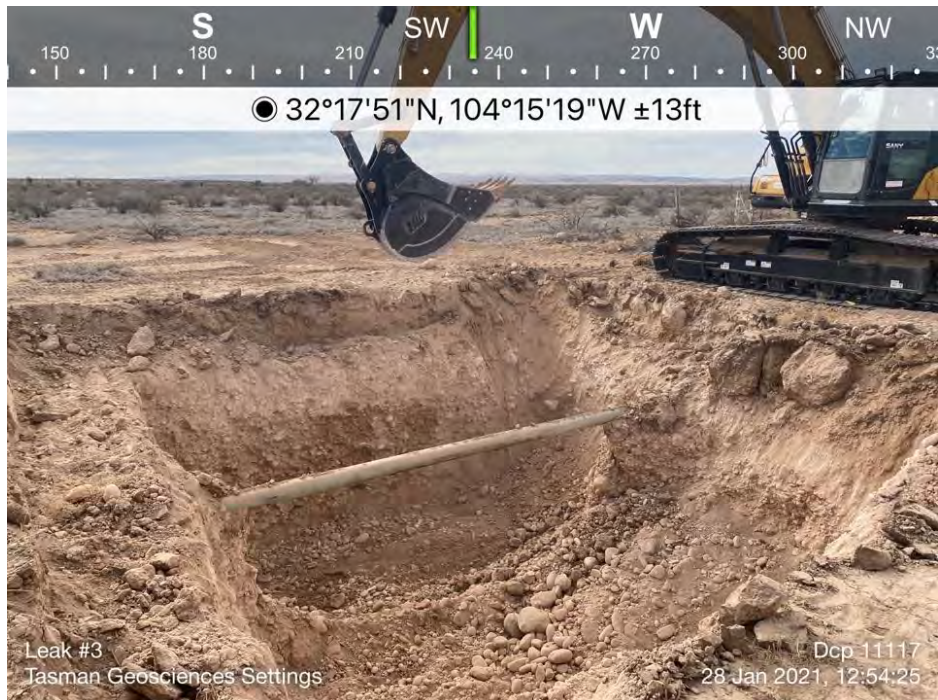
Excavating Release

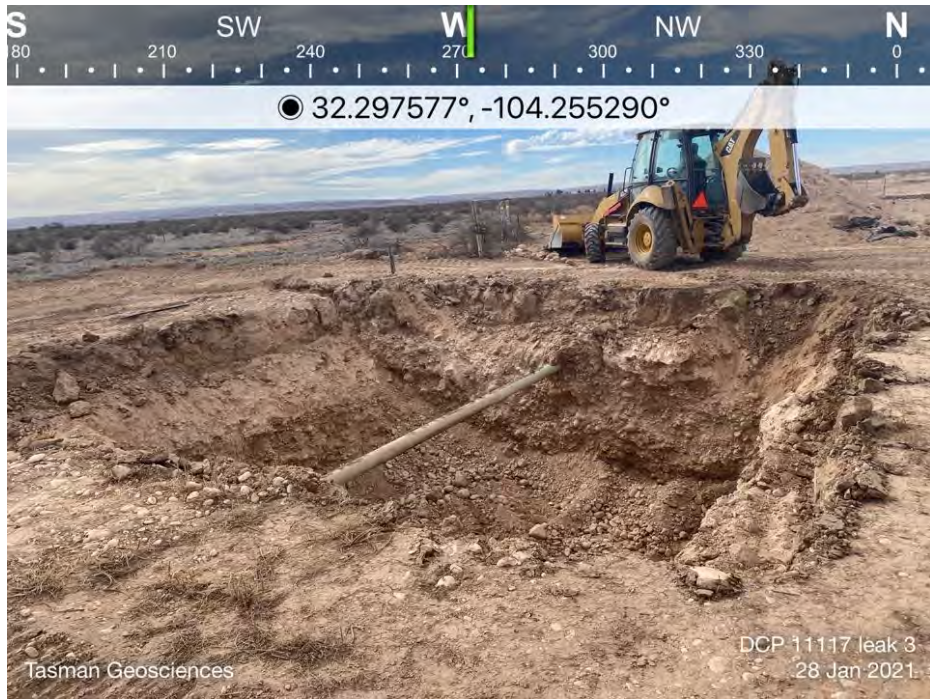
Excavation

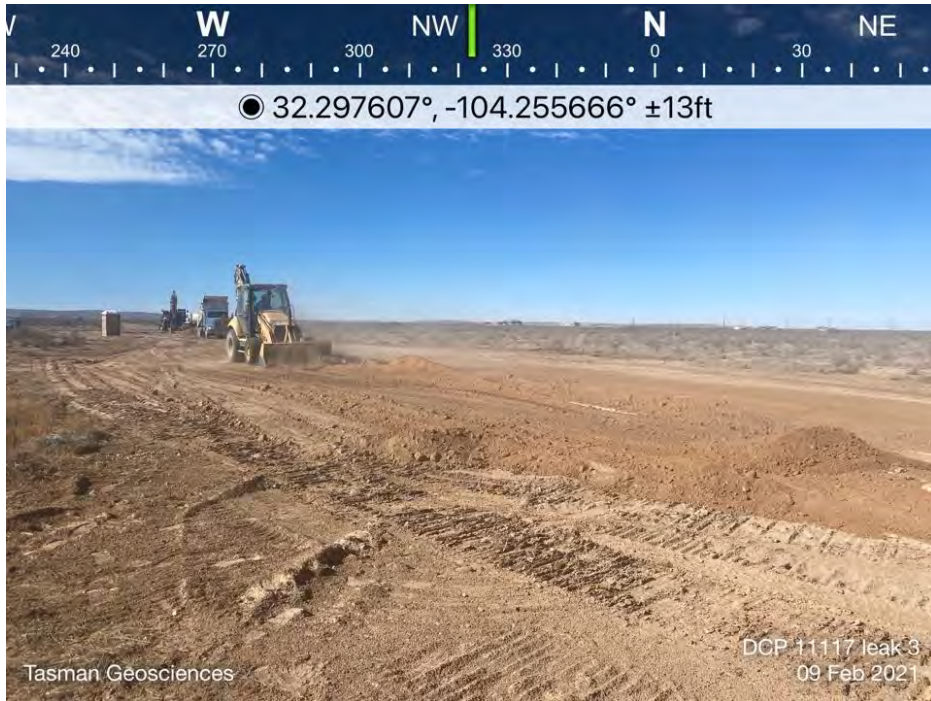
Backfilled Excavation
