## Release Notification

**RE: Revised Remediation Work Plan – SVE System  
James Ranch Unit #10 Battery  
Remediation Permit Numbers 2RP-3179, 2RP-3464, and 2RP-5243  
Eddy County, New Mexico**

LT Environmental, Inc. (LTE), on behalf of XTO Energy, Inc. (XTO), is pleased to present the New Mexico Oil Conservation Division (NMOCD) with this Revised Remediation Work Plan (Work Plan) for the James Ranch Unit #10 Battery (Site). The Site is located in Unit H, Section 1, Township 23 South, Range 30 East, in Eddy County, New Mexico (Figure 1).

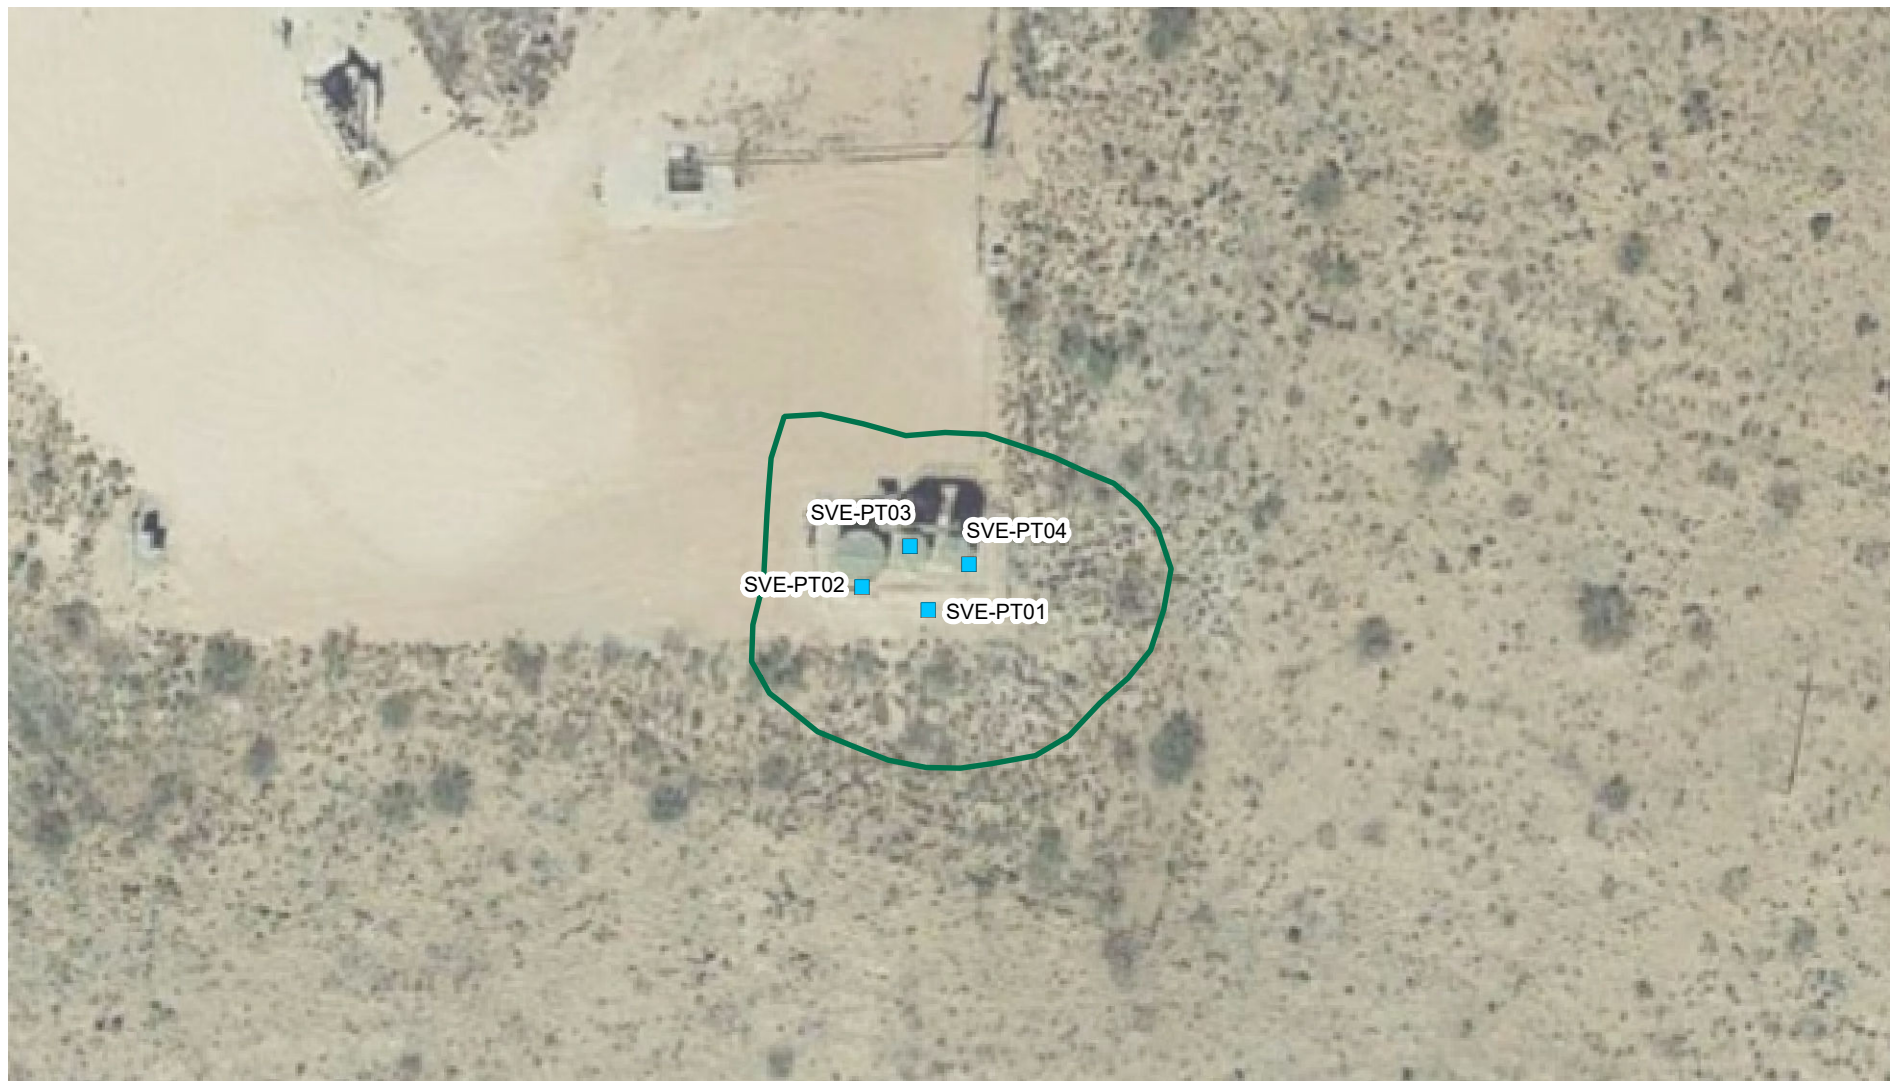
Four SVE wells (SVE-PT-01 through SVE-PT-04) were installed prior to testing in the locations presented on Figure 2. During the advancement of each SVE well, continuous soil sampling was conducted, which included describing the lithology based on the Unified Soil Classification System (USCS) as specified in American Society for Testing and Materials (ASTM) D2488, observations of staining and odors, and field screening of volatile aromatic hydrocarbons and chloride utilizing a calibrated photo-ionization detector (PID) and Hach® chloride QuanTab® test strips, respectively. Soil boring logs were completed at the time of drilling and are provided with the construction diagrams of the SVE wells as Attachment 2.

Vacuum was applied to two of the SVE wells (SVE-PT-01 and SVE-PT-04), while the other two SVE wells were utilized as observation wells (SVE-PT-02 and SVE-PT-03). SVE wells SVE-PT-02 and SVE-PT-03 will ultimately be utilized for full-scale SVE design. The SVE wells were screened across different lithologies observed in the subsurface to test applied vacuum responses and influence within those lithologies.
