# Closure Report

McIntyre B SWD Release  
NMOCD Reference No. NAPP2036441453

Terracon Project No. AR207572

RE: **Closure Report**  
McIntyre B SWD Release  
Unit O, Section 20, T17S, R30E, Eddy County, New Mexico  
Terracon Project No. AR207572

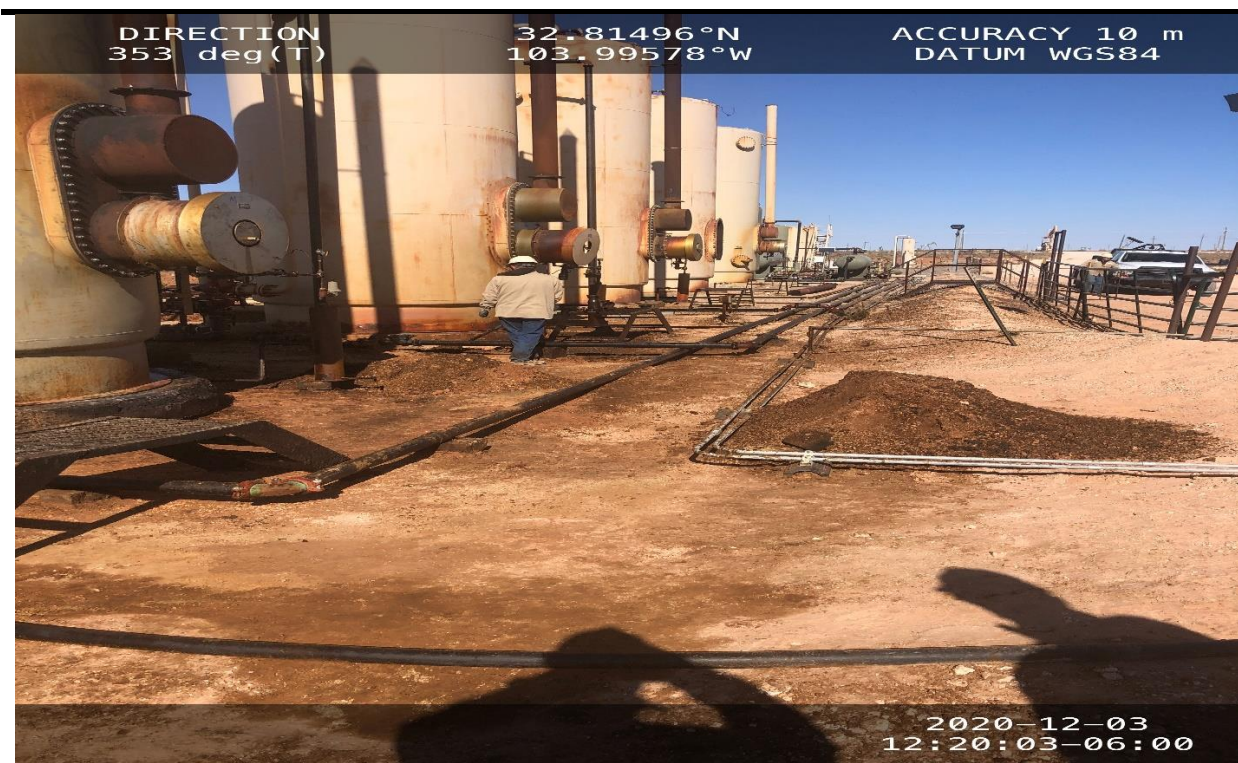
PHOTO 1: View of spill and tank battery, facing north. 12-3-2020

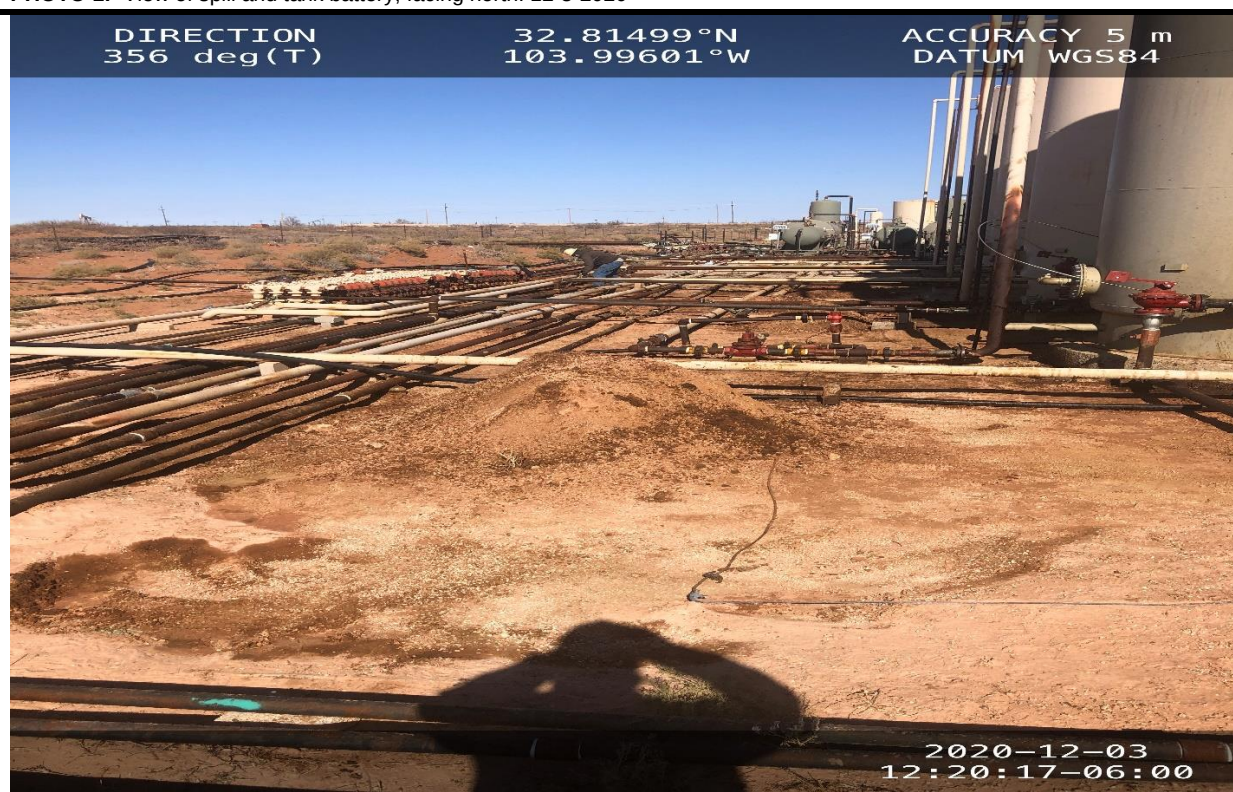
PHOTO 2: View of spill and tank battery, facing north. 12-3-2020

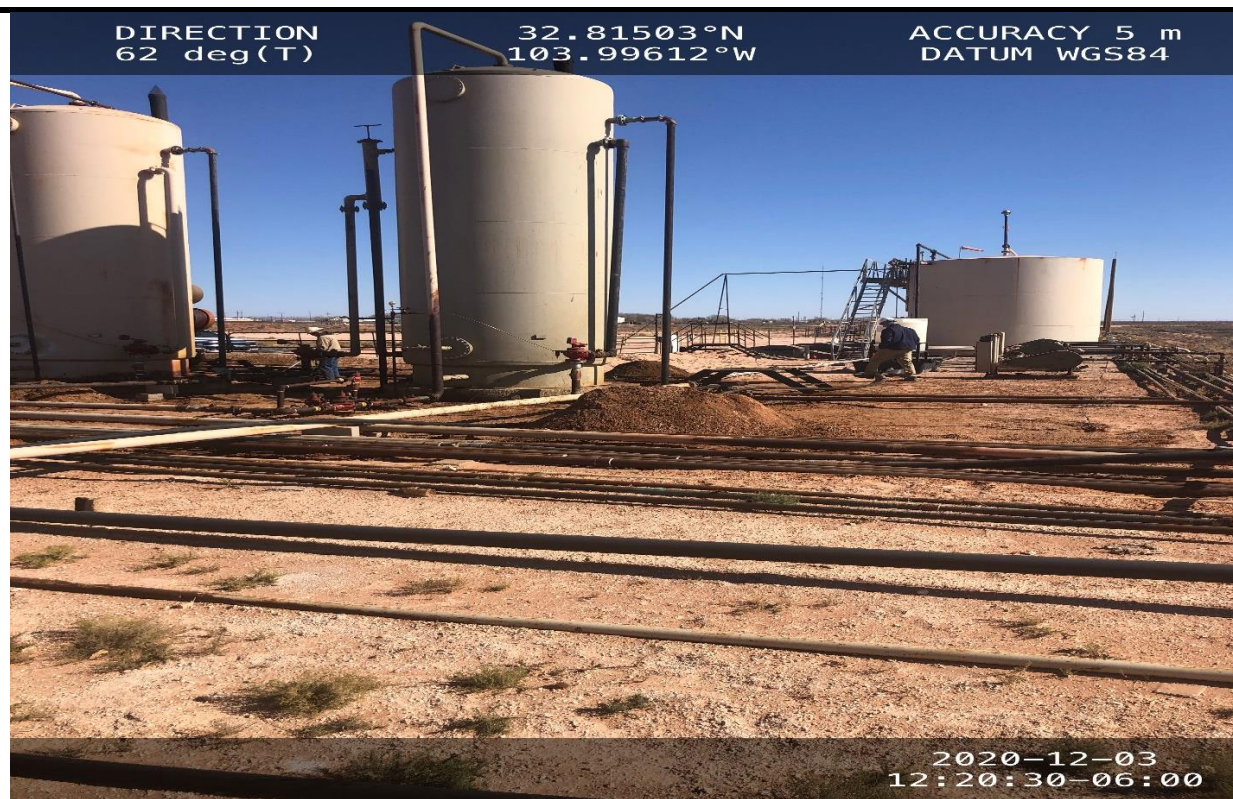
**PHOTO 3:** View of tank battery and excavated area, facing east. 12-3-2020

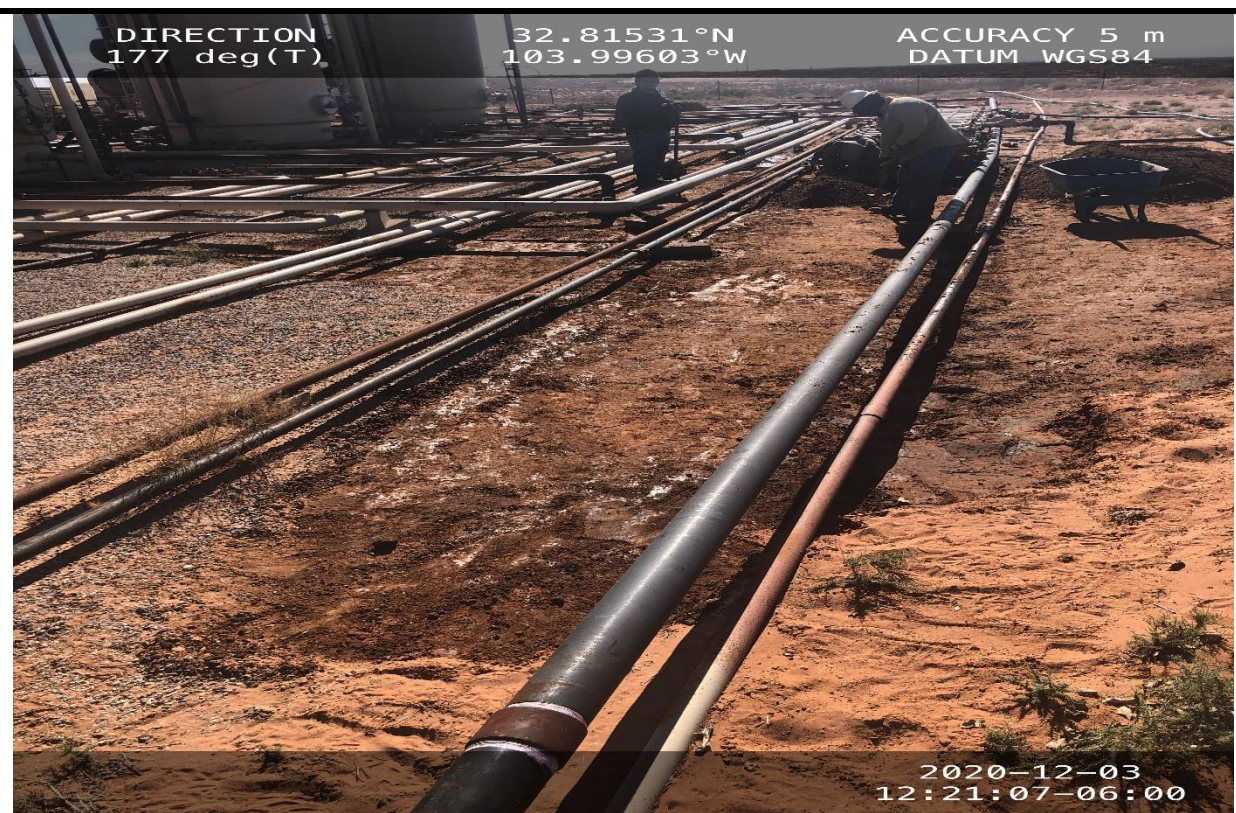
PHOTO 5: View of spill and tank battery, facing south. 12-3-2020

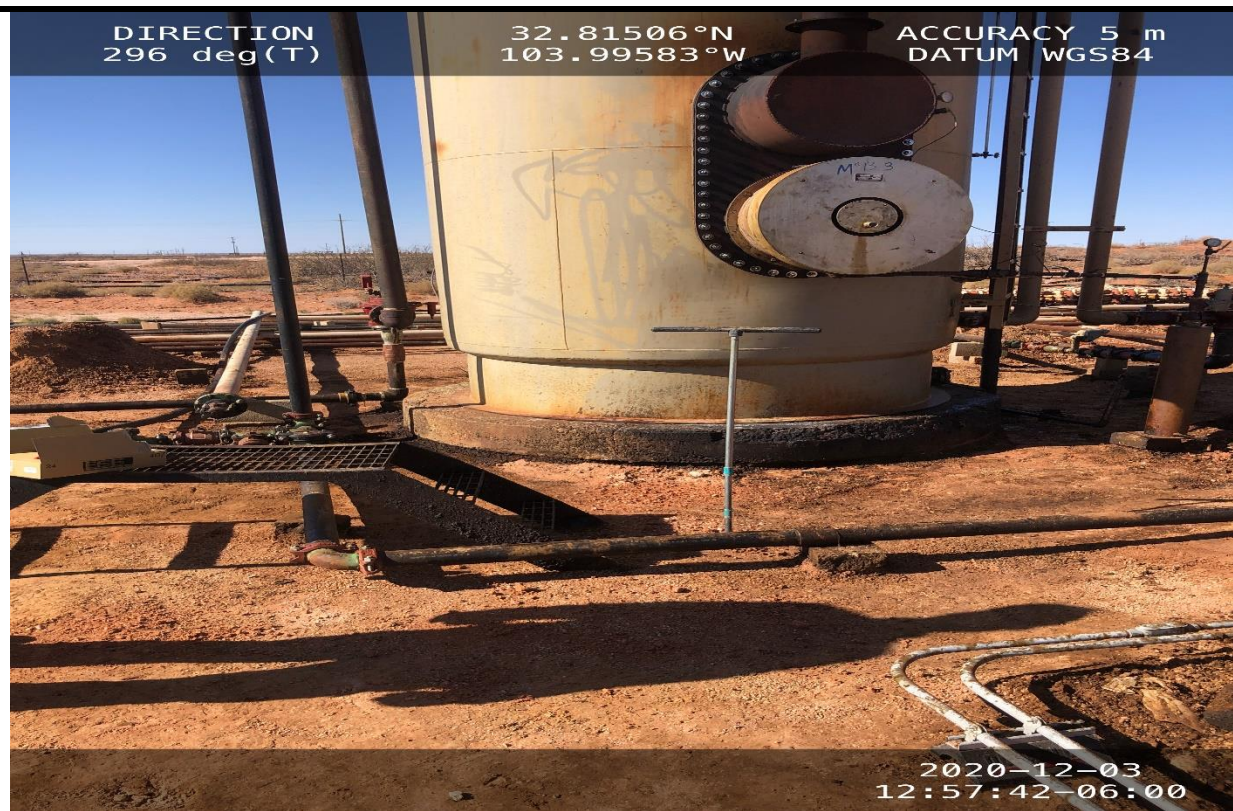
PHOTO 7: View of HA-3, facing northwest. 12-3-2020

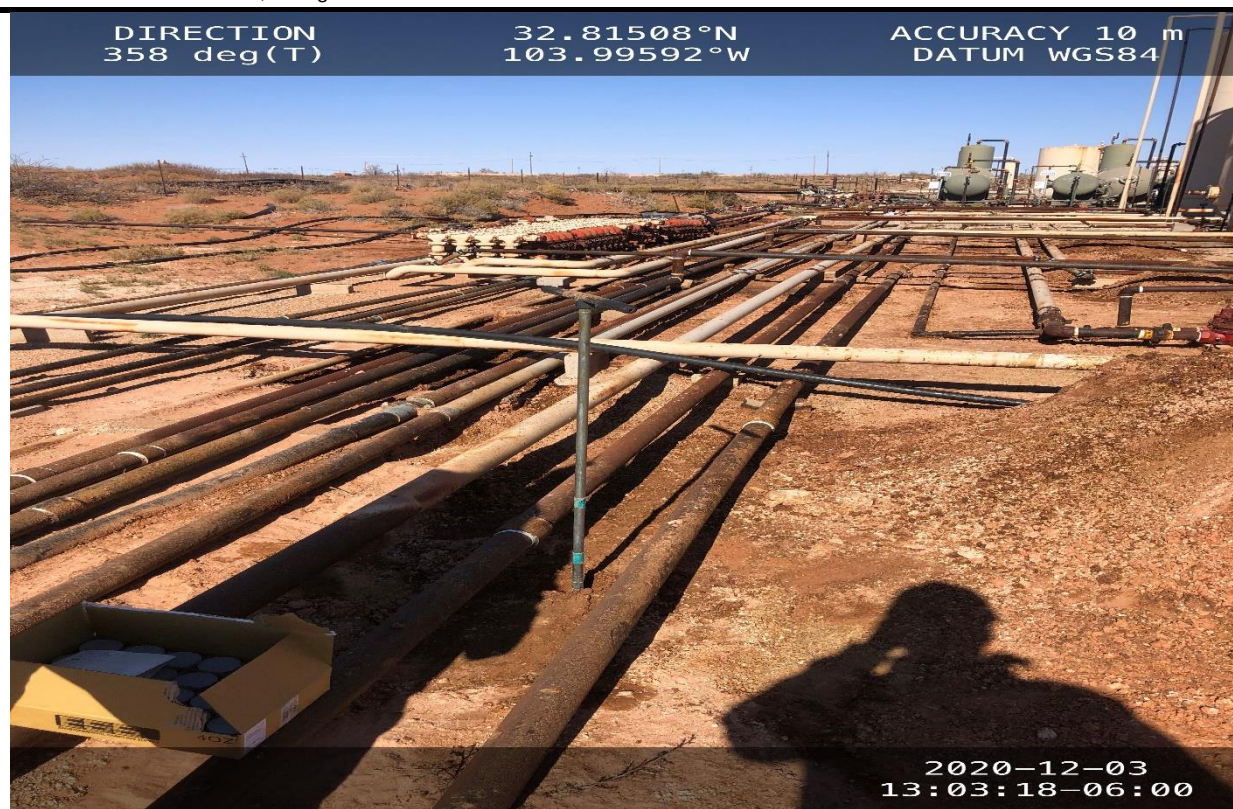
PHOTO 8: View of HA-4, facing north. 12-3-2020

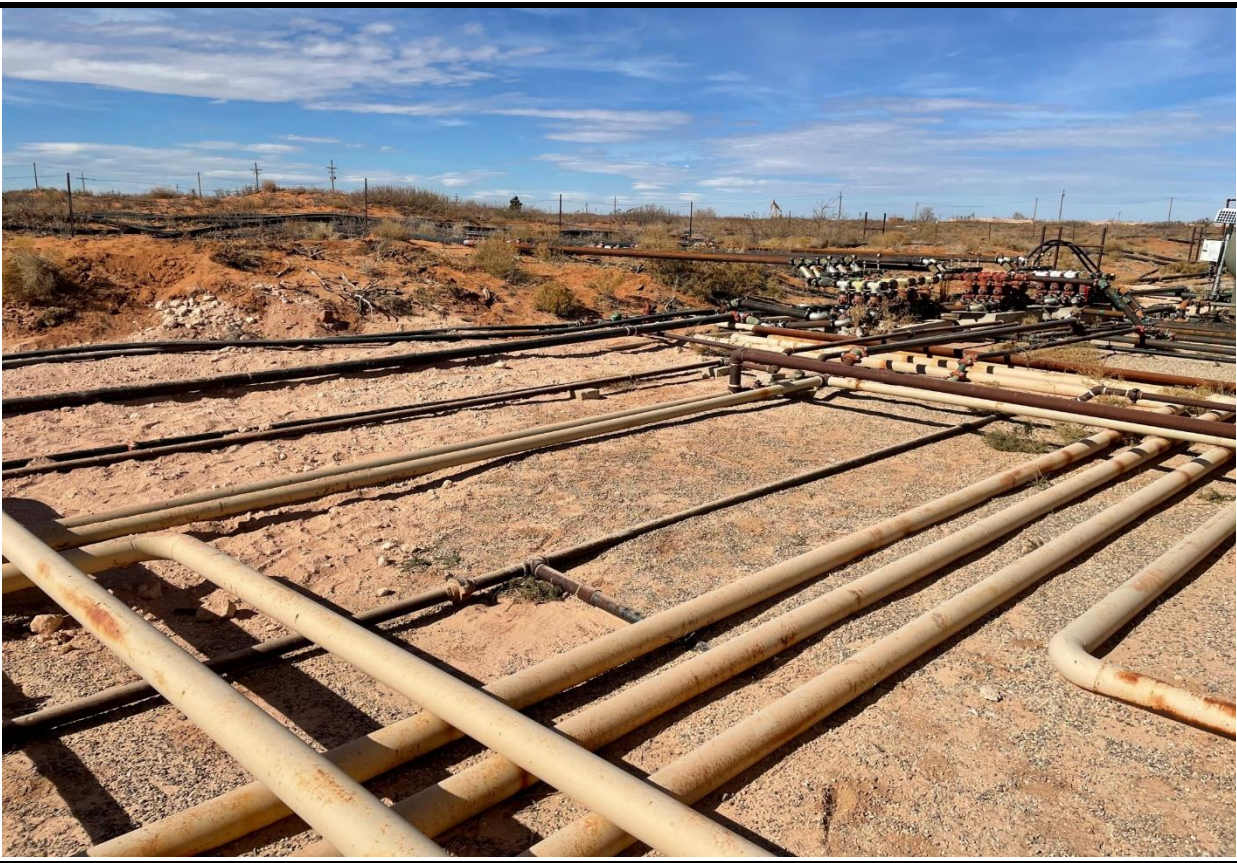
**PHOTO 9:** View of remediated area, facing northwest. 2/3/2021

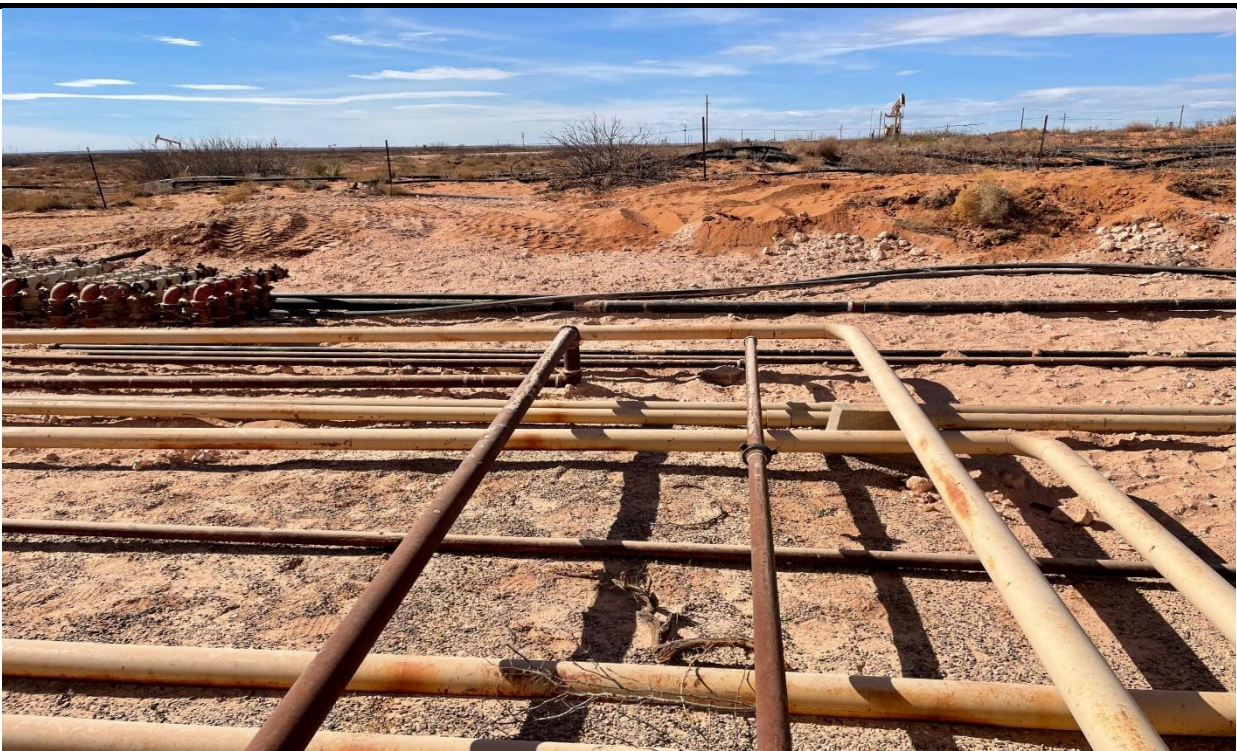
**PHOTO 10:** View of remediated area, facing west. 2/3/2021

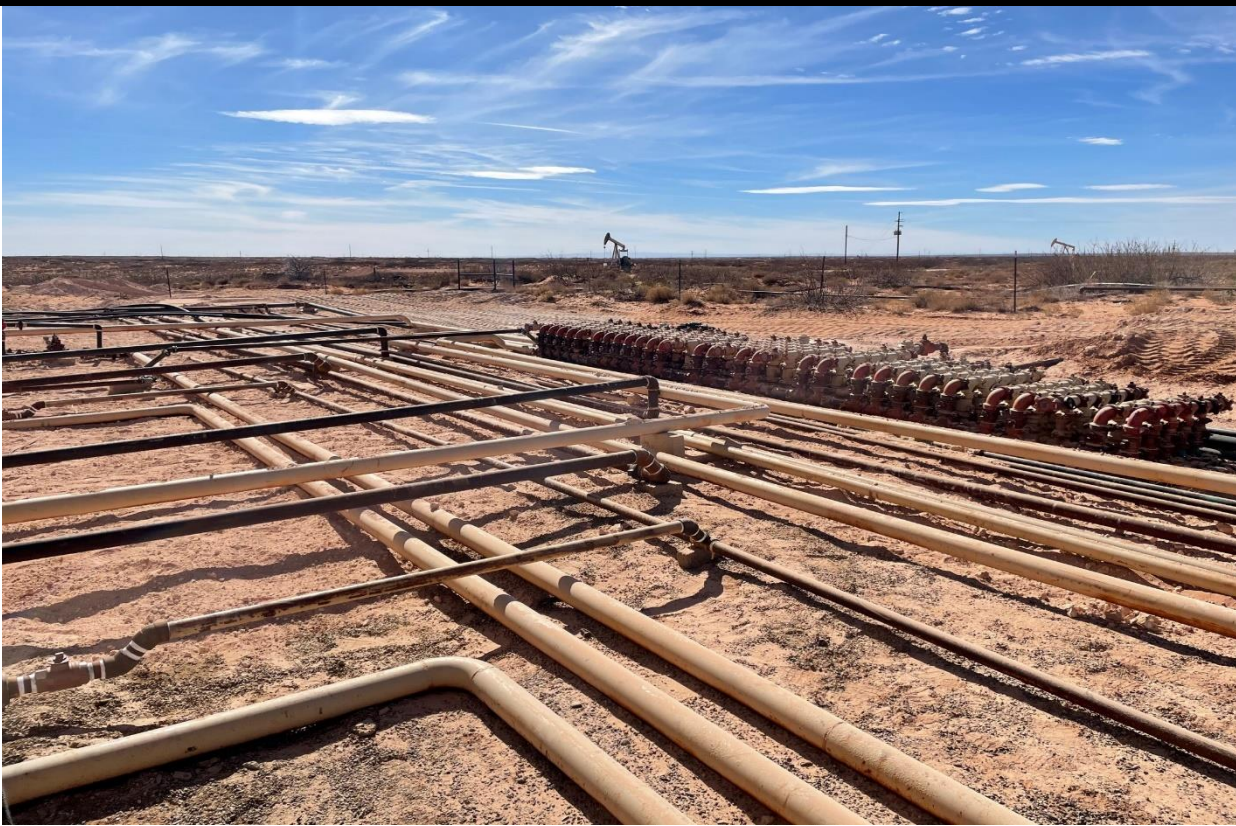
**PHOTO 11:** View of connectors and remediated area, facing southwest. 2/3/2021

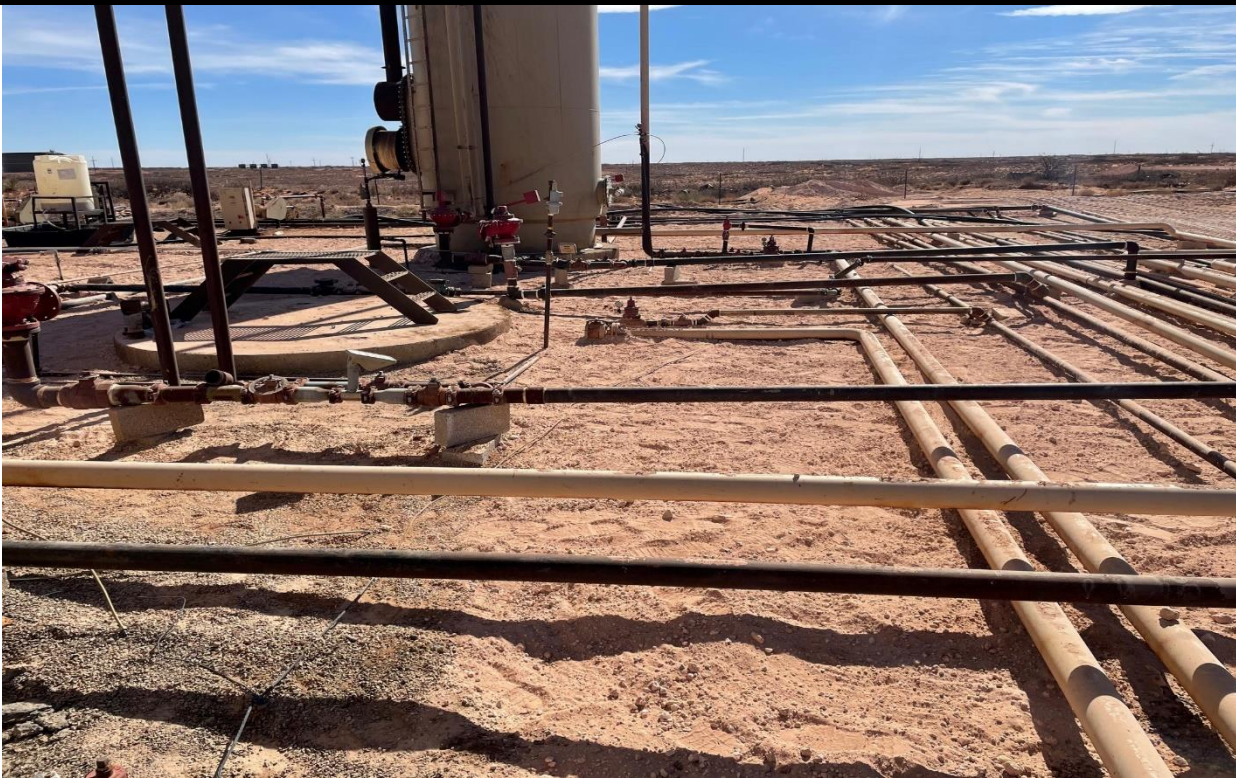
**PHOTO 12:** View of tank battery and remediated area, facing east. 2/3/2021

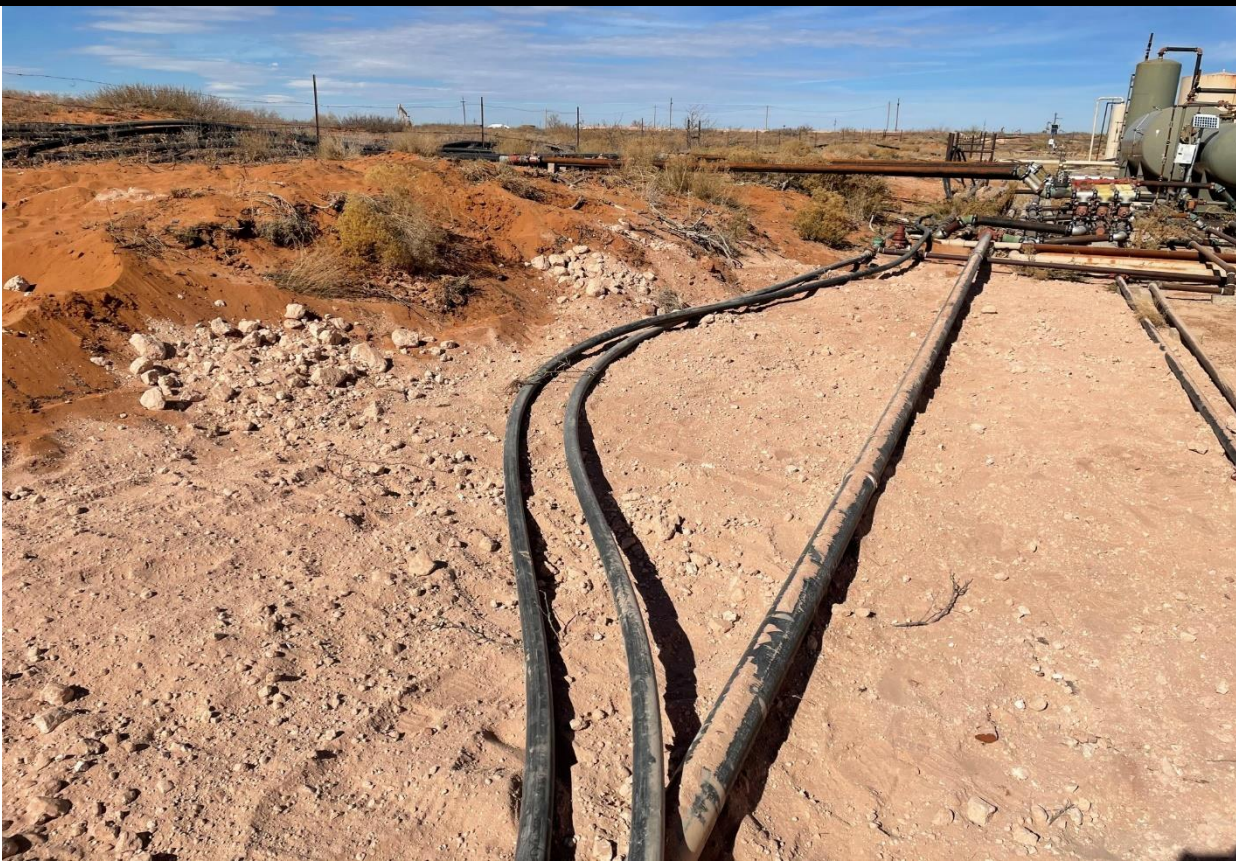
**PHOTO 13:** View of remediated area, facing north. 2/3/2021

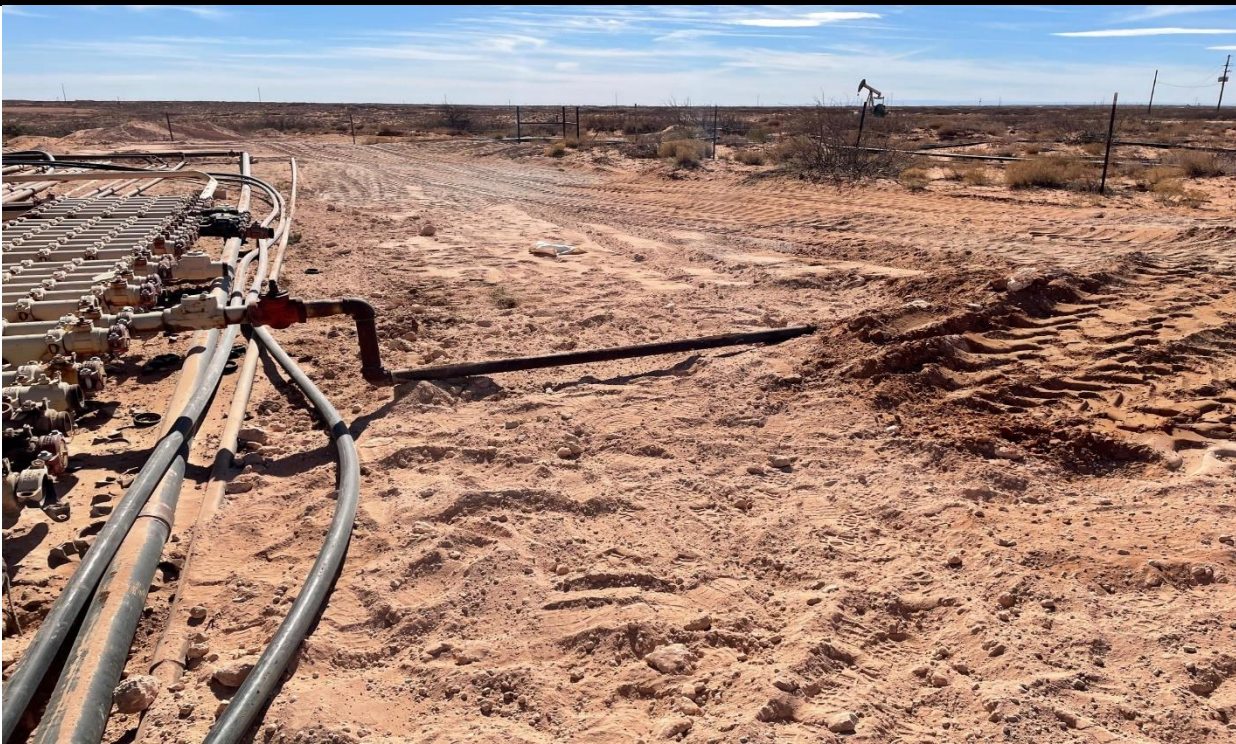
**PHOTO 14:** View of remediated area, facing south. 2/3/2021

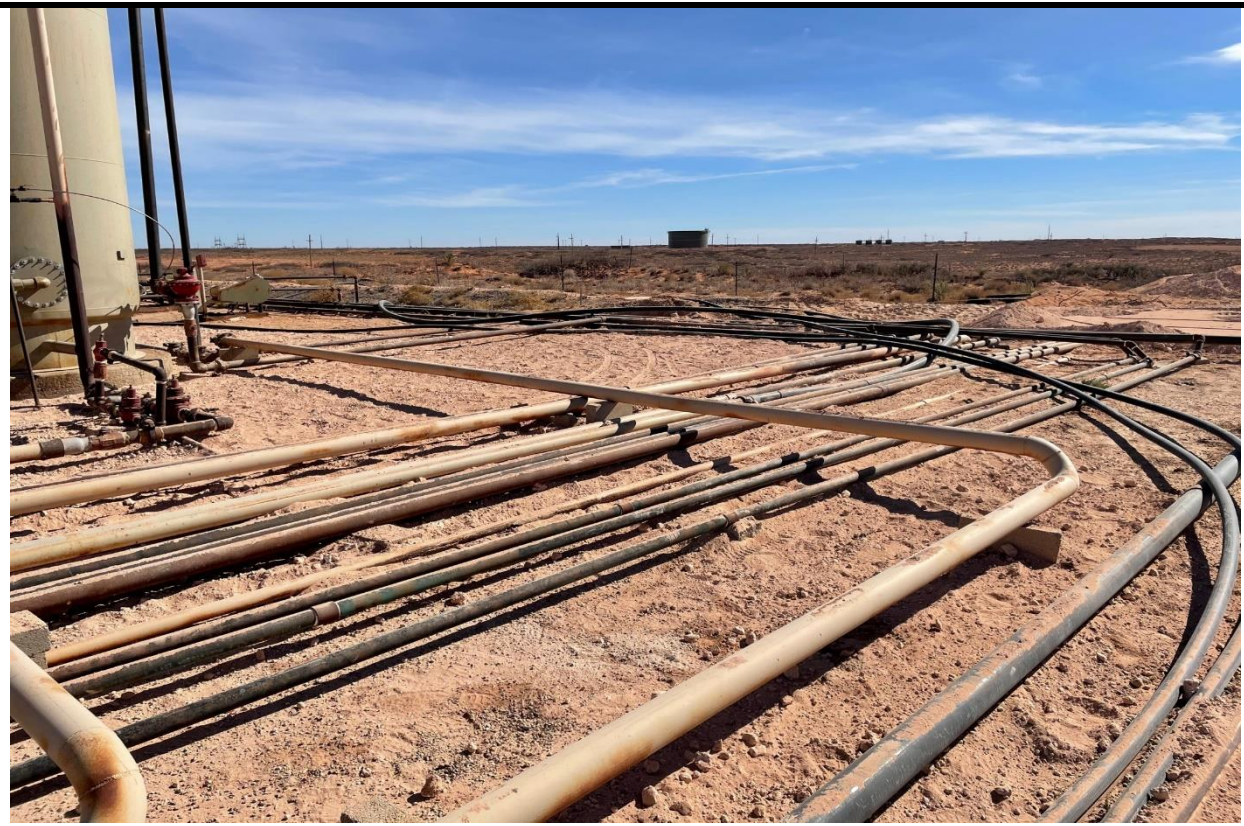
**PHOTO 15:** View of tank battery and remediated area, facing southeast. 2/3/2021

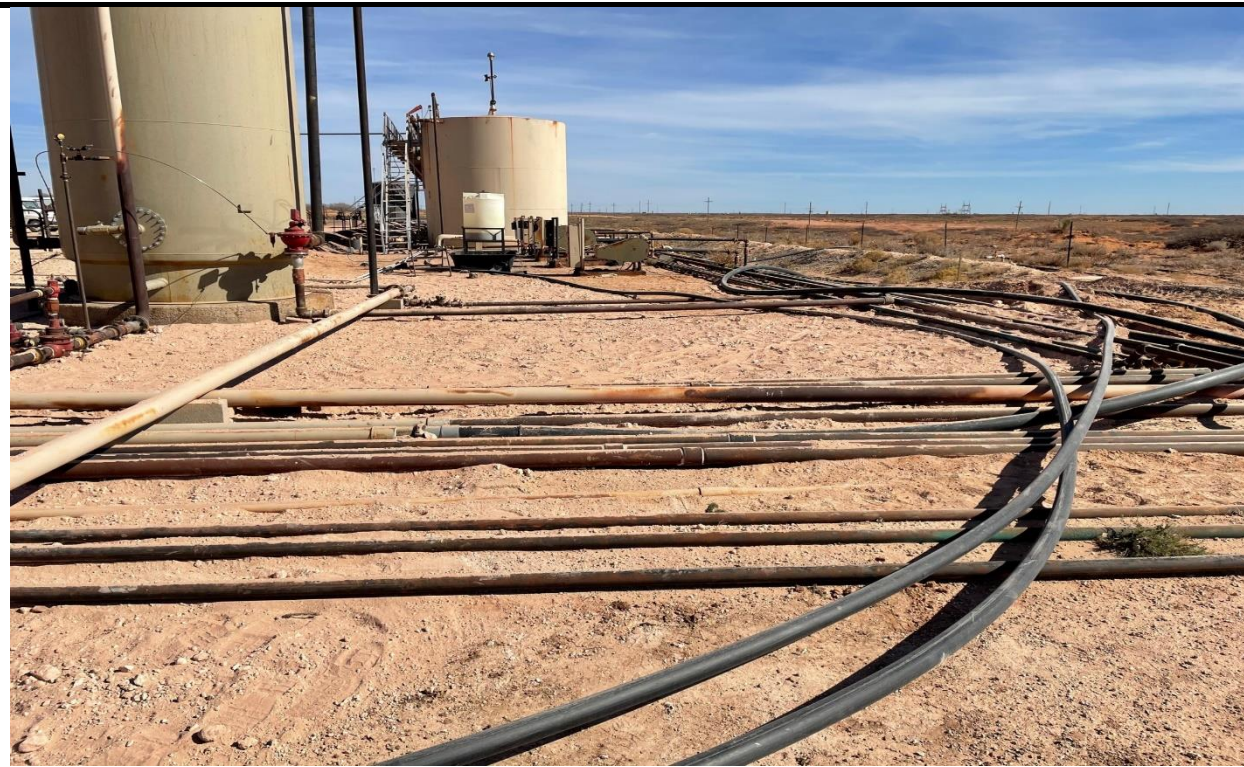
**PHOTO 16:** View of tank battery and remediated area, facing east. 2/3/2021

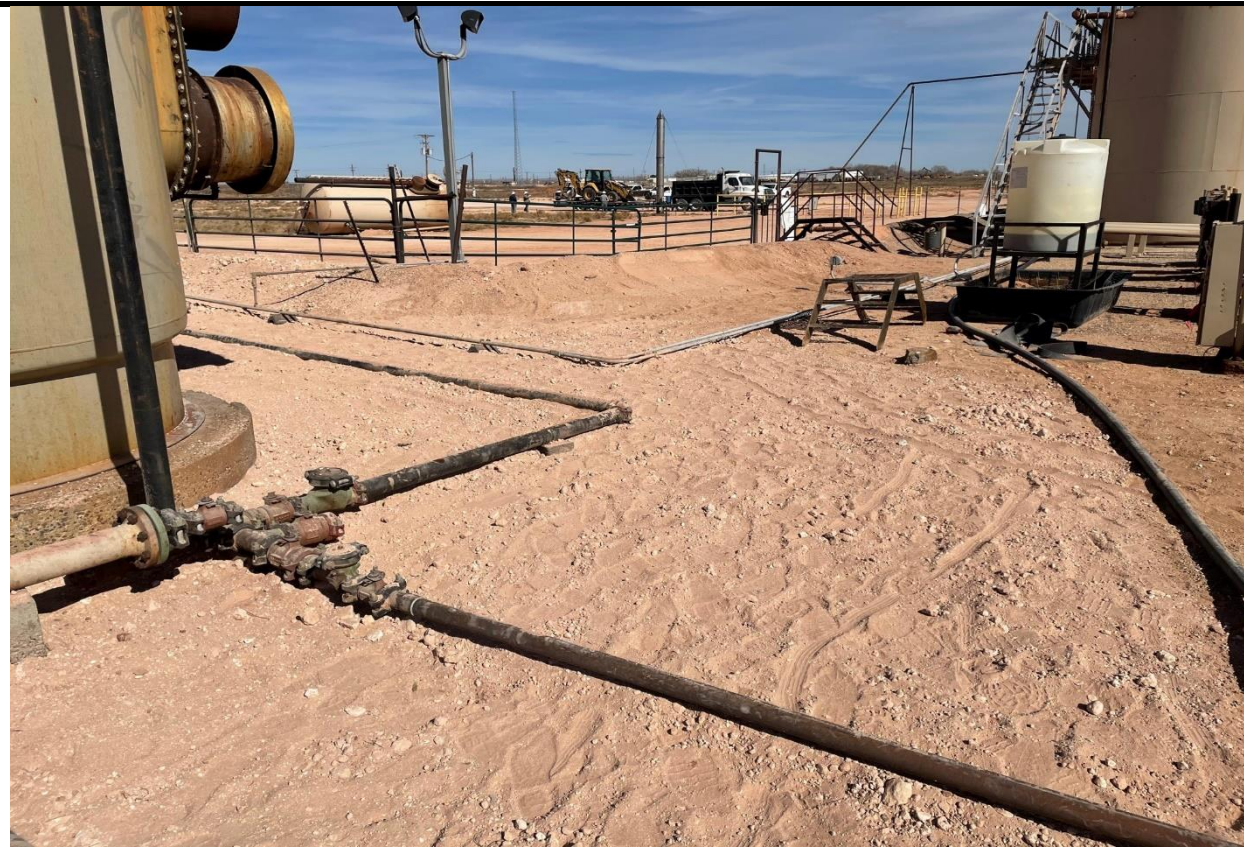
**PHOTO 17:** View of tank battery and remediated area, facing northeast

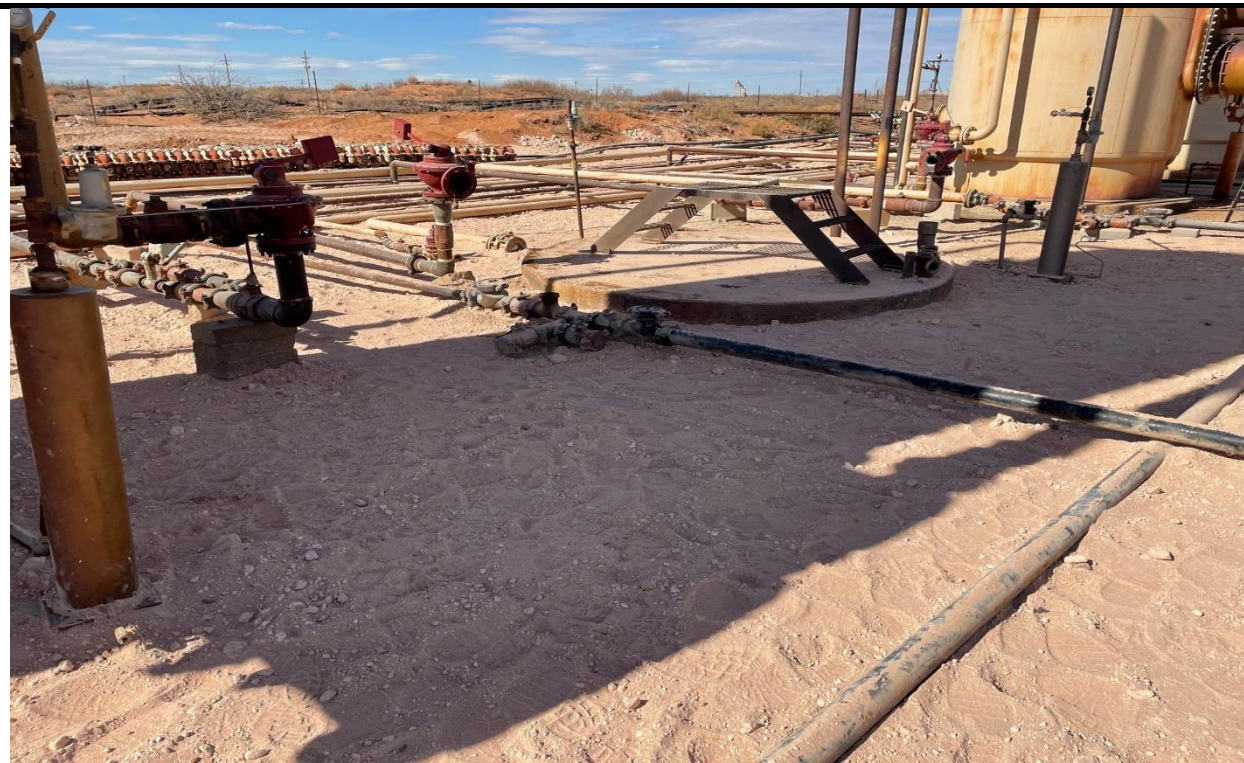
**PHOTO 18:** View of tank battery and remediated area, facing northwest. 2./3/2021
